# AAC - HEBT/Ring/RTBT Overview

Feb. 2 - 4, 2010

by Mike Plum

Ring Area Manager

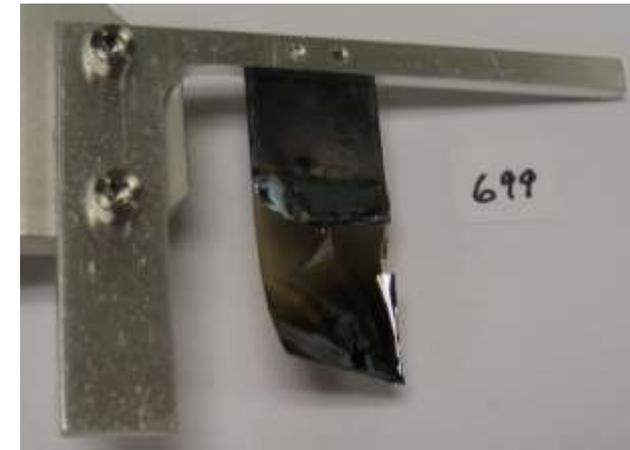
Typical foil damage before May 3

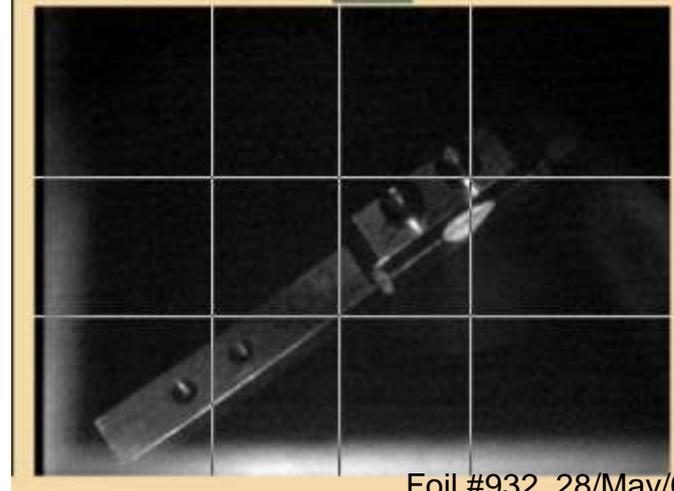
Foil #932, 28/May/09

(Failed June 12)

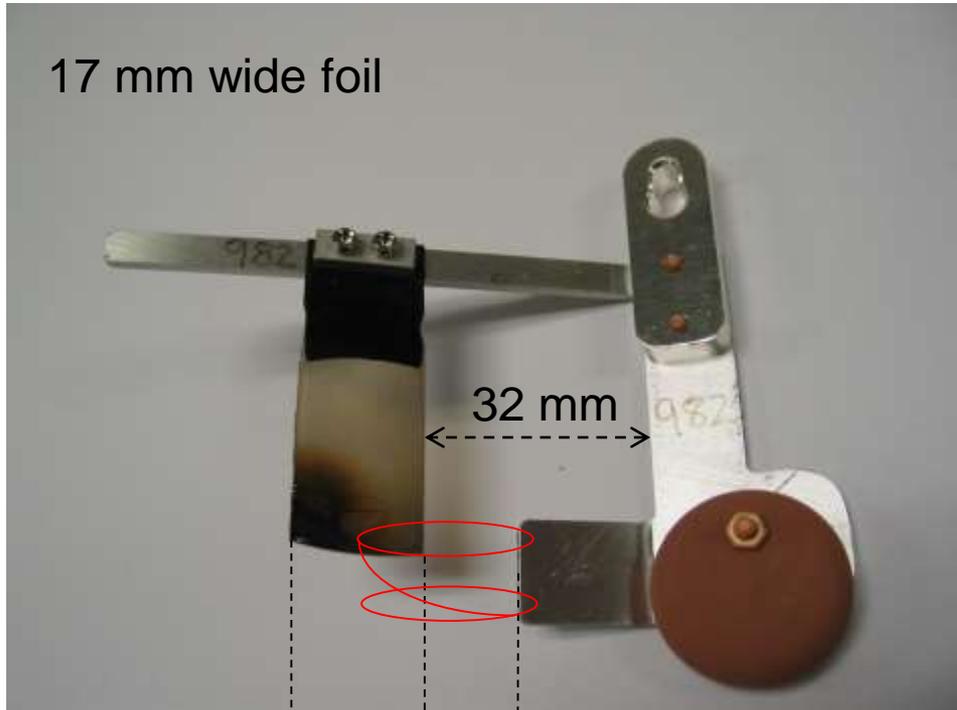
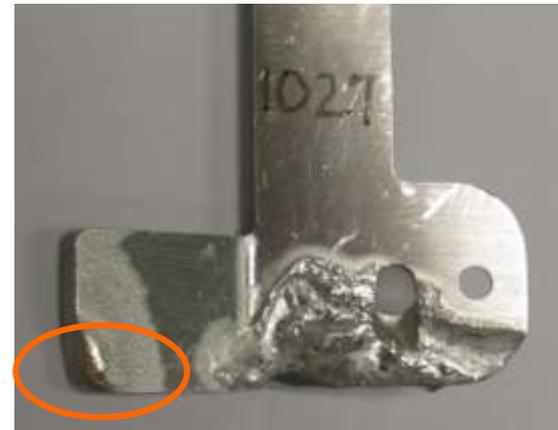
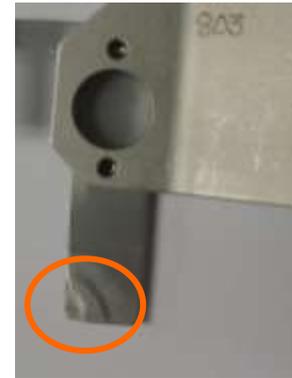
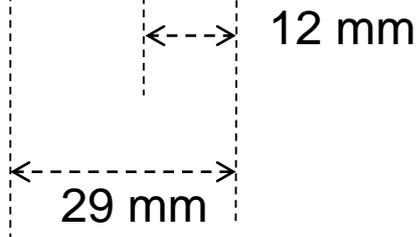
All this melted aluminum evaporated and was deposited on the vacuum chamber walls, other foil brackets, and everything else in sight

Foils should be mounted >24 mm horizontally from the bracket. All new foils will be mounted at the “+1 cm” position. Also helps to use high temperature material for brackets.

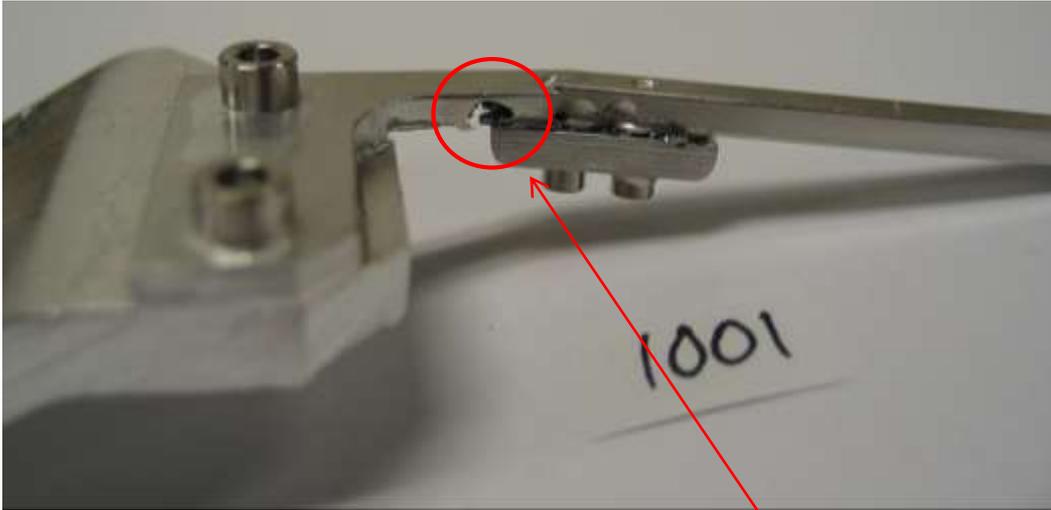
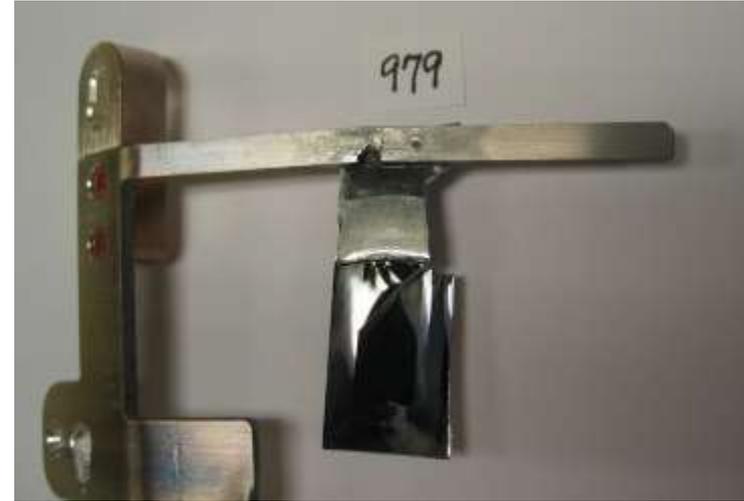
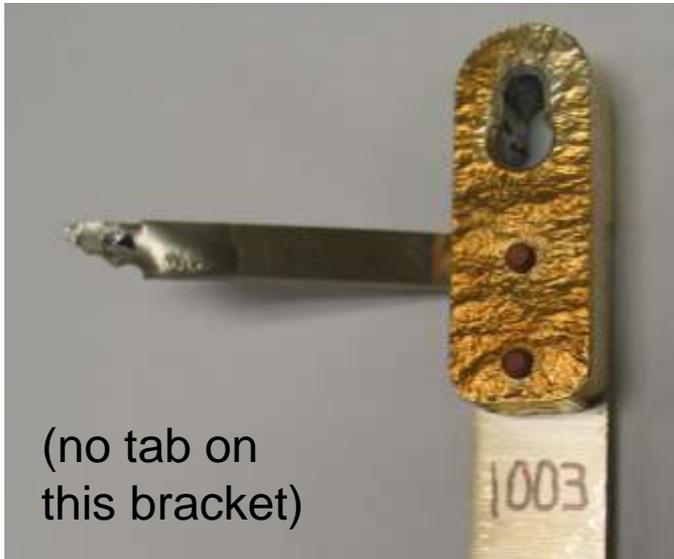
Clearest evidence to date of vacuum breakdown

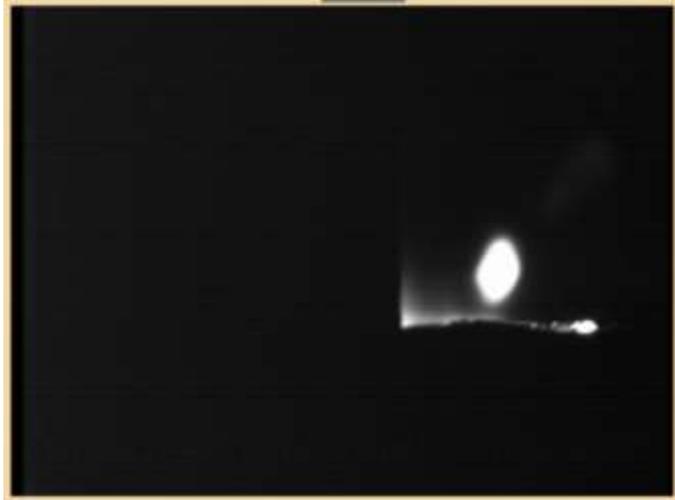
Beam on (1.02 MW, 18/Sep9)

- “Hot spots” on the bottom edge of the foil were observed for the first time in September 2009. They are visible at 600 kW, maybe less... Not always just on the bottom edge.
- Most likely explanation is anode-spot in-vacuum breakdown. If so, this could actually be helping us.
- Next most likely explanation is something nearby, with some thermal mass, glowing visibly hot. This light is then reflected off the foil.

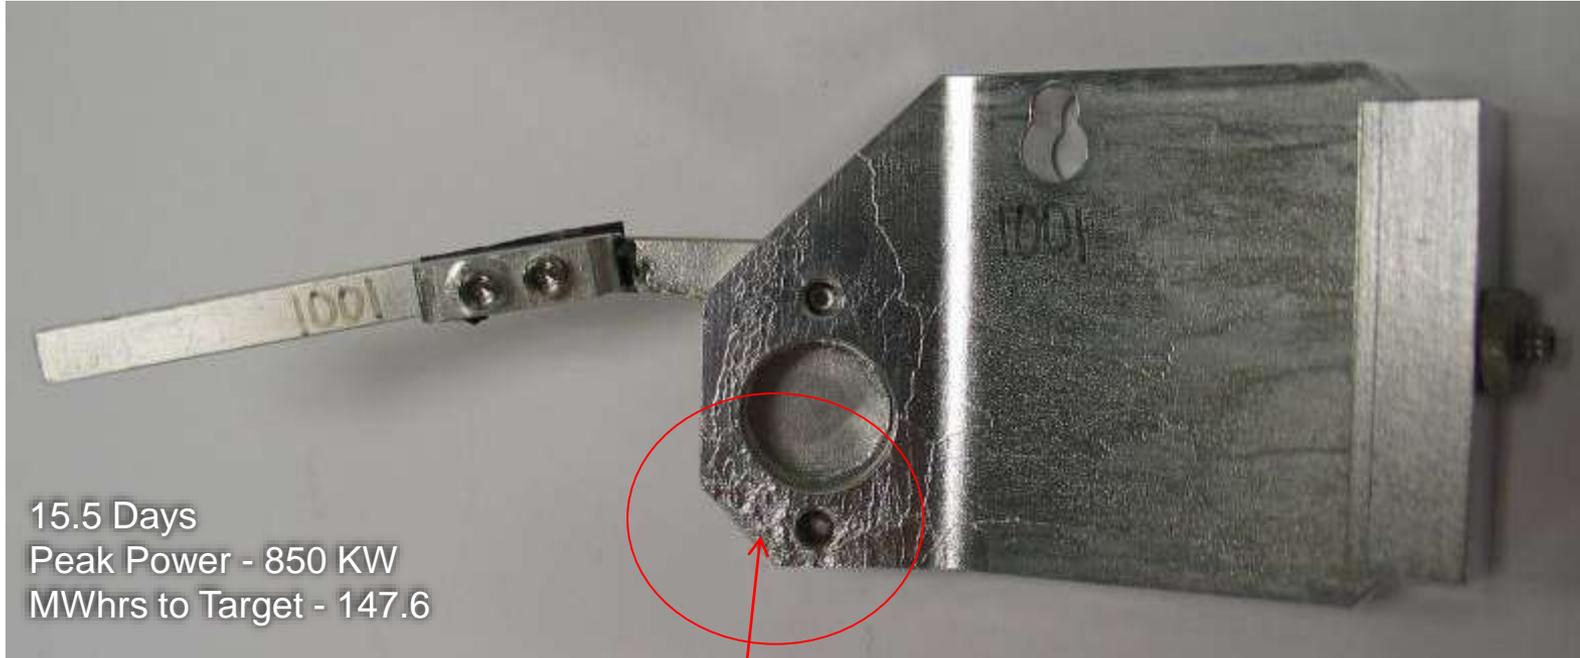
Reflected convoy electron damage?

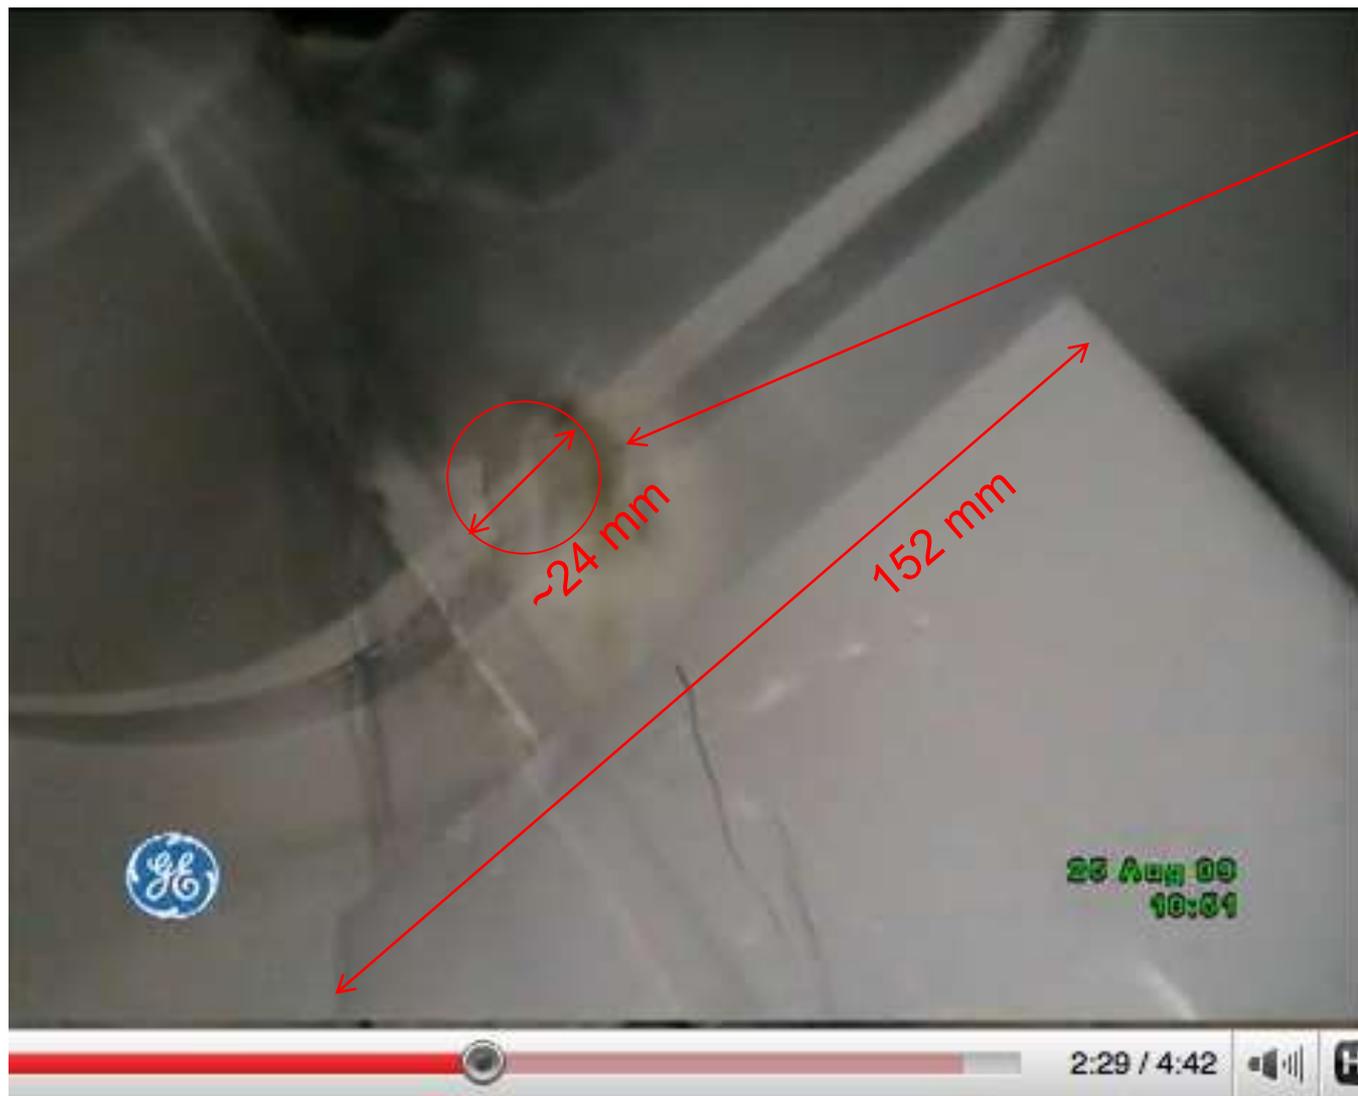
Could be reflected  
convoy electrons  
or trailing-edge  
multipactoring

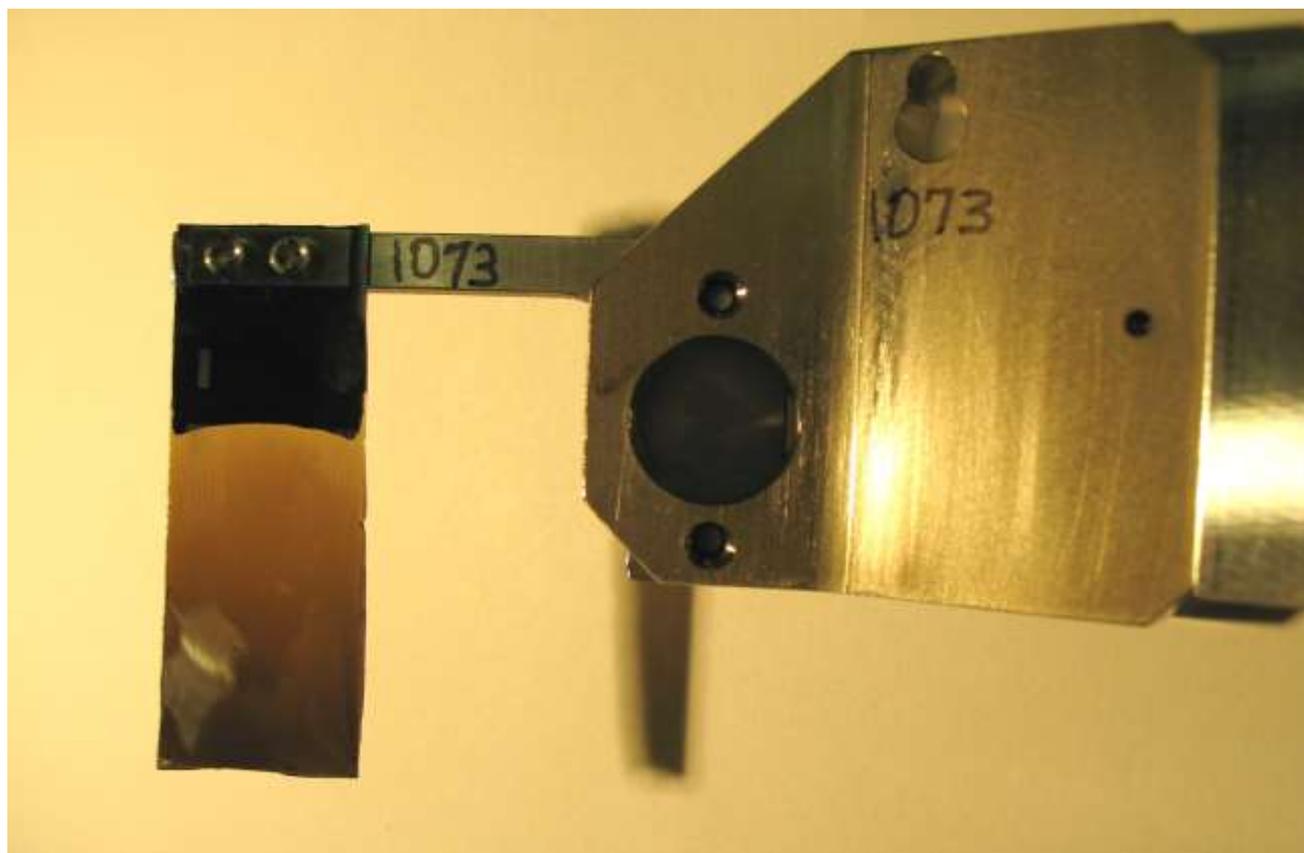
Champion foil used for entire Sep-Dec/09 run cycle.  
Mounted with gold foil, 17x30 mm free area, 344  $\mu\text{g}/\text{cm}^2$ , peak  
beam power  $\sim 1.03$  MW. Charge to target = 4820 Coul.  
Pivots freely on chain-saw pin.  
Previous record for  $>680$  kW operation was  $\sim 14$  days, 978 Coul.

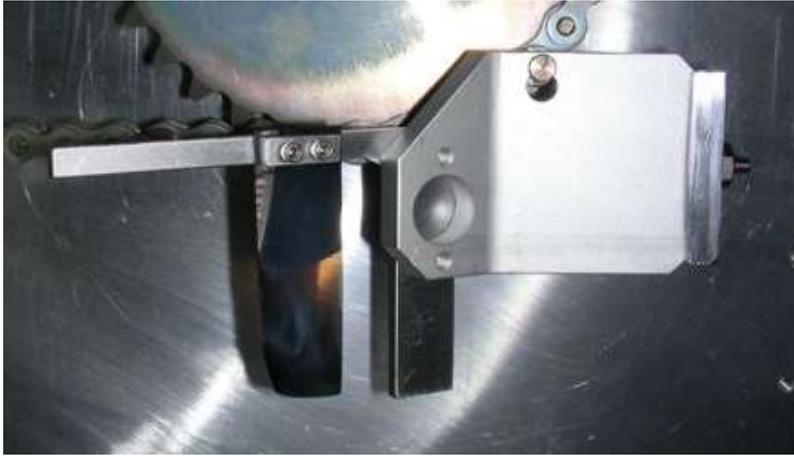
1<sup>st</sup> gen., used thru Jan/09  
Al bracket 0.25 in, Al snap ring washer 0.090 in

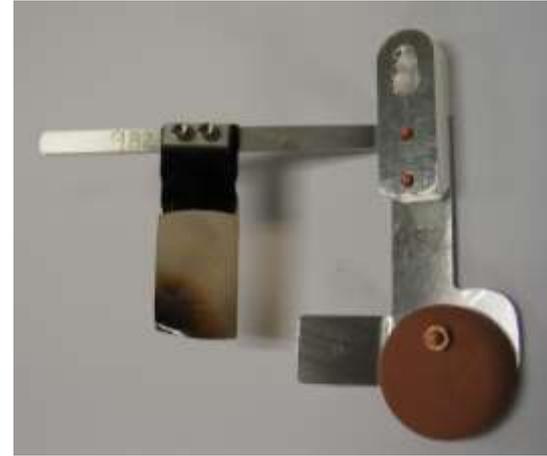
2<sup>nd</sup> gen., used Mar/09 – 17/May/09  
Silver plated Al “tombstone” hanger, 0.340 inch thick

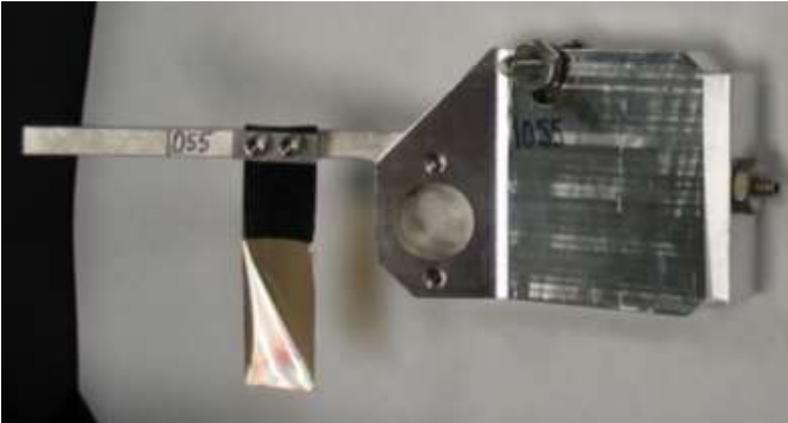
3<sup>rd</sup> gen., used 19/May/09 – 13/Jul/09  
Same original but has bottom cut off.  
Silver-plated aluminum washers, 0.085 inch thick

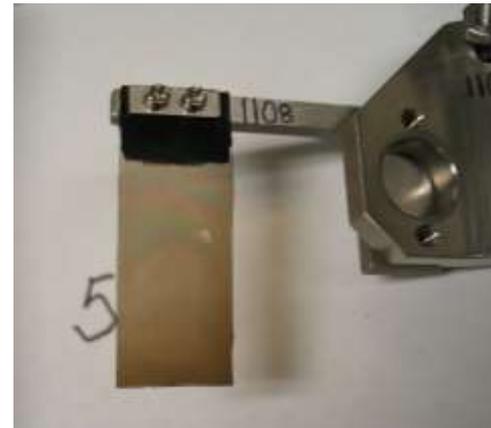
4<sup>th</sup> gen., used Sep/09 to present  
Ti bracket, SS washer 0.093 inch, +1 cm position
