SNS Linac Modulator Operations and Performance

V. Peplov

January, 2012

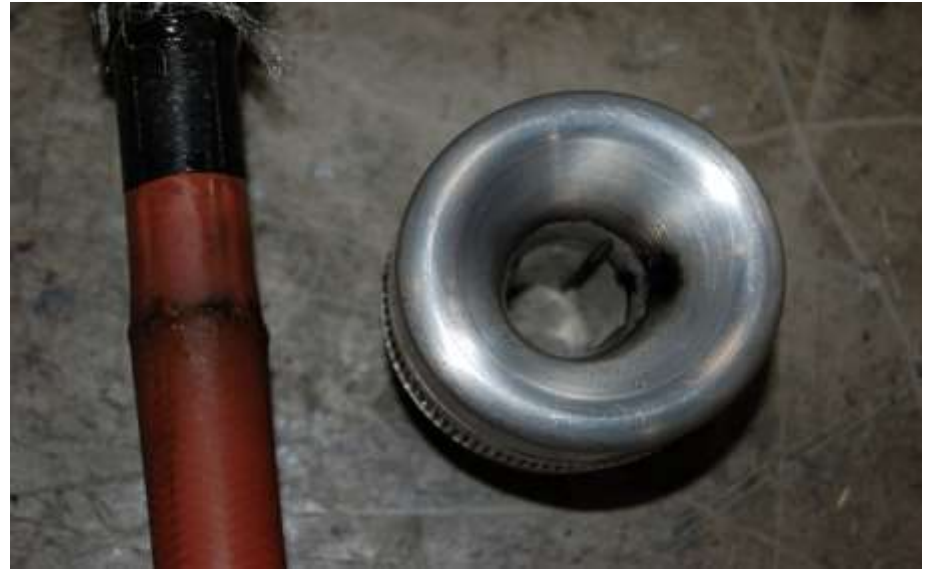
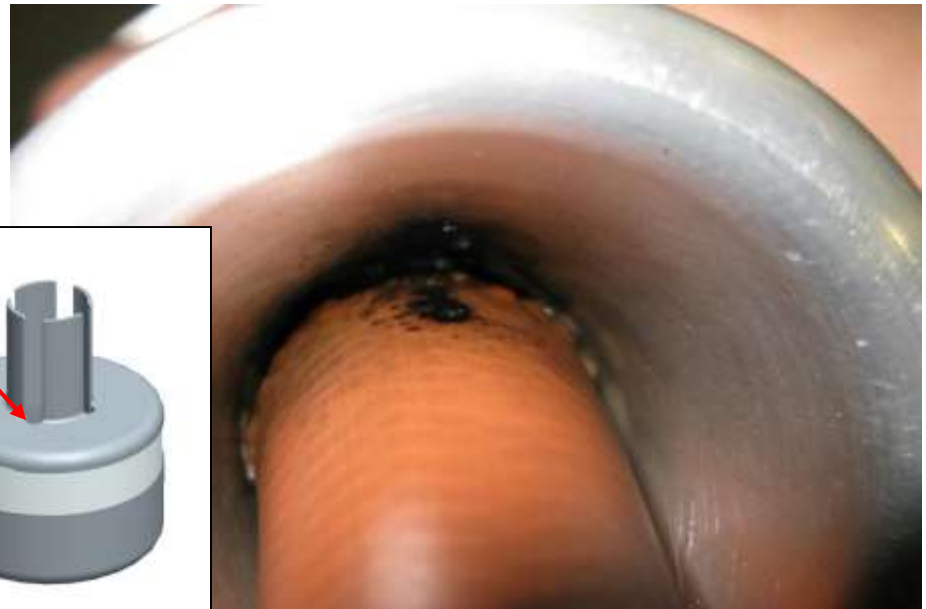
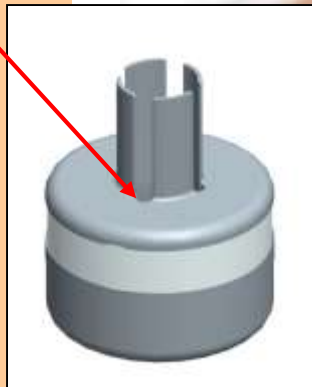
HV output cable damage

3 events during 2011-1:

- SCL-18, SCL-15 and CCL-2
- Downtime – 20.3 hours total

What happened:

- Long time in service
- Swelling in the oil
- Air bubble possible
- Insulator degradation

Result: Shorted / Arcing Cable

What was done:

- Damaged cables replaced and re-terminated
- New cables in 7 NCL modulators (Summer -2011)
- New cables in 4 SCL modulators (Jan. 2012)
- Improved receptacle return connector (larger radius, no sharp edges) designed and manufactured
- Testing on RFTF

Plans:

- Complete replacement in SCL (Jan. 2012)
- Re-terminate cables with improved receptacle return connector

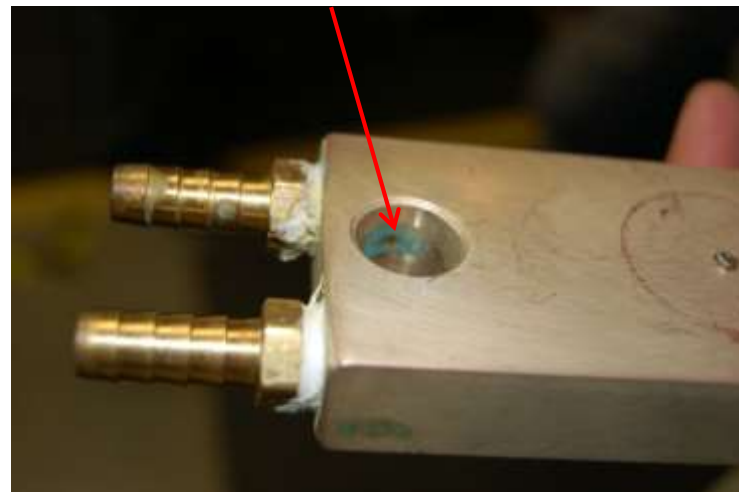
Pinhole Leak with Corrosion

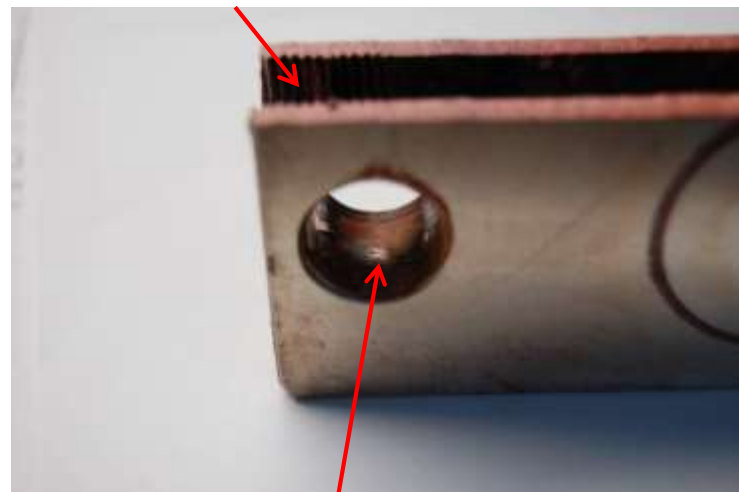
- Failed SCR Cooling Bus - Pinhole Leak with Corrosion
- Rough estimate ~ 0.01" wall thickness between Cooling Water Threads and Wall of Clearance Hole for SCR clamp
- The Clearance Holes for the SCR clamp do not centered in the Bus
- Suspect Repair: the wall of the Clearance Hole has been "soldered" (perhaps to repair a leak at the manufacturer)

Threads for Cooling Water Fittings

The wall of the Clearance Hole "Soldered"

- Temporary replaced with other type spare bus
- New bar bus with +0.75" extended length fabricated
- Spare assembly tested and ready for installation

- Install spare unit to HVCM CCL-2
- Fabricate improved parts
- Replace in all SCR cabinets according to schedule

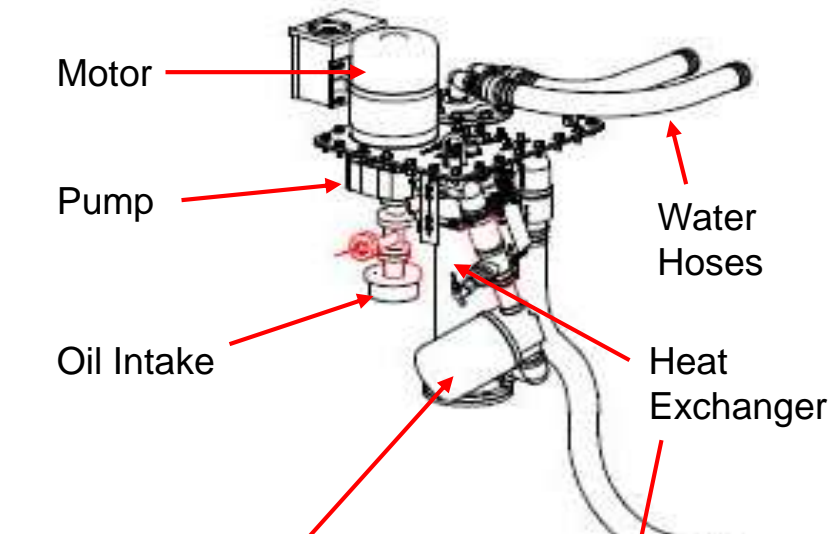
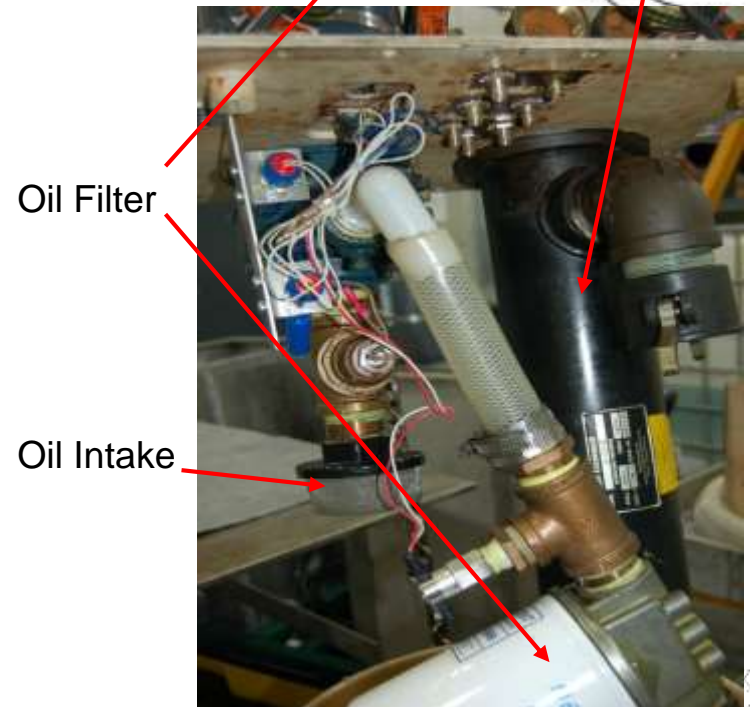
Oil Pump failure

Mechanical issues

- Long time in service; works 24/7
- Bearing load, vibration: bearing failure is typical
- It takes ~2 hours to replace the assembly
- 6 times & 8.5 hours downtime in 2011

Oil/tank overheating

- Cooling efficiency depends on the unit installed
- Mod RFQ: tank temperature changed from ~70°C to ~42°C after assembly replacement
- Pump impeller, filter, heat exchanger - ?
Continue monitoring and inspection
- Larger impeller in the pump: test shows tank temperature drops down by ~3°C

- Install temperature detectors in the tank (10 probes installed in RFQ tank in Jan. 2012)
- Oil flow measurement
- Vibration analysis
- New system design in progress

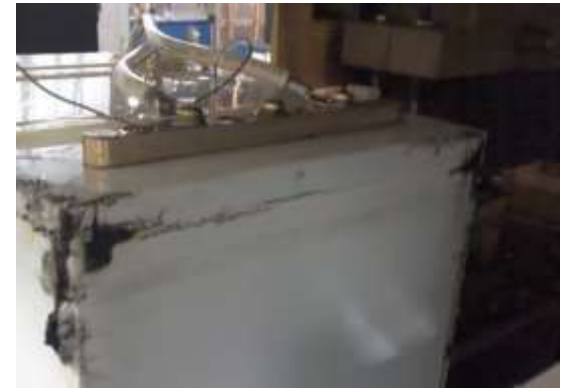
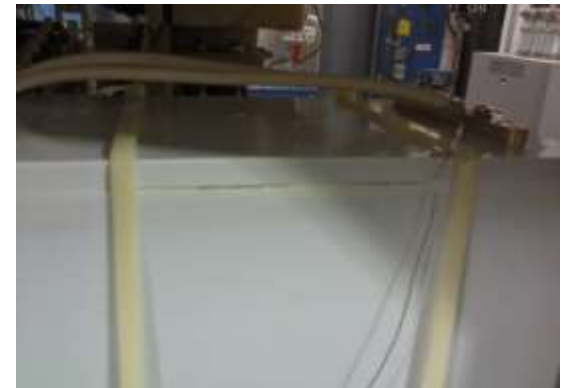
Tank has been opened and inspected in Dec. 2011:

- Harmonic trap capacitors (1.8 nF & 180 kV)
 - One cap looks good and passed 180 kV hipotting test
 - Two caps - internal breakdown at 100 kV and 120 kV
- Return HV cable – signs of pinch through breakdown
- Two bad capacitors on the rectifier stack
- Boost capacitors : one failed, two have split cases

Done in Jan. 2012:

- 3 new spare boost capacitors installed
- Caps tipped to avoid internal air bubble
- New spare harmonic trap capacitors installed
- Caps on rectifier stack replaced
- HV cable replaced

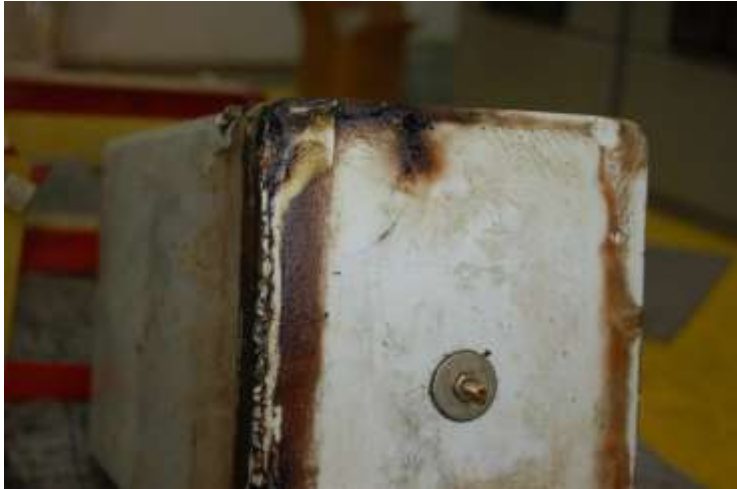
Old 120 kV / 3100 pF GA capacitor (failed);
Replaced in Summer 2010

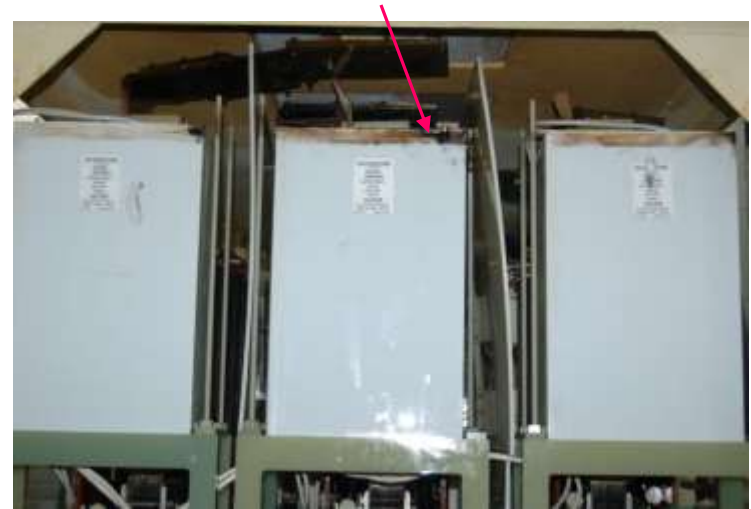
Jan. 2011 inspection:
New capacitors failure (brackets removed)

- Upper brackets removed to avoid air traps
- Zip-straps used instead
- DTL and CCL (7 total) modulators upgraded

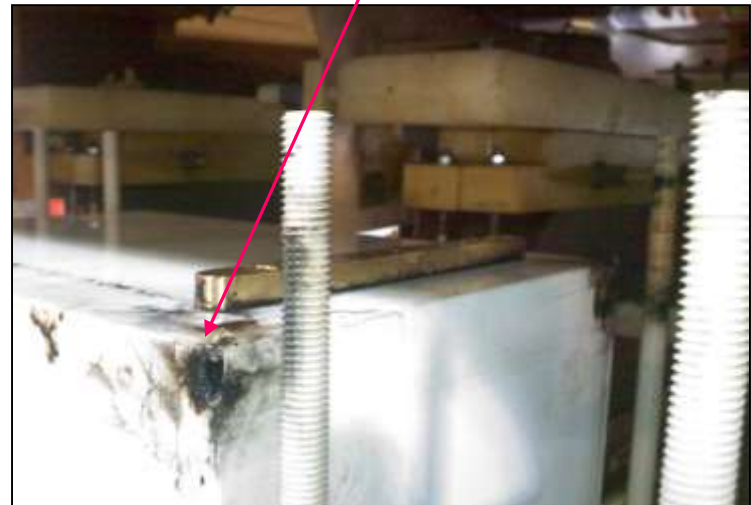
Capacitor's Corner

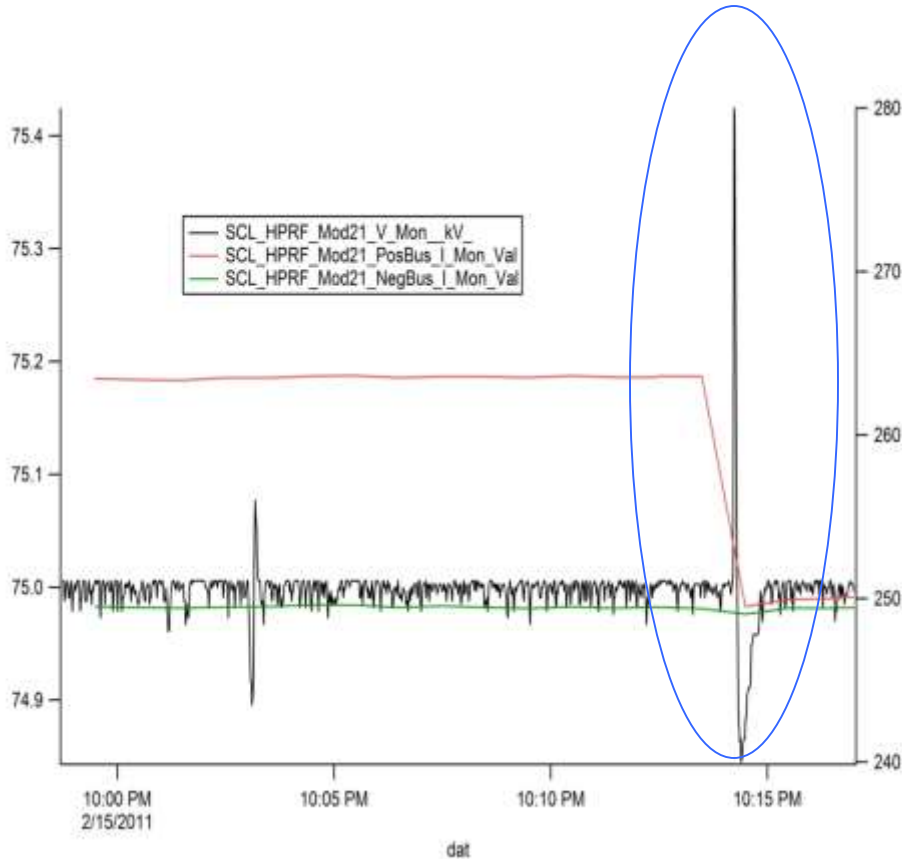
Feb. 15, 2011
Chatter Fault
15 Amp Step in Pos Bus Current

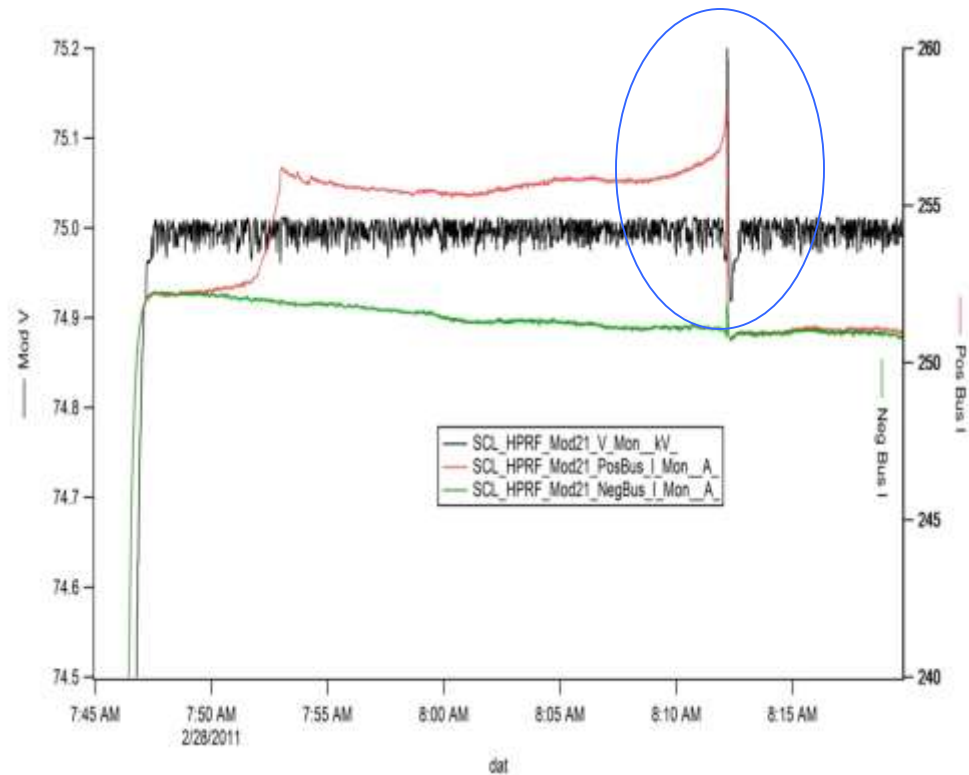
Start up Feb. 28, 2011
7 Amp step in Pos Bus Current
causes 200V jump in Mod V

SCR Feedback signal moved from Positive Bus Current sensor to Negative

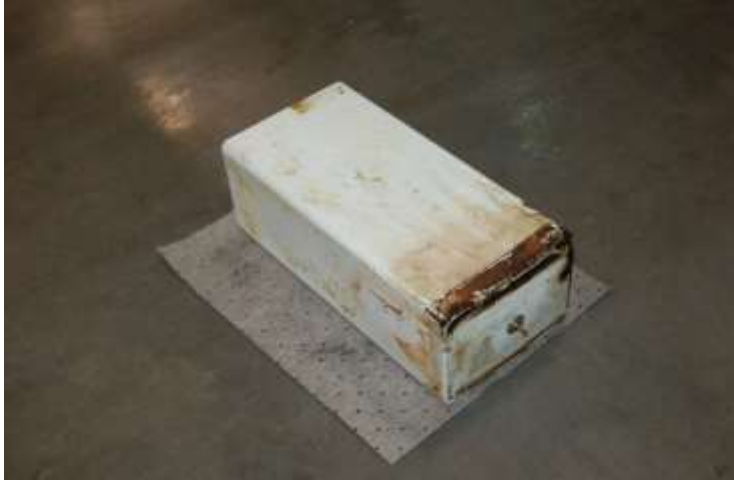
Old 120 kV / 3100 pF GA capacitor (failed)

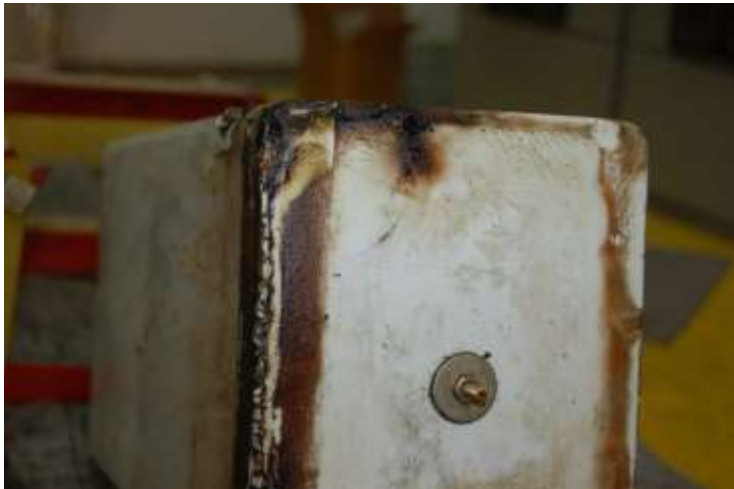
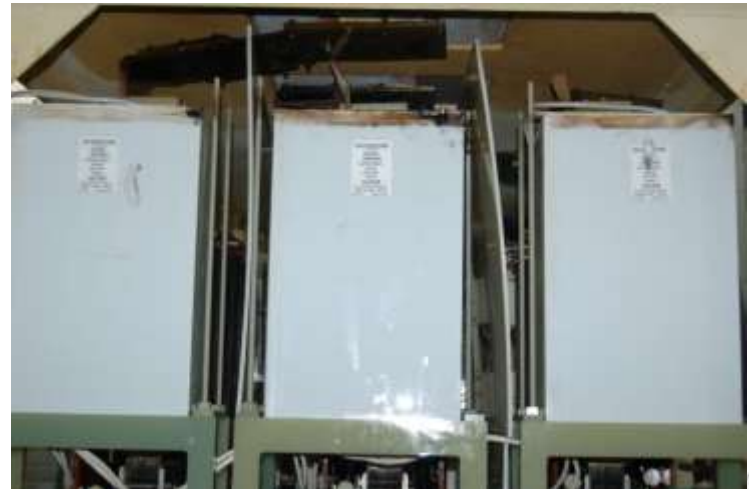
New capacitors failure (brackets removed)

CCL4, RFQ – Damage on the caps

- Inspection in Jan. 2011 revealed the problem
- Analysis and simulation done (SNS and CSI)
- Mounting brackets changed

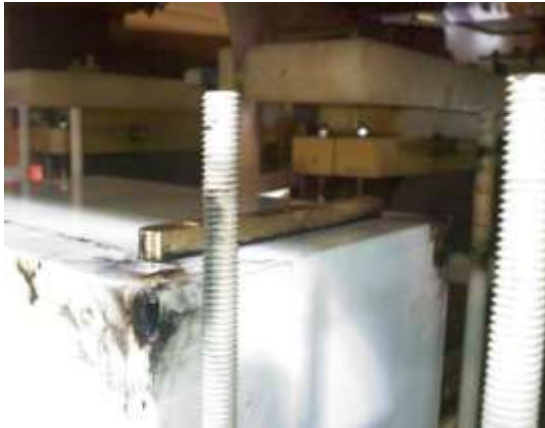
Cap Corners

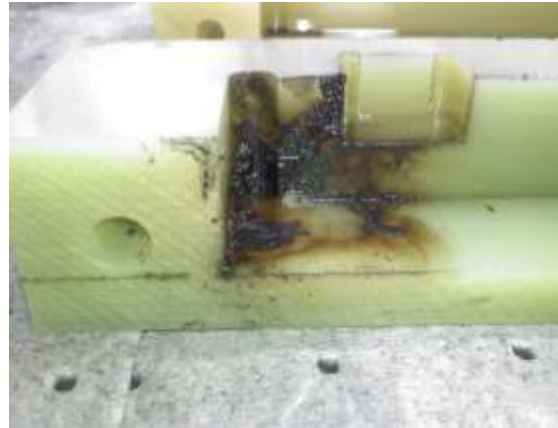
RFQ Brackets

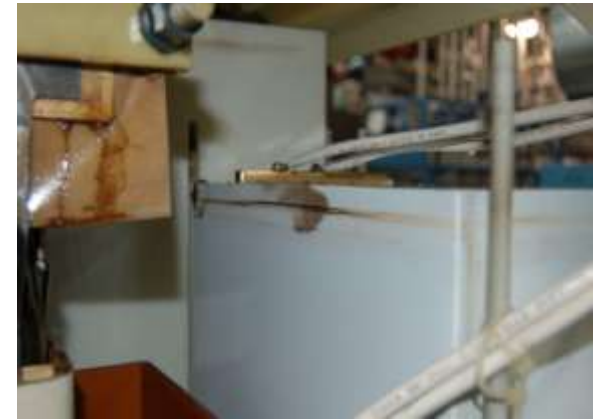
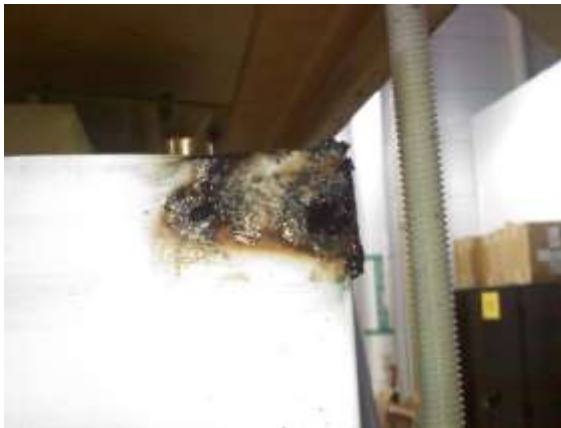
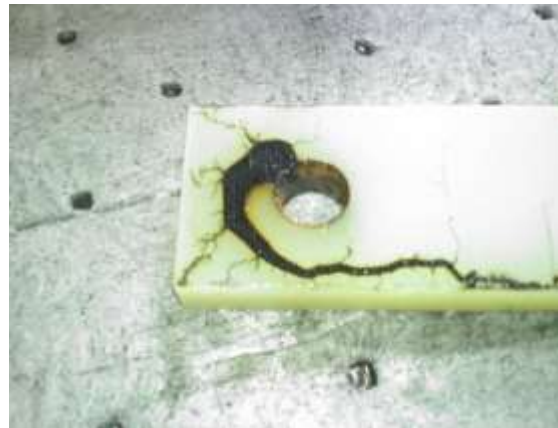
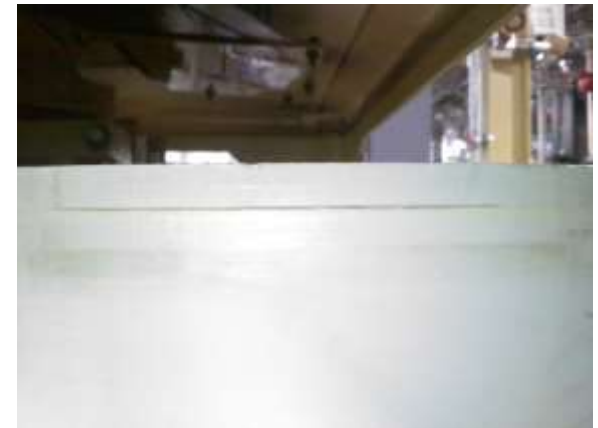
Cracks on the case

- Presence of air bubbles either inside or external to the capacitor creates a problem where corona inception will eventually cause degradation of the surrounding insulation system and lead to catastrophic failure
- The upper brackets should be replaced with another style of bracket less likely to trap air
- The capacitor should be mounted at a slight angle to force any air that may be trapped internally away from the electrode since the manufacturer cannot guarantee that the unit will be bubble-free
- A follow-on inspection should occur at the next available opportunity to conform the mitigation strategy employed during the recent winter shutdown
- Further testing should continue on the virtually-equivalent SCL boost capacitors in the HEBT modulator for as much time as operational and other developmental demands will permit.
