Target Development

Target cavitation damage mitigation R&D efforts have been suspended

Five hole cuts were made in T3 beam entrance window – Where's the leak?

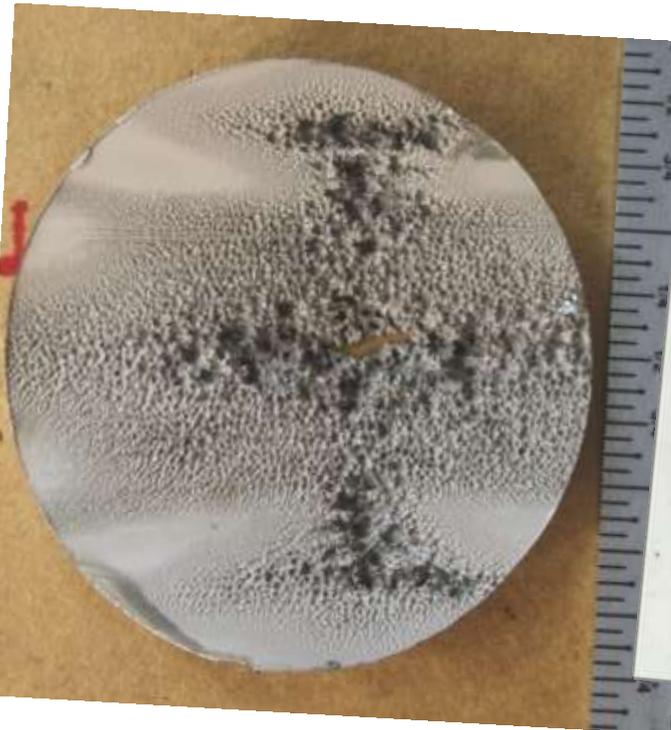
T1

Damage on target inner vessel wall specimens cut from center of beam window surface facing bulk mercury

Cleaned at B&W

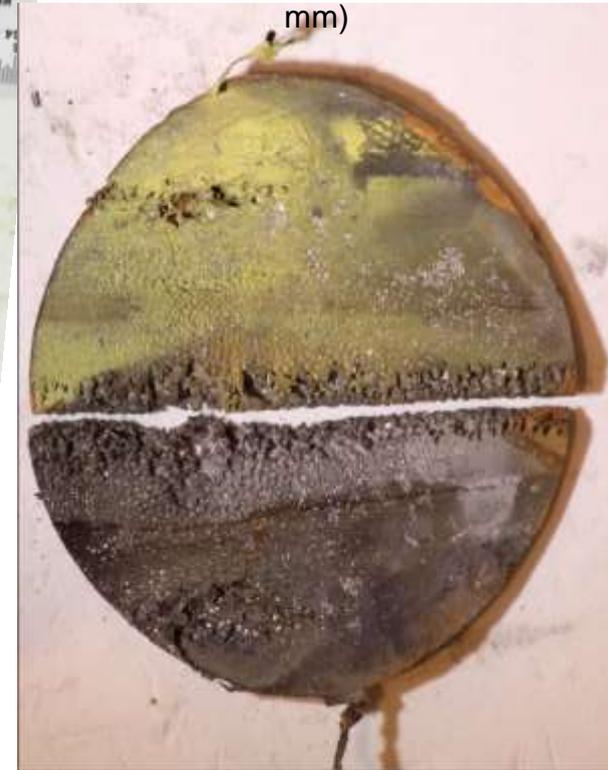
T3

Fractured across full
width of inner window
(cut missed target center by ~ 13
mm)

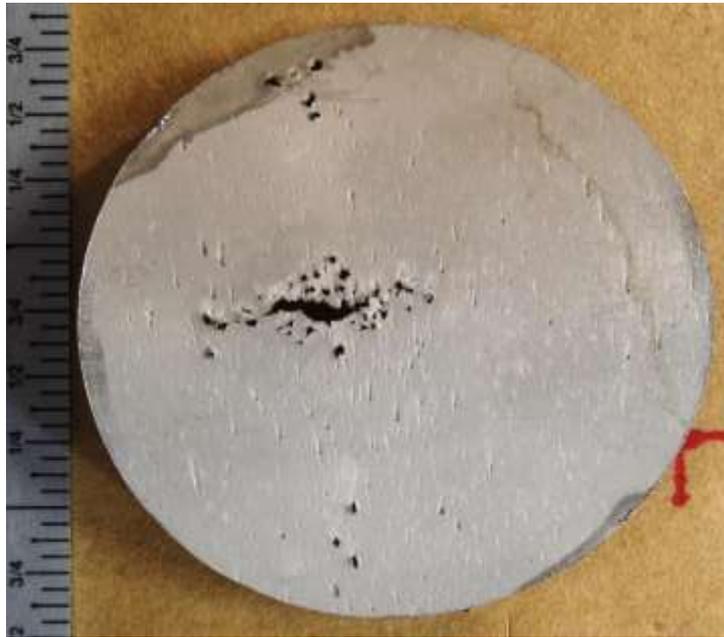
T1

Damage to inner vessel wall at center surface facing mercury channel

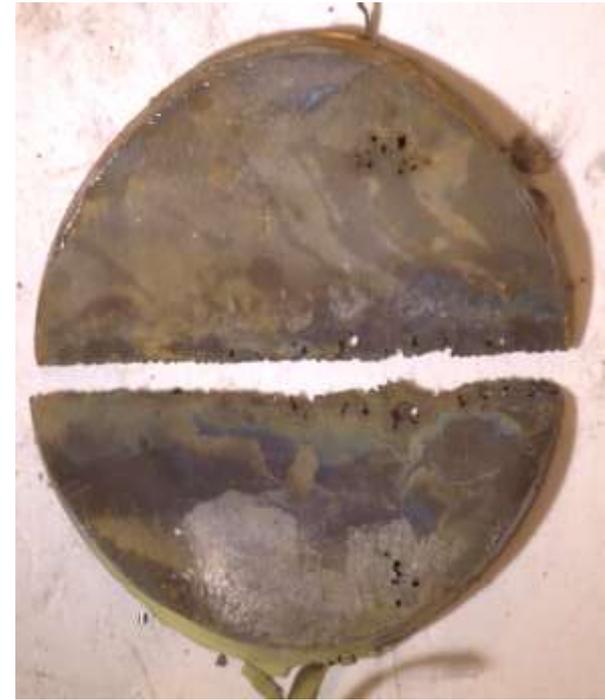
- **T3 material for mercury vessel front body and outer beam window underwent hot isostatic press (HIP)**
 - Process adopted to reduce porosities that were observed in T1 and T2 which required numerous TIG weld repairs
 - HIP has consequence of fully annealing the material, which has less cavitation damage resistance vs. cold-worked mat'l
 - *HIP used with all targets after T2*
- **Window mercury flow orifice was removed beginning with T3 operation**
 - Increased window channel flow velocity to compensate for reduced mercury pump speed

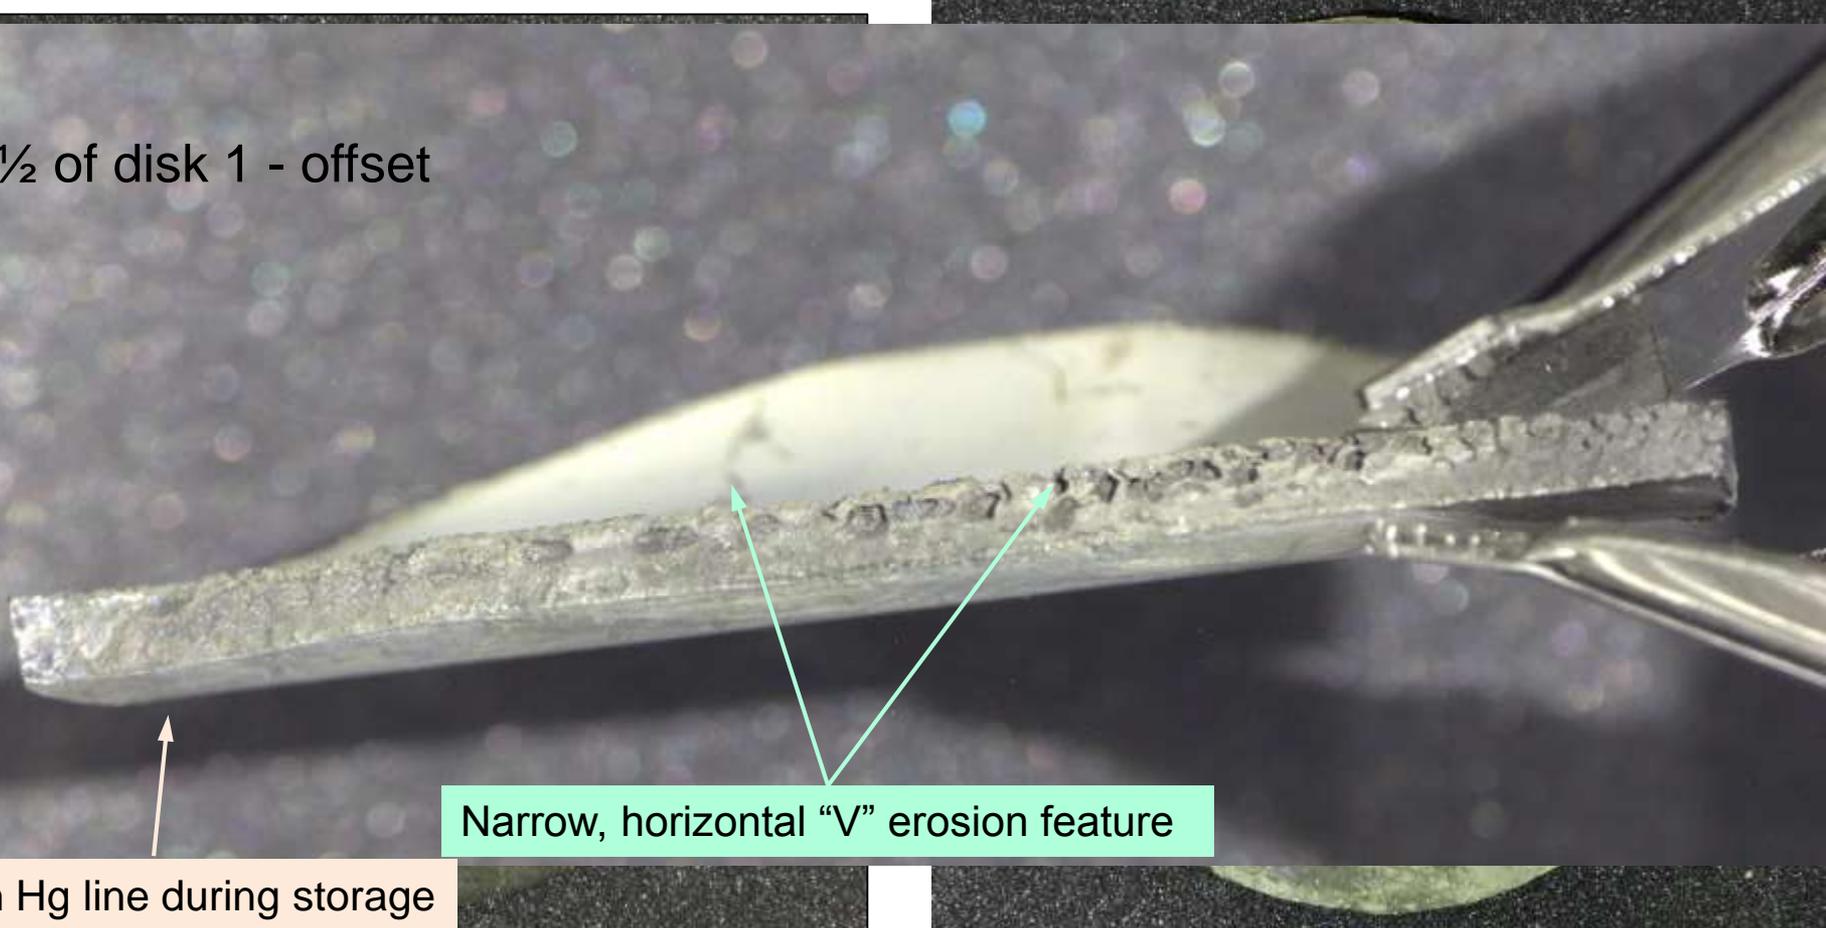
Target 2 inner wall – disks 1 & 5

Narrow, horizontal “V” erosion feature

High Hg line during storage

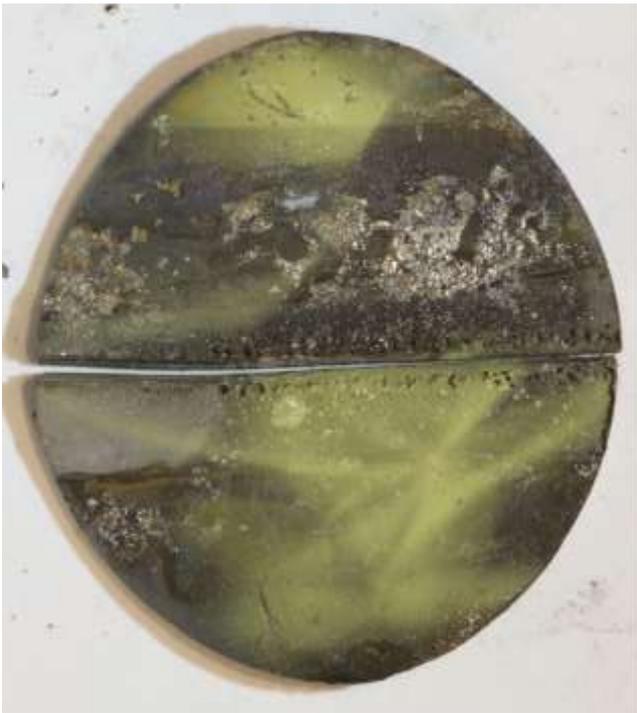
Disk 1
(driver side)

T3 inner wall surface facing bulk Hg

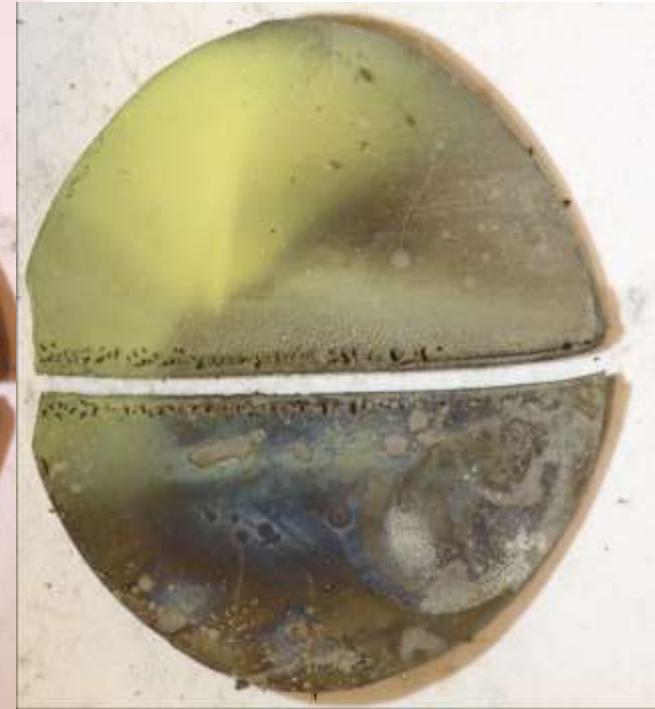
Disk 9
(passenger side)

Missed center by ~ 13 mm

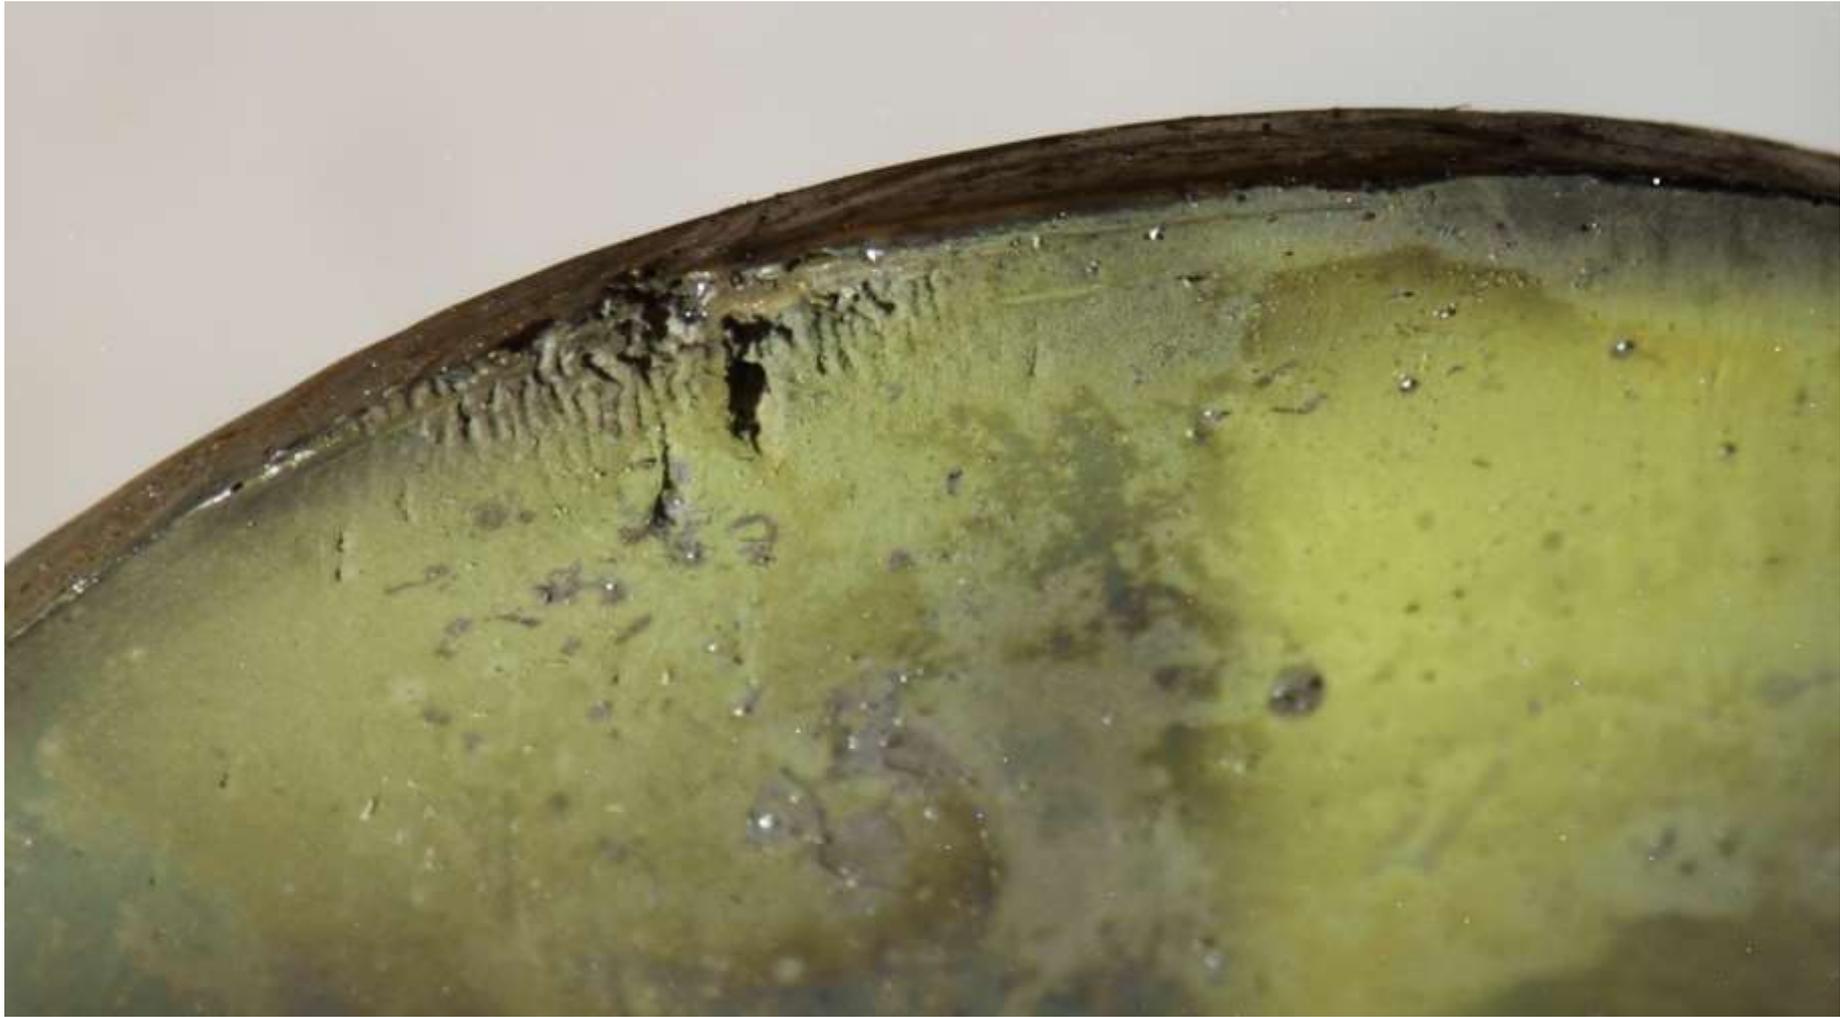
T3 disk 10 eroded region at top edge

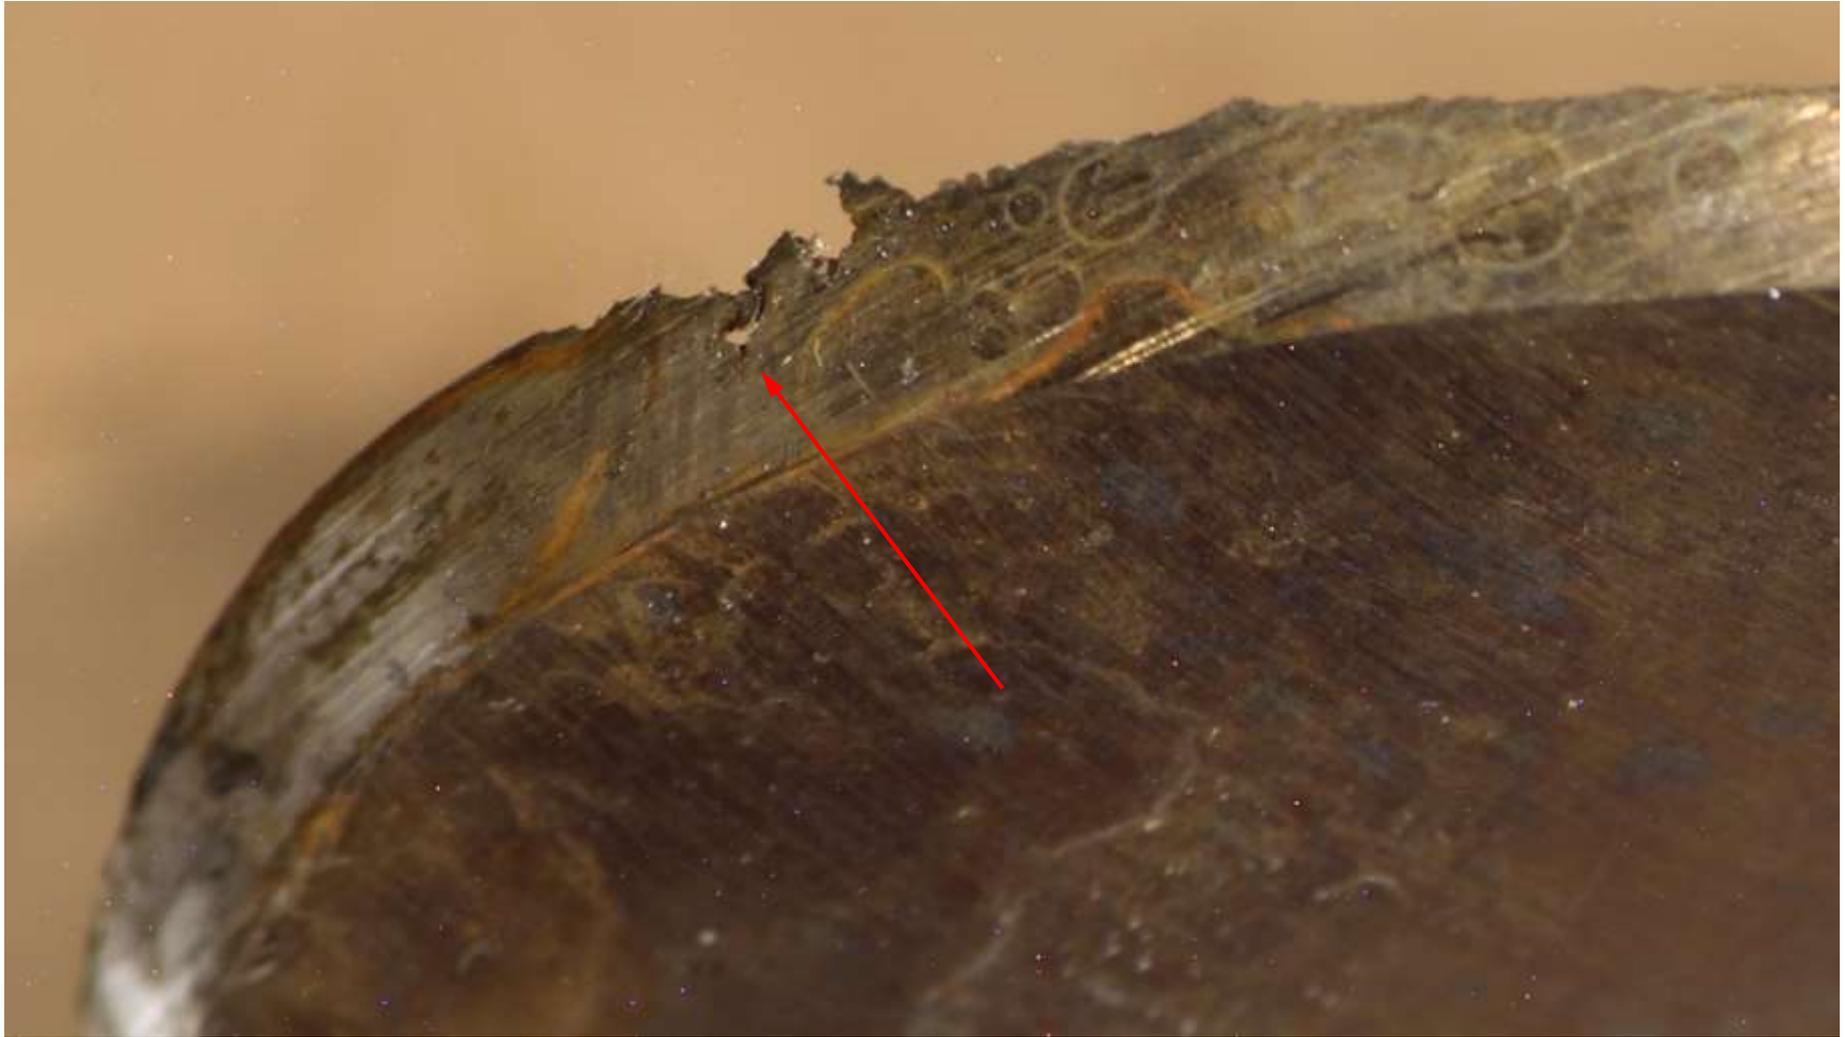
Partial through-wall hole in disk 10

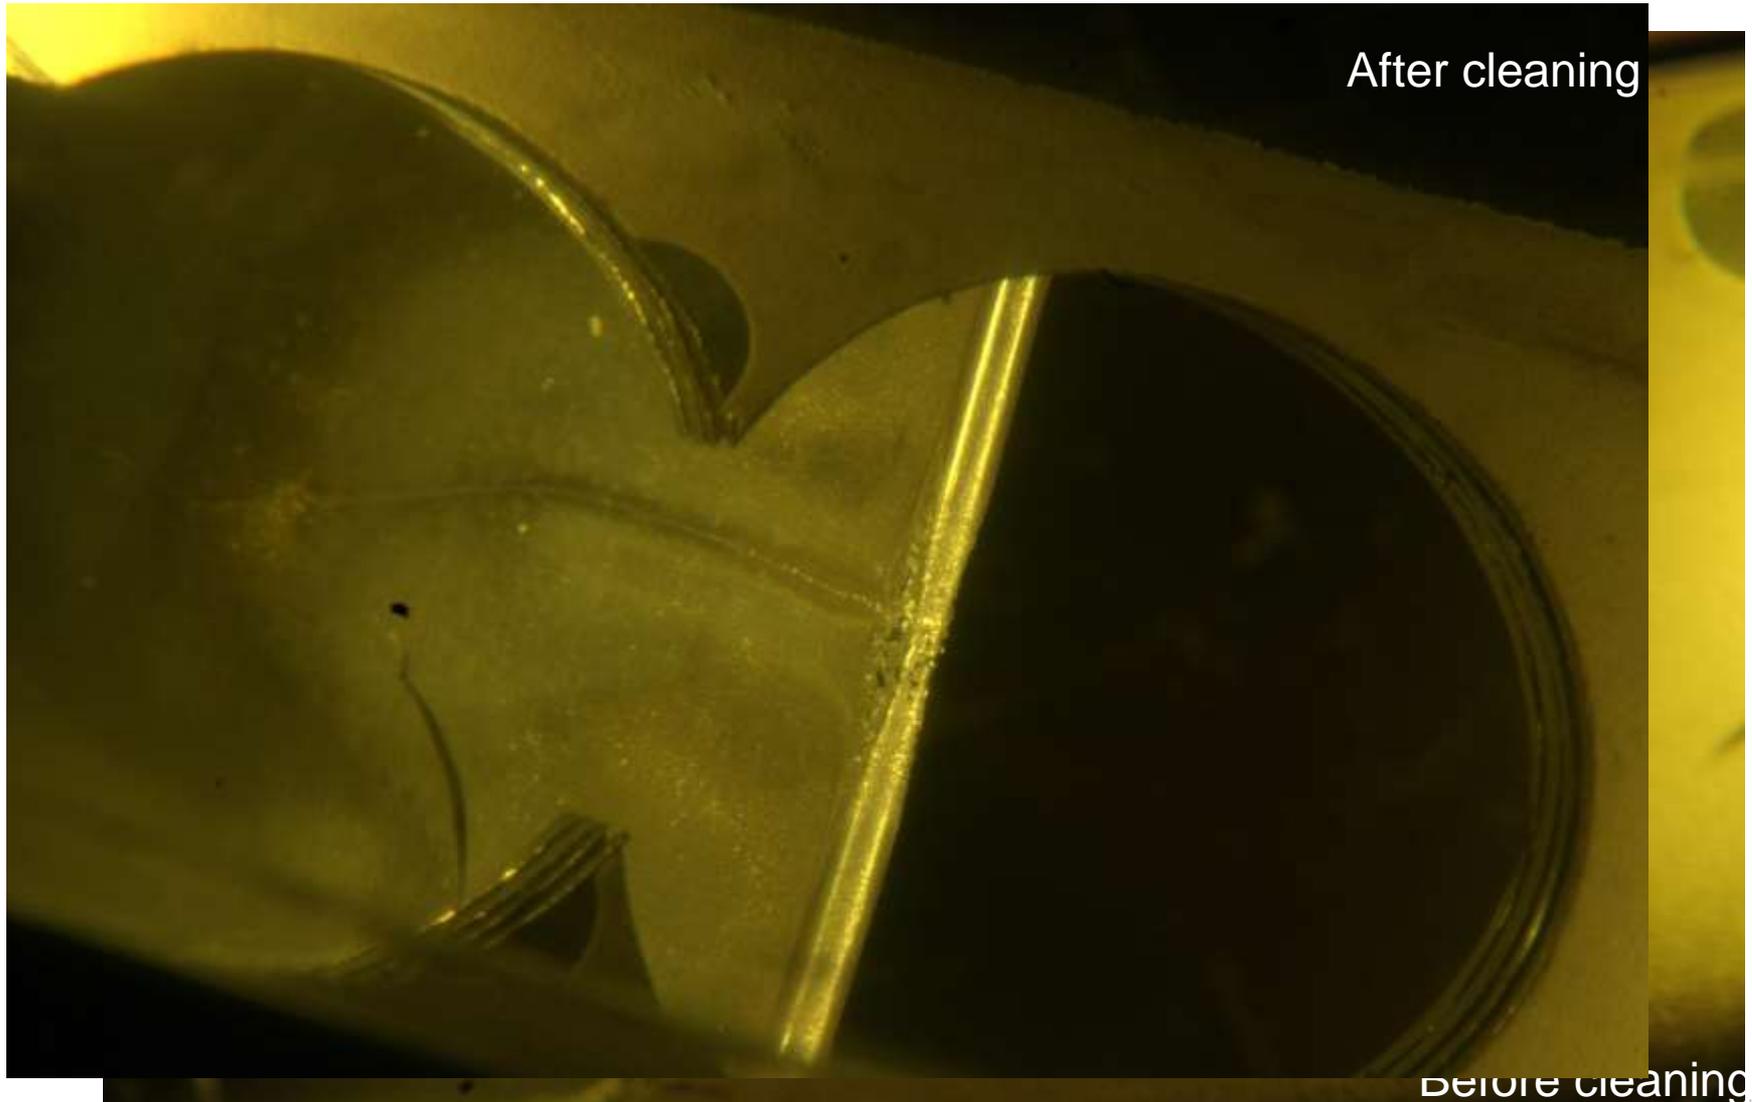
Erosion on center flow baffle

Sharp line (both sides) – suggest a crack

- Central baffle appears to be cracking; erosion at tip
 - Spots of through-wall erosion on front body seen in T3
- **We have not found the leak in T3 yet**

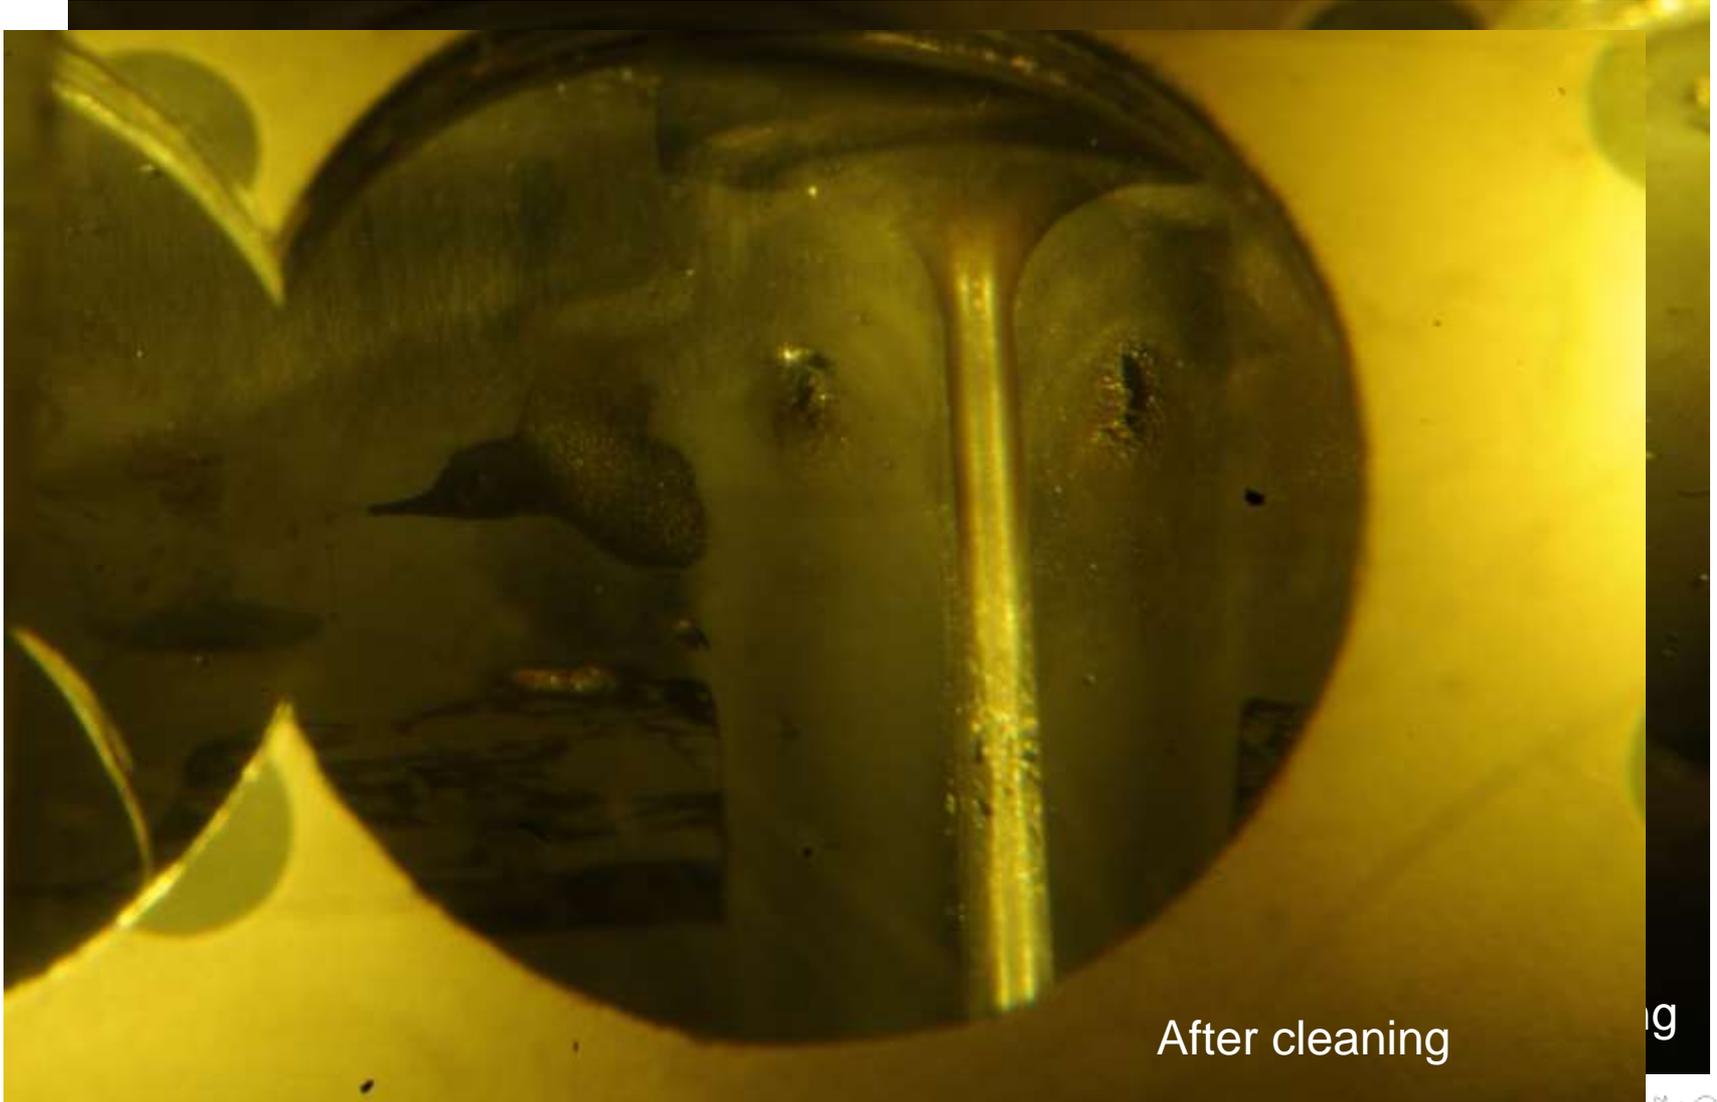
T3: Severe erosion at base and top of center flow baffle

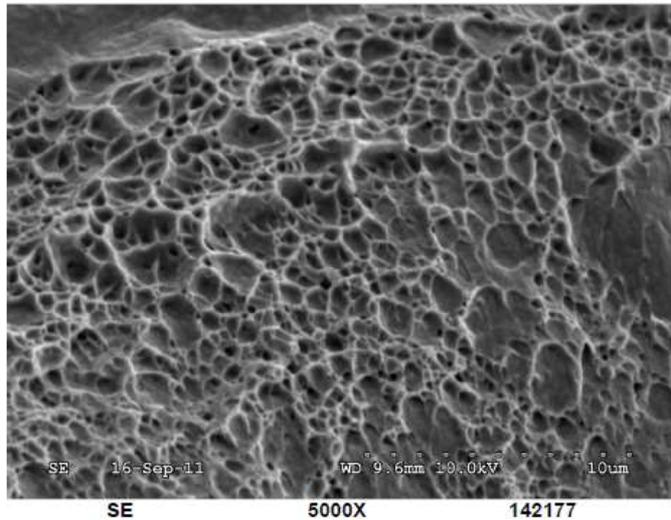
Figure 9.4.1.3: Higher magnification micrograph of lower right area of Figure 9.4.1.2. Fracture morphology is ductile microvoid coalescence.

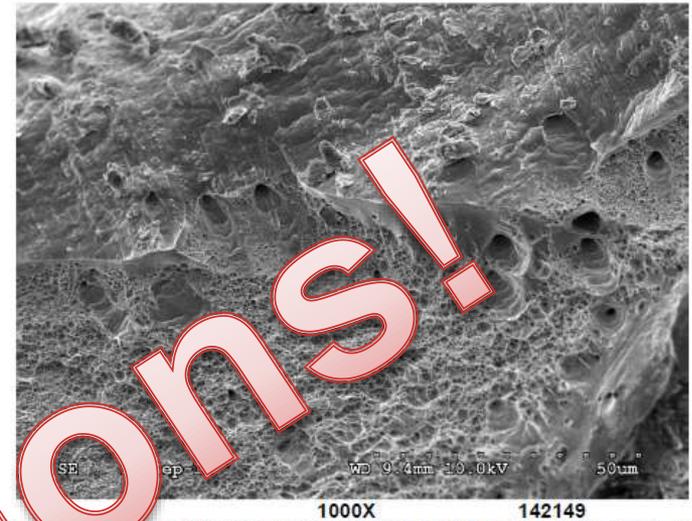
Figure 9.1.3.8: Lower magnification micrograph showing area 4 in Figure 9.1.3.1. The lower half of the image contains ductile microvoids; the upper half exhibits evidence of ductile fracture.

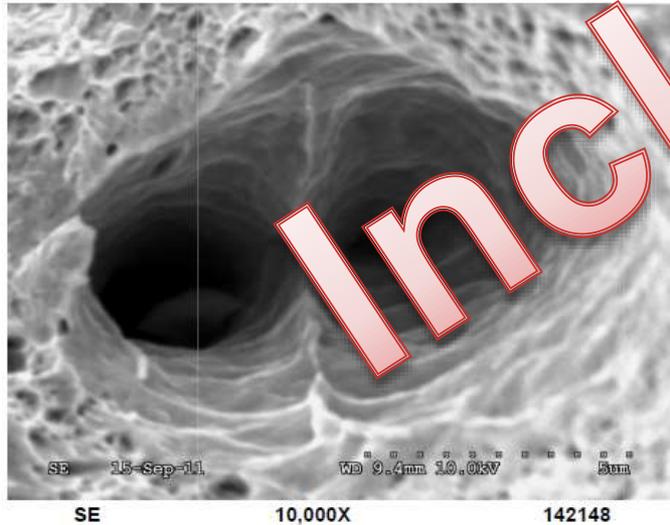
Figure 9.1.3.7: Very high magnification SE micrograph showing two closely spaced microvoids located at point 3 in Figure 9.1.3.1. The initiating inclusion is visible inside the left microvoid.

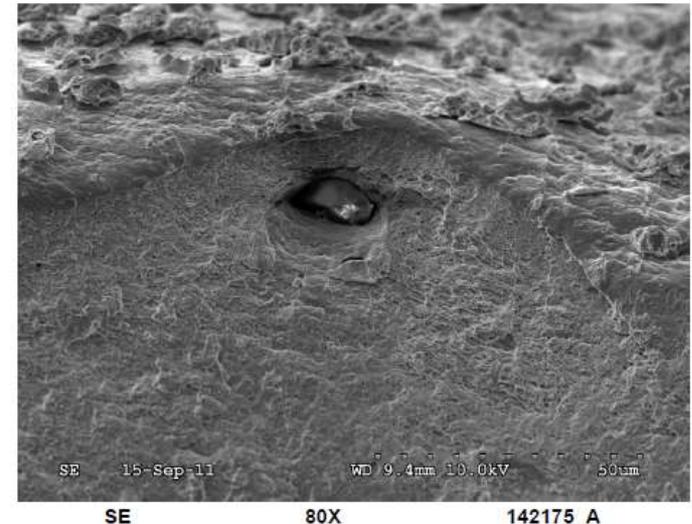
Figure 9.1.4.7: Higher magnification SE micrograph taken of area 4 in Figure 9.1.4.1. Ductile shear fracture is evident, along with an inclusion within a void.

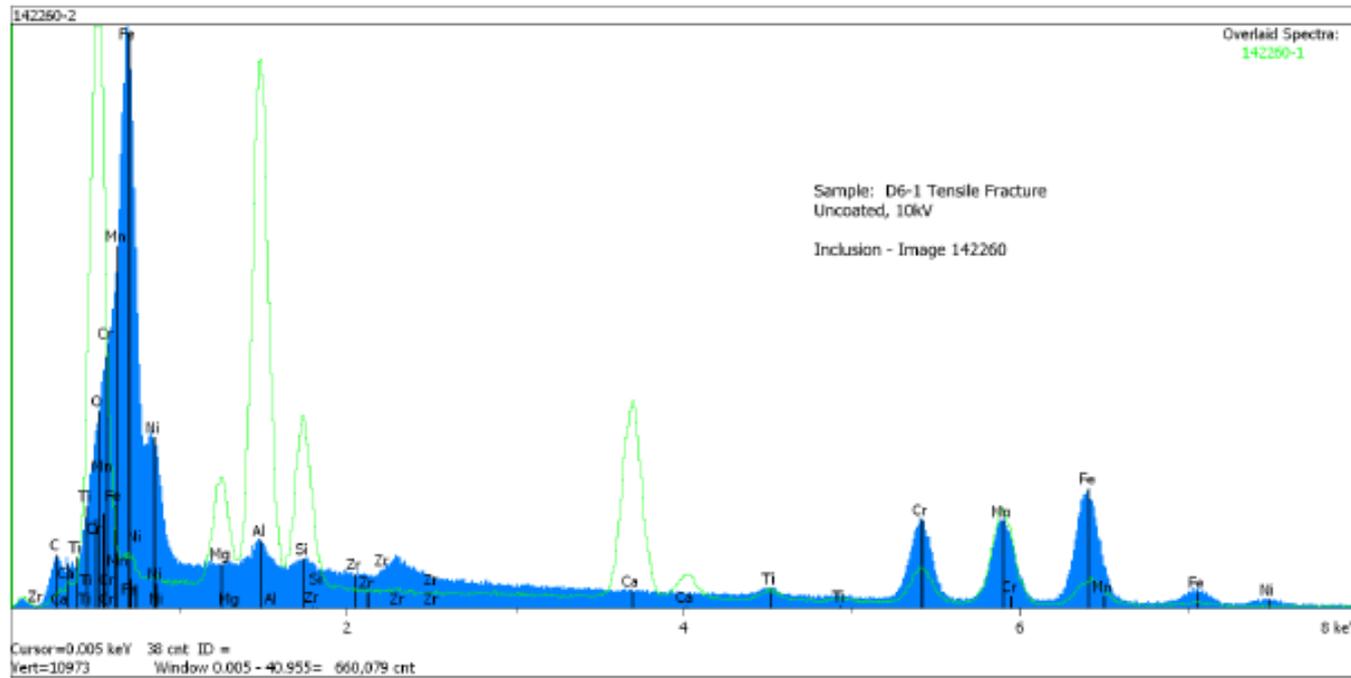
Comparative EDS spectrum results.

EDS results on inclusion indicate aluminum, calcium, oxygen, ...

Figure 9.3.2.4: EDS spectrum results comparing inclusion (green line) to base material (solid blue). The inclusion contained higher concentrations of magnesium, aluminum, silicon, calcium, and oxygen compared to the base material.

- Calcium Aluminate treatment is a method for reducing alumina inclusions
- Are the sizes and distribution density typical for these forms of stainless steel??
- How can we improve on this?
