# Linac Modulator Operations and Performance

V. Peplov

Feb. 2010

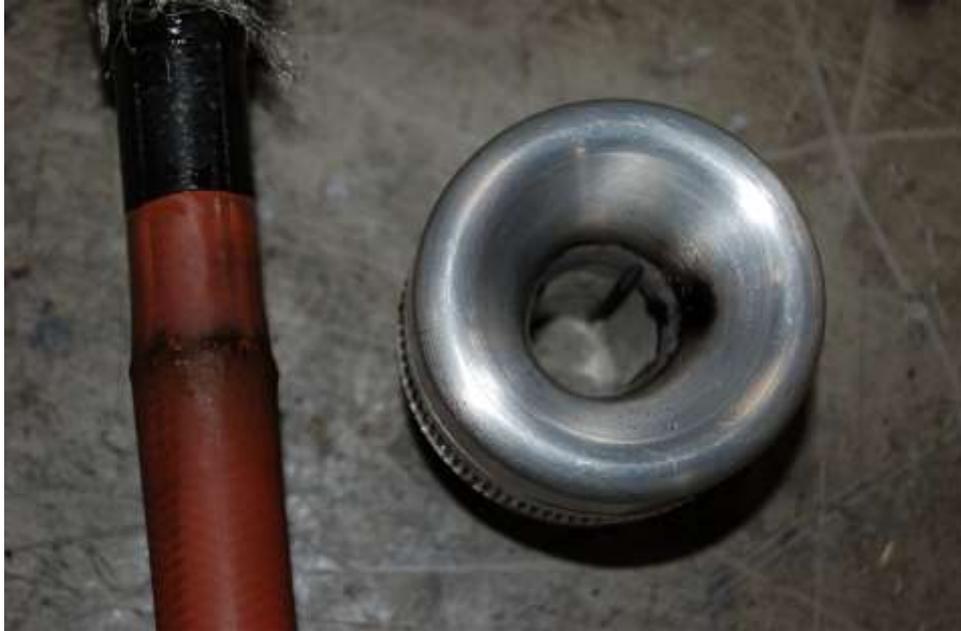
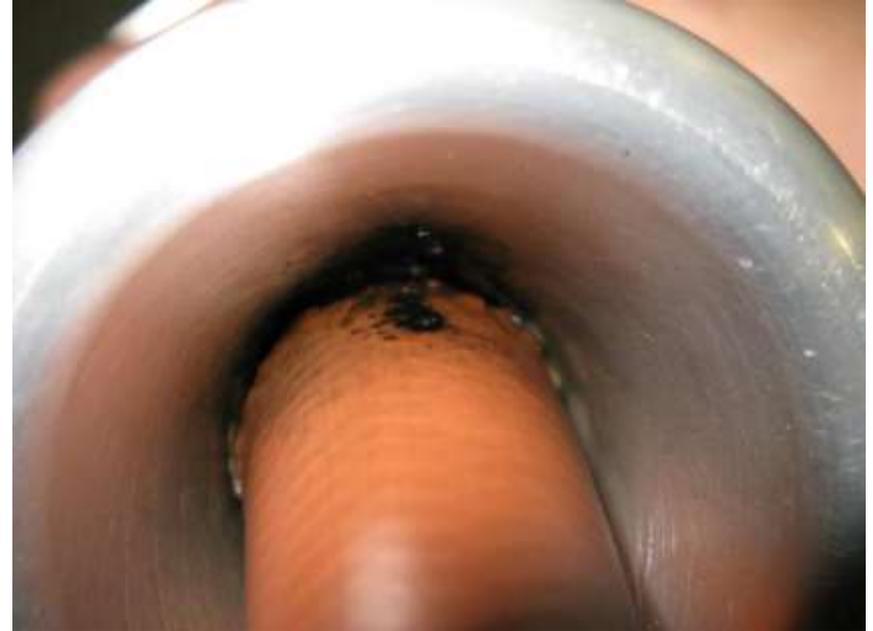
# HV output cable damage

- DTL-1 (RFQ) modulator: all three output cables have been re-terminated
- Largest numbers of operation hours
- Insulator degradation during long operation in the oil
- Inspection of all cables in the gallery
- Spare cable ordered

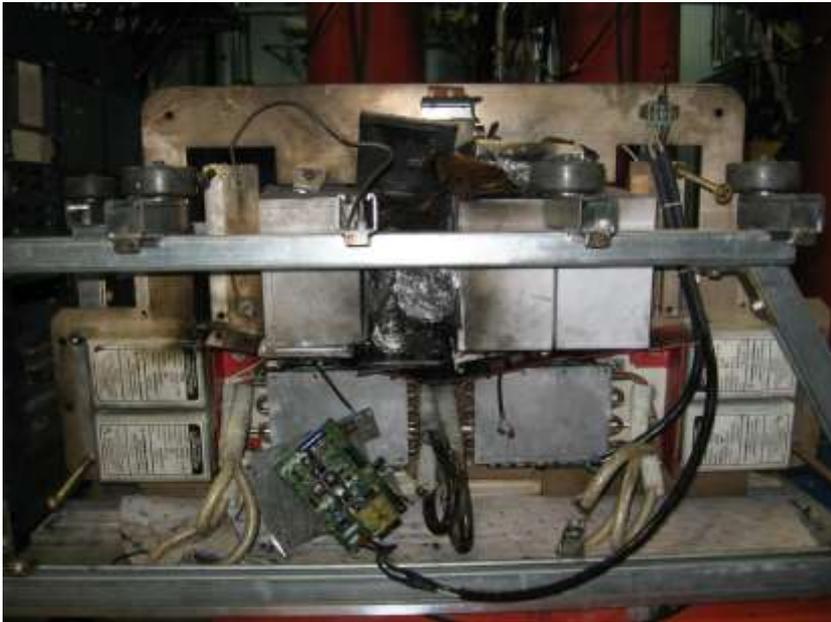
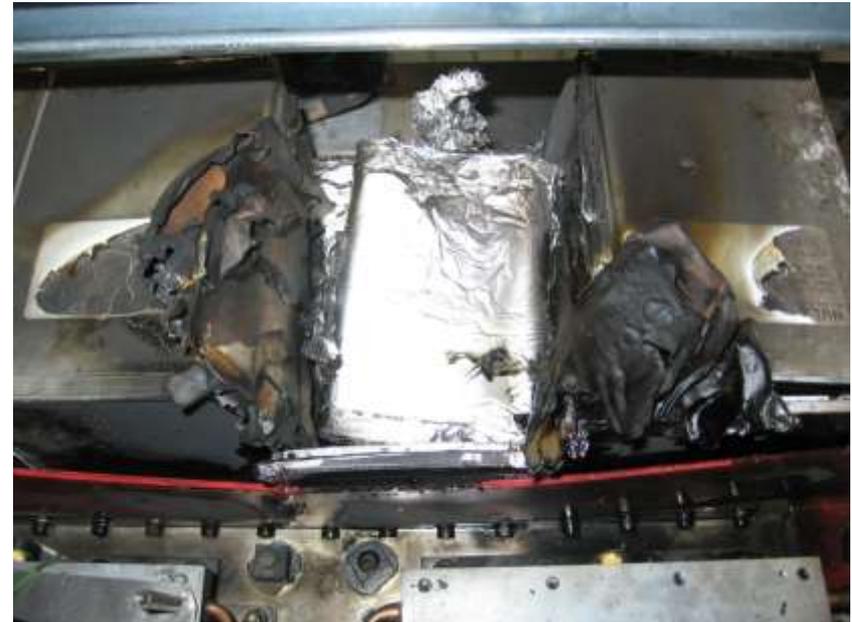
# SCL Mod 15: Smoke alarm

An NWL capacitor failed on B phase IGBT switch plate on 11/07/2009

- Downtime – 12.9 hours
- Classic capacitor failure - blast only - no fire (canola oil) - less damage
- Adjacent caps, IGBTs and driver cards destroyed
- Charring of the cables that were above the cap bank - replaced
- Header cable damage - replaced
- Switch plate - replaced
- Re-termination several fiber cables
- Cleaning up the mess

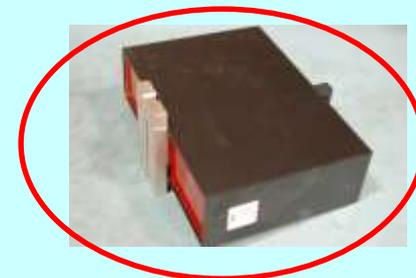
## 4. Dry self-healing AVX/TPC caps:

- Case temperature does not exceed 100°F at full duty cycle,
- No degradation after 1 year usage (were installed on CCL-4 in Dec.2008,
- Tested for 500 fault events (10 years equivalent),
- **Installed everywhere during present outage**
