Linac Modulator Upgrades

David E. Anderson

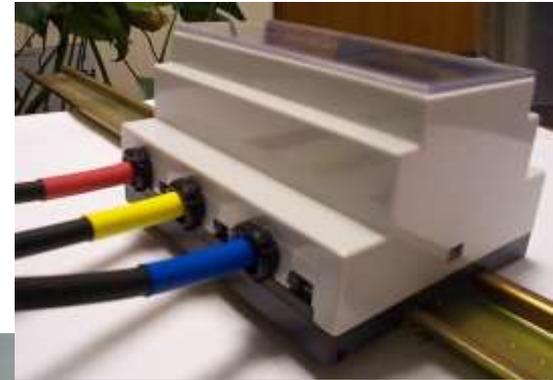
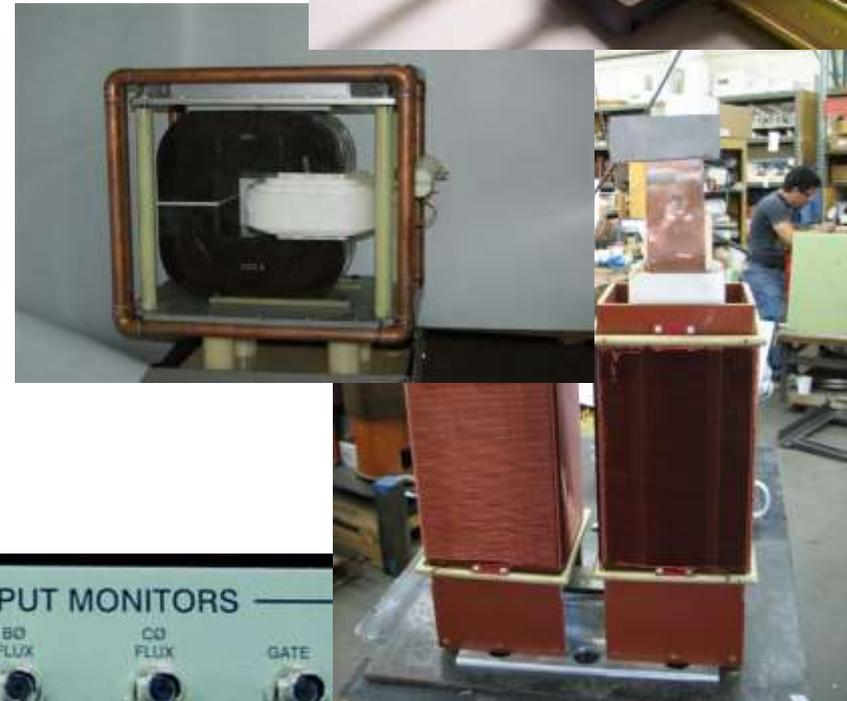
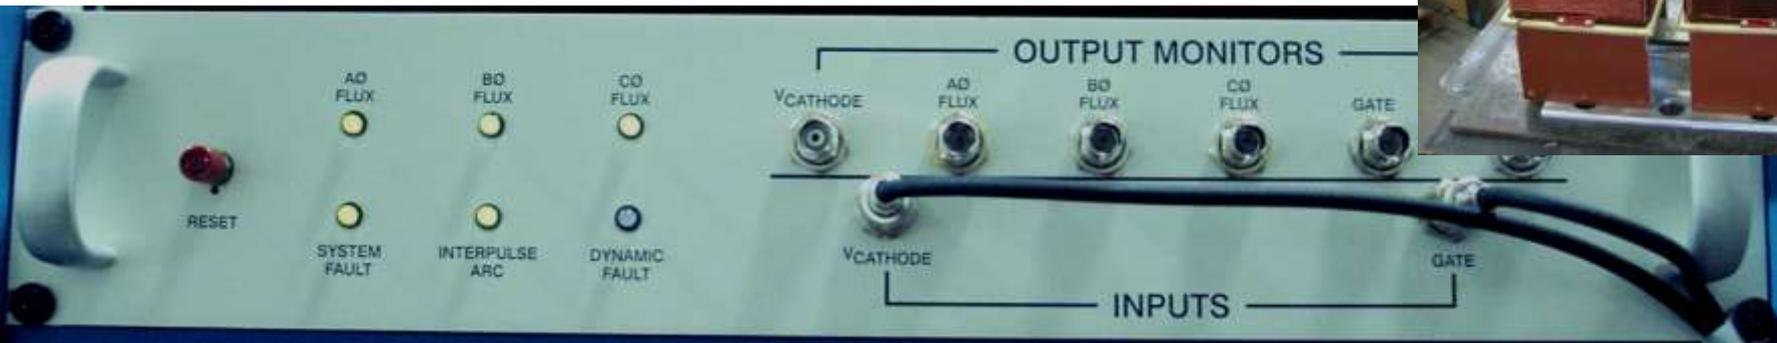
HVCM Modulator Upgrades AIP-02

- Higher duty cycle revealed system limitations, SCL IGBT commutation current issues
 - Retuned SCL resonant circuit parameters
 - Installed new magnetics
 - Installed Dynamic Fault Detection Chassis (DFDC)
 - Protects transformer saturation
 - Protects from dV/dt events
- New Rogowski probes show I_C
- Real time signal monitoring

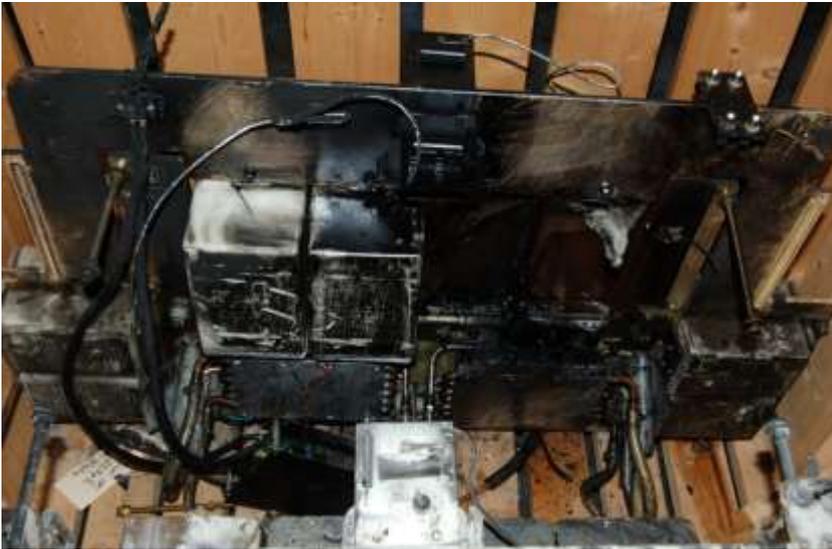
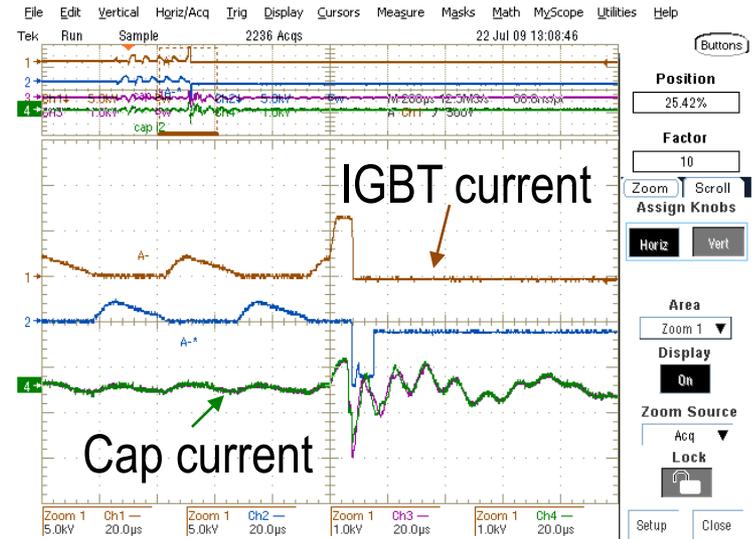
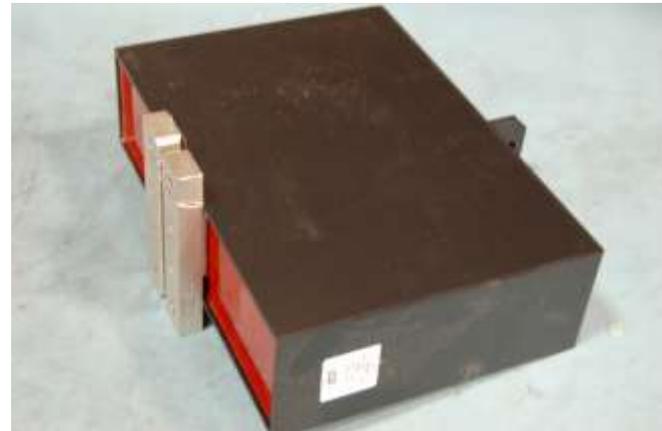
HVCM Fires – Capacitor Replacement

- Cause of multiple fires, other failures from collateral damage
- Replacing capacitors w/ self-healing AVX units shown
 - 500 fault shots + ~1 year of ops on 12 units and largest $\Delta C \approx 0.2\%$

- Self-clearing = no catastrophic failures, no collateral damage

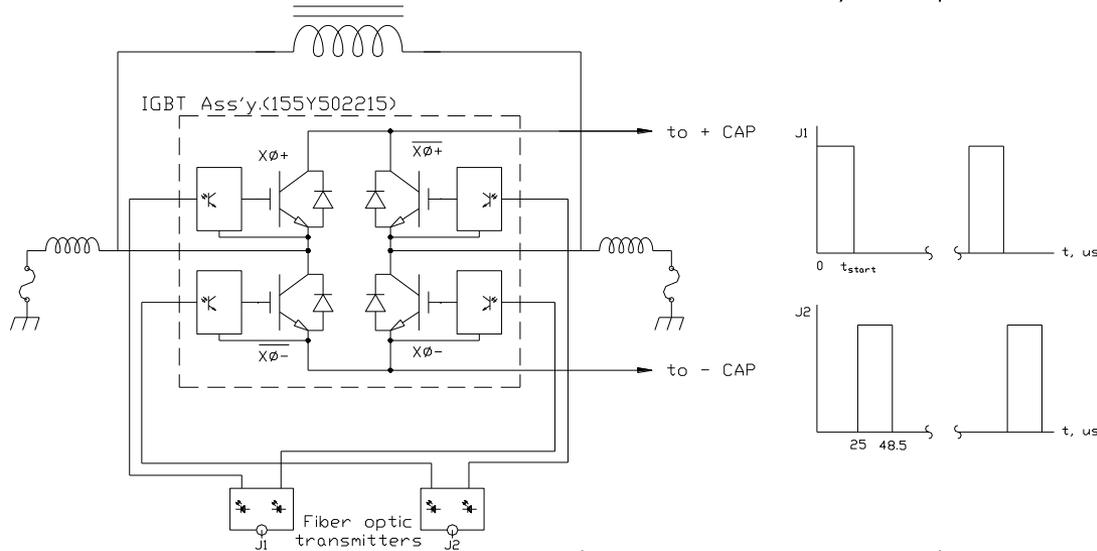
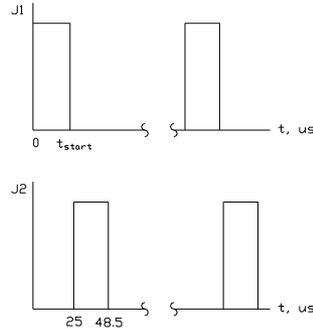
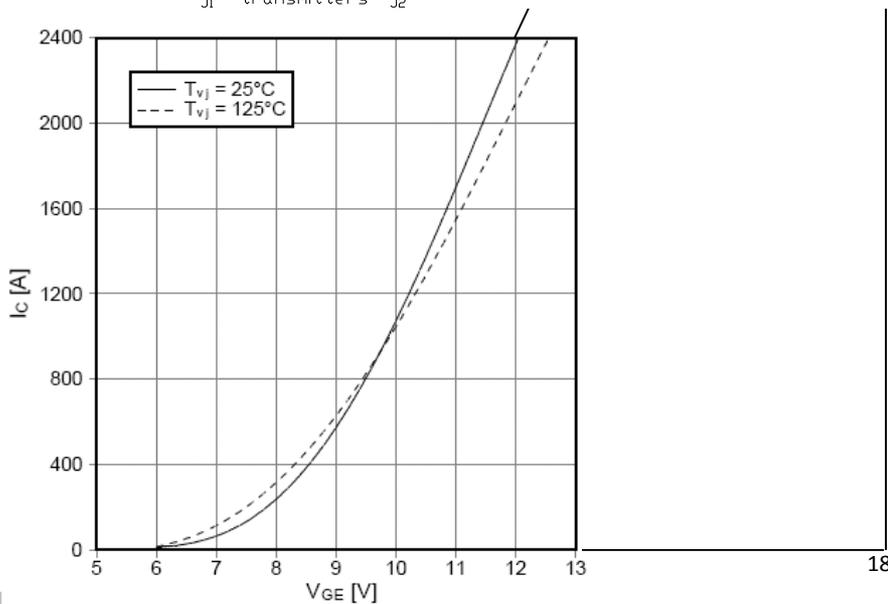
HVCM Existing IGBT Gate Drive Concerns

- Severe overdrive increased saturated current levels
 - Fault currents higher
 - Carrier recombination time longer?
- Slow drift of electronic delays
 - Leads to timing skew
 - Leads to flux saturation
- No on-board IGBT fault detection / protection
- 120 V ac distribution safety concerns
- Insufficient isolation derating for operating voltages
- Poor EMI shielding
- Interface w/ new controller

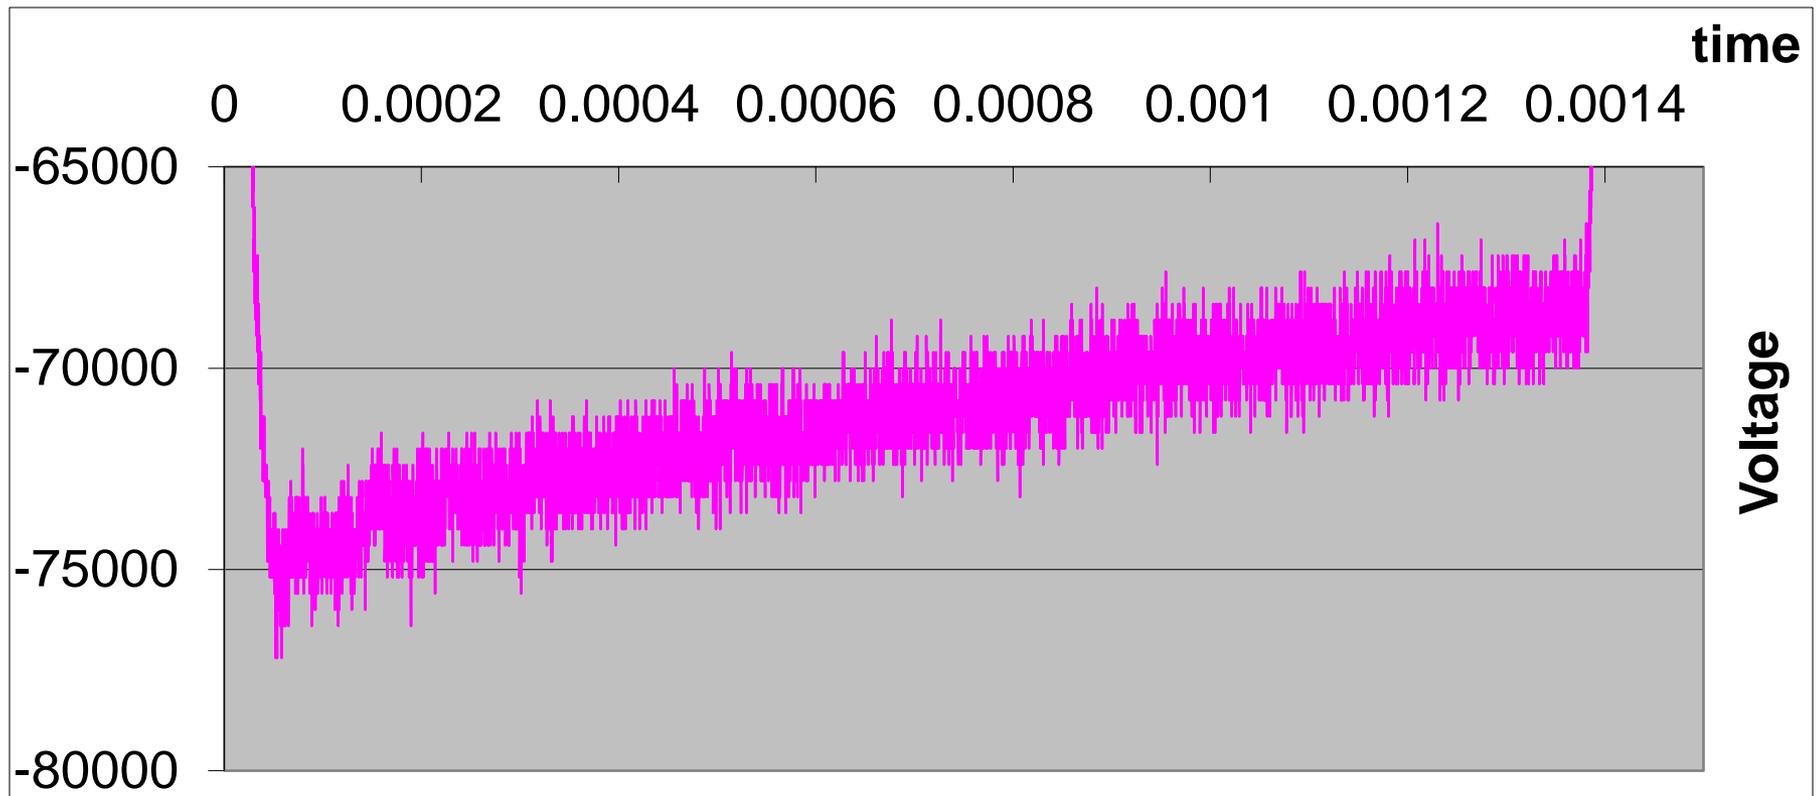
Modulator Droop Problem

- Example of SCL-Mod1 Output Voltage Waveform
- ~8.3% droop over 1.35 ms pulse width
- RF power reduction at end of pulse

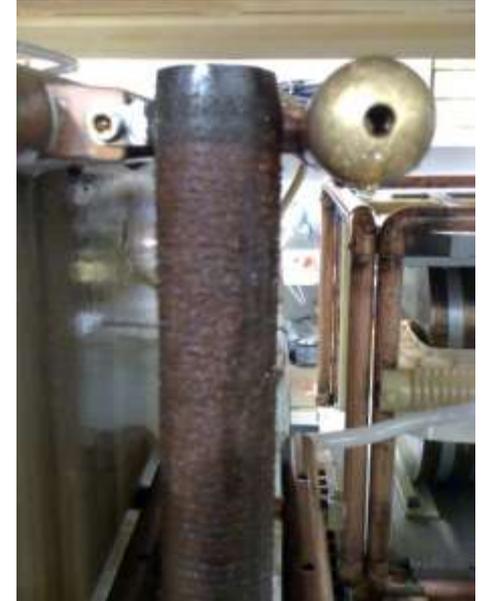
In-tank Component Reliability

- Study of in-tank components revealed that several did not possess proper engineering de-ratings
 - Capacitors – dissipation factor resulted in thermal failure – estimated ~200 W dissipation, 100°C
 - De-Qing resistor – operating power exceeds rating
 - Divider capacitors – inadequate voltage rating
 - Connecting wires/cables – high current density
- Analysis based on PSpice simulations & device datasheets
- Redesign/replacement process started
- Test capacitors ordered from vendors, testing planned for thermal performance
- Major effort planned for upcoming Summer shutdown
