SNS Target Post Irradiation Examination Program 2012-2013

SNS Accelerator Advisory Committee

May 8, 2013

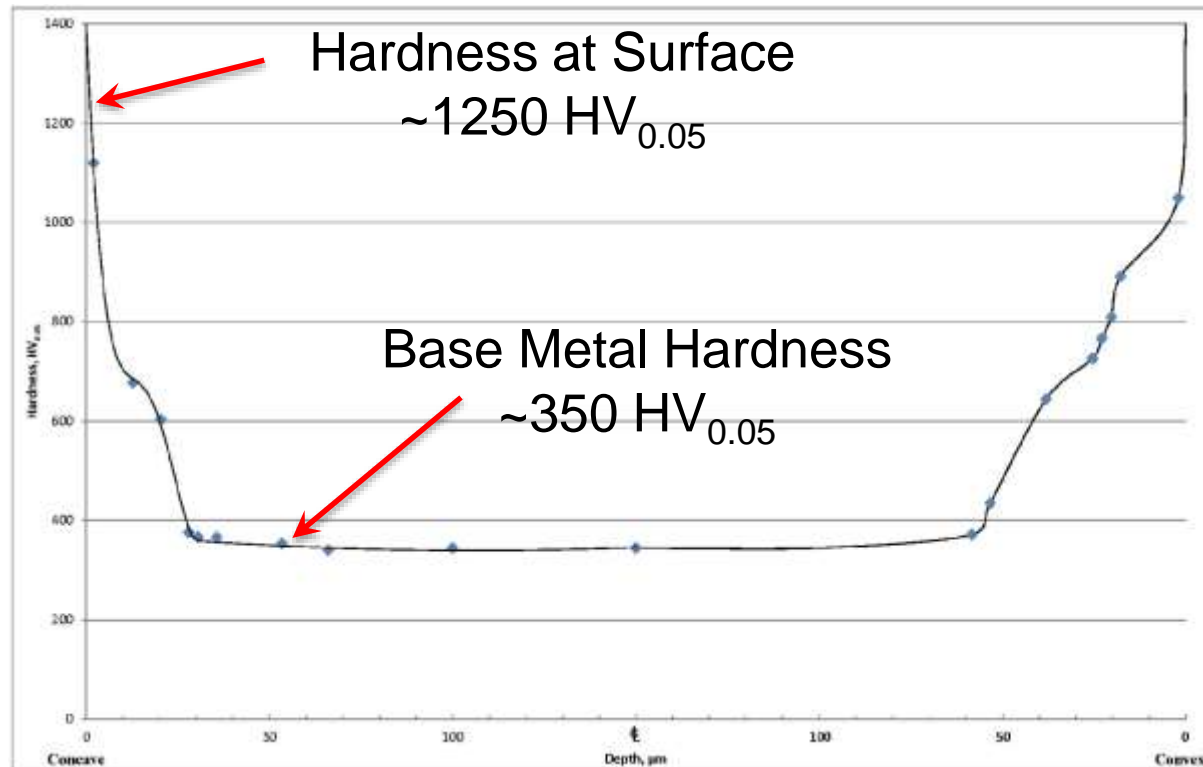
Disk 5/Target 1 Hardness Profile

Hardness testing showed the Kolsterising® treated layer was present after irradiation

- Microhardness values from Target 1 indicate the high-initial hardness at surface was still present after irradiation
- Data suggest Kolsterised layer remains stable after irradiation to ~4-5 dpa, thereby maintaining protection throughout a typical target lifetime

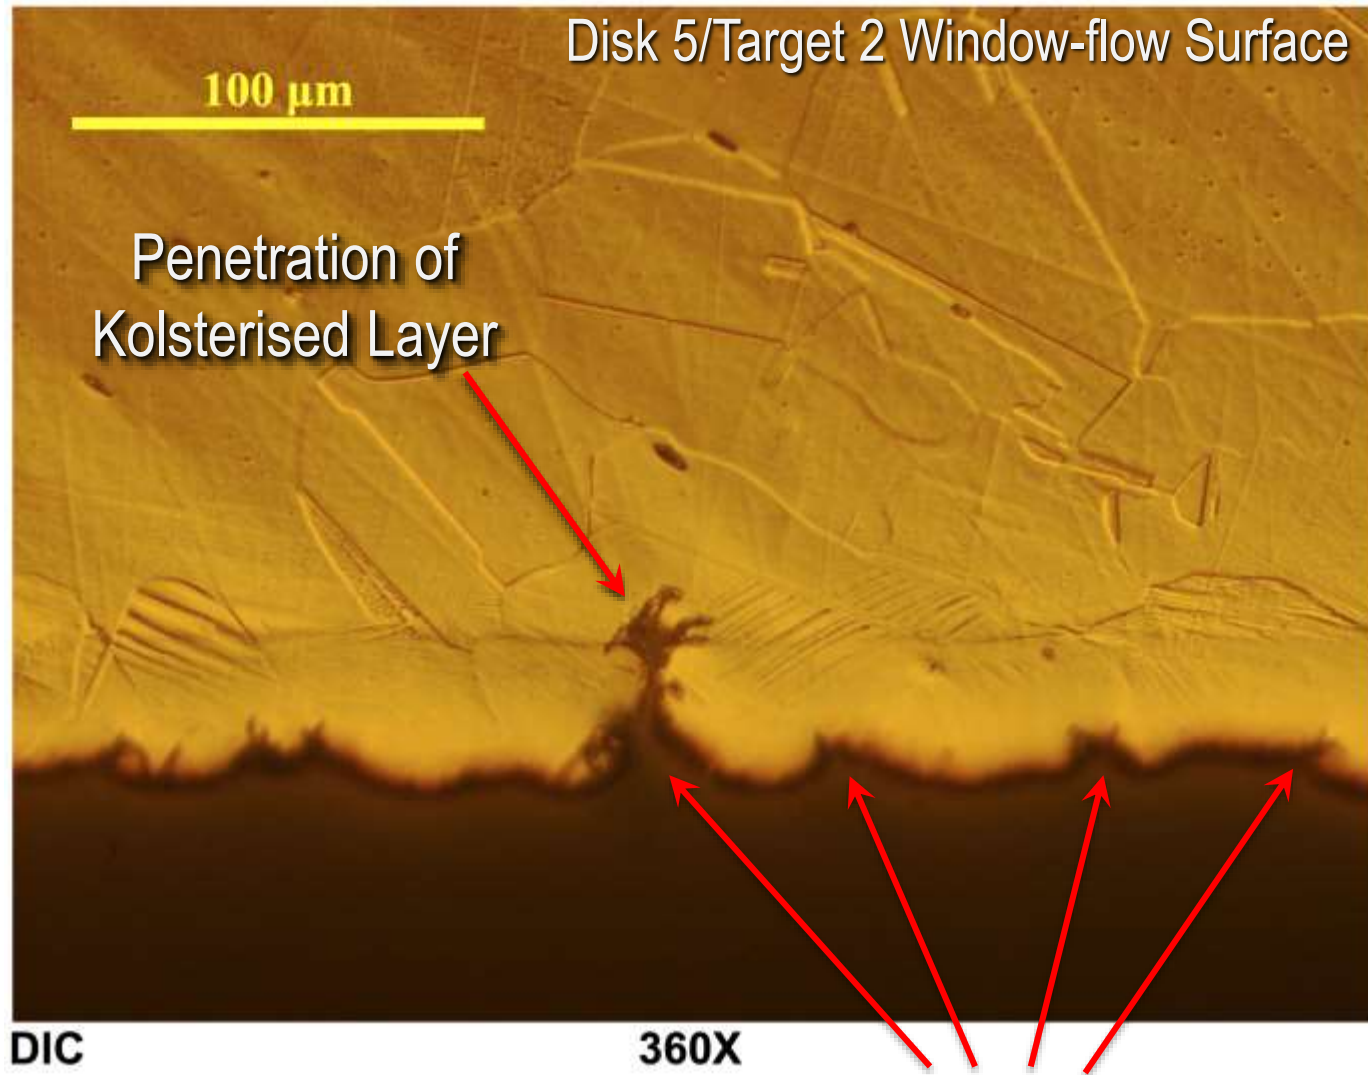
Penetration of Kolsterised layer leads to accelerated erosion damage

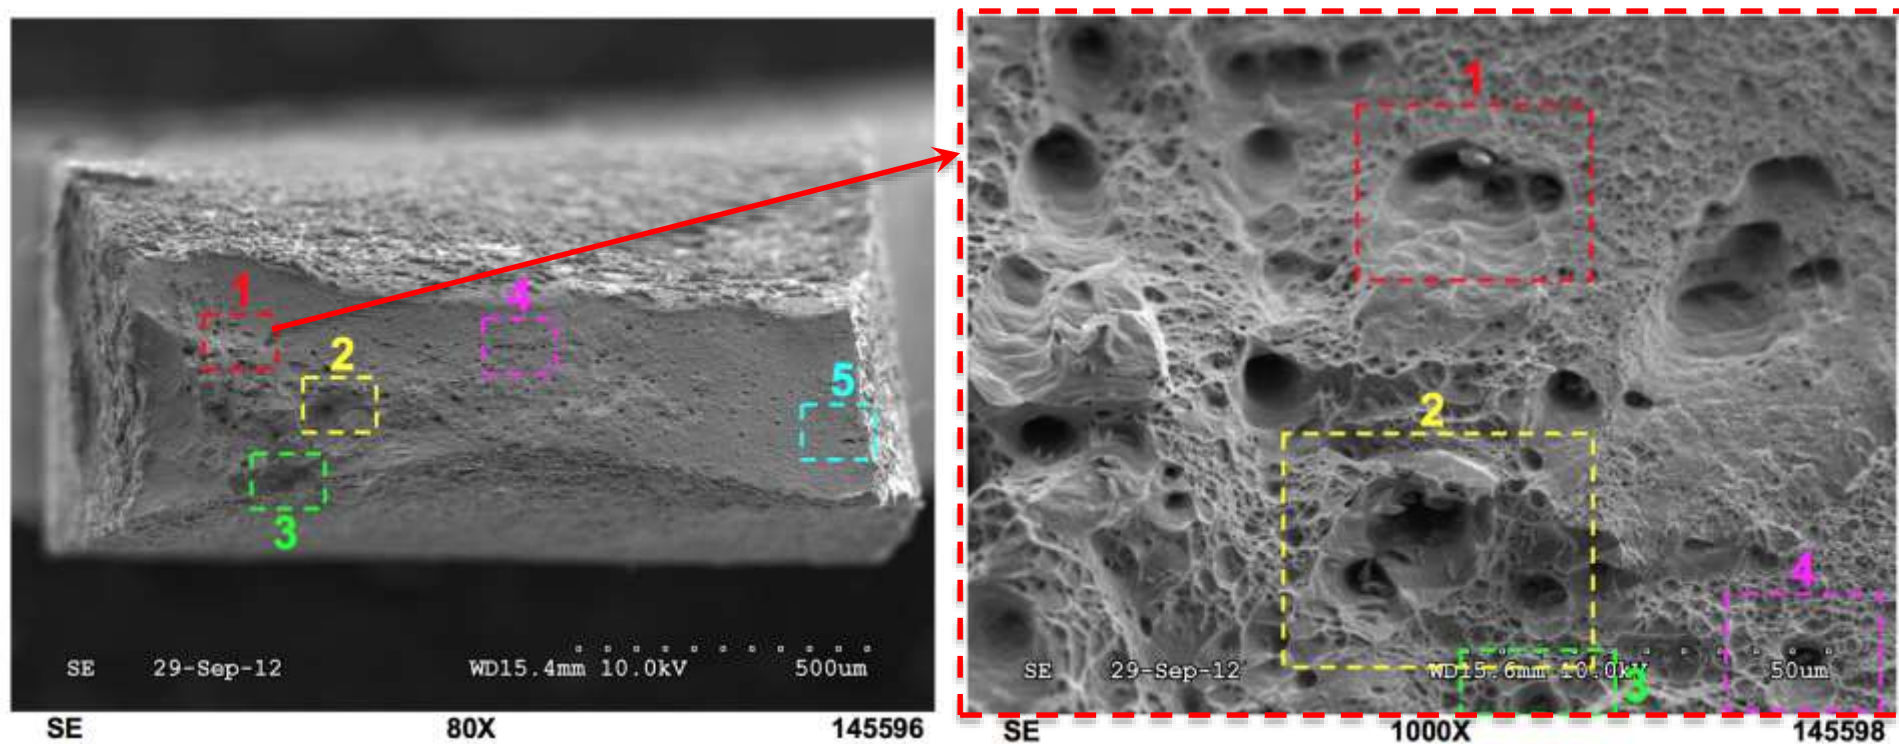
Nonmetallic Inclusions were found on fracture surface of tensile specimens

- Significant amounts of nonmetallic inclusions were found on all fracture surfaces examined
- Inclusions with several different compositions were found including Ca, Al, S, O, Mg

Presence of nonmetallic inclusions prompted purchase of “clean-grade” ESR processed 316L

- Nonmetallic inclusions were observed in material of the Targets 1 and 2 beam-entrance region, or “windows”
- Inclusions were characterized for Target 2 material according to ASTM E45
- After consultation with steel manufacturers a “clean grade” plate of electro slag remelt (ESR) processed 316L was purchased
- The ESR processed 316L plate will be used to fabricate future target beam entrance windows

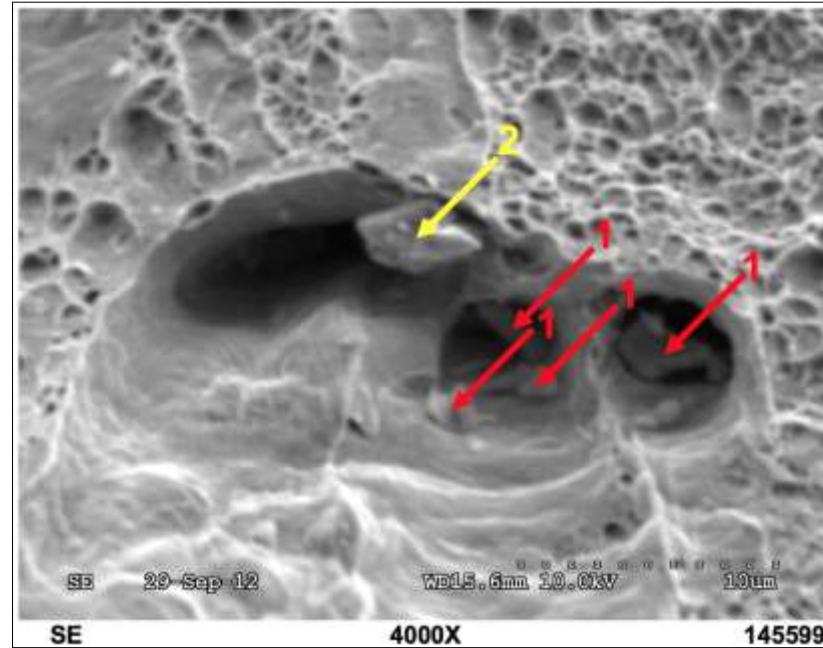
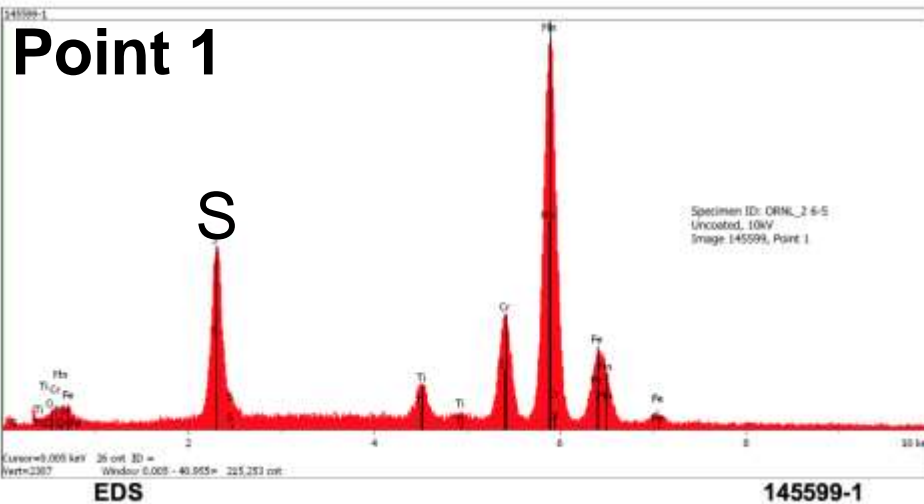
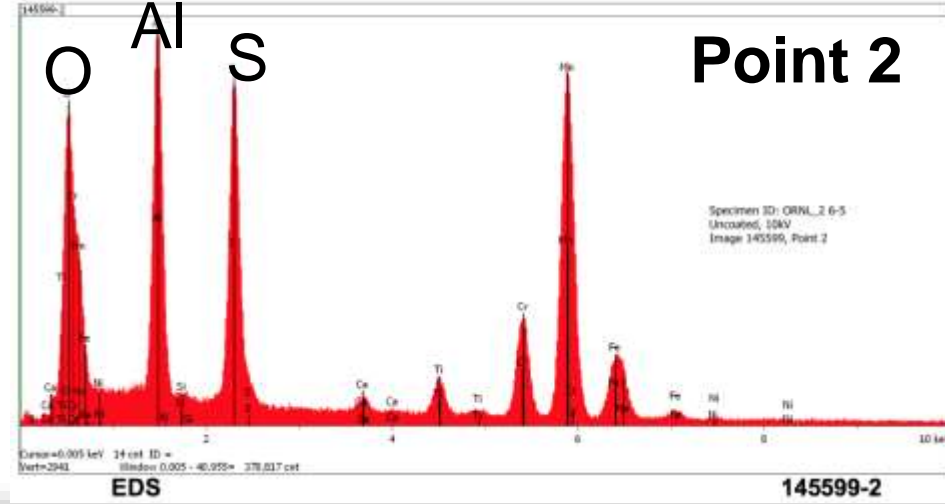
Nonmetallic inclusions were comprised of several different chemical compositions

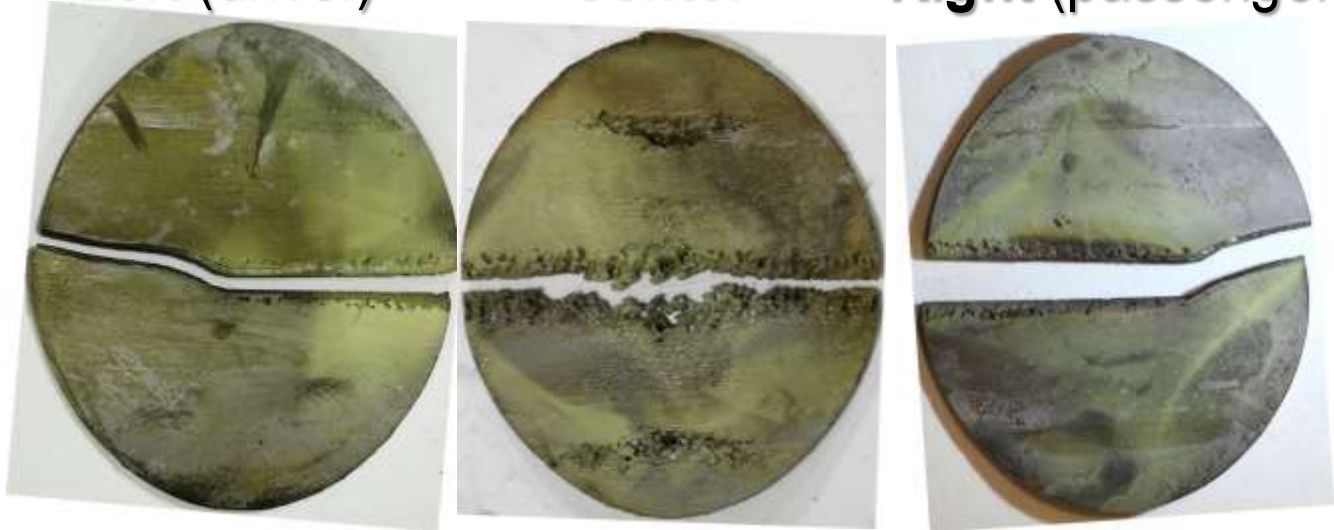
Target 4

Significant cavitation-induced erosion was observed on inner wall of Targets 4 and 5

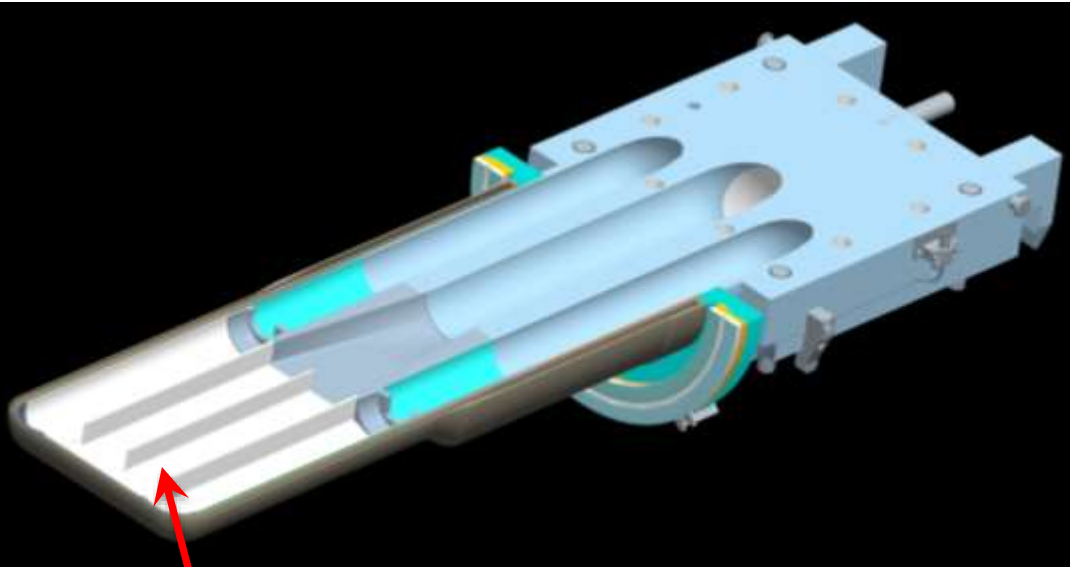
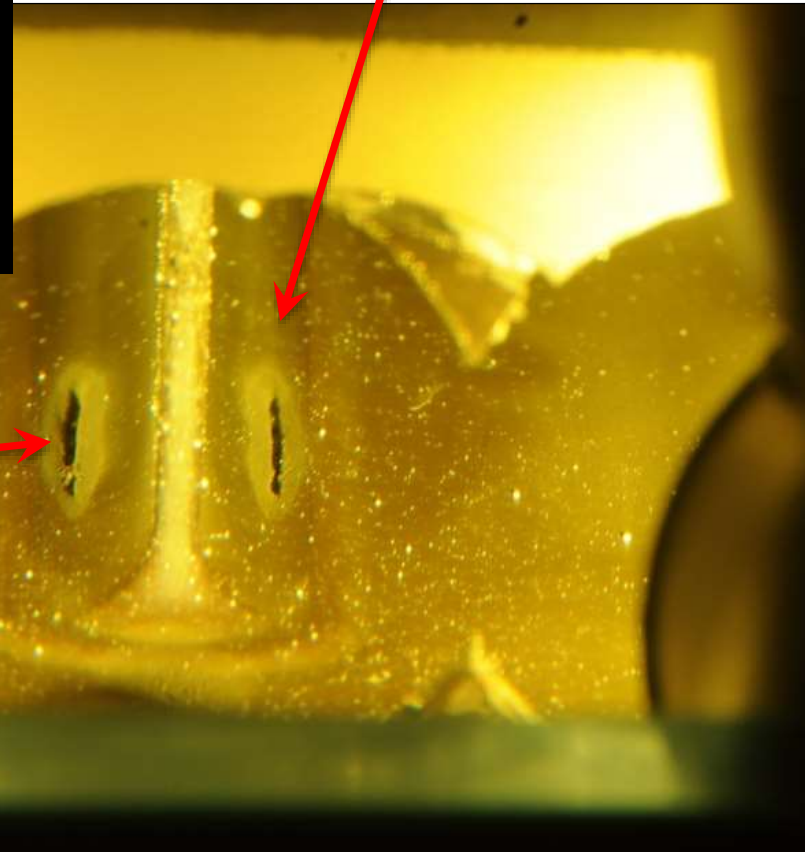
Top Interior Surface
of Target 5

Slit-shaped erosion “Hot Spots” were observed on either side of center baffle

Slit-shaped
Cavitation-Induced
Erosion Patterns

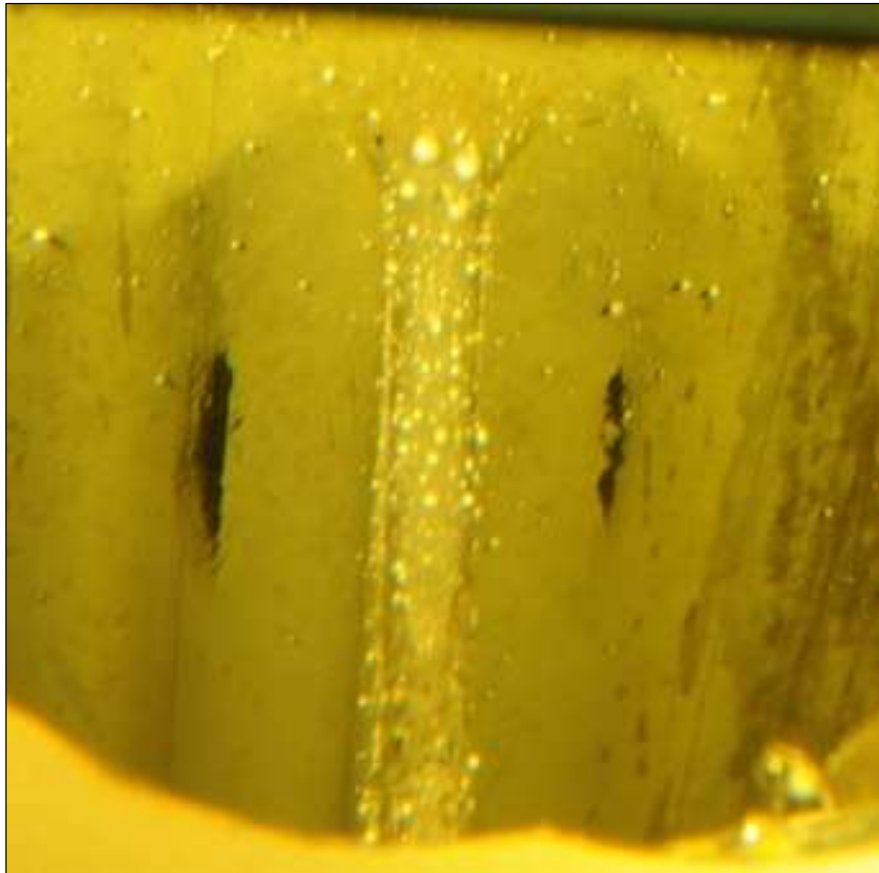
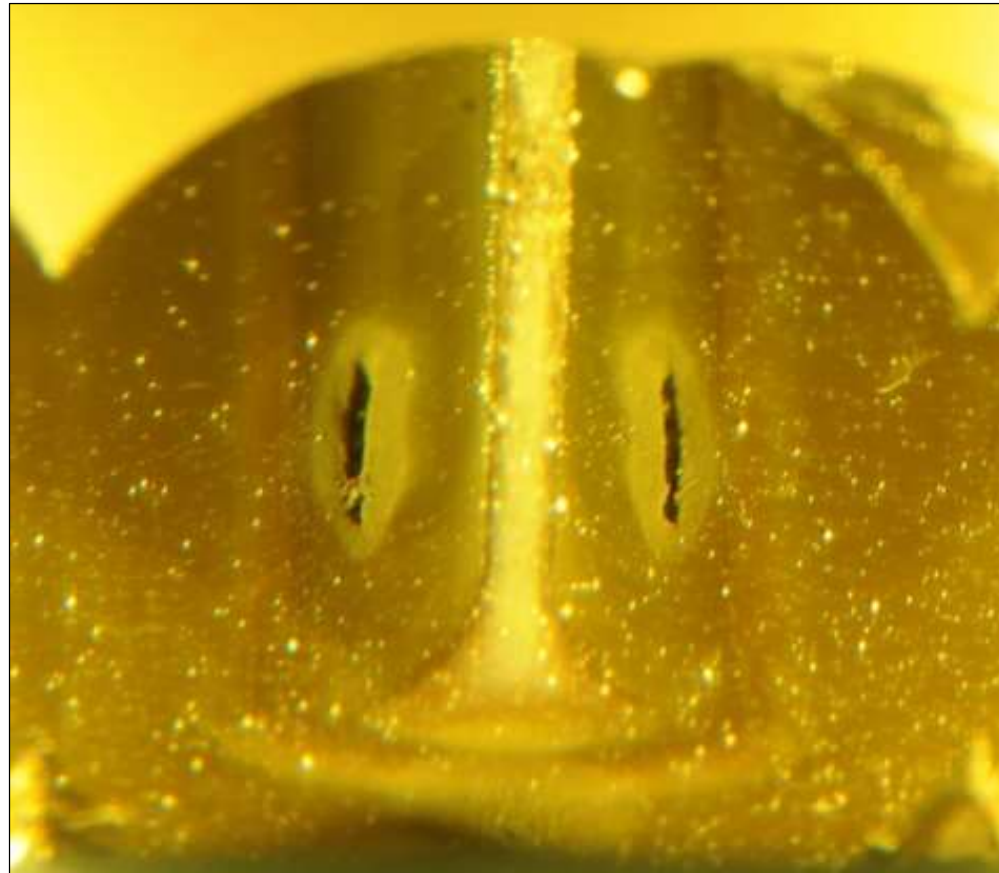
Slit-shaped erosion “hot spots” were observed on top and bottom inner surface of Targets 4 and 5

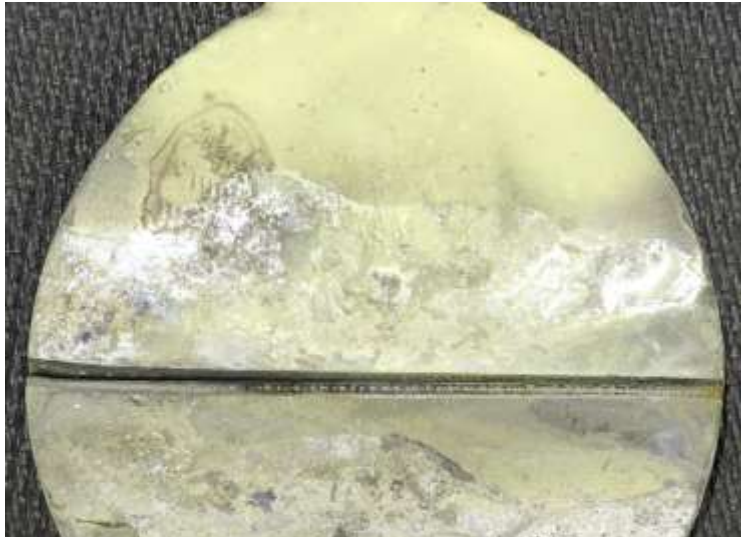
Left Off-center

Significant cavitation-induced erosion observed on Target 6 vessel inner surface

- Significant erosion was observed on the bulk flow facing surface of Target 6 and inner wall was segmented in two pieces after 617 MW-hr

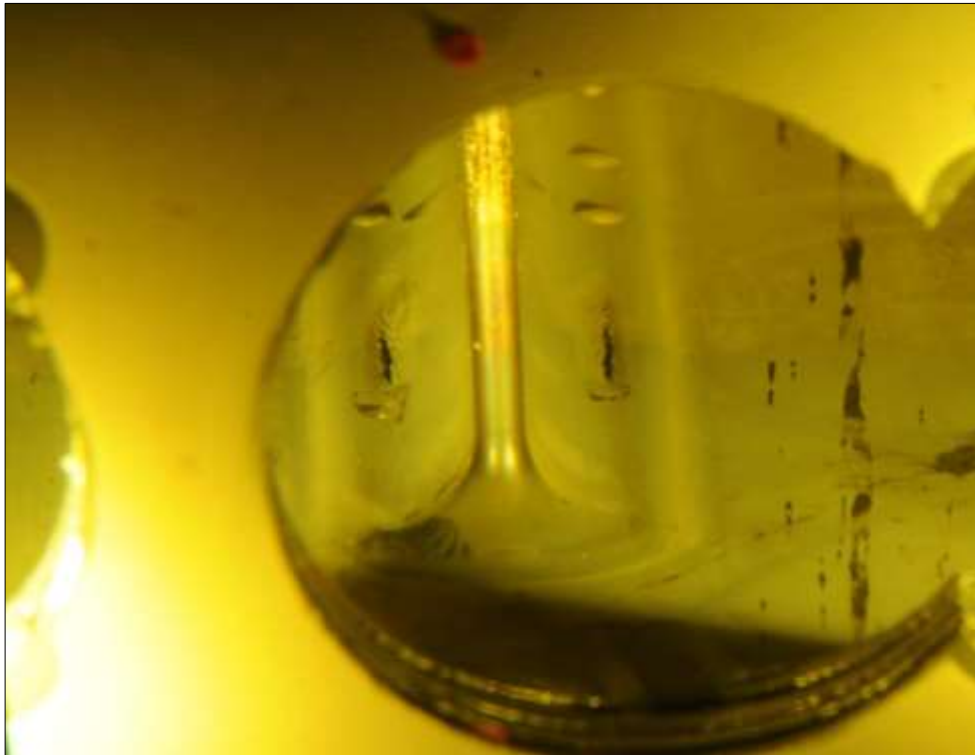
Erosion Hot Spots on Target 6

Erosion “hot spots” and crack-like feature on center baffle were observed on Target 6 after 617 MW-hr

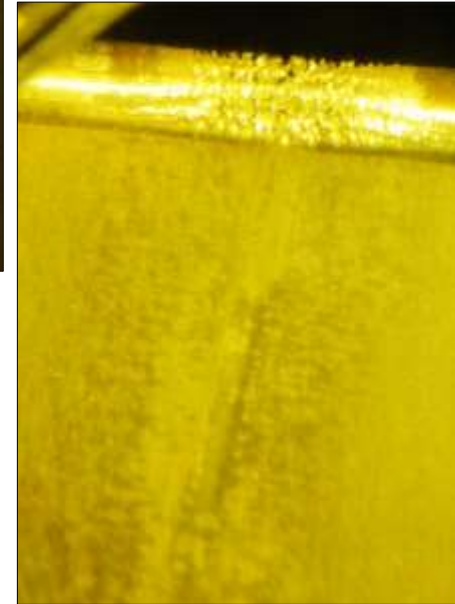
Center Baffle (after cleaning)

Crack-like feature
observed on center
baffles of Targets 2-5

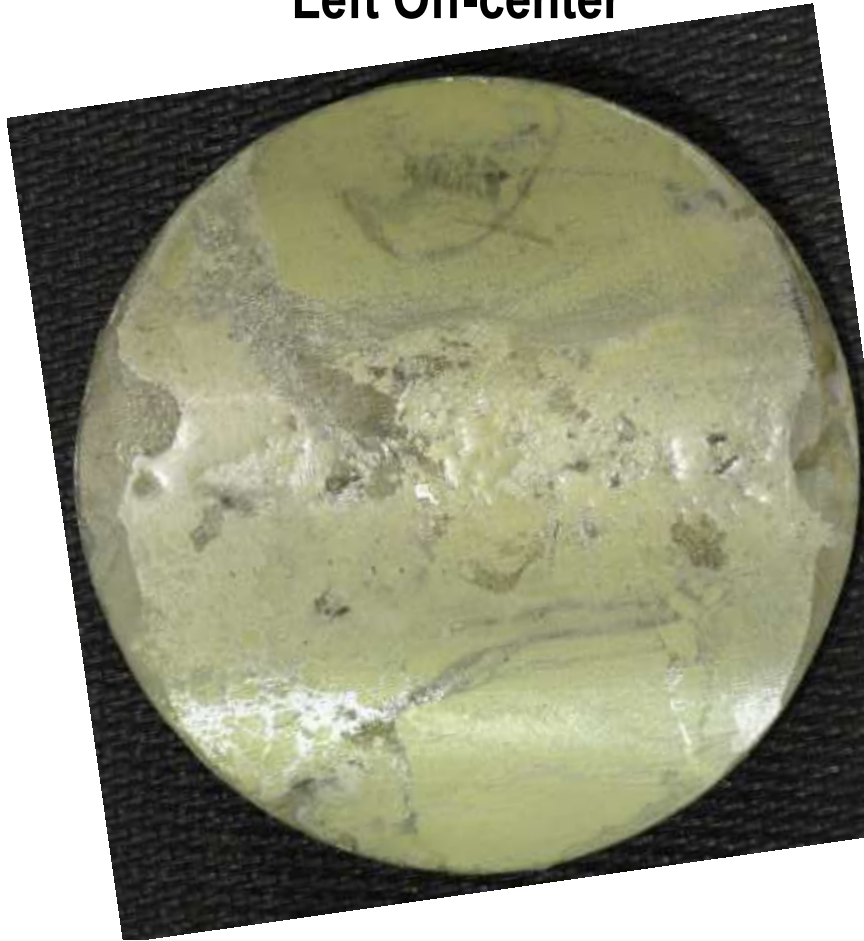
Left Off-center

Small amount of cavitation-induced erosion observed on Target 7 vessel inner surface

- Erosion was observed on the bulk flow facing surface of Target 7; a small patch of erosion was observed along the vertical beam center after 98 MW-hr

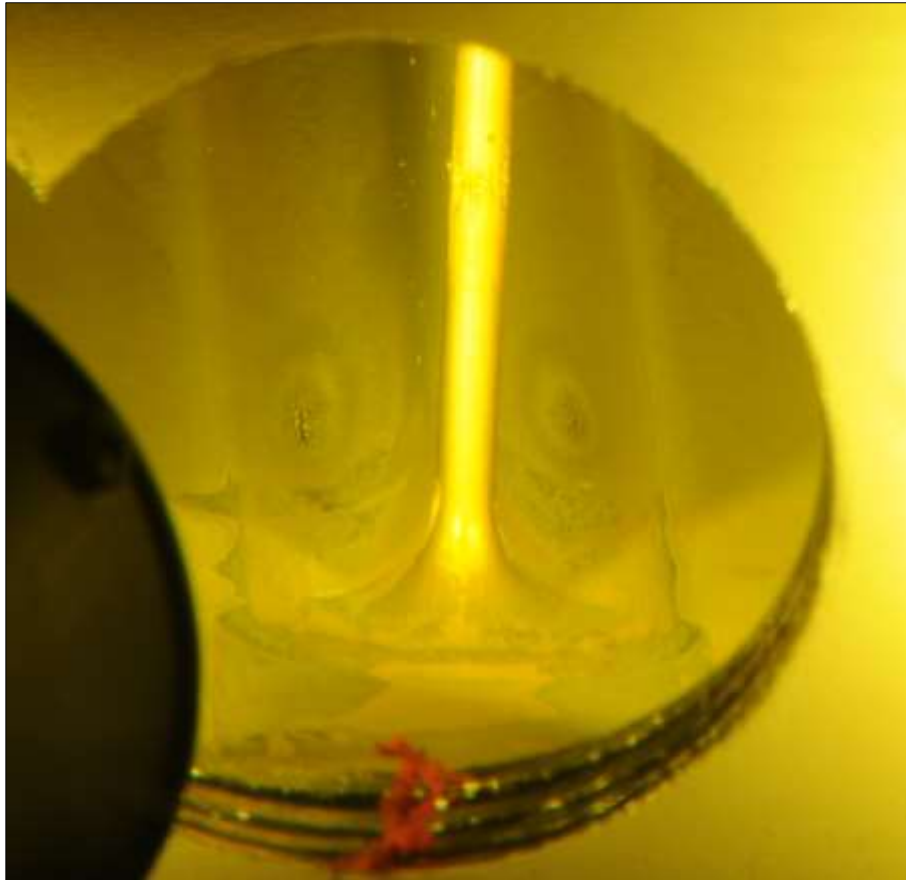
Erosion Hot Spots on Target 7

Erosion “hot spots” were observed on Target 7 – but no crack-like feature was apparent

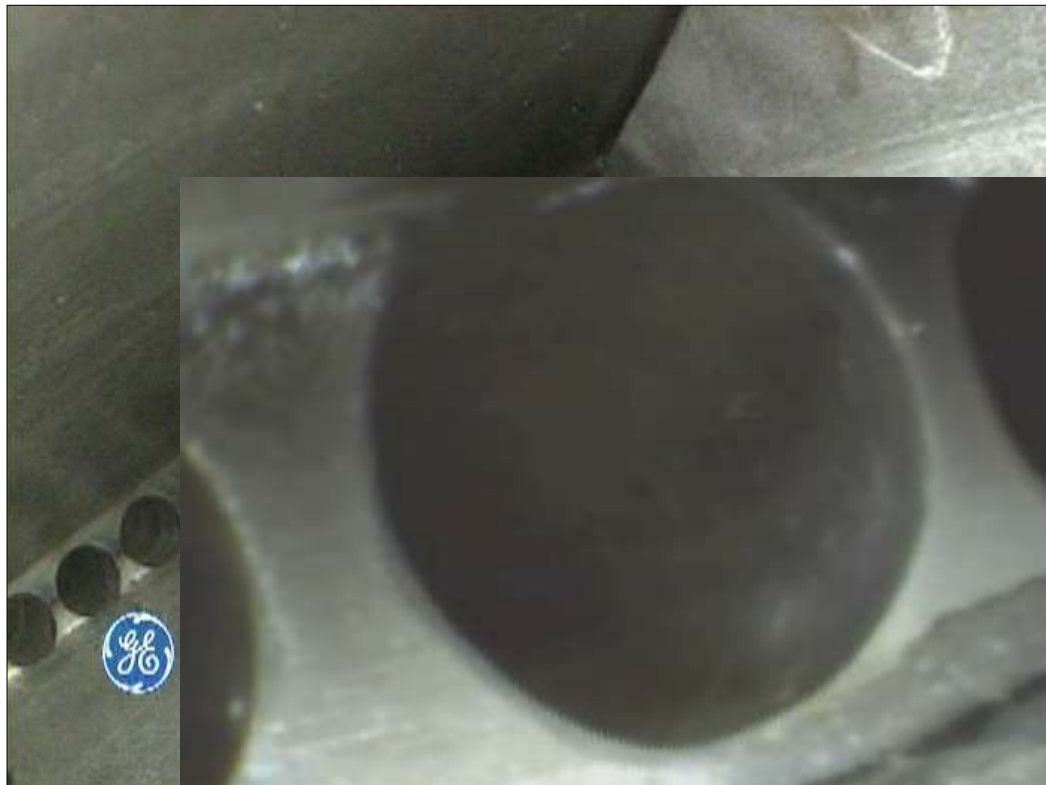
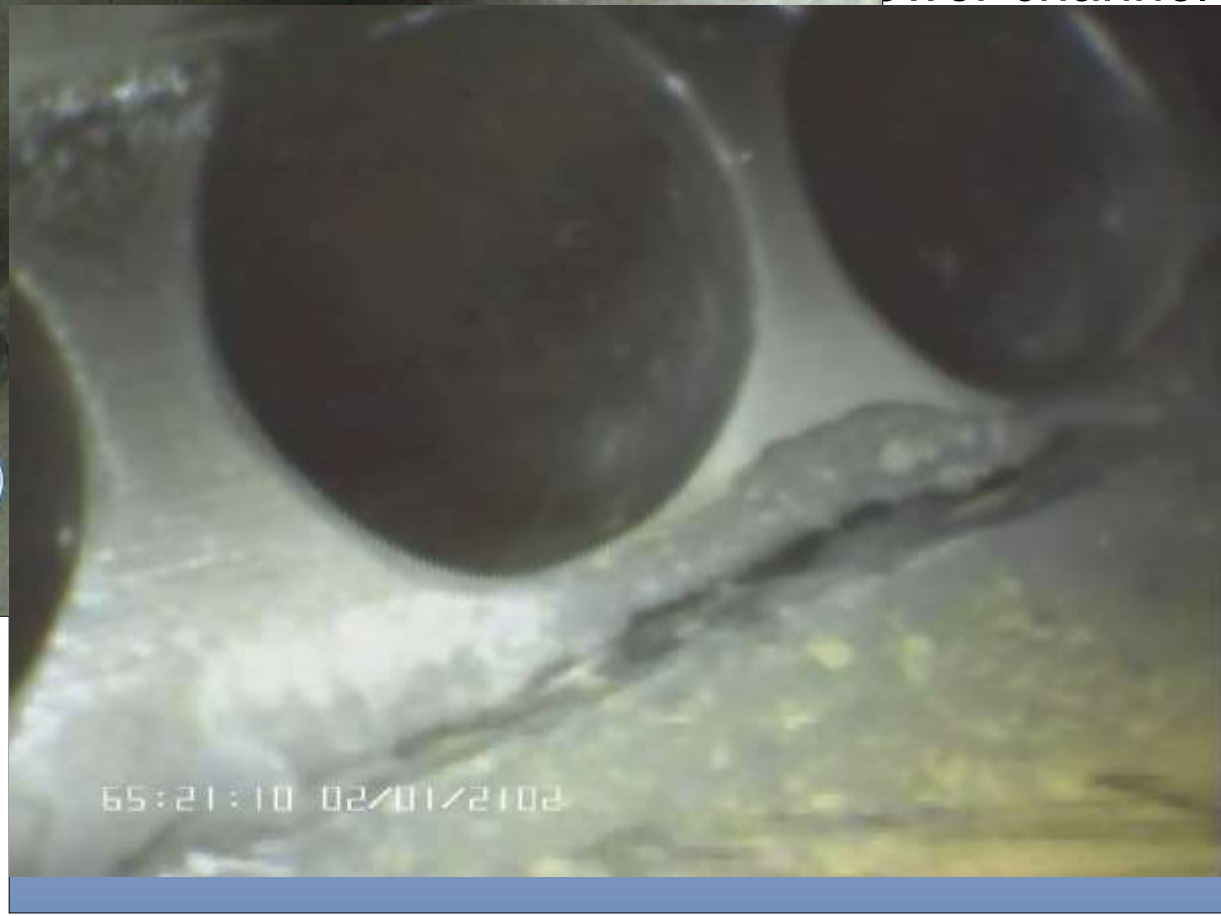
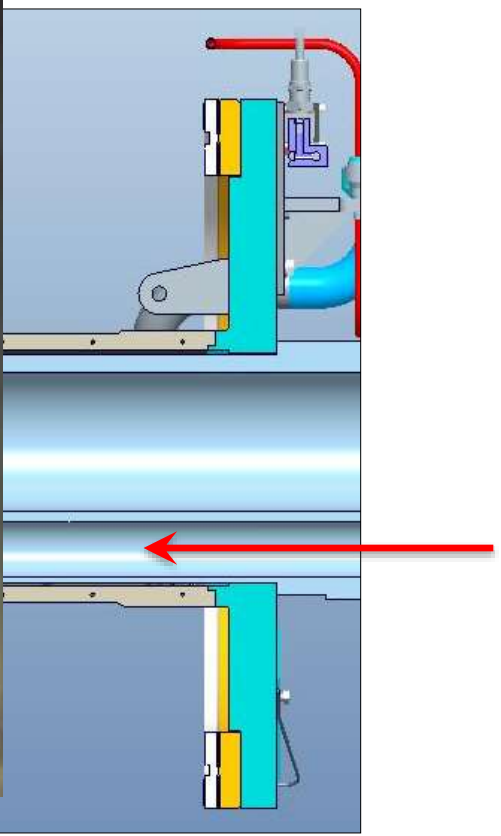
Articulating videoprobe examination found a crack like feature on a weld joint

ed into the window flow supply
lower channel flow paths

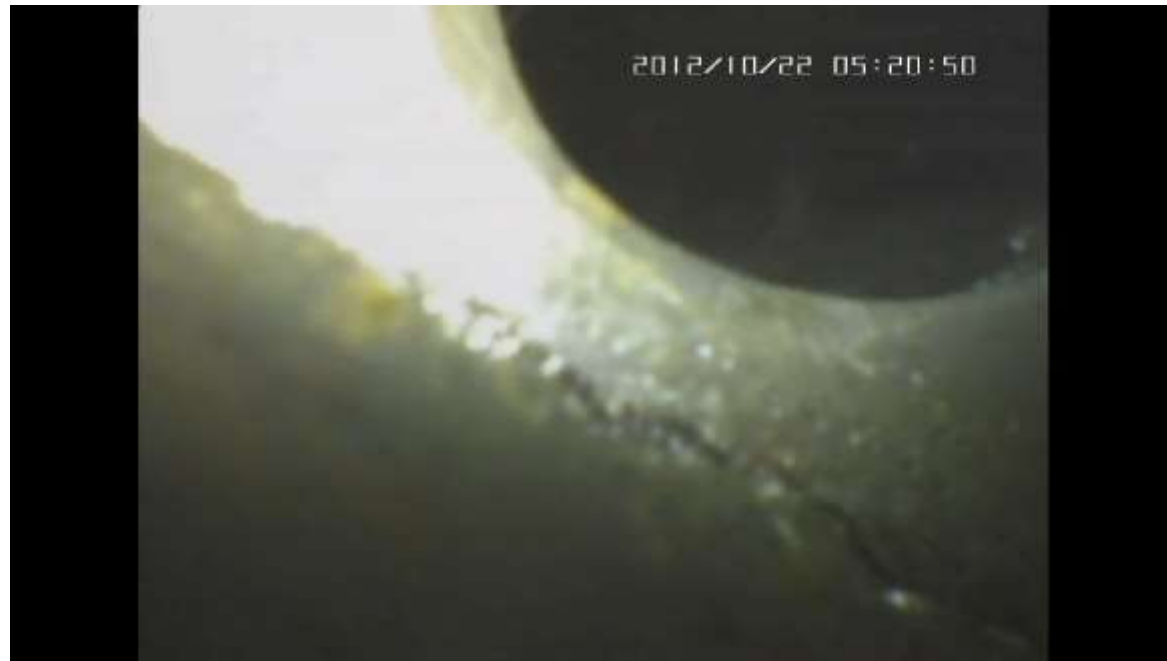
Target leaks were located using bubble solution and videoprobe inspection

- On Oct. 22, 2012 the videoprobe was reinserted into the window-flow supply passage and the interstitial volume was pressurized to ~30 psi
- “Snoop” was poured down the videoprobe cable and made its way to the “area-of-interest”:

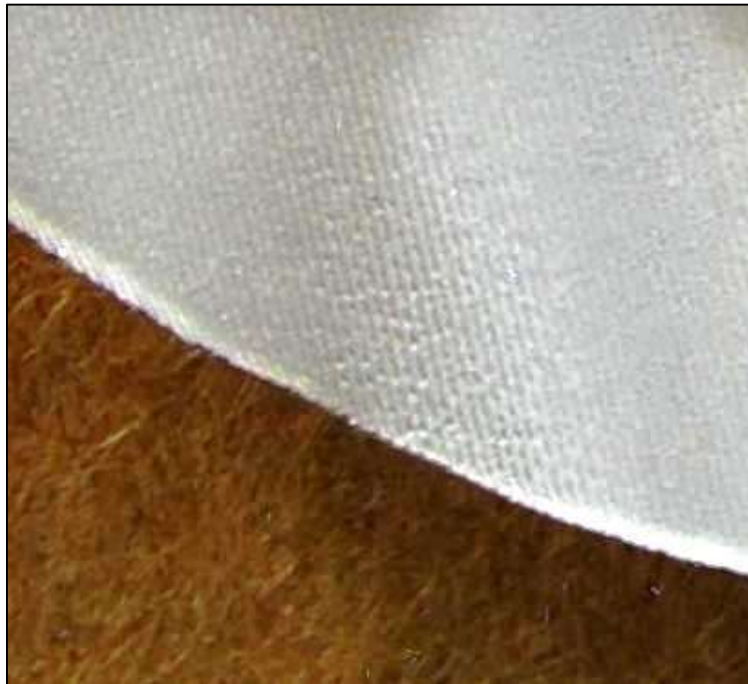
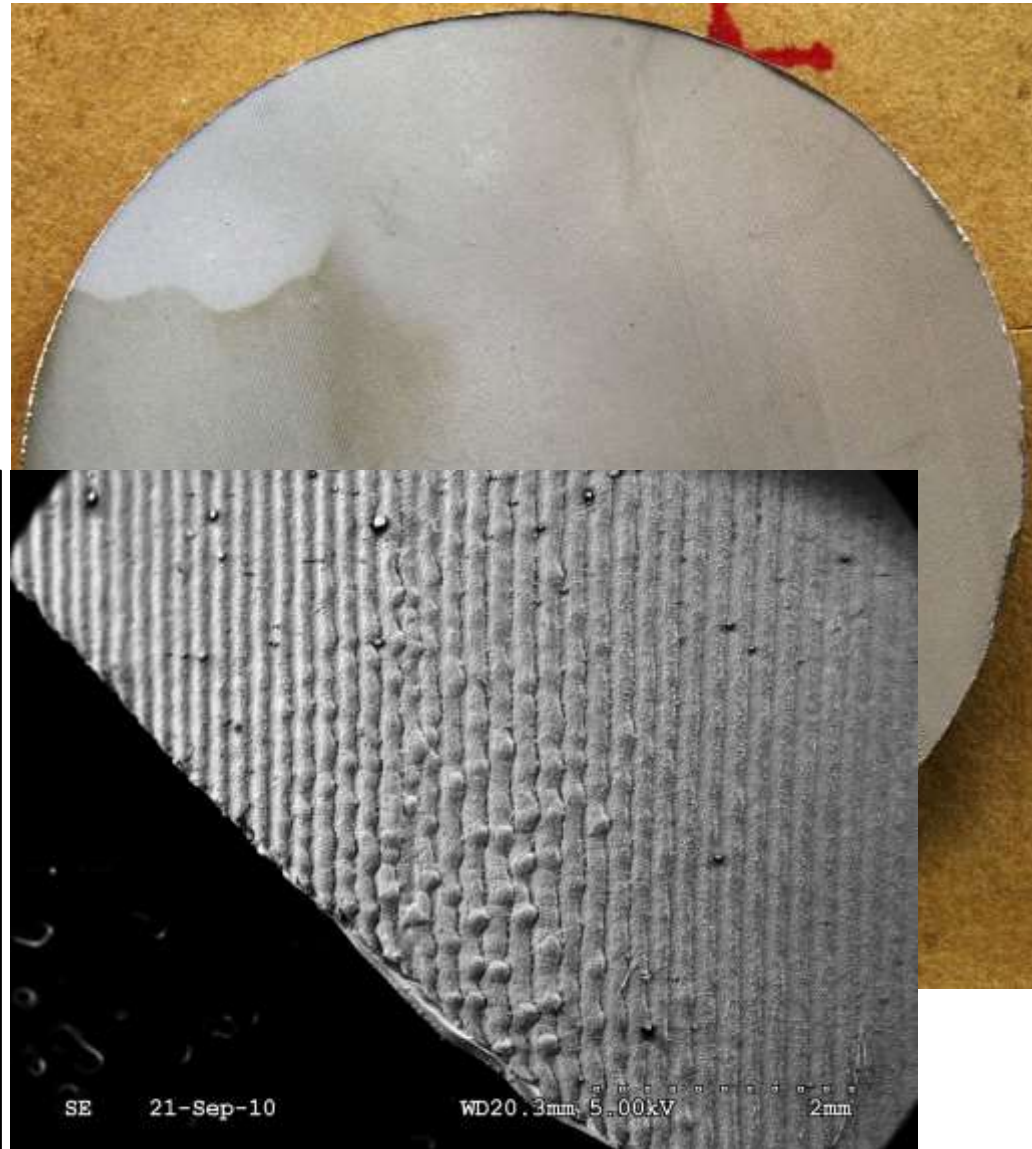
Machining marks from wire EDM act as nucleation sites for cavitation erosion

- Machining “line” marks left by wire EDM has been shown to act as nucleation sites for erosion
- To increase incubation period, the nucleation sites will be eliminated by polishing the vessel inner surface
