# Linac Modulator Performance and Upgrades

**David E. Anderson, presenter**

# High Voltage Converter Modulator (HVCM) Talk Overview

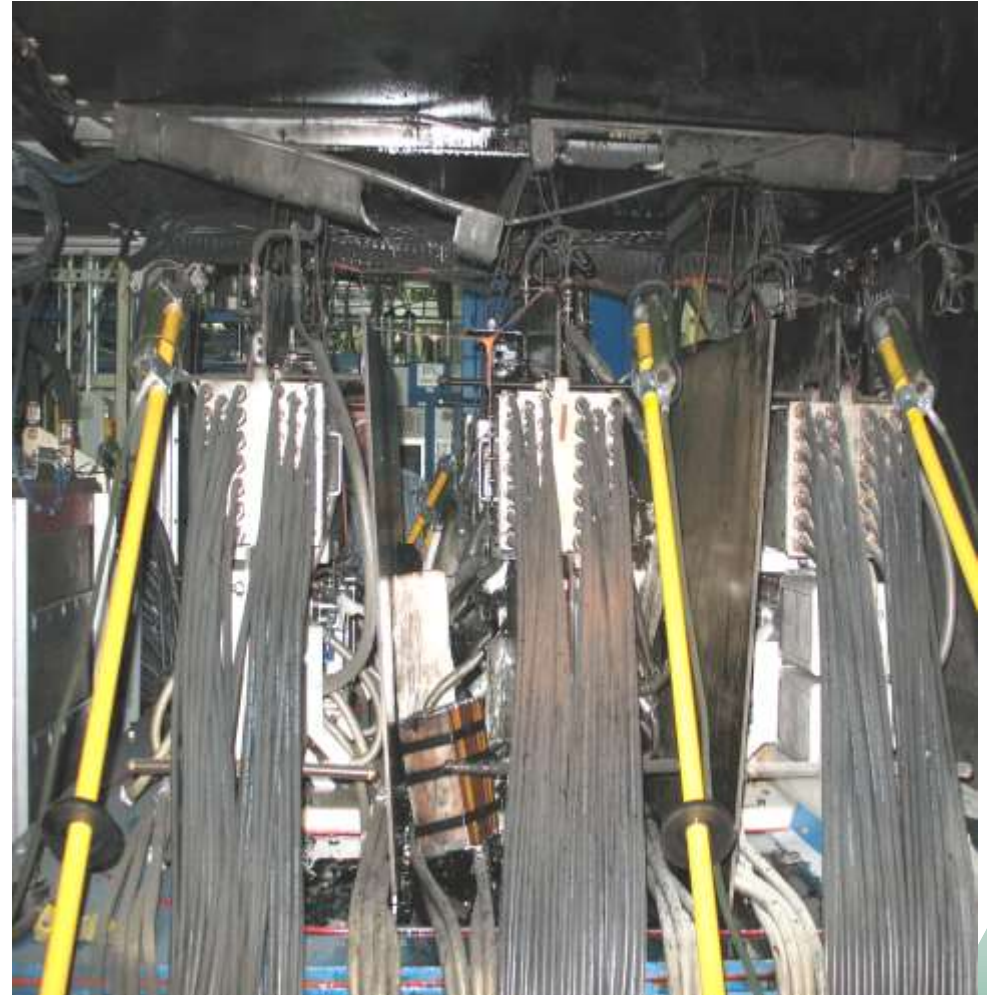
# HVCM Recent Fires

- **5 Fires to-date**
- **Collateral damage and long recovery times**
- **3 primary causes**
  - **Open air arcing between different potential surfaces**
  - **Corona degradation of insulation leading to failure**
  - **Capacitor failure**

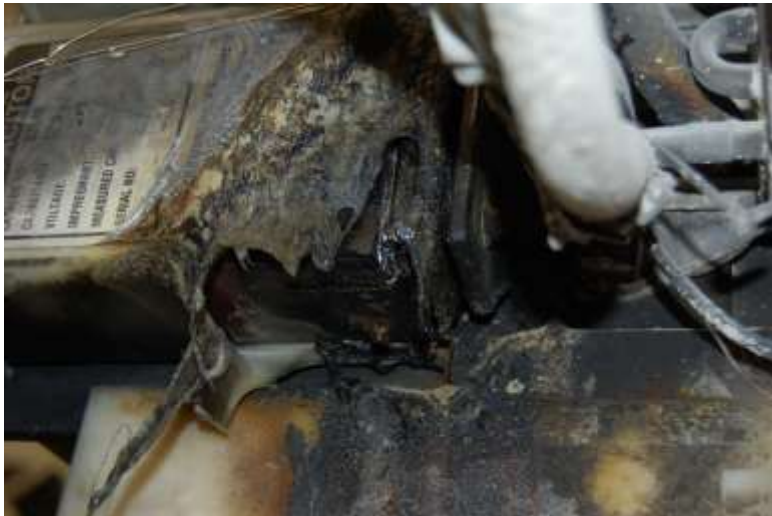
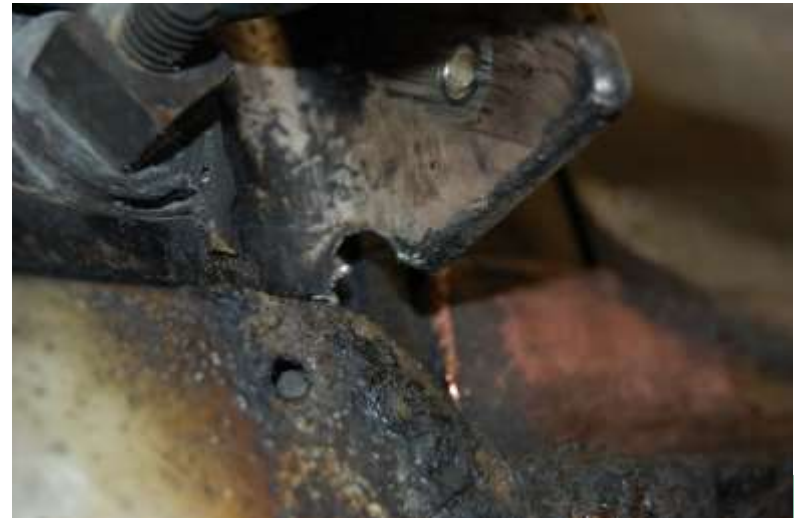
# HVCM Recent Fires – Arcing

- 1<sup>st</sup> fire, none since, in RFTF
- Workmanship or residual dirt believed responsible
- Repeated arcing acted as ignition source for combustibles
- Corrected with improved training of assemblers, no faults w/ same root cause since (Jan 07)

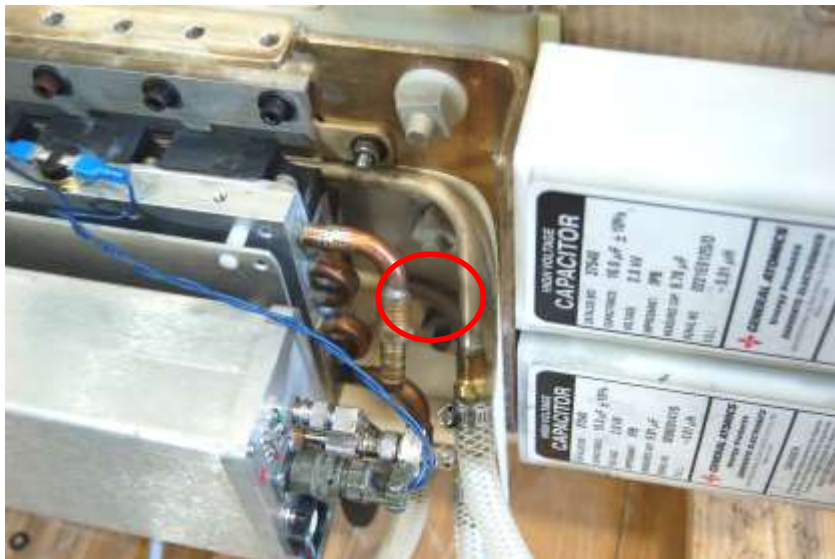
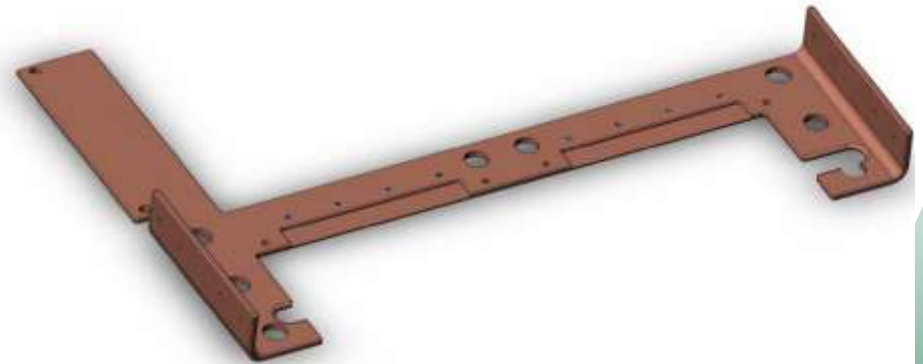
# HVCM Recent Fires – Insulation Degradation

- Cause of 2 fires and likely many of the IGBT failures
- Original design relies on single layer of DMD to insulate cooling tubes from different polarity bus
- Interference fit between tube and bus compresses DMD and can cut material if sharp edges present
- Corona degrades insulation over time, resulting in arc event
- Insulation double, short-term sol'n., cutout long-term

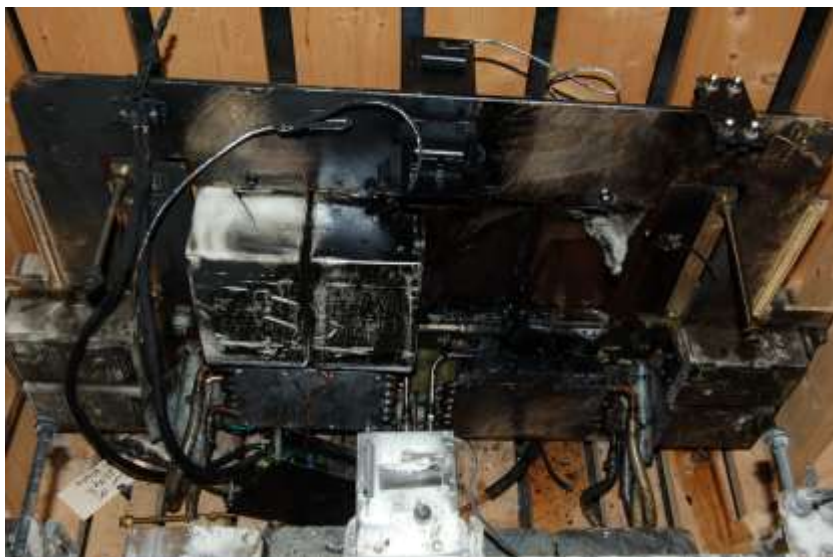
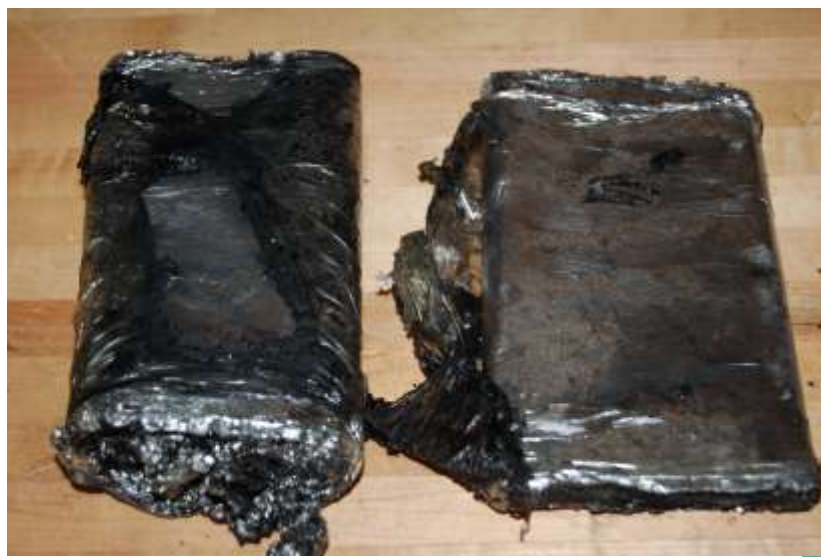
# HVCM Recent Fires – Capacitor Failure

- Cause of 2 fires, other failures due to collateral damage
- Likely internal cap failure and subsequent energy dump
- Cap MTBF 500,000 hours @ 2.4 kV, 168 units
- Path forward
  - Improved lifetime capacitors
  - Non-flammable impregnants (identical cap with rapeseed oil in-house)
  - Reconstituted mica/other technologies?
  - Self-clearing technology?
  - AIP in place to address this concern
