SNS target challenges and progress

Presentation to
**SNS Accelerator Advisory
Committee**

Phil Ferguson
SNS Source Development Group Leader

Oak Ridge, Tennessee
May 7, 2013

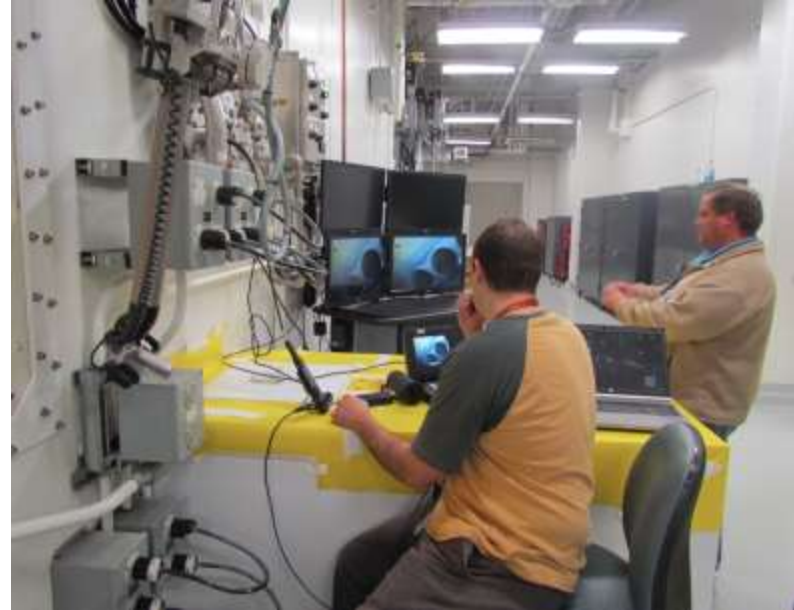
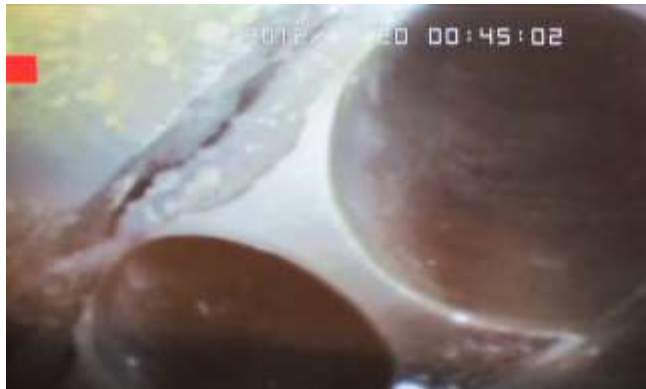
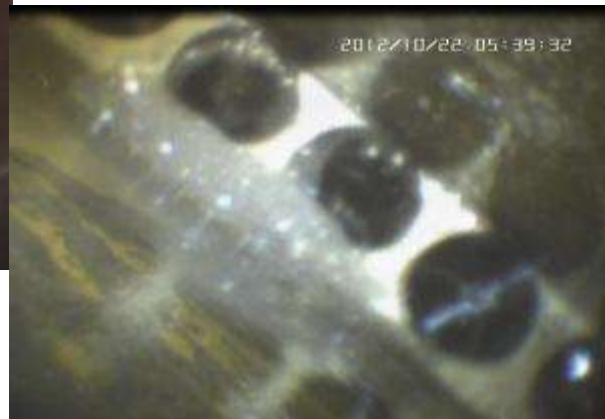
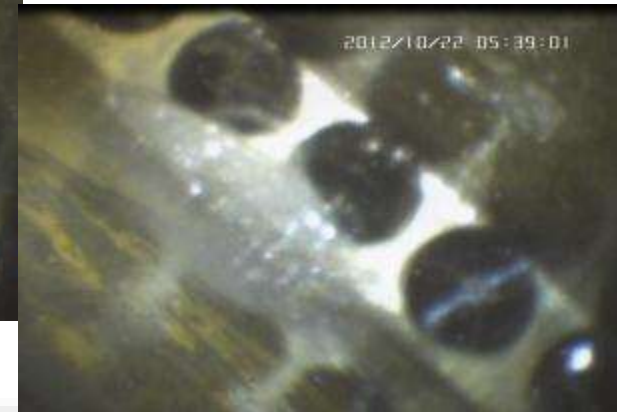
Videoscope examination revealed an issue

- Bore-scope examination of T6 indicates:
 - A feature of interest in the window flow tube manifold entrance
 - Confirmation of a leak path between the interstitial space and this location in the window flow tube by injecting snoop liquid and observing bubbles

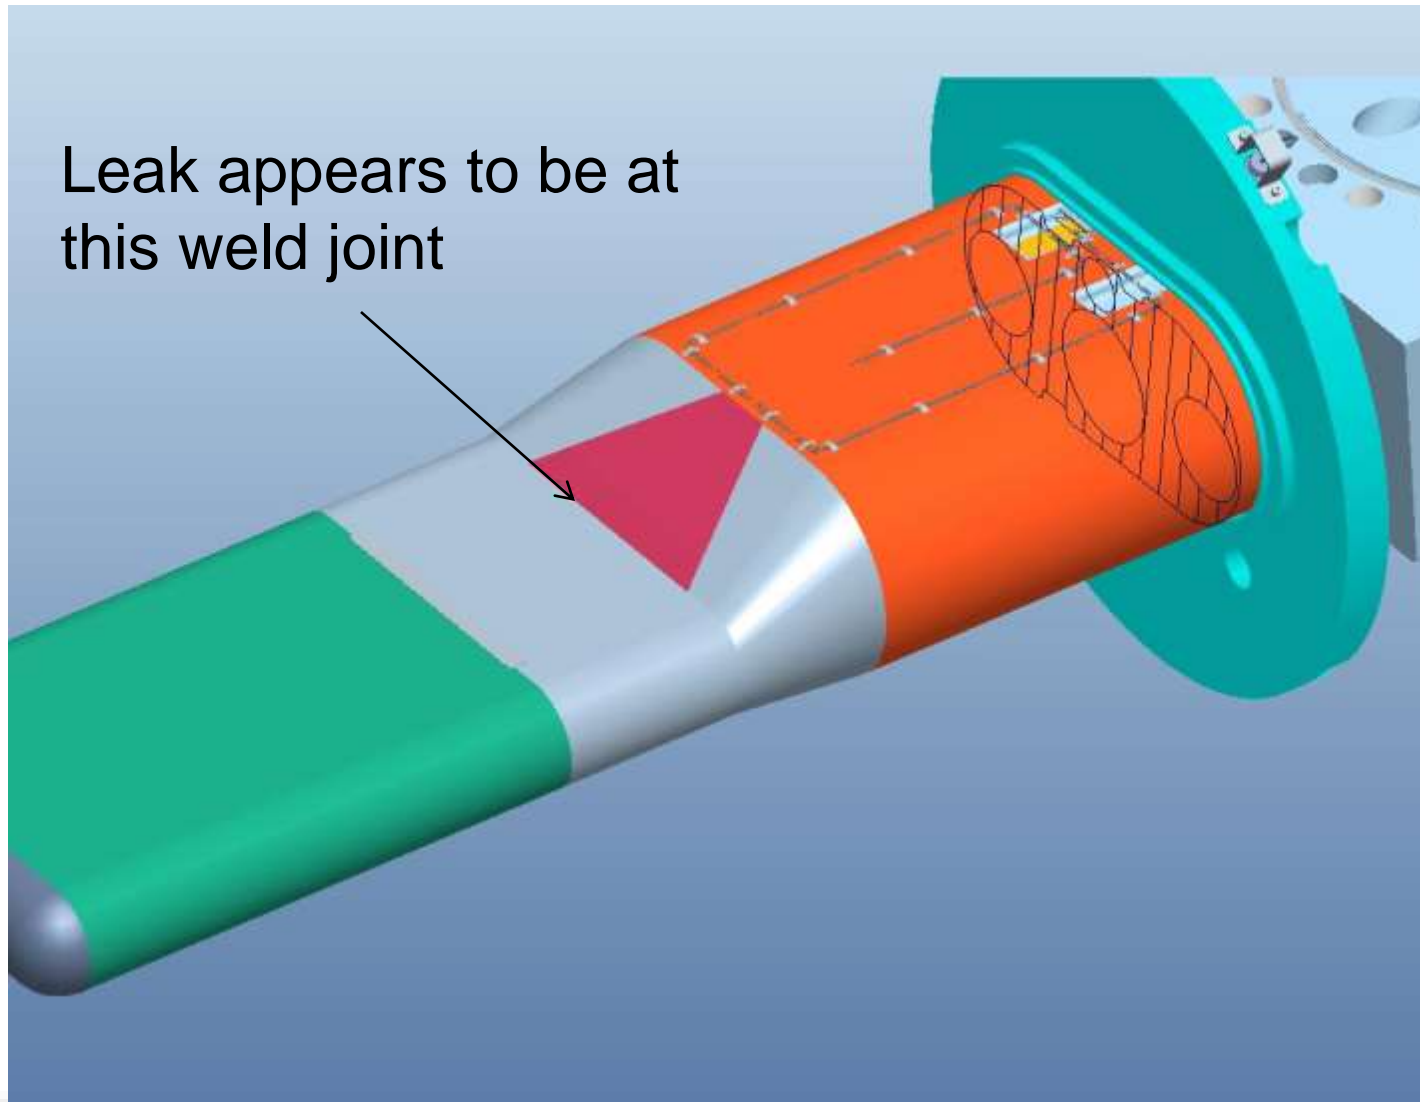
The leak appeared to be at a weld joint on the outer boundary of the mercury vessel for T6

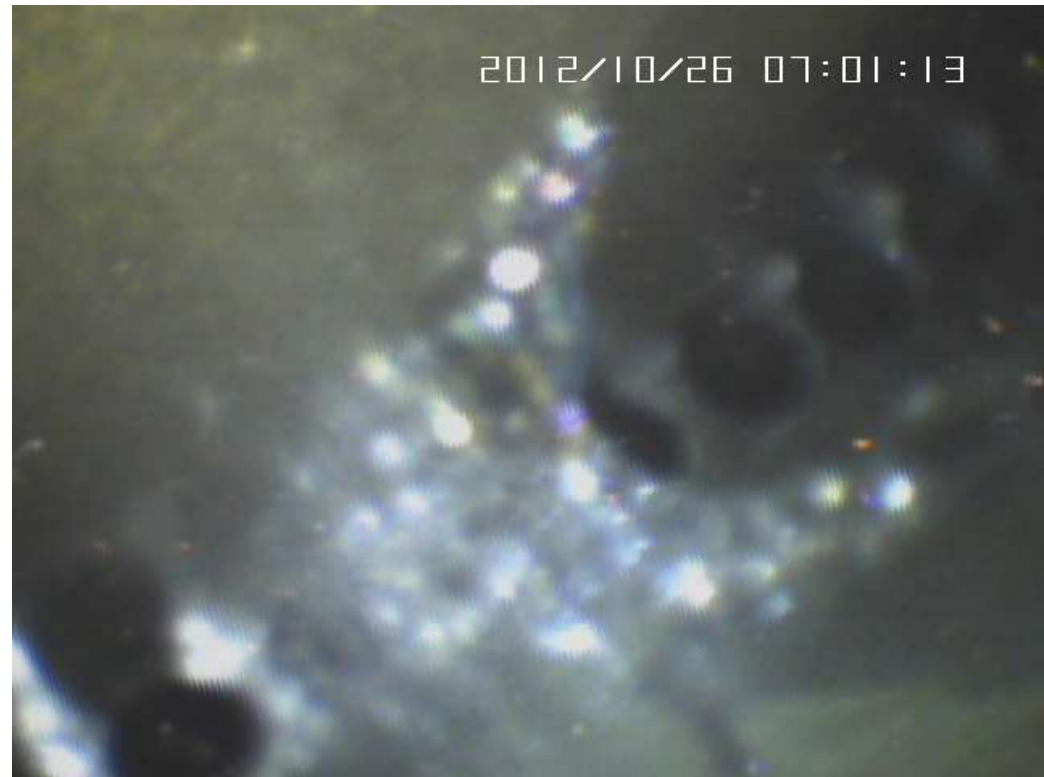
Videoscope of T7 showed a similar leak in the mercury window flow inlet

- Down to 2 targets, and a common mode failure identified
 - Do the remaining targets have this issue?
- Need to understand the exact nature of the leak
 - Manufacturing defect, operations induced, etc.

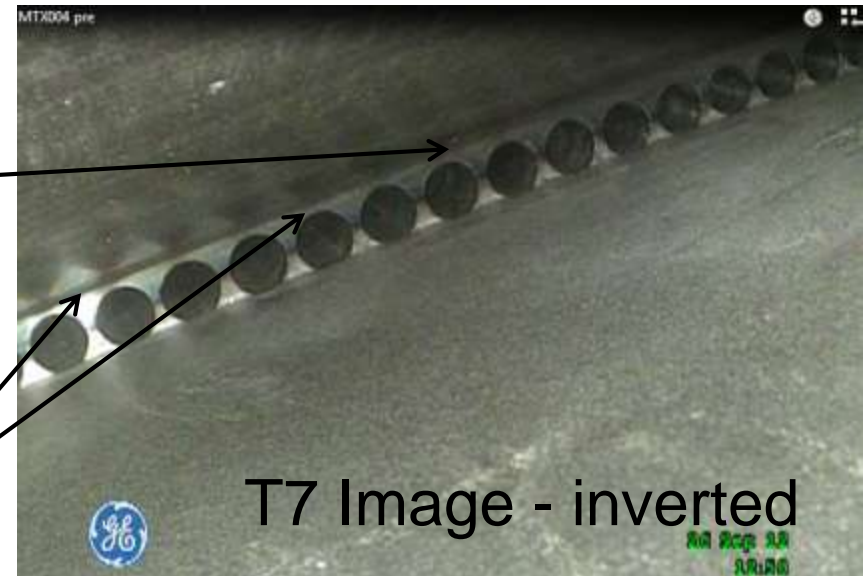
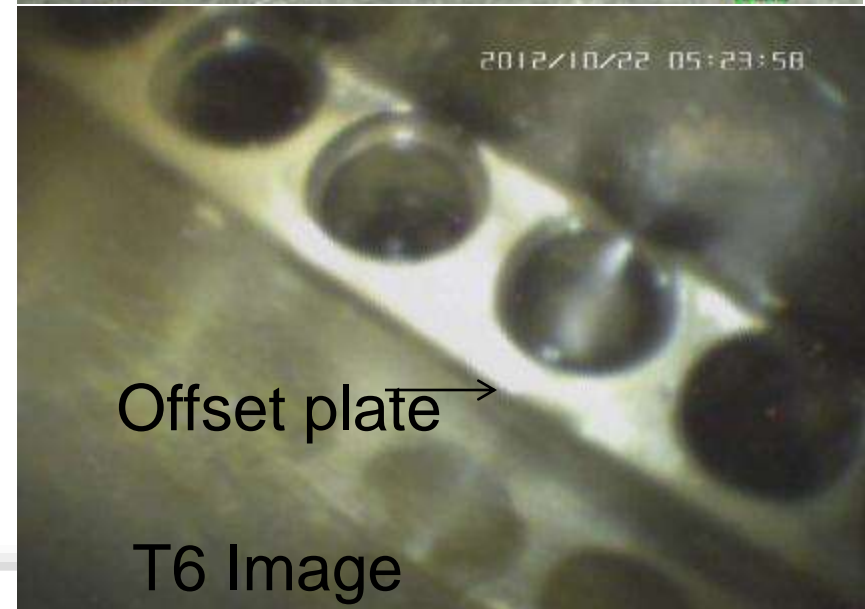
What happened on T6 and T7?

- Transition cover plate was installed offset from design condition
- There was not enough weld in the failed joint on the transition cover plate
- The weld in the failed joint was not a full penetration weld
- NDT is difficult in this area

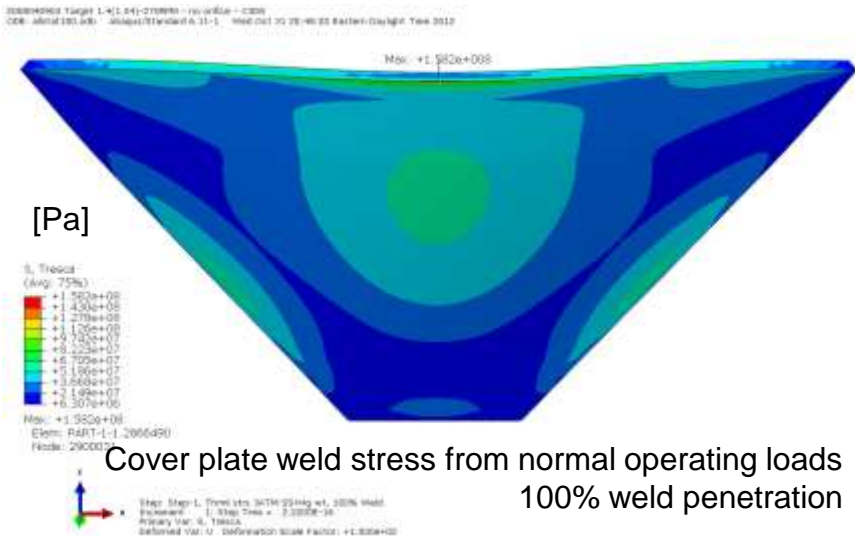
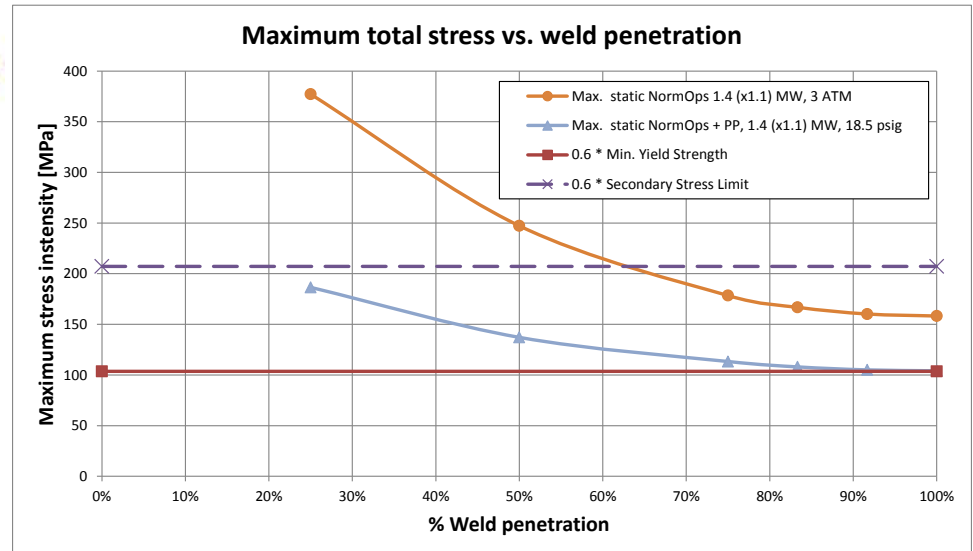
Analysis of the offset joint weld reveals credible evidence to why it failed

- Plate offset leads to reduced weld thickness / penetration
- New analyses of mercury vessel show cover weld stress dependency on weld penetration
- At ~50% weld thickness / penetration, stress goes up quickly
- Operating stresses are higher than previously estimated, but not high enough to cause failure at startup → fatigue suggested

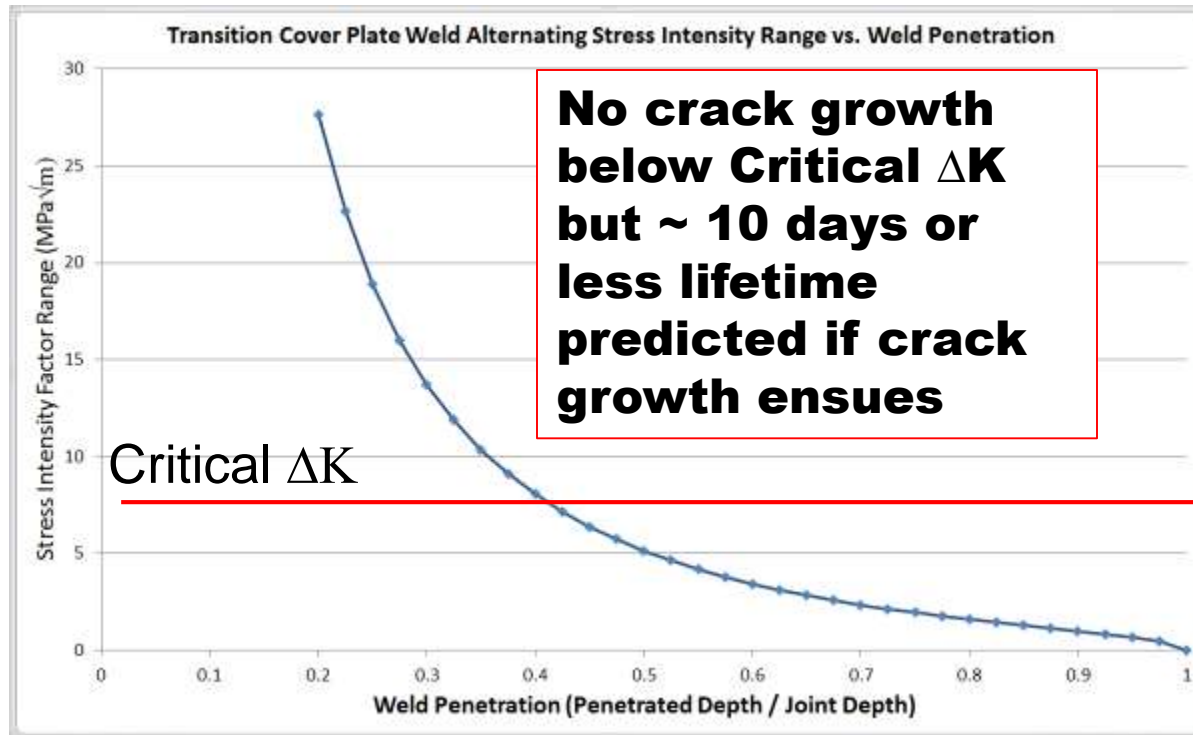
Fatigue Fracture of Cover Plate Weld

- Lack of weld penetration results in initial crack at leak location
- Beam pressure pulse causes high cycle ($\sim 1 \times 10^8$ cycles for T6 and $\sim 2 \times 10^7$ T7) alternating stress, which could grow crack
- Based on empirical data, no crack growth predicted if weld penetration 45% or better however with less weld, failure predicted in under ~ 200 hours at 1MW beam power.

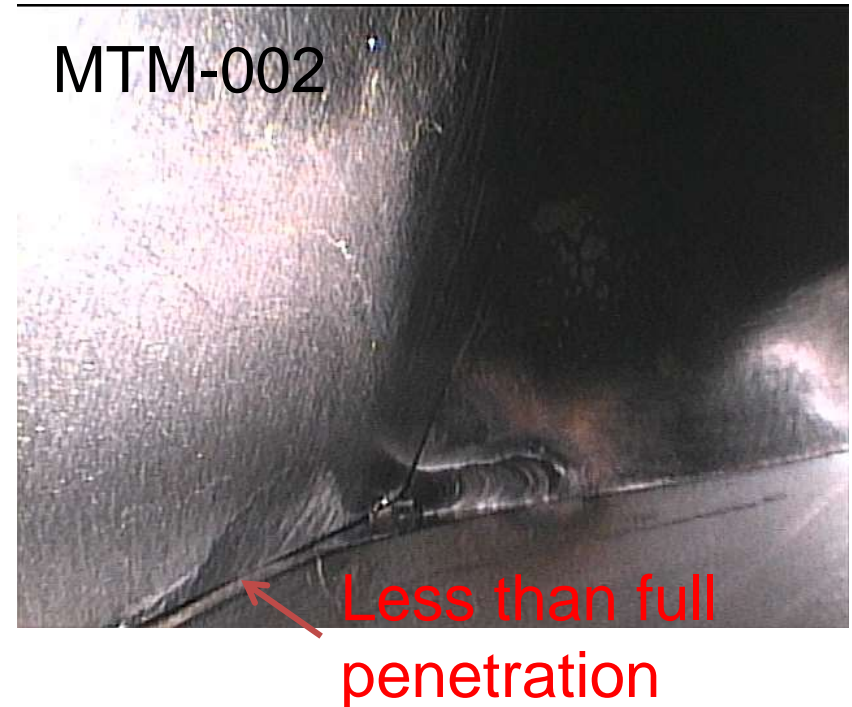
Videoscope examination of the prepared target (MTM-002) showed it suffered a similar weld issue

- Returned to the manufacturer
- Decision to remove the water shroud, repair the weld, and re-weld the water shroud in place
- On schedule for a July 2013 return
- More from Peter Rosenblad tomorrow

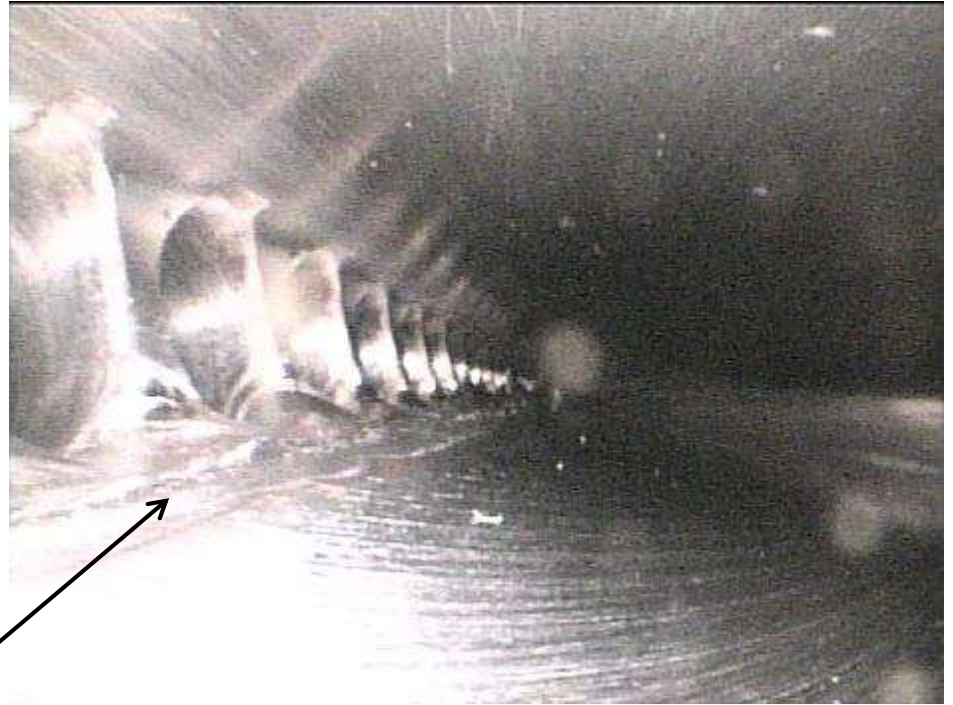
Target 8 (MTM-003) was more robust than T6 and T7 based on evidence of as-designed weld

- Mitigating factors based on analysis of the transition joint
 - The fit-up of the transition cover plate appears to be as-designed in inspection videos
 - There is evidence of weld penetration in the videos – Level 3 inspector has also reviewed video of the inside of the joints and finds them acceptable
 - Additional stress analysis shows T8 meets our design criteria
 - Additional QA performed with support from HFIR

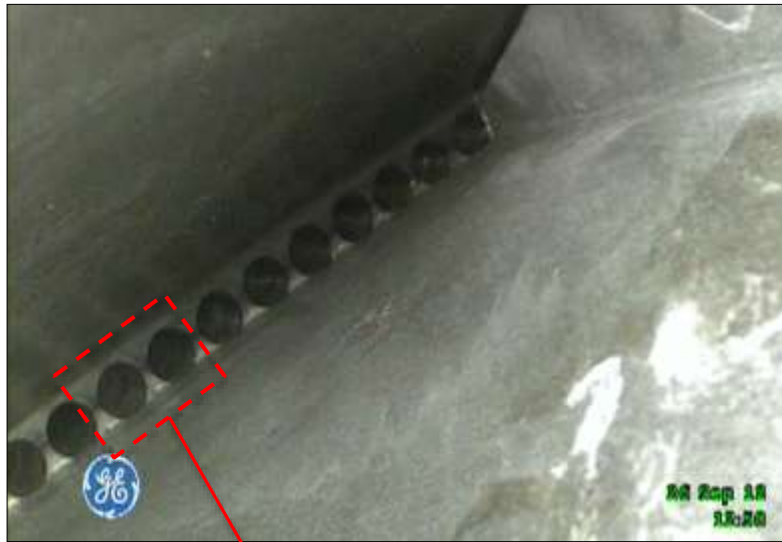
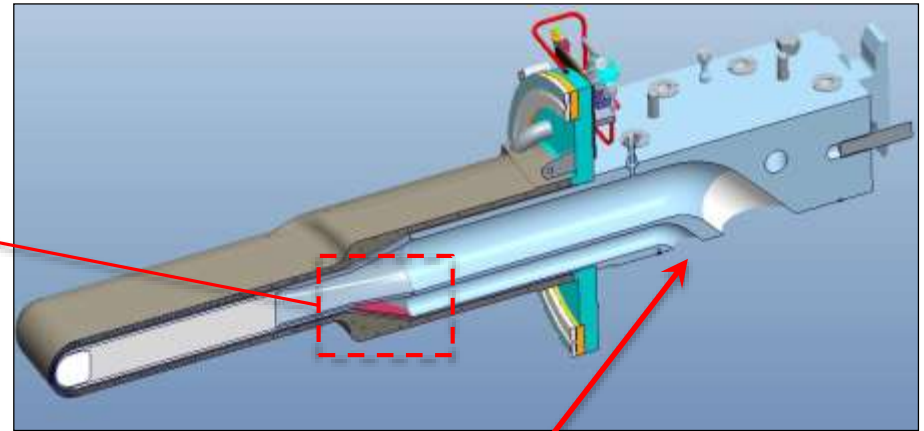
Location of Leaks in Targets 6 & 7 Were Located Using an Articulating Videoprobe

- An articulating videoprobe was inserted into the window-flow supply passage of Targets 6 & 7 and the leaks in were discovered using “Snoop” leak indicator
