# **Ion Source and LEBT Performance, Limitations and Challenges**

**Martin Stockli**

**AAC Review**

**January 10, 2012**

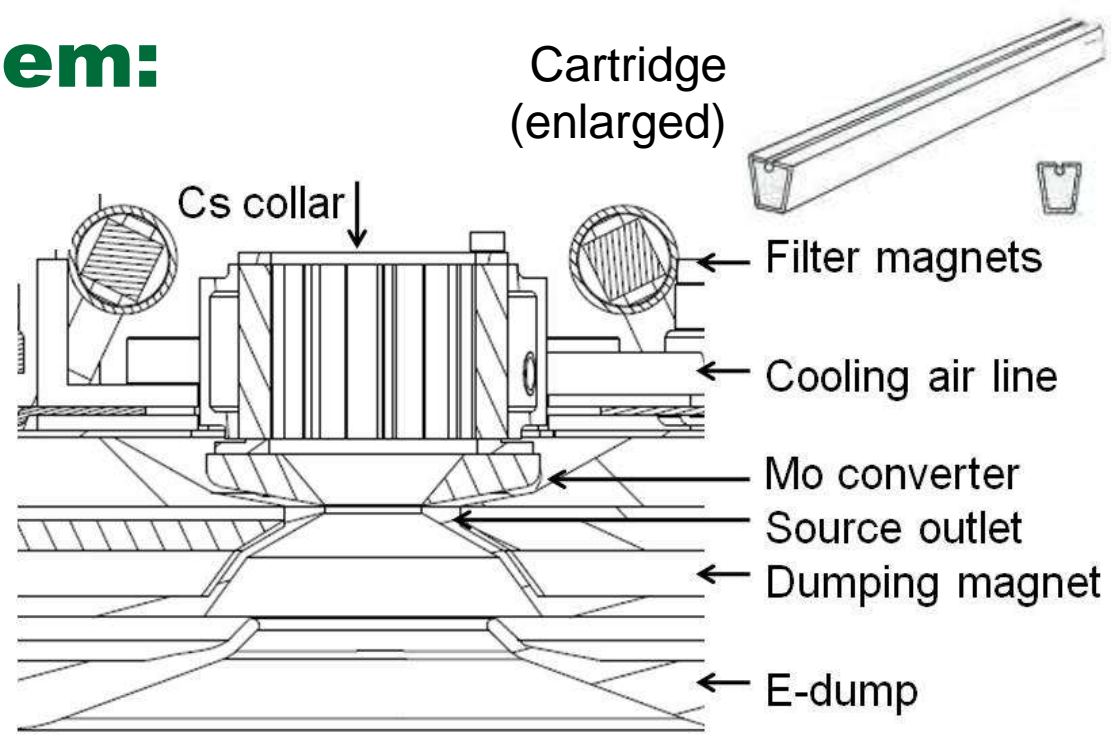
# The $\text{Cs}_2\text{CrO}_4$ System:

- To minimize Cs-induced arcing in our ultra-compact LEBT and the nearby RFQ, LBNL introduced 8  $\text{Cs}_2\text{CrO}_4$  cartridges (SAES Getters), which together contain **<30 mg Cs**. They are integrated into the Cs collar.

- The Mo ion converter is electrically and thermally attached to the Cs Collar. The temperature of the system is controlled with heated air.
- Right after being evacuated, the system is outgassed and the Mo converter is sputter-cleaned for ~3 hours. Then the collar is heated for 10 minutes to  $550^\circ\text{C}$  to release **~3 mg of Cs**. Then the temperature is lowered to  $\sim 180^\circ\text{C}$ . This appears to produce an optimal monolayer of Cs, which appears to become persistent.
- After a few days the  $\text{H}^-$  beam becomes persistent.
- **No beam decay or signs of age** are normally noticed.

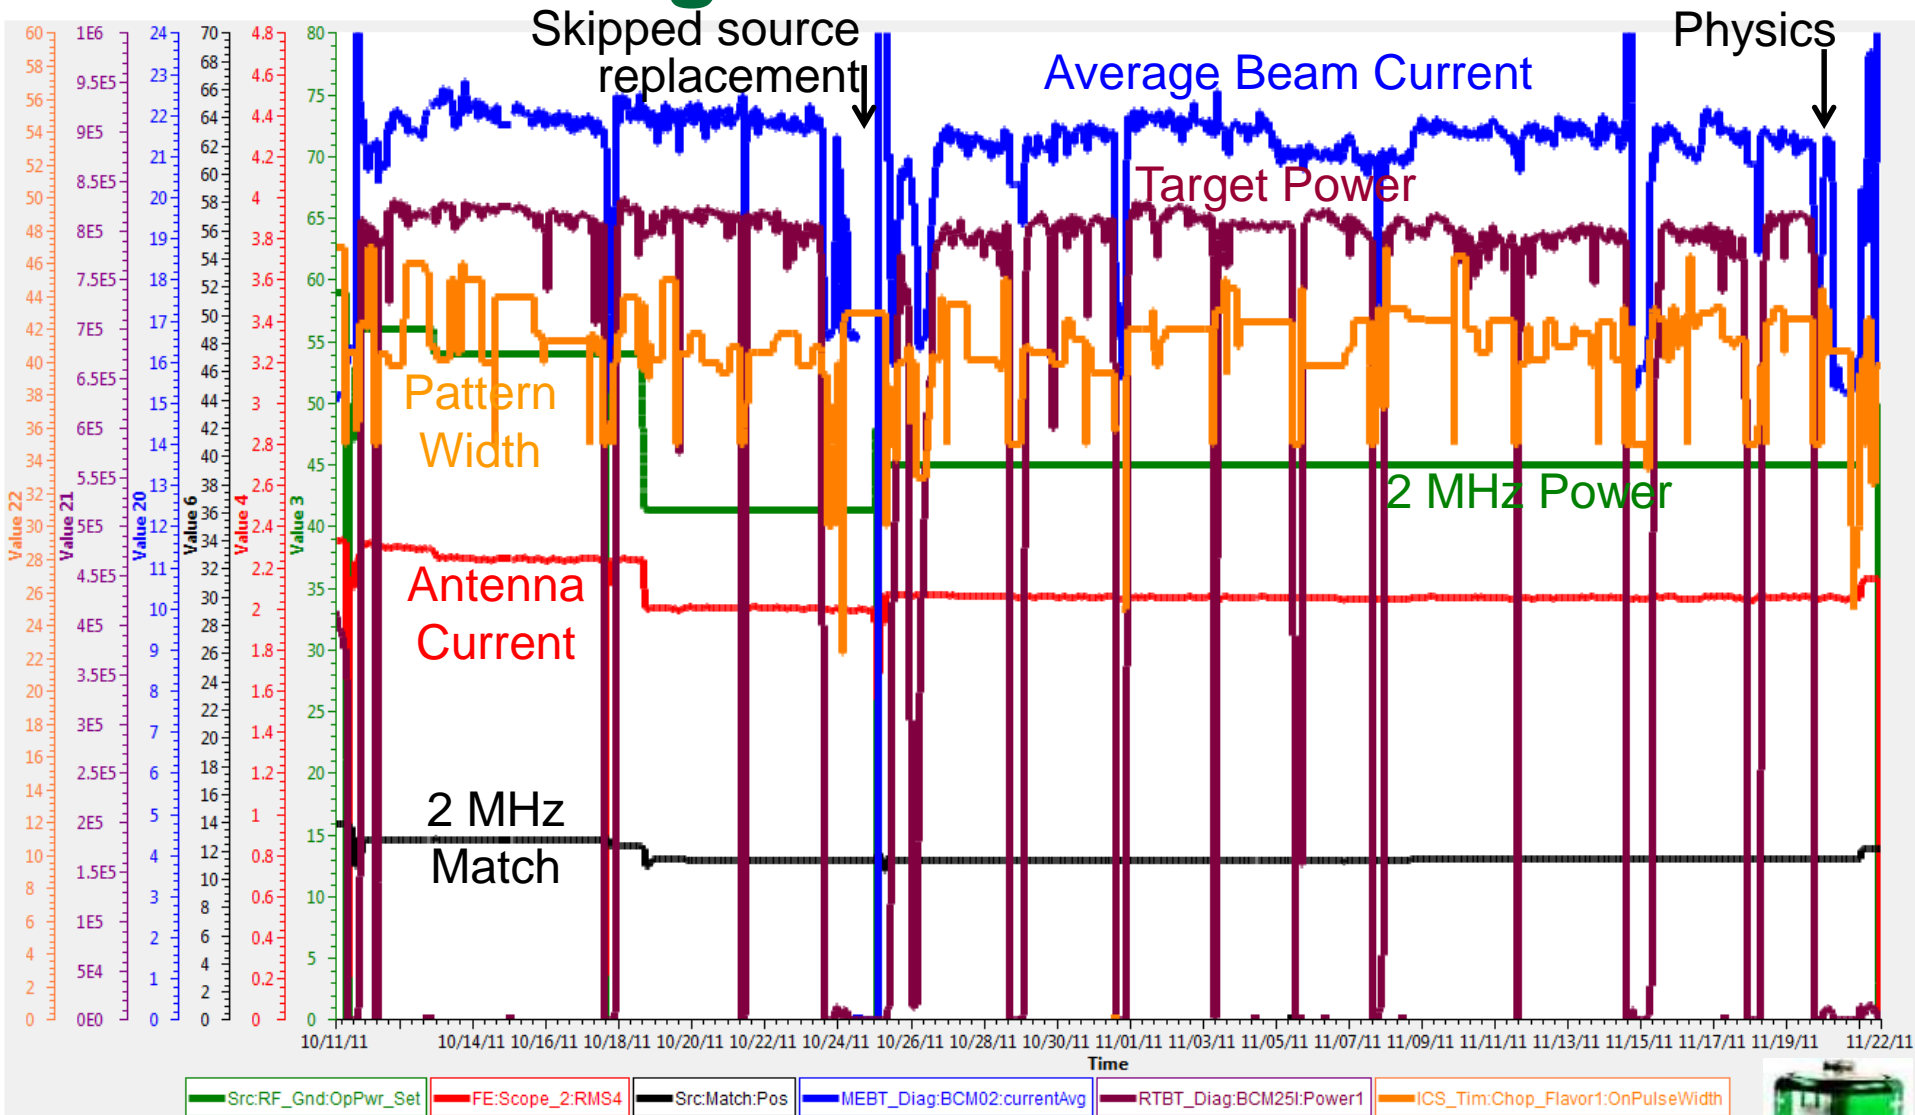
# 6 weeks of degradation-free 38 mA Beam

On 11-22-11, source #3 was removed after running degradation-free for 6 weeks producing ~38 mA LINAC beam current.

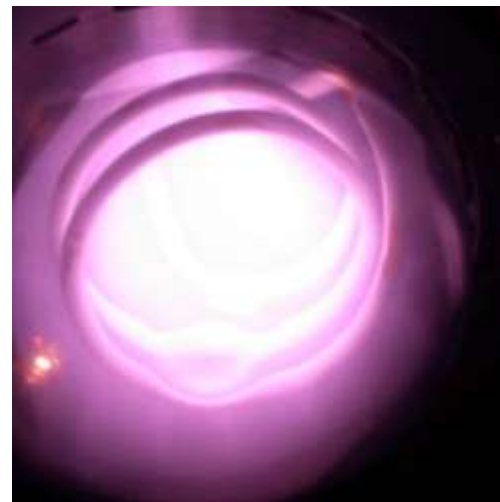
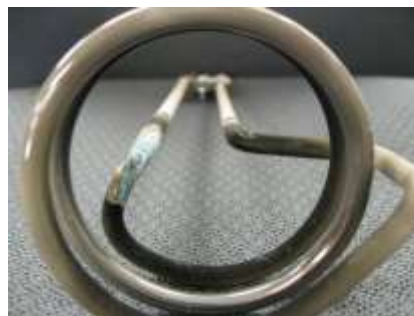
# The SNS Antenna Problem

- Since raising the RF power to ~60 kW and the source pulse length to 0.9 ms in 2010, the antenna failure rate increased from ~1 per run to ~4 per run.
- Most antennas fail within the first week of operation, long before the end of the typical 4-week service cycle, which suggests infant mortality.
- Failure analysis shows that ~77% of antennas fail in the leg bends, which penetrate into the core of the plasma. Apparently intense heating combined with high porosity can drive the porcelain surface above the melting point, which destroys the insulation.

1. are extending the source service cycle
2. are testing thinner porcelain coatings
3. use tighter acceptance criteria in the leg bends and exclude any tangible surface imperfections
4. develop a relaxed radii antenna where the legs do not penetrate the plasma core
5. develop an external antenna source

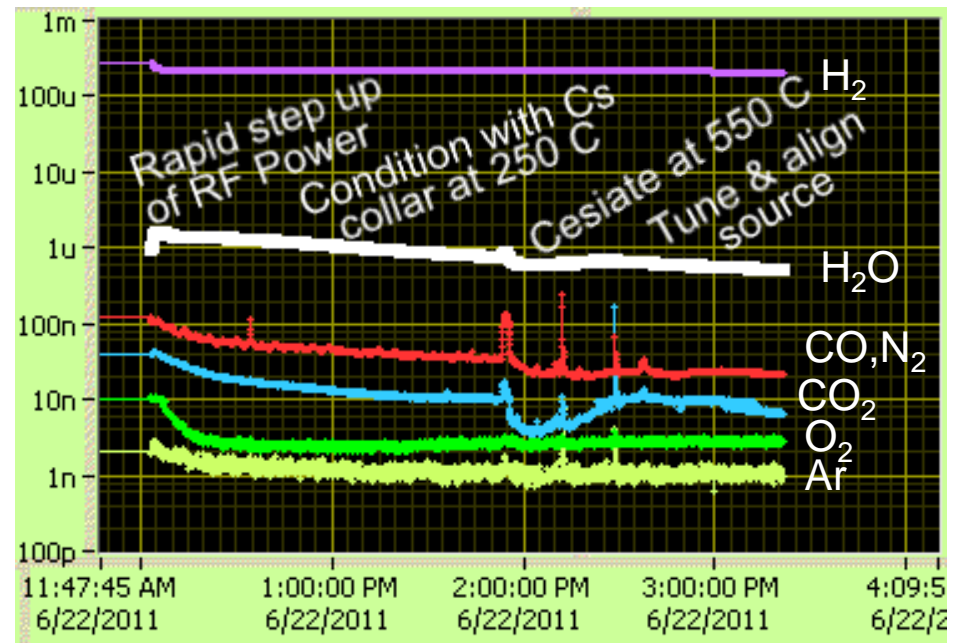
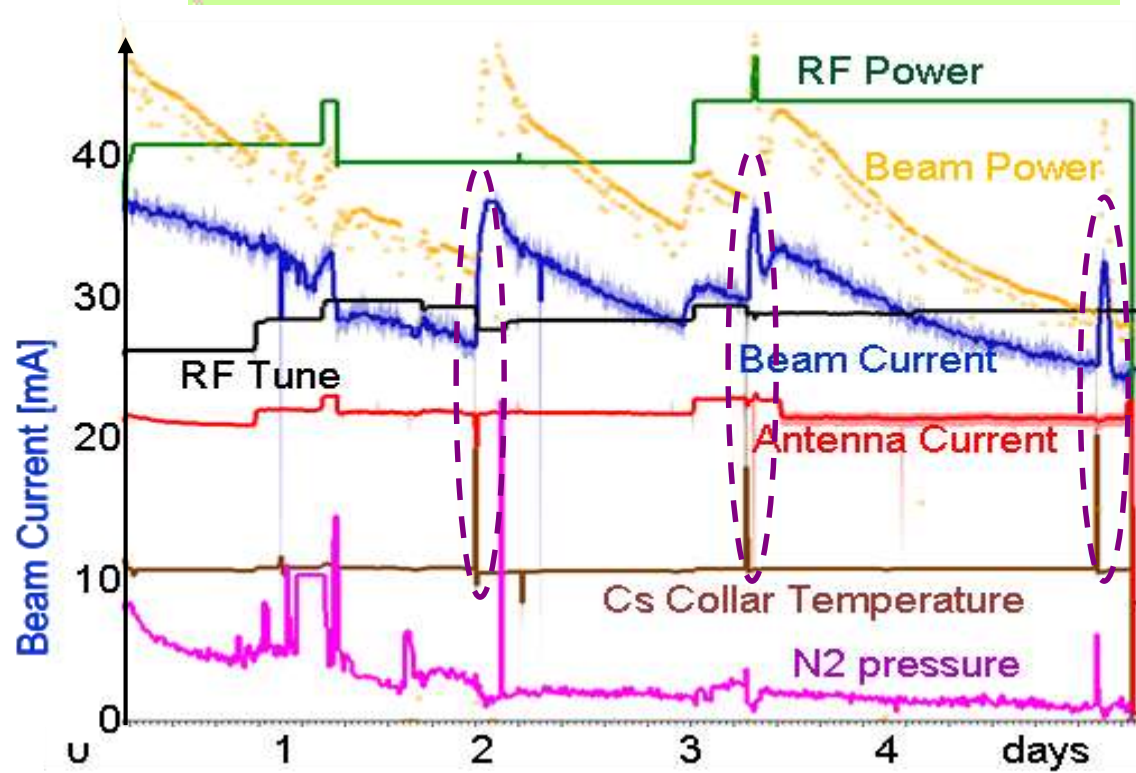
# A Leaky Source

- June 22, 2011: Source #2 is installed and no leak is found with a He leak check.
- A smooth startup lowers all relevant partial pressures rapidly.
- Cesium yields ~36 mA.
- However, the beam current decays at a rate between 1 and 2% per hour.
- Two recesiations restore temporarily most of the beam, but the decay continues.
- A 3<sup>rd</sup> recesiation restores some beam within an hour but decays within the next hour to the previous level.
- The source has to be replaced on day 5!

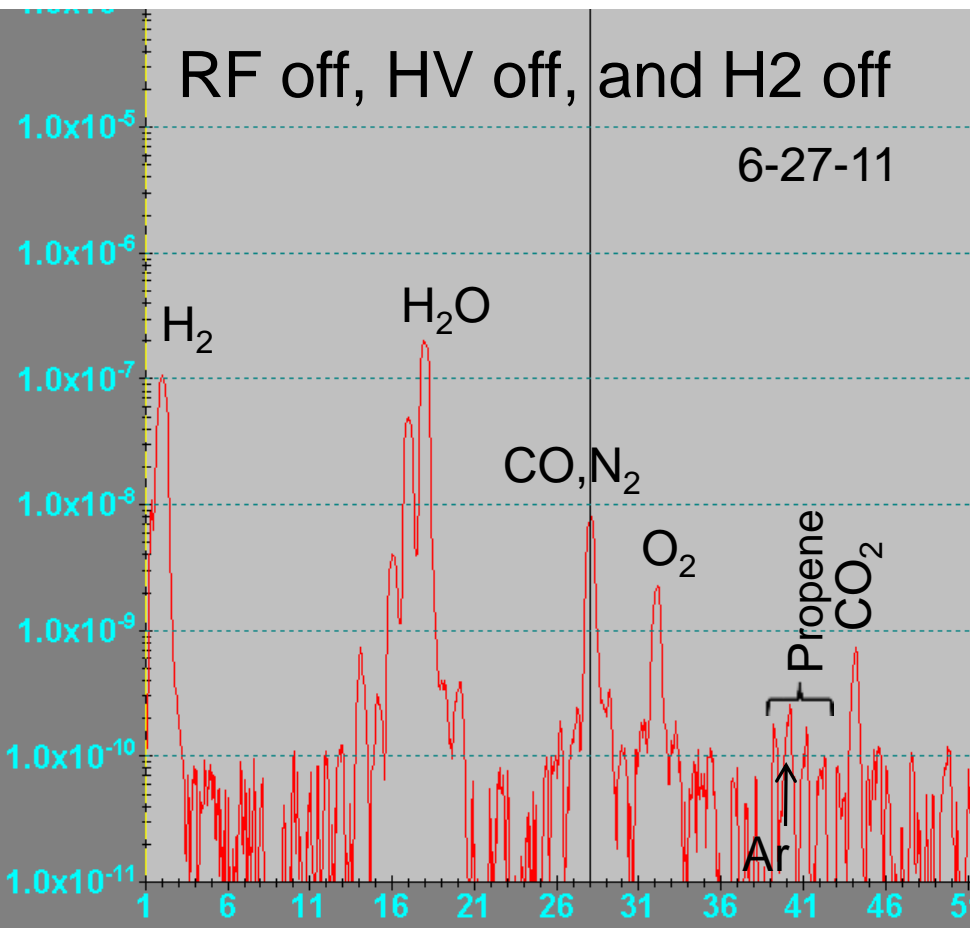
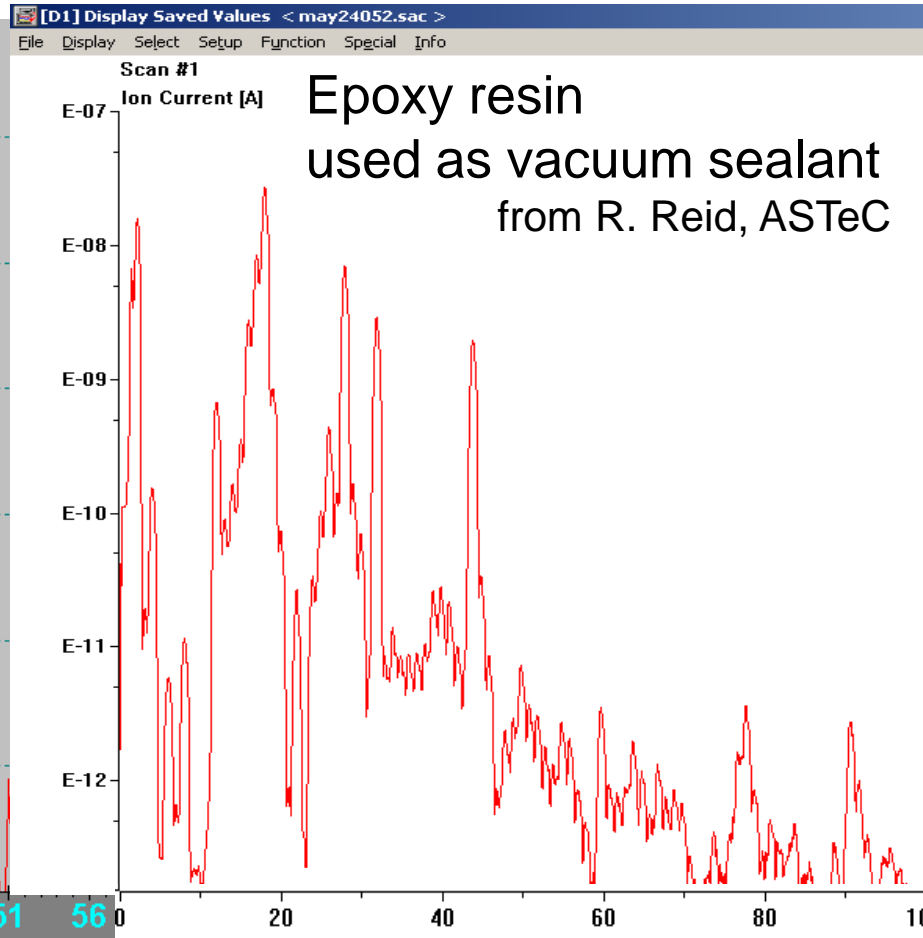
# The LEBT Vacuum 101

- Looking at the LEBT RGA, air leaks are often suspected due to the high pp of mass 28 and 32.
- However, the LEBT and ion source are thoroughly leak checked before the start of every run.
  - Every ion source is leak checked as the 2<sup>nd</sup> last step in the refurbishment process.
  - In addition the ion source and LEBT are leak checked after every ion source installation.

**The red, 65-kV insulator is made of epoxy, which has a very similar fingerprint!**

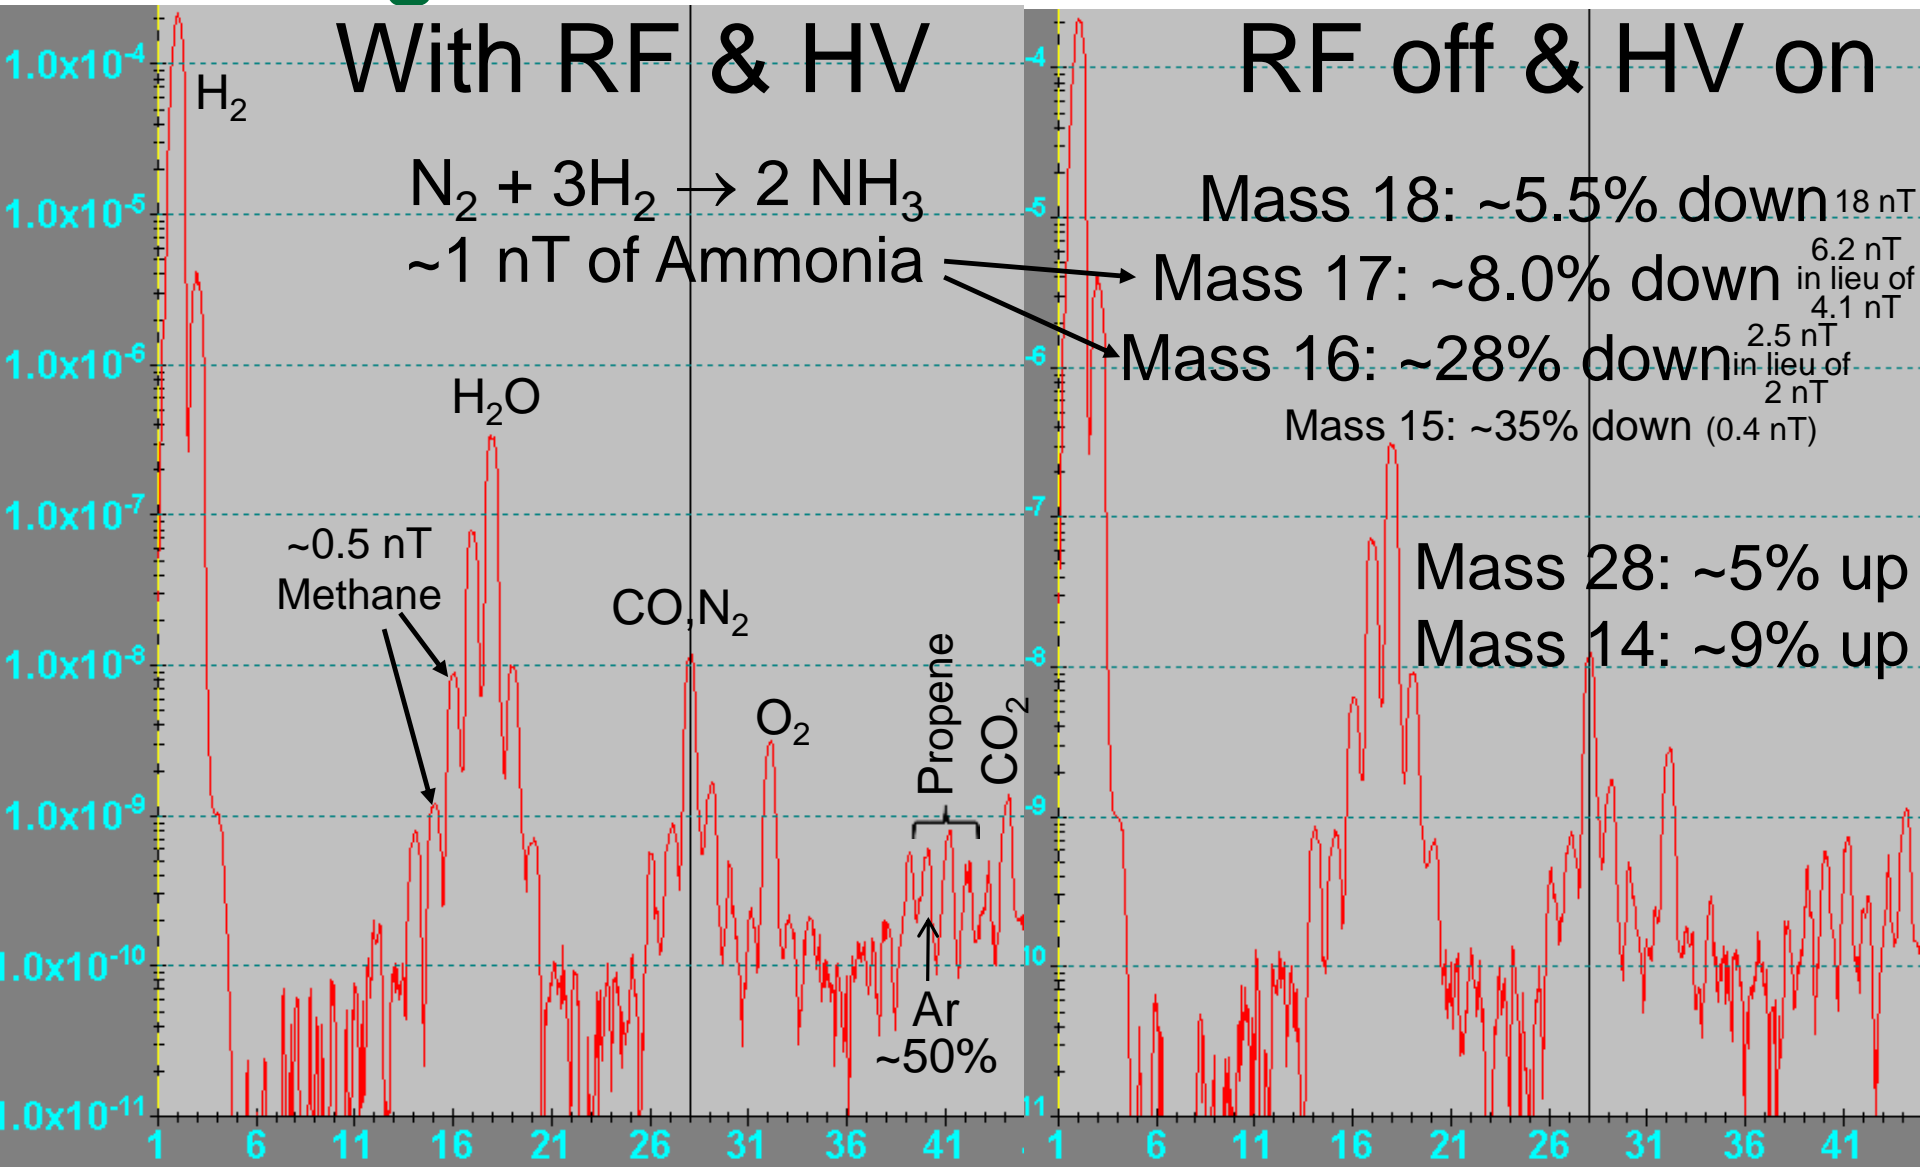
# The Staged Shutdown of Source #2!

Barely noticeable, the hydrogen plasma converted a  $10^{-6}$  air leak into  $NH_3$  and  $H_2O$ !  
**A  $\sim 10^{-10}$  leak in a window increased to  $\sim 10^{-6}$  when being heated by plasma!**

- The leaking window was an old style brazed mini-CF window. All windows have been replaced with new style brazed windows.
- Large leaks limit beams to a few mA, an immediate attention getter! The LEBT RGA will show a large increase of mass 40 (air) or 18 (water). We check the LEBT RGA for signs of large leaks every time before starting to condition and before starting to cesiate a new source!
- Small leaks are difficult to identify due to
  1. The large LEBT pumping speed
  2. The large emission of air-like components by the epoxy insulator
  3. The possible chemical conversion of the major components of air
  4. The interference of the major Ar peaks with propene ( $m=40$ ) and water ( $m=20$ ), both of which vary for several reasons.A constant beam decay is currently the most sensitive leak indicator! However, this becomes only obvious after ~ a day when expecting a persistent beam!

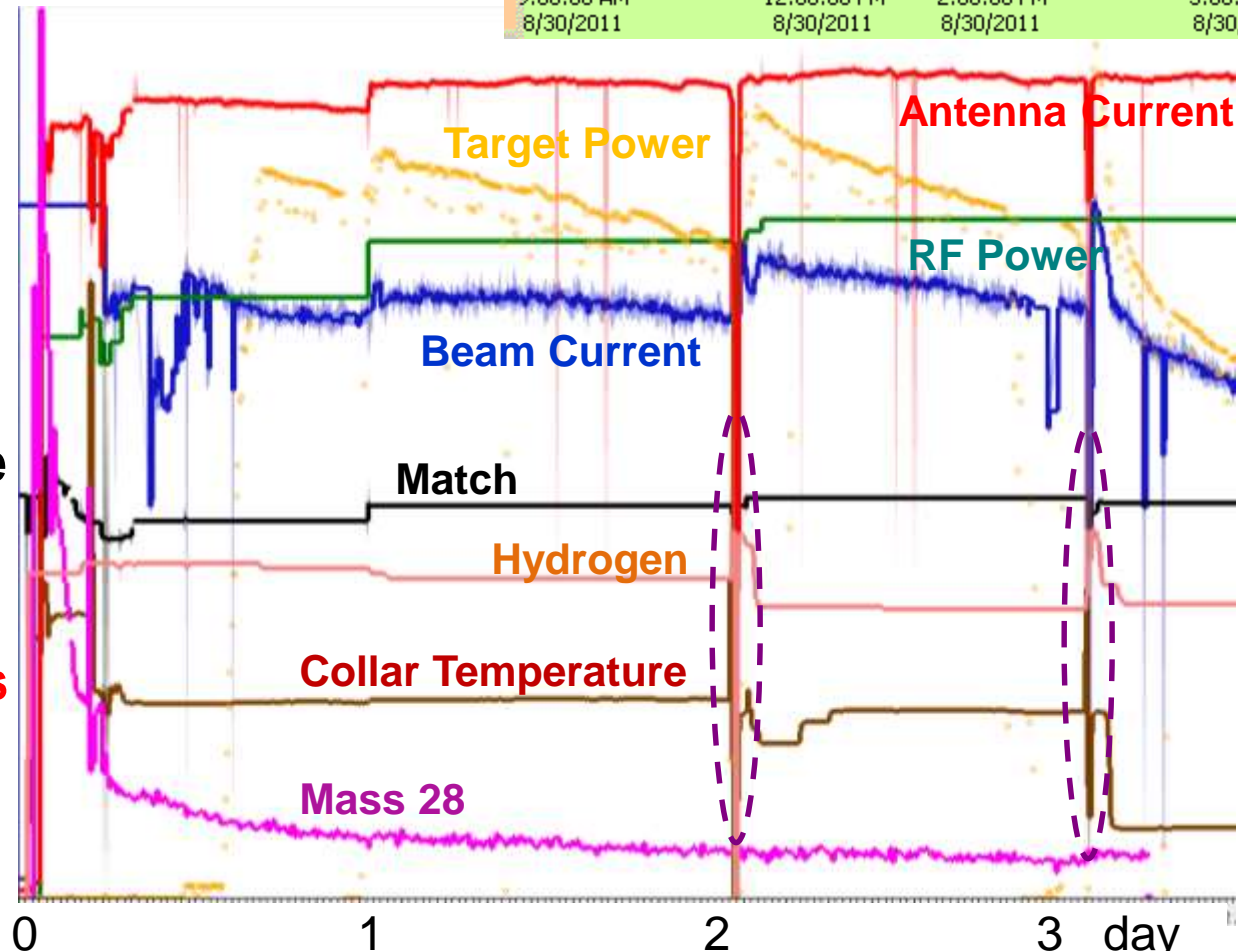
# The First Poisoned Source

- August 30, 2011: Source #4 is installed and no leak is found with a He leak check.
- A smooth startup lowers all relevant partial pressures rapidly.
- Cesium yields  $\sim 31$  mA.
- The beam current decays by 11%/day.
- A 3<sup>rd</sup> day recesiation raises the beam current by  $\sim 15\%$ , and the beam loss to 15%.
- A 4<sup>th</sup> day recesiation raises the beam current by  $\sim 30\%$ , which rapidly decays to the previous level, and then decays with  $\sim 45\%$ /day.
- A staged shut down shows RF to produce 2 nT Methane
- An extensive leak check finds no relevant leaks.
- **The beam loss increasing with each cesiation suggests a poisoned source!**
- The source is replaced with source #3, which initially runs normal.

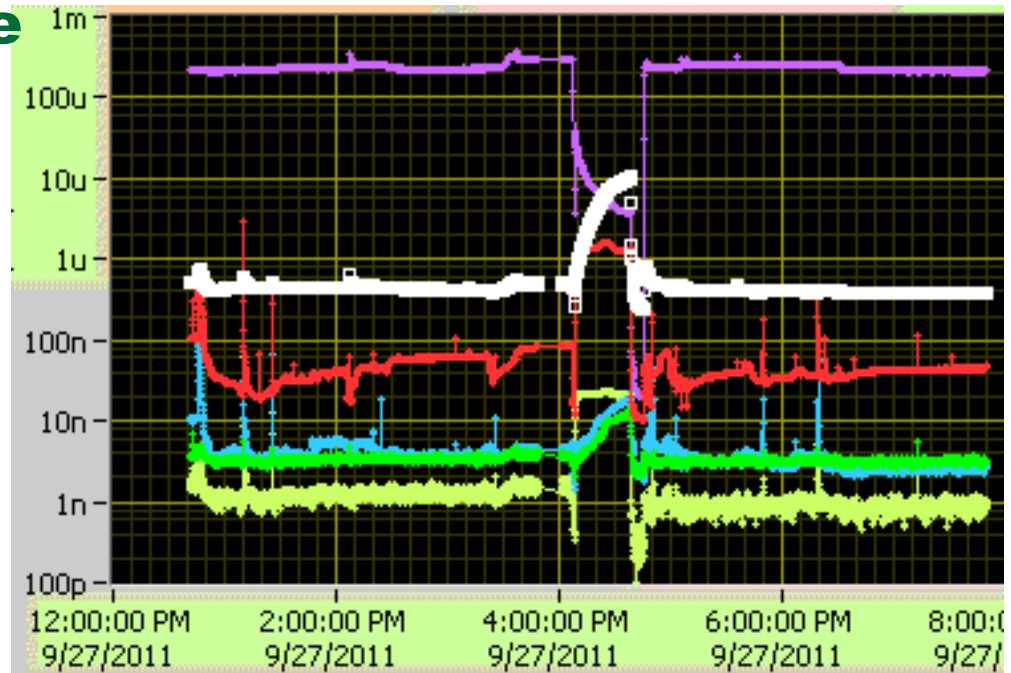
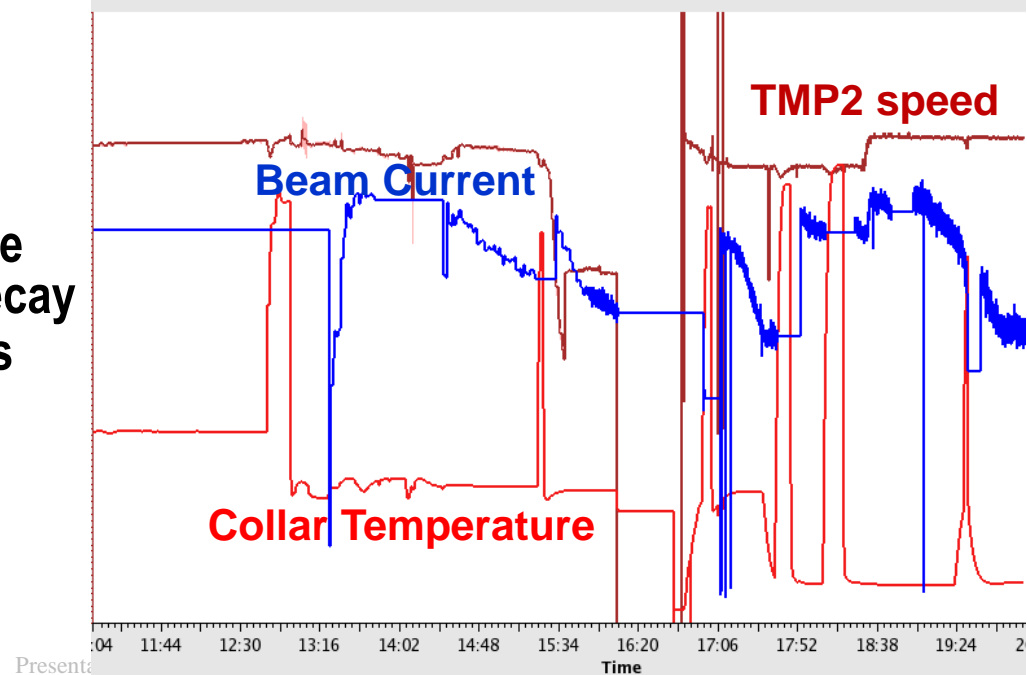
# A gravely Poisoned Source

- September 27, 2011: Source #2 is installed and no leak is found with a He leak check.
- The startup is smooth, but excess of mass 28 and 32 are noted.
- Cesium yields  $\sim 33$  mA.
- The beam current decays by  $\sim 18\%$ /hour, while mass 28 & 44 rise.
- A recesiation increases the beam current, but accelerates the decay.
- The RGA shows large amounts of  $\text{CO}$ ,  $\text{CH}_4$ , and  $\text{C}_3\text{H}_6$ .
- TMP2 fails due to lack of cooling water. Water blockage found, removed, and restarted.
- Numerous recesiations can restore the beam but do not improve the beam decay
- Lowering the collar temperature slows the decay rate, but it remains near  $20\%$ /hour.
- **Beam rises show that Cs is delivered, but it does not stick!**
- **This is consistent with a severely poisoned Mo collar!**

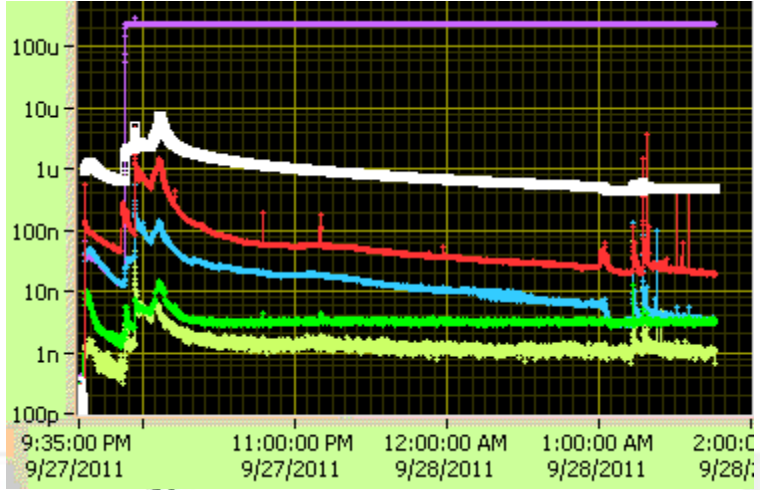
# Source #4 Poisoning confirmed

- The same evening, September 27, the severely poisoned source #2 is replaced with the refurbished source #4.
- Nothing unusual is noted during startup, which yields ~36 mA.
- However, the beam decays with ~1% per hour.

- Timid recesiations restore some of the beam but do not stop the decay.
- Extensive leak checking reveals no leak;
- Activating the rotary feedthrough of the LEBT gate valve raises the pressure.
- The rotary feedthrough of LEBT gate valve is replaced with a blank.
- Source #3 starts up under heavy LEBT arcing which continues for several days.
- The degraded LEBT vacuum requires a low lens-1 voltage, yielding ~34 mA.

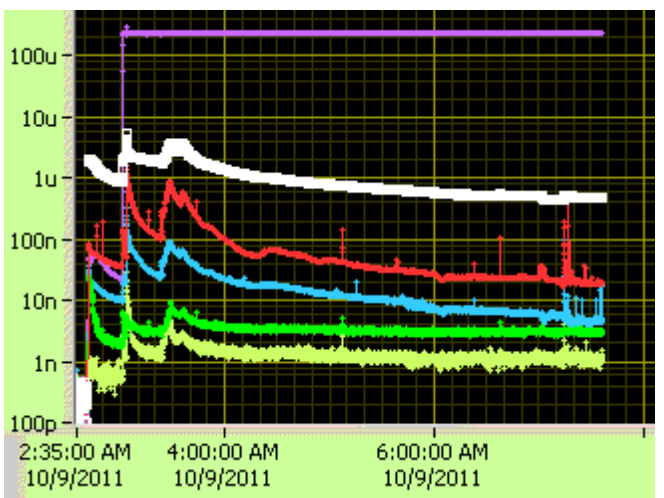
# Source #4 Poisoning reconfirmed

- 10-8-11: A lens-1 event requires lower lens-1 voltage.
- Beam hits lens-2 and becomes unstable.
- Retune restores 38 mA.
- 6 hours later the antenna fails.
- Source #4 starts up normally, yielding ~34 mA.
- It decays with ~1%/hour .
- Clearly, the rotary feedthrough was not the problem.
- A Monday cesiation briefly restores the beam, which rapidly decays back to the 1% slope.
- Source #3 is installed on maintenance day and starts up with ~36 mA.
- It decays for ~12 hours, but then starts growing.
- This source made more than 800 kW.

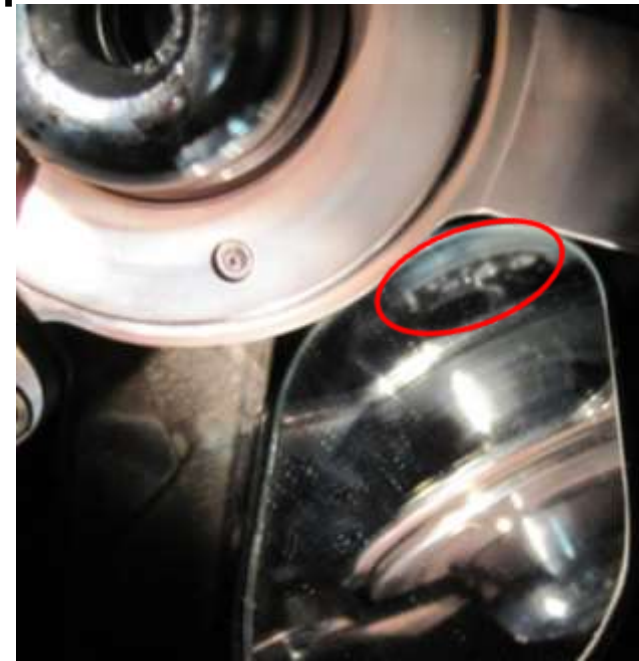
- The Electric Group has eliminated the LEBT chopper failures by implementing smart protections.
- We started to monitor sputtering from the LEBT chopper target and from intersegment arcing, which coats the intersegment insulators of lens-2.

- Uncontrolled beam losses and corona discharges lead to a lens-1 failure, causing ~2 days downtime.
- A subsequent similar event was mitigated by venting the LEBT for 20 min. with N<sub>2</sub> and running with a reduced lens-1 voltage.

- Since then, the lens-1 voltage is lowered every time the load current exceeds a certain threshold.

***We work towards using the supply's current limit to prevent the overheating of lens-1!***

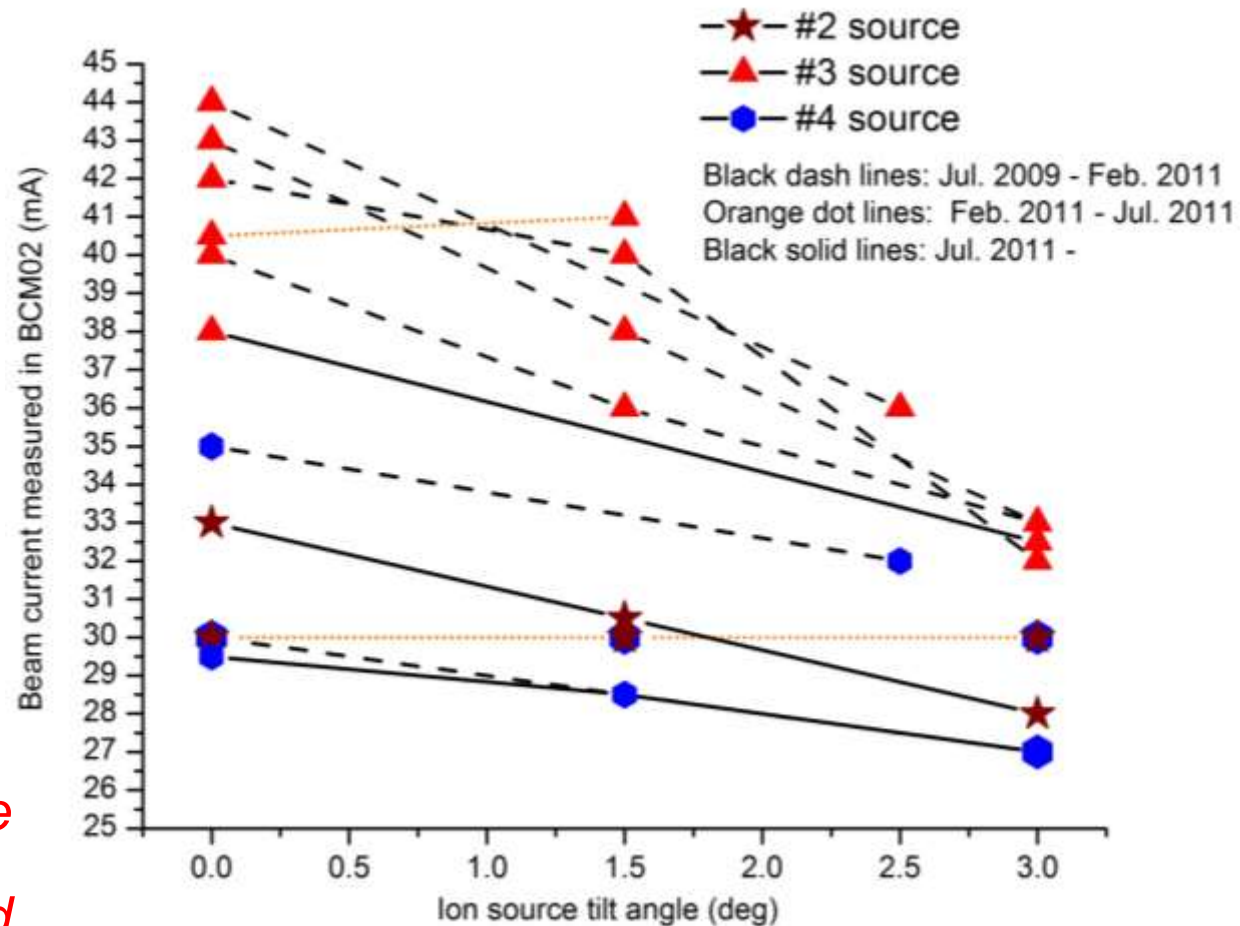
# Ion Source Tilt and Offset Experiments

- Design estimation and the first few years' operation experience showed 2.5-3.0° tilt angle be the optimal for maximizing the beam in the BCM02
- Starting in July 2009, we found more BCM02 beam currents with the ion source at smaller tilt angles. The beam always peaked at a 0° tilt angle for the next three ~0.5 year LEBT service cycles, using different LEBTs and all three different ion sources.
- However, in the first half of 2011, the BCM02 beam current showed no significant dependence on the tilt angle. The angle was set to 1.5°.
- Starting in July 2011, with a newly refurbished LEBT, the BCM02 beam current peaks again at 0° tilt.
- It is unclear why the BCM02 beam current peaks near 0° tilt, and not at the design angle of 3°.

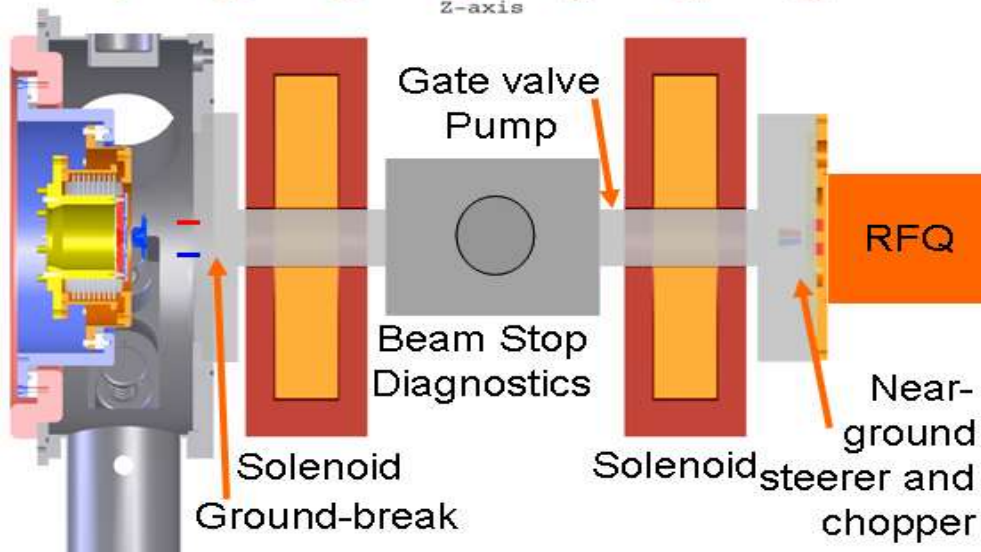
# The State of the cool, arc-free 2-Solenoid LEBT

- 2-solenoid LEBTs stay cool because they are cooled by ambient air.
- Near-ground chopper is at RFQ entrance, far from the arcing source.
- It combines a working chopper with a proven high-power LEBT design.
- Differential pumping and a gate valve may help the RFQ.
- Diagnostics allows for full power source testing.

*A prototype 2-solenoid LEBT is being assembled to demonstrate that the beam at the LEBT exit 1) is stable, 2) meets the RFQ input Twiss parameters, 3) produces beam rise and fall times as least as fast as the baseline e-LEBT.*

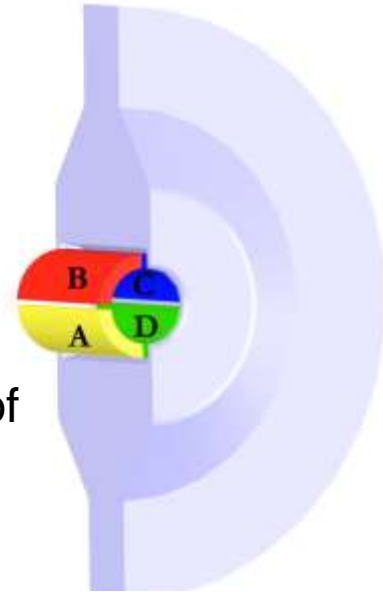
# Alternative: Eliminate arc-induced chopper failures with a shielded, near-ground chopper for the e-LEBT

- If the prototype 2-solenoid LEBT fails to meet the 3 requirements, and chopper failures cause again significant downtime, we will develop a near-ground chopper for the e-LEBT.
- When the chopper is placed between the lenses, the 2<sup>nd</sup> lens re-straightens the beam. Successful chopping requires displacing the beam sufficiently before it enters the second lens.
- Model calculations show that lengthening the chopper and increasing the aperture of the 2<sup>nd</sup> lens allow for complete chopping of the beam. However, the load on the LEBT chopper target is higher!

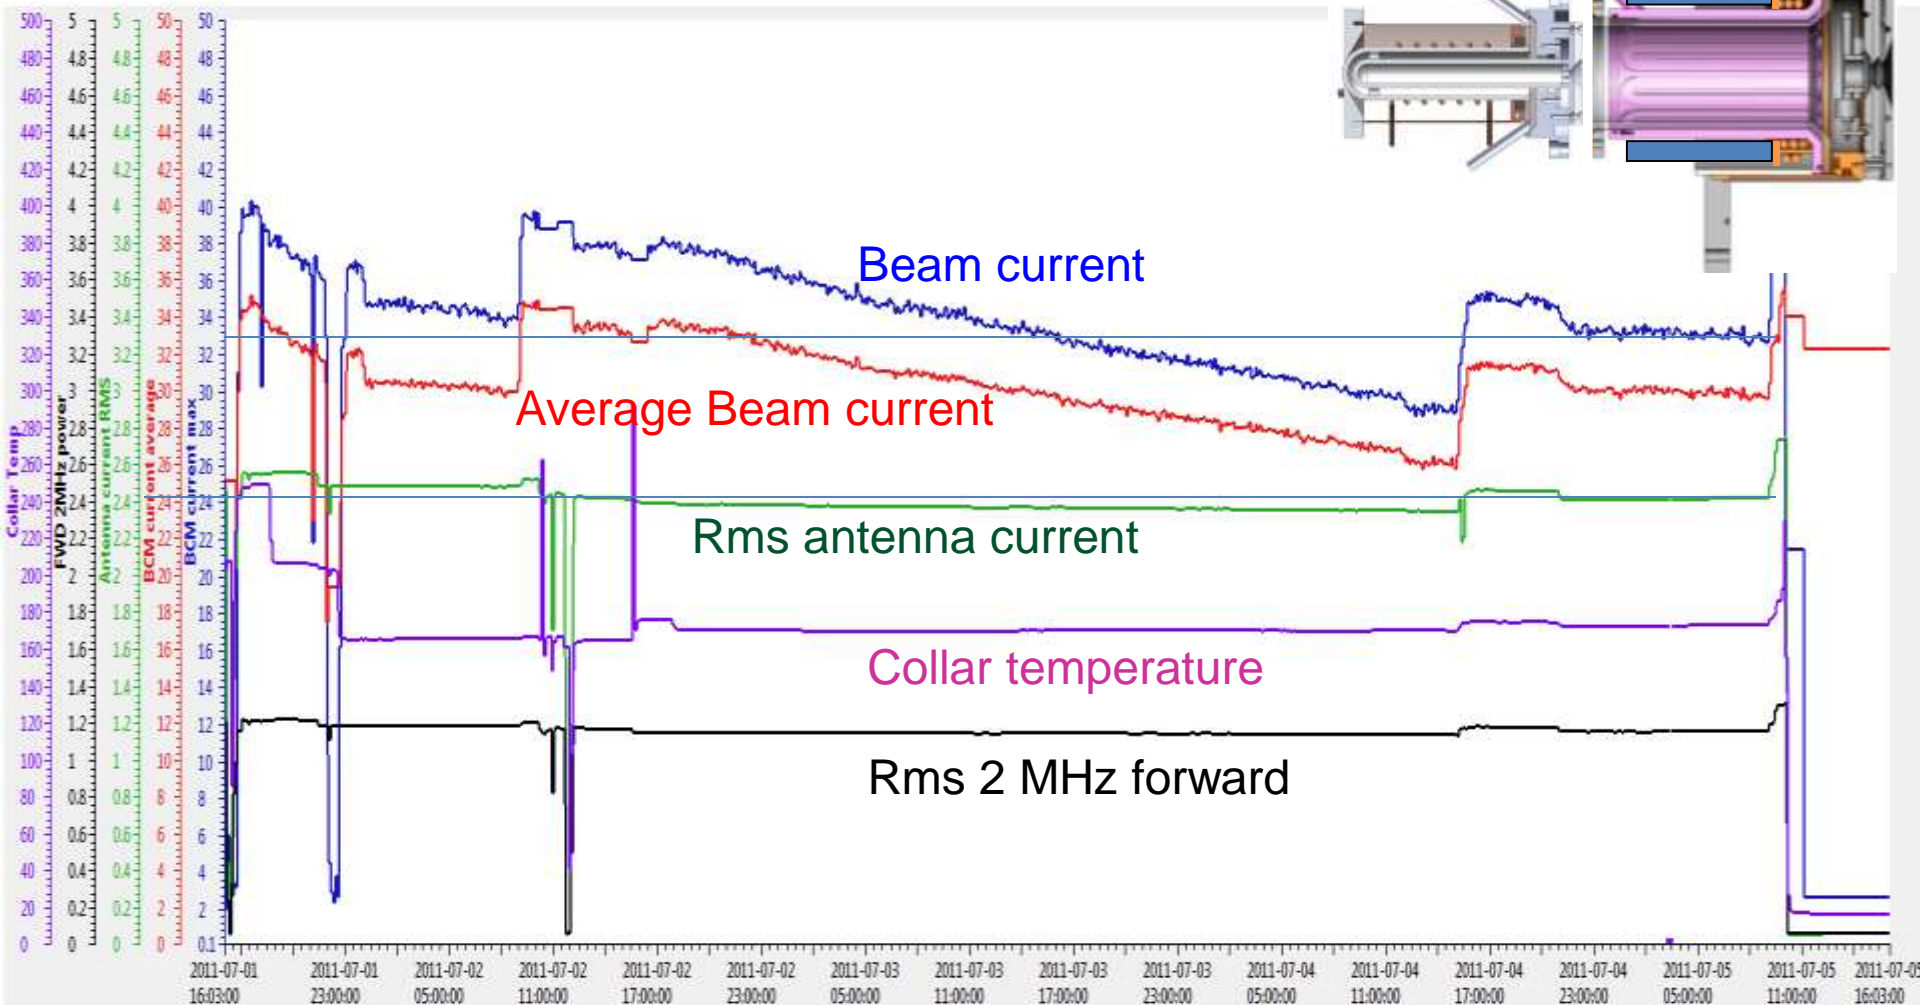
# A Top Priority: the External Antenna Source

A recent test of our external antenna source on the FE showed the beam to decay, partly due to change in tune, partly due to a loss of Cs. The impurities appear to originate from the AlN plasma chamber.

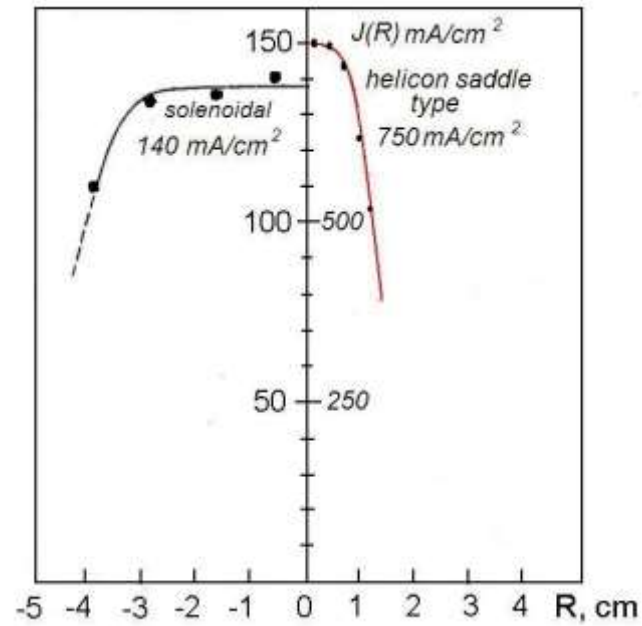
# A Helicon Saddle Antenna for the SNS H- source

- Vadim Dudnikov, collaborating with Muons, Inc., and SNS, is developing a Helicon saddle coil for the SNS external antenna source. This is expected to increase the plasma density near the outlet aperture by a factor of 5.
- The source has delivered ~50 mA with ~50 kW at low duty factor. Developments continue to further improve the efficiency and to develop a source that can withstand the rigors of 7.2% duty factor and long term operation. If very successful, a Frontend test is likely to follow.
