Mechanical Systems Performance and Plans

M. Baumgartner

AAC Meeting January 10-11, 2012

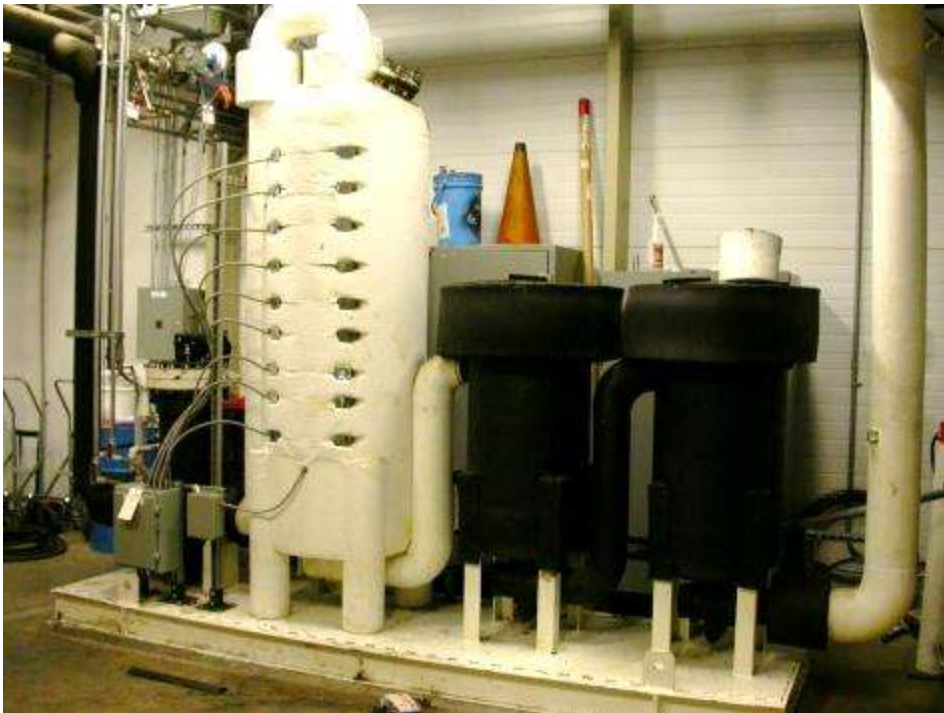
Oil Removal Skid

- Helium Compressor bulk oil separator failed and overloaded downstream oil removal skid

- **140.5 hours in FY10 to zero hours since**
- **Cleaned system with heated dry nitrogen**
- **Replaced the skid coalescer elements, charcoal, and final filter**
- **Inspected and returned the bulk oil separator elements to original design**
- **Switched cooling on the oil cooler and after cooler from tower water to chill water**
- **Switched to another PAO-based oil known to have far less light hydrocarbons and purified oil before use.**
- **Installed calibrated Linde gas monitoring system & now monitor helium impurities in real time**

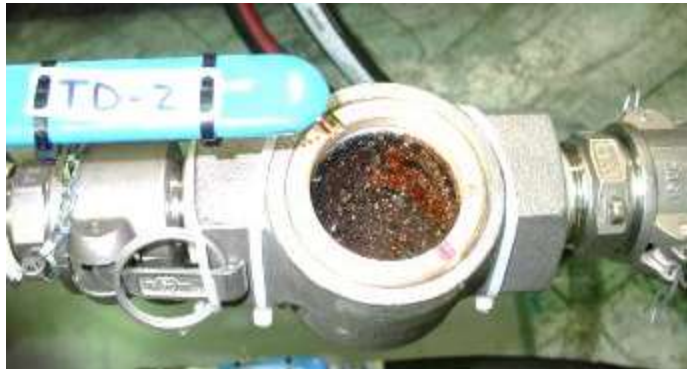
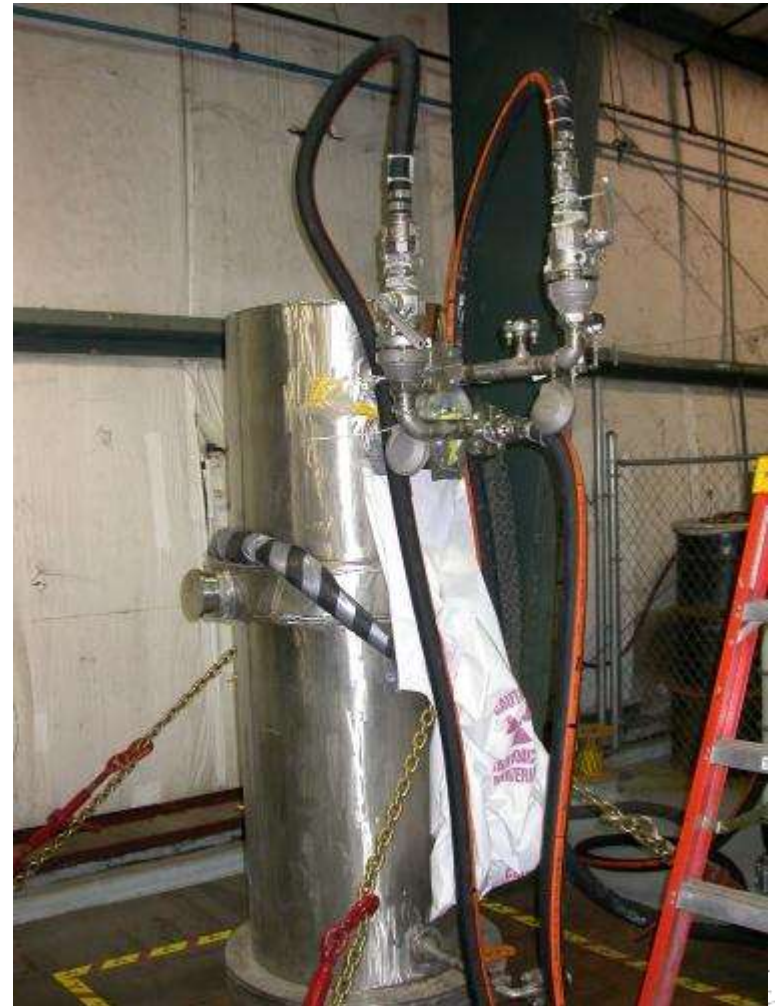
Target Water System Resin Replacement a Reality

- Two resin beds replaced last year, 4 scheduled for 2012

In-Service	Date	Removed From	Months
IX Column	Date	< 1.5 Mohm-cm	Service Date	Service
IX-9350A			12/2005	0
IX-2560A	4/1/2006		6/8/2009	38
IX-1550A	4/1/2006		9/2/2009	41
IX-2020A	4/1/2006		8/16/2010	52
IX-1040A	4/1/2006		2/7/2011	58
IX-2560B	6/8/2009	3/2/2011	7/8/2011	21
IX-2560A-R1	7/27/2011			
IX-1550B	9/2/2009	11/17/2011		26

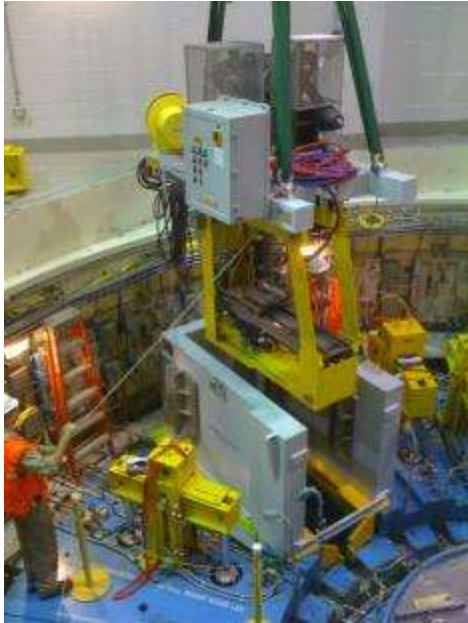
Installation of CVI Robot

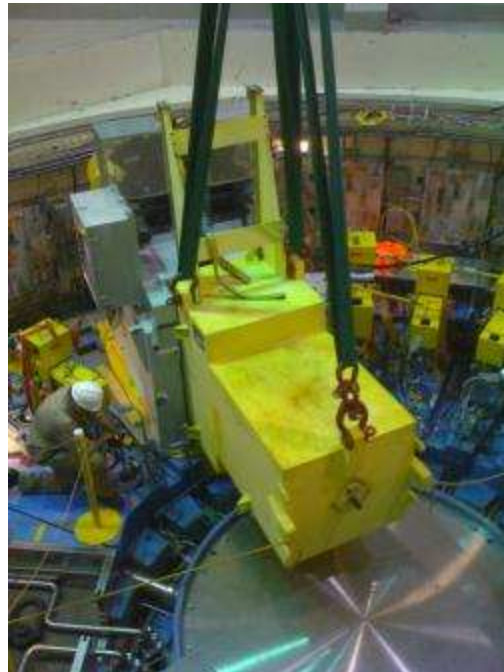
Installation of CVI Plug Cask

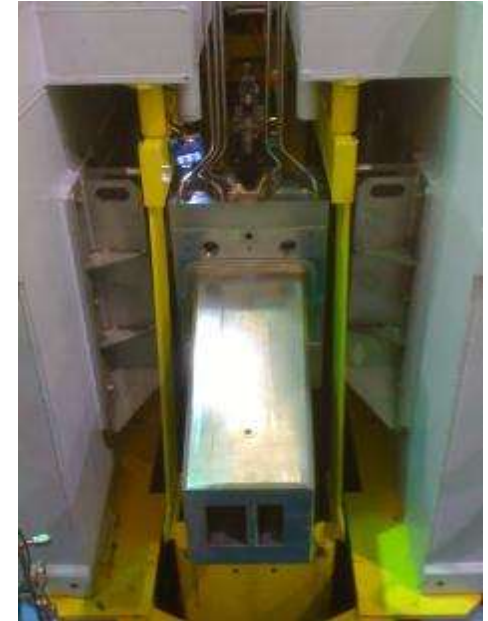
New BL16 CVI Loaded into Robot

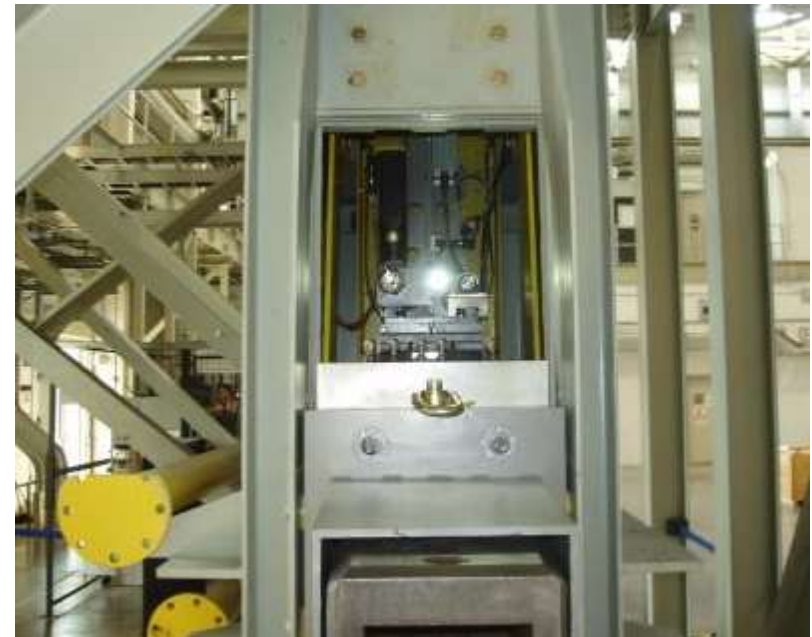
CVI Robot Lowered to the Base of the mockup test stand

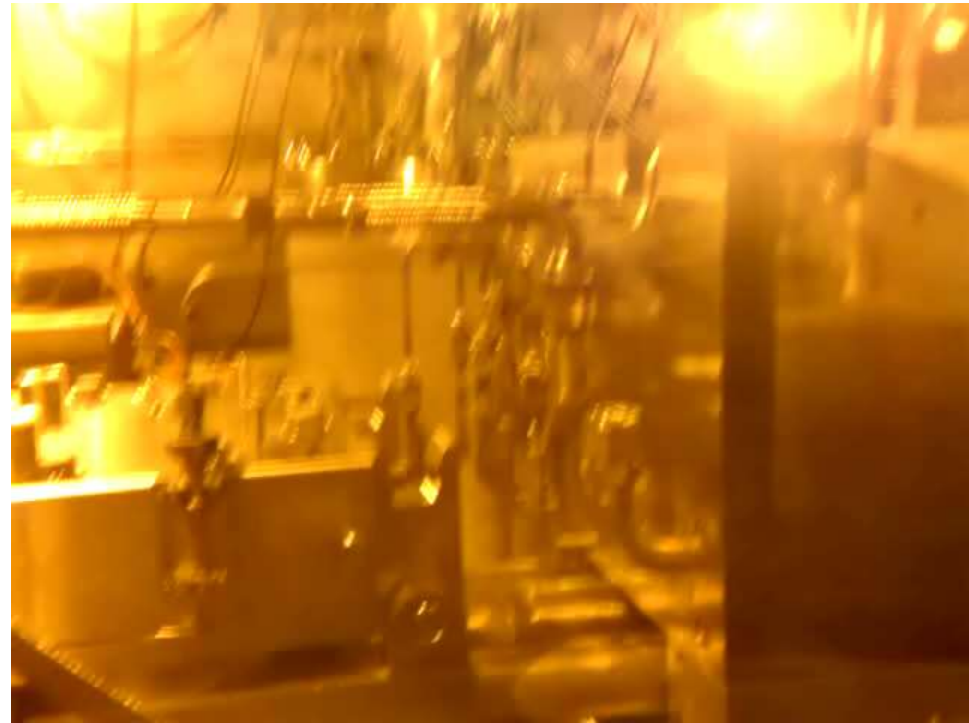
- Mid-cycle replacement
 - Target out of commission: 4/3/11
 - New target in beam permit: 4/19/11
- Post-installation water leak created a challenge

- In 2 days (over a weekend):
- Concept to test water circuit with target carriage extracted developed, fabricated, installed, used, and problem fixed

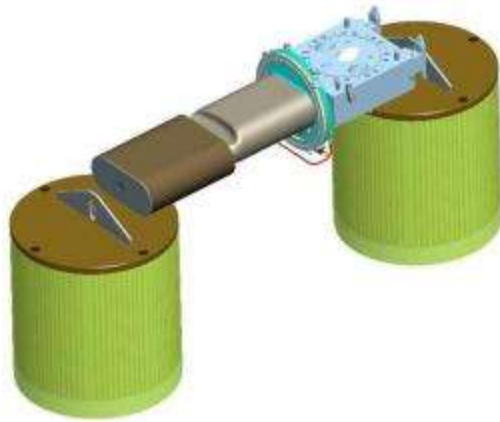
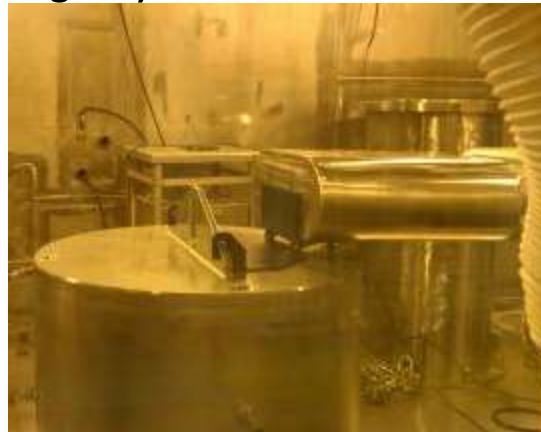
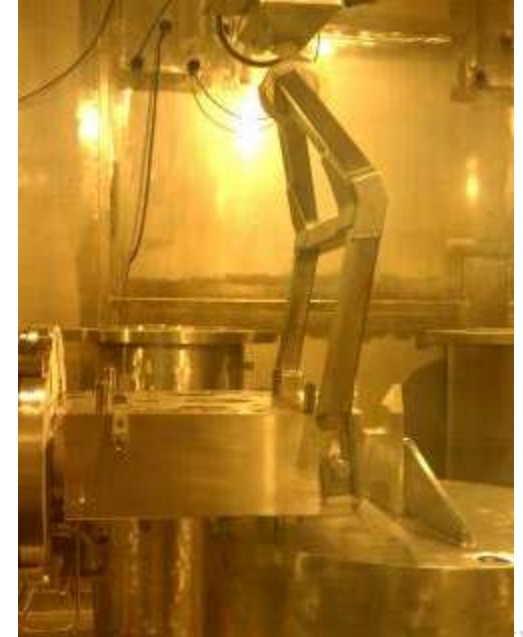
- The need: Inspect the inside of target #3 using a boroscope before nose cutting potentially damaged the leak site
- When vertically suspended (only way spent targets could be handled), mercury puddles obscure the inside of the target nose.
- The solution:
 - Use storage cask lids as “saw-horses”
 - Design a fixture to restrain target nose movement as the target module is rotated through the vertical to the horizontal (and back again)

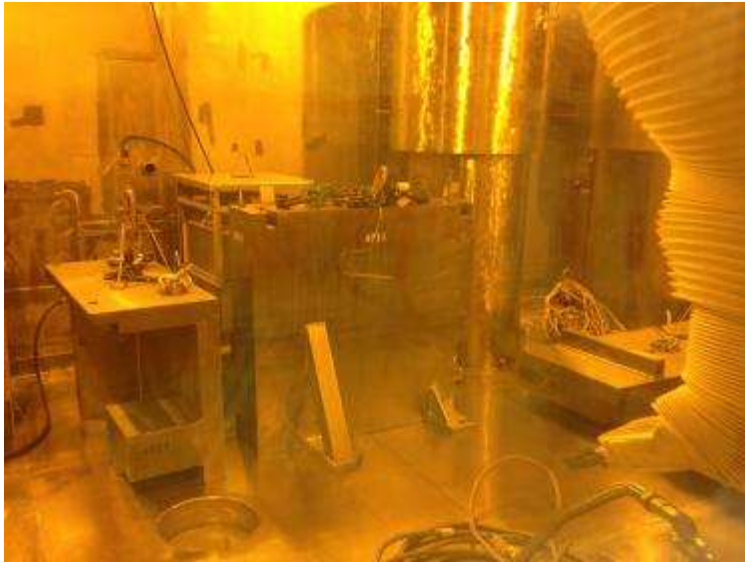
Service Bay View from WW #2

- **Necessary PIE activities compete with mandatory remote handling maintenance floor space requirements**
 - Analysis of PIE floor space needs performed for new proposals
 - Management approves new activities, balancing the operational risk
 - Example: Wachs saw use disapproved

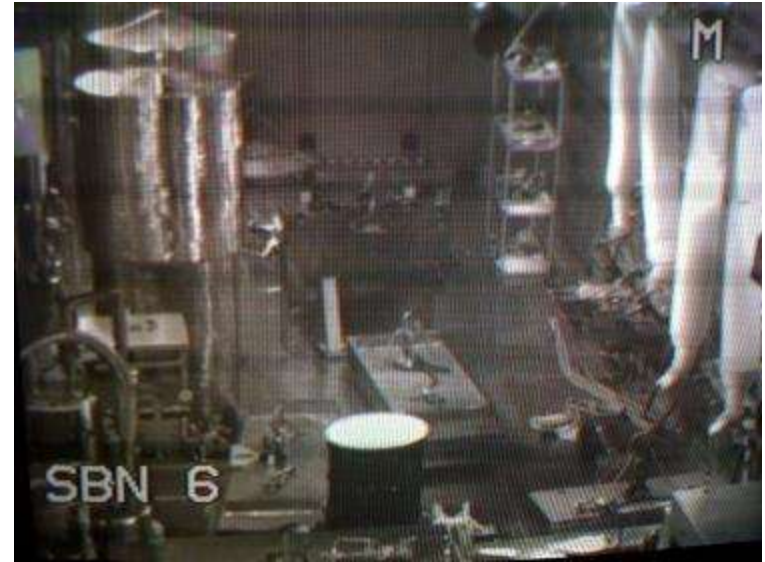
View from Mercury Loop Looking East

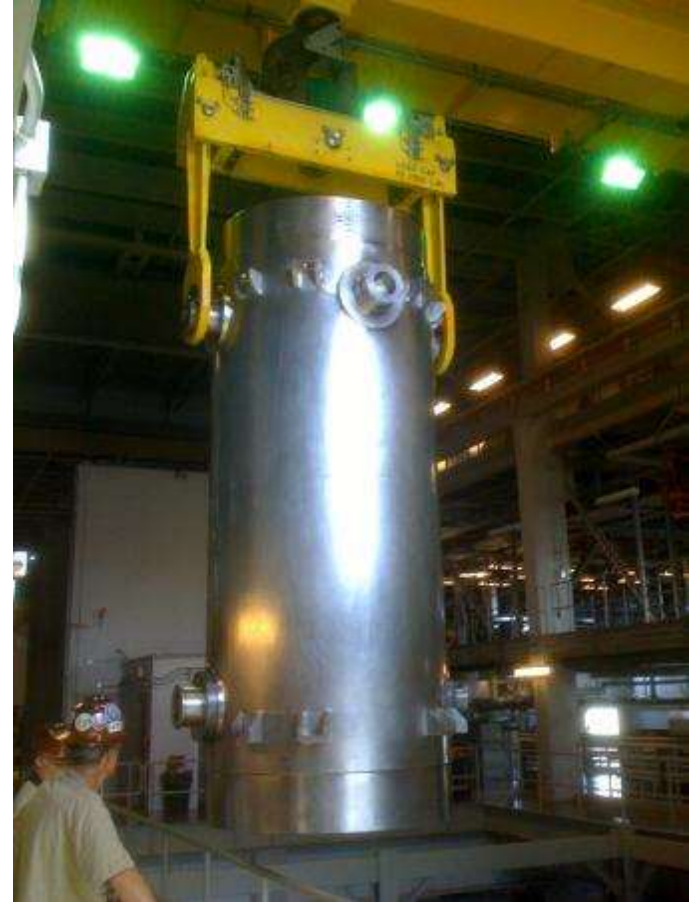
- The issue:
 - One TN-RAM cask exists and is used nationwide by other labs and the nuclear power industry--operated by Energy Solutions
 - No licensed alternative cask exists
 - Target and PBW disposal method designed for use of the TN-RAM cask
 - Contractually we get the cask upon request if available; last year we got it once.
 - We perform two target changes/year and a PBW change/year; with 2 targets in storage, we need the cask at least 4 times per year.
 - Currently, targets stay in the Service Bay until disposition
 - Reliance on a single TN-RAM cask represents a vulnerability

- **Actions:**
 - Learned how to request the cask: **Stop asking, start telling. We have the cask 4 times this year (maybe 5).**
 - **A Waste Disposition & Feasibility Analysis began October, 2011 to identify the range of casks that could be used for SNS needs, relative costs and availability, and TN-RAM alternatives that could be used for PBW disposal.**

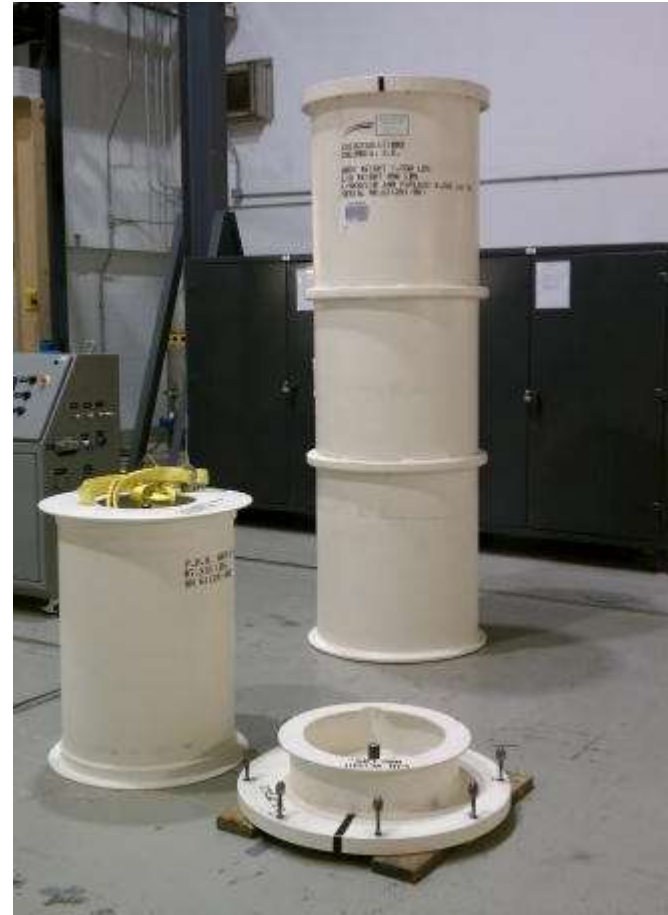
PBW Liner used with TN-RAM cask

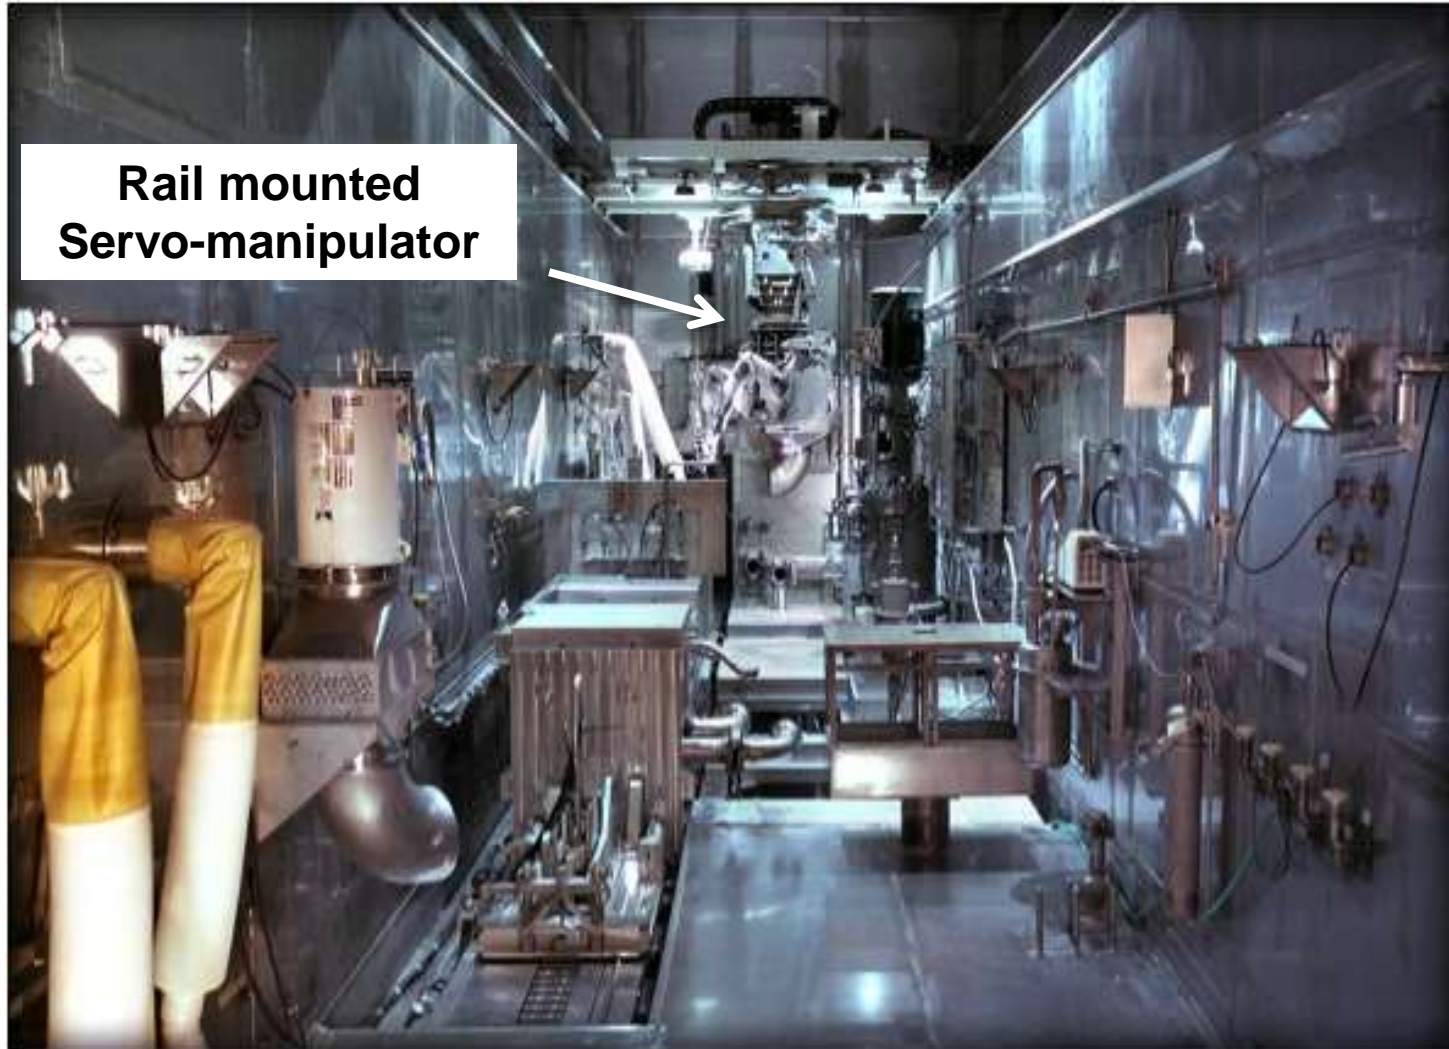
View of the Service Bay Looking West

- **Issue:**
 - Equipment is frequently used for target maintenance and PIE activities
 - Last month the vendor (Telerob) announced it was no longer going to support the equipment—not cost effective.
- **Only minor issues with the equipment to date but**
 - we have limited operating experience
 - Service Bay radiological conditions will become more severe as power increases continue
- **Actions:**
 - Telerob provided a list of remaining spare parts available for purchase (\$125K). List is being reviewed and proprietary components will be purchased.
 - Telerob documentation of our configuration will be requested.
 - Inventory of spare parts will be conducted and alternate sources of parts that are not Telerob unique will be identified.
 - **Long term: Build our own parts or install of new servo-manipulators**
