Ion Source Development, Plans, and Test Stand

Martin Stockli

Accelerator Advisory Committee Review

March 25, 2015

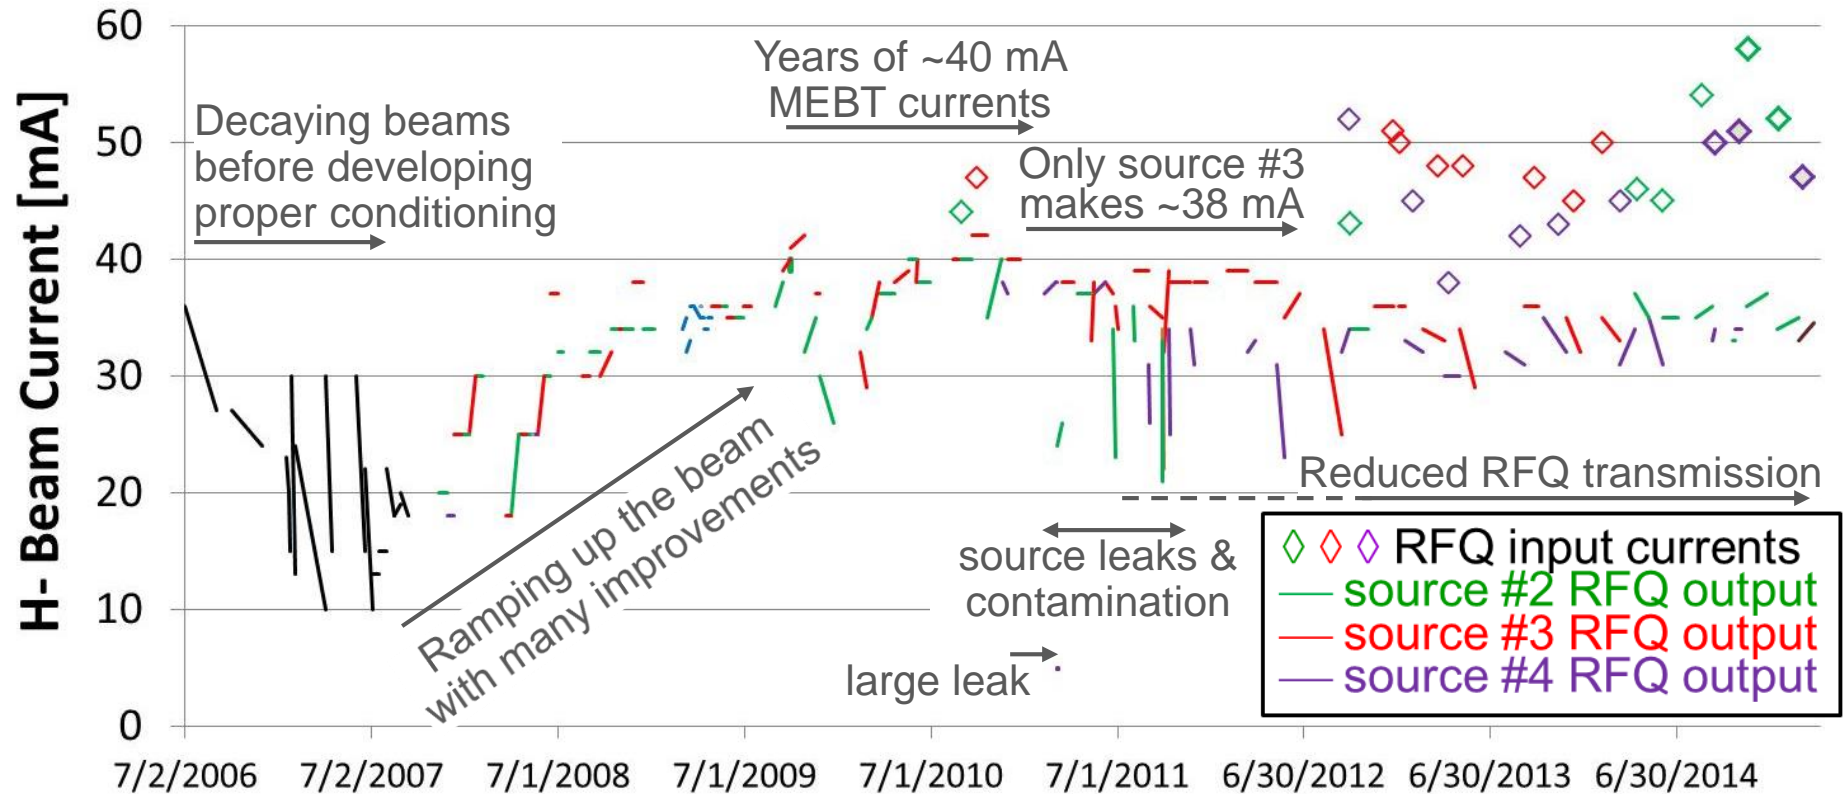
Ion Source and LEBT Performance History

127 production source cycles provided as many opportunities to learn, improve and perfect the operation of our H⁻ ion source and drive up its performance to unprecedented levels.

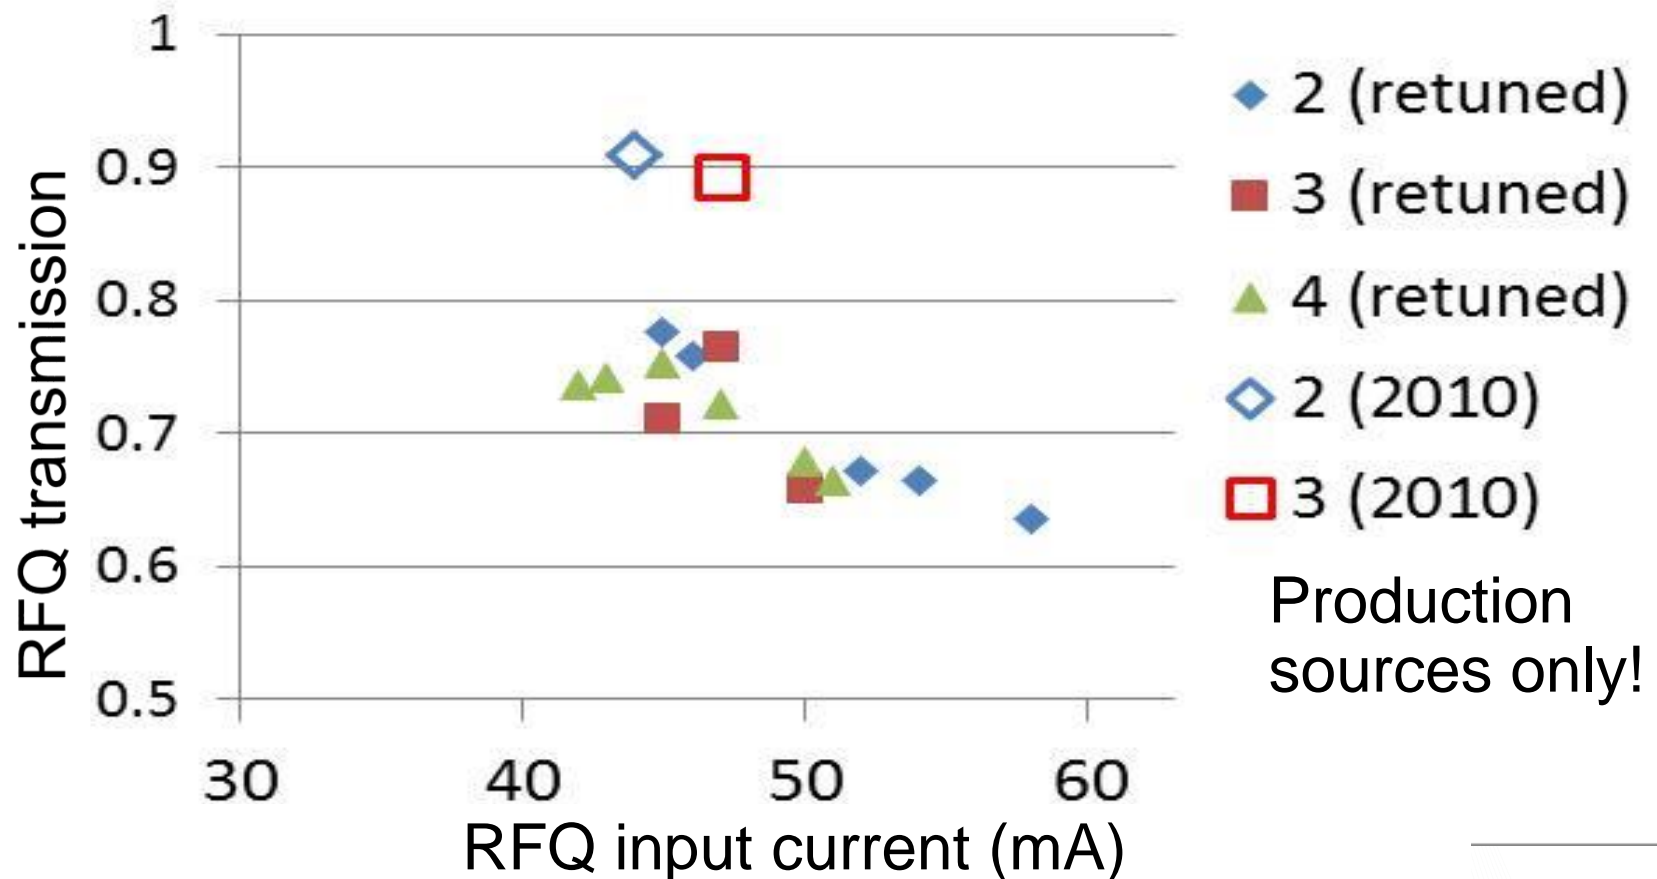
RFQ Transmission

- In 2012 RFQ transmission measurements showed a large scatter.
- The 2013 RFQ retune improved transmission and reduced the scatter.
- More carefully LEBT tuning further reduced the scatter since 2014 (see #2).

The 1.4 MW challenge has helped us to increase the MEFT current to a consistent ~35 mA.

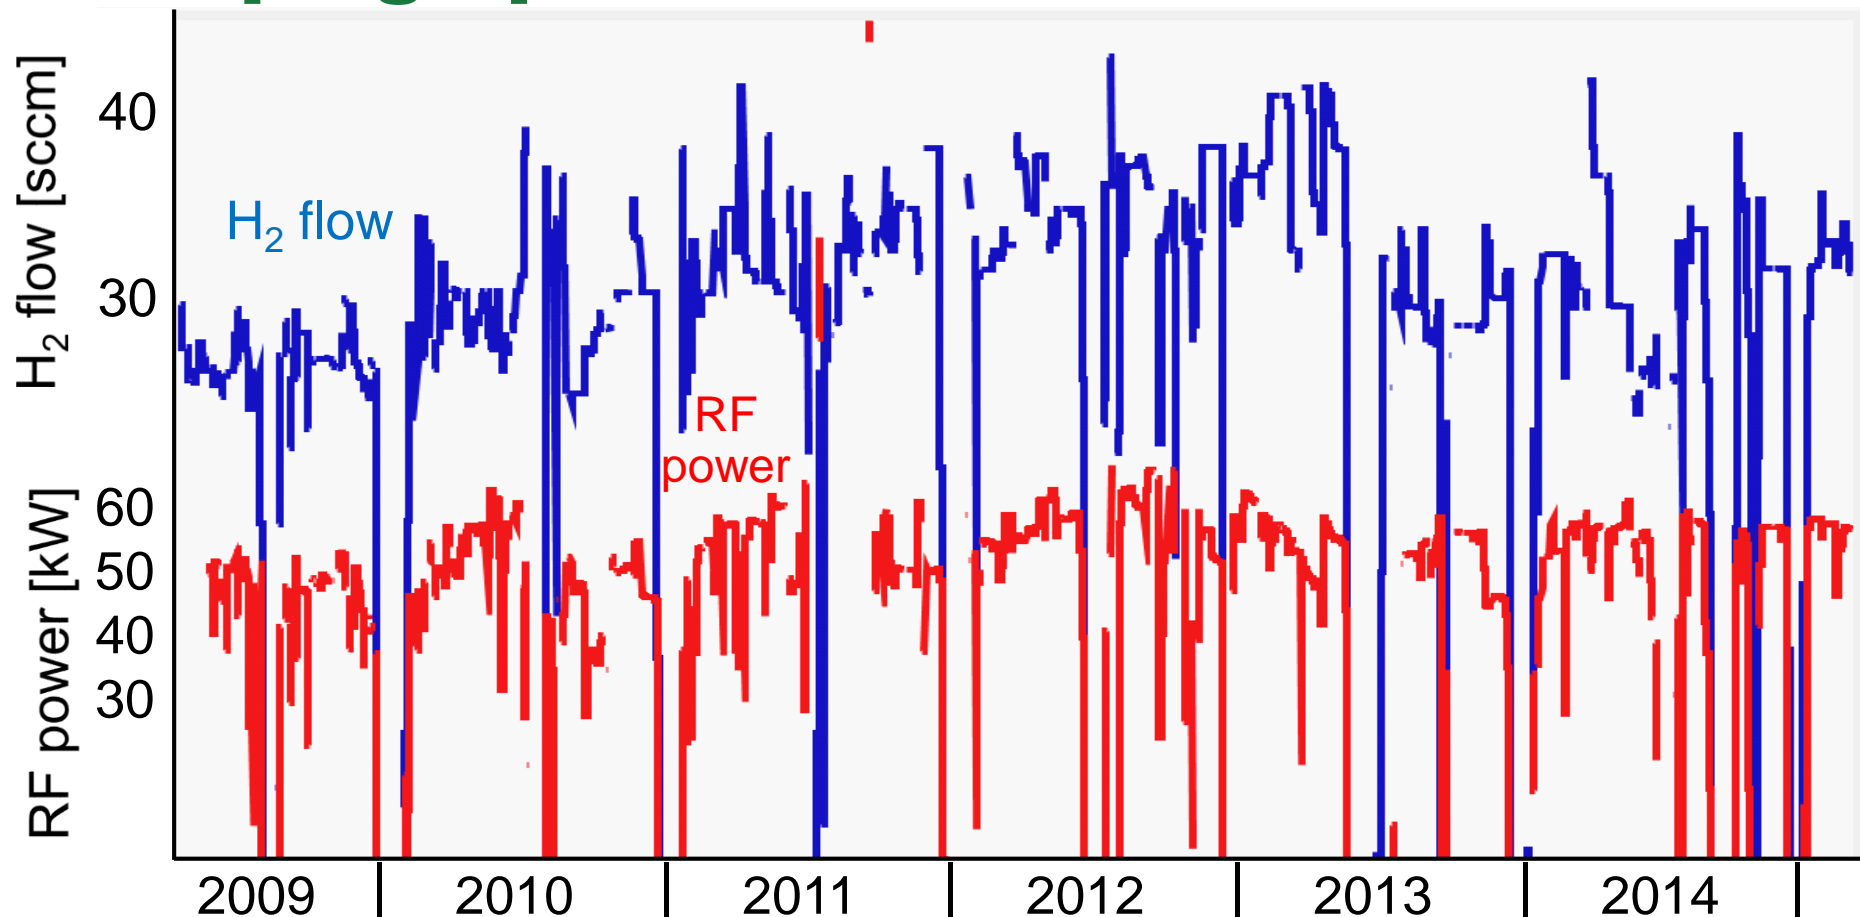
Ramping up the Ion Source

- After 2009 the H₂ was increased from 25 to 30 sccm to avoid plasma outages.
- In 2011 we started to increase the H₂ up to 40 sccm and the RF power up to 60 kW to compensate for the decreasing H- beam current in the MEBT.
- Since the RFQ retune, we use mostly ~30 sccm and ~55 kW.

However, less H₂ should allow for higher RFQ powers and higher transmissions!

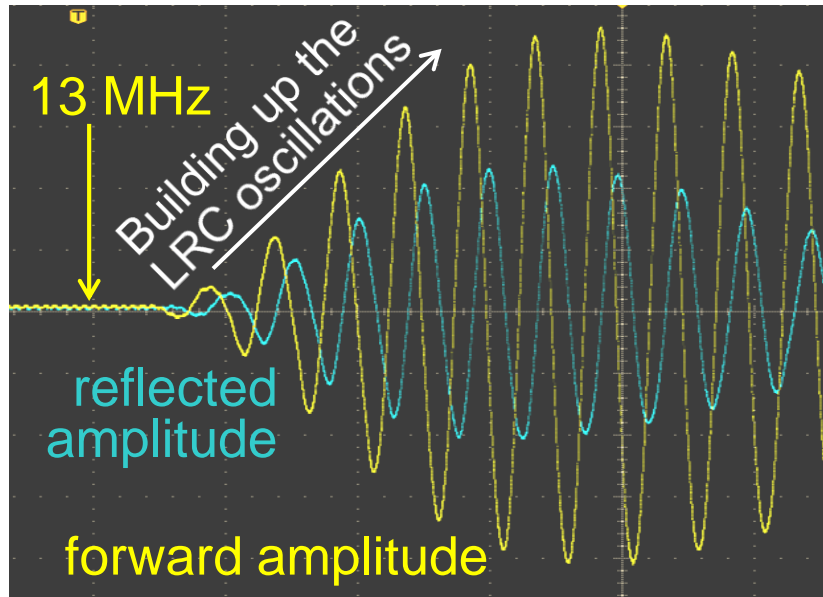
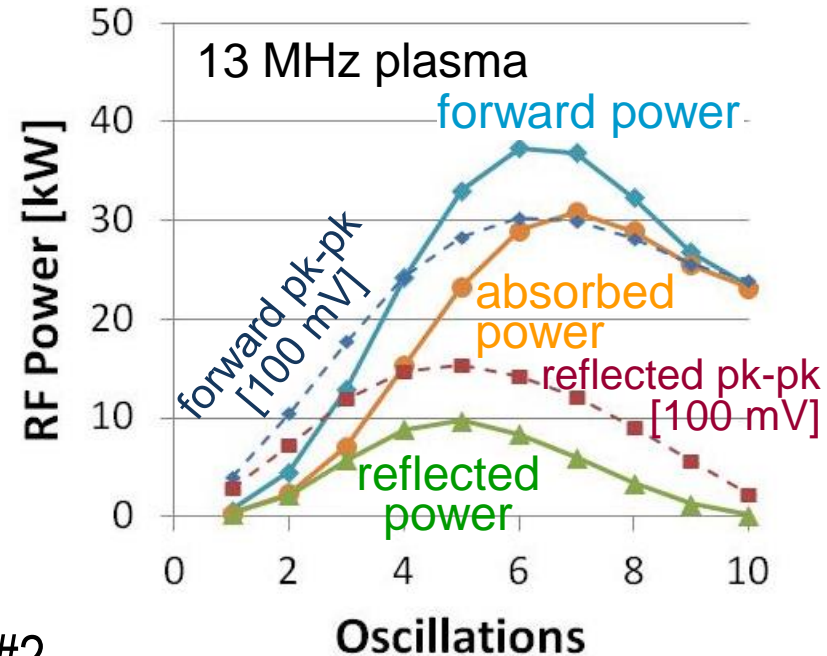
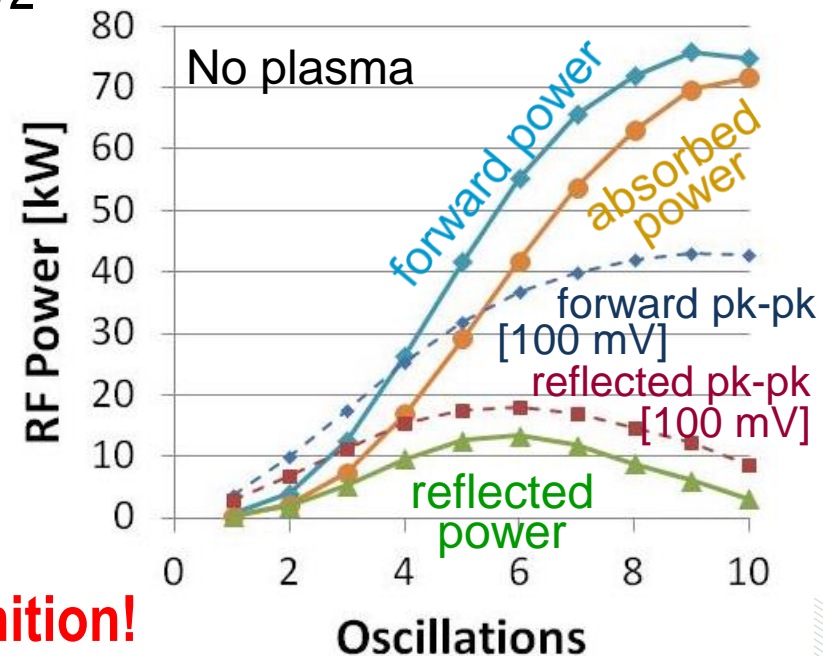
Ramping the 2 MHz with 1.96 MHz

- RF build-up was studied with 4-week-old source #2 using a 2 MHz directional coupler on ground.
- With 13 MHz plasma the LRC circuit rapidly builds up oscillations before drifting off resonance due to the evolving plasma inductance.
- Only little RF power is reflected because the plasma absorbs the RF readily.
- However, without plasma the LRC circuit builds up to 76 kW, absorbing up to 71 kW. The electric fields generated by the very large antenna current are unable to break down the pure H₂ gas.

The 80 kW QEI cannot provide reliable ignition!

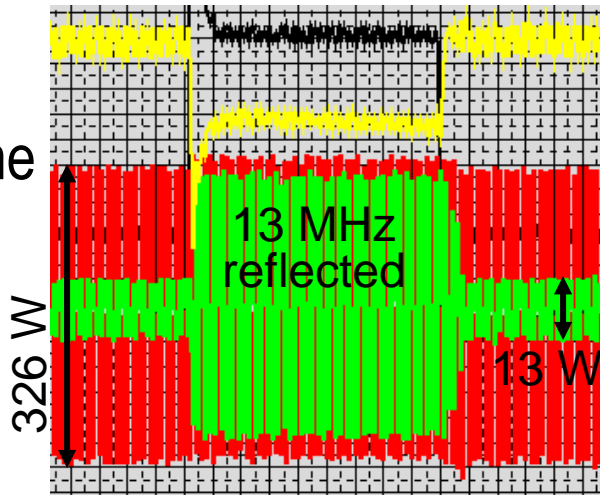
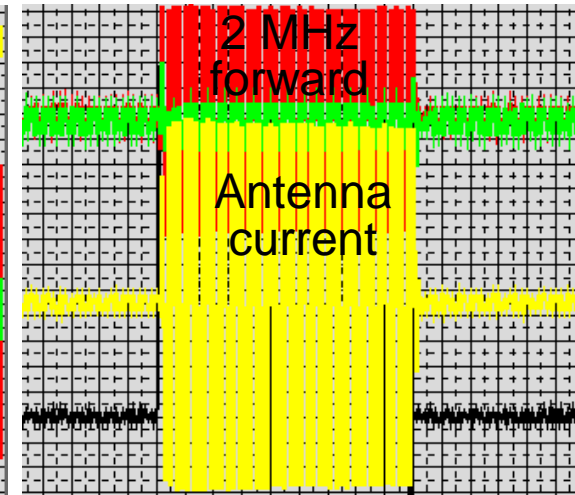
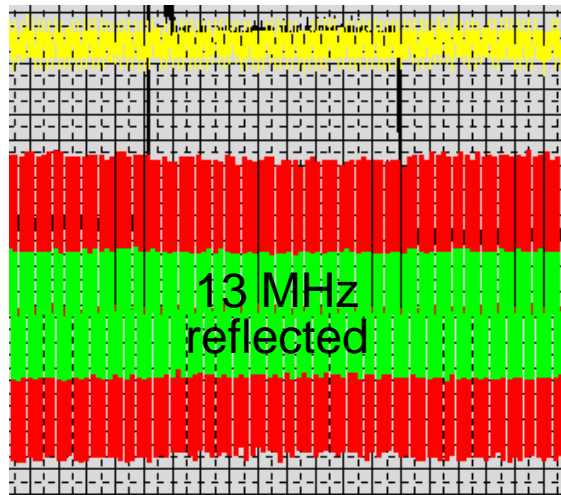
A Plasma Outage

Seen from the 2 MHz
directional coupler on ground

30 sccm

13 MHz
recovers
quickly

20.5 sccm

13 MHz starts
to struggle

19 sccm

13 MHz plasma
struggles

18 sccm

13 MHz
plasma dies

- Despite slightly inconsistent tunes, the observed 13 MHz signals appear robust with a minimum clampdown if any.
- No excessive power spikes have yet been observed, maybe due to the 60 Hz trigger rate and the ~ 1 Hz update rate of the scopes.
- Triggering the scopes with the intense plasma light allows for capturing the time around the last pulse to study each outage.
- This was tried with 39-day old source #2.
- The 2 MHz kept the 13 MHz forward power \sim uniform but quadrupled the reflected amplitude without clampdown.
- Plasma outages quadrupled the 13 MHz reflected power.
