Target Systems Performance and Plans

T. McManamy
NFDD Chief Engineer

AAC Meeting February 2 -4, 2010

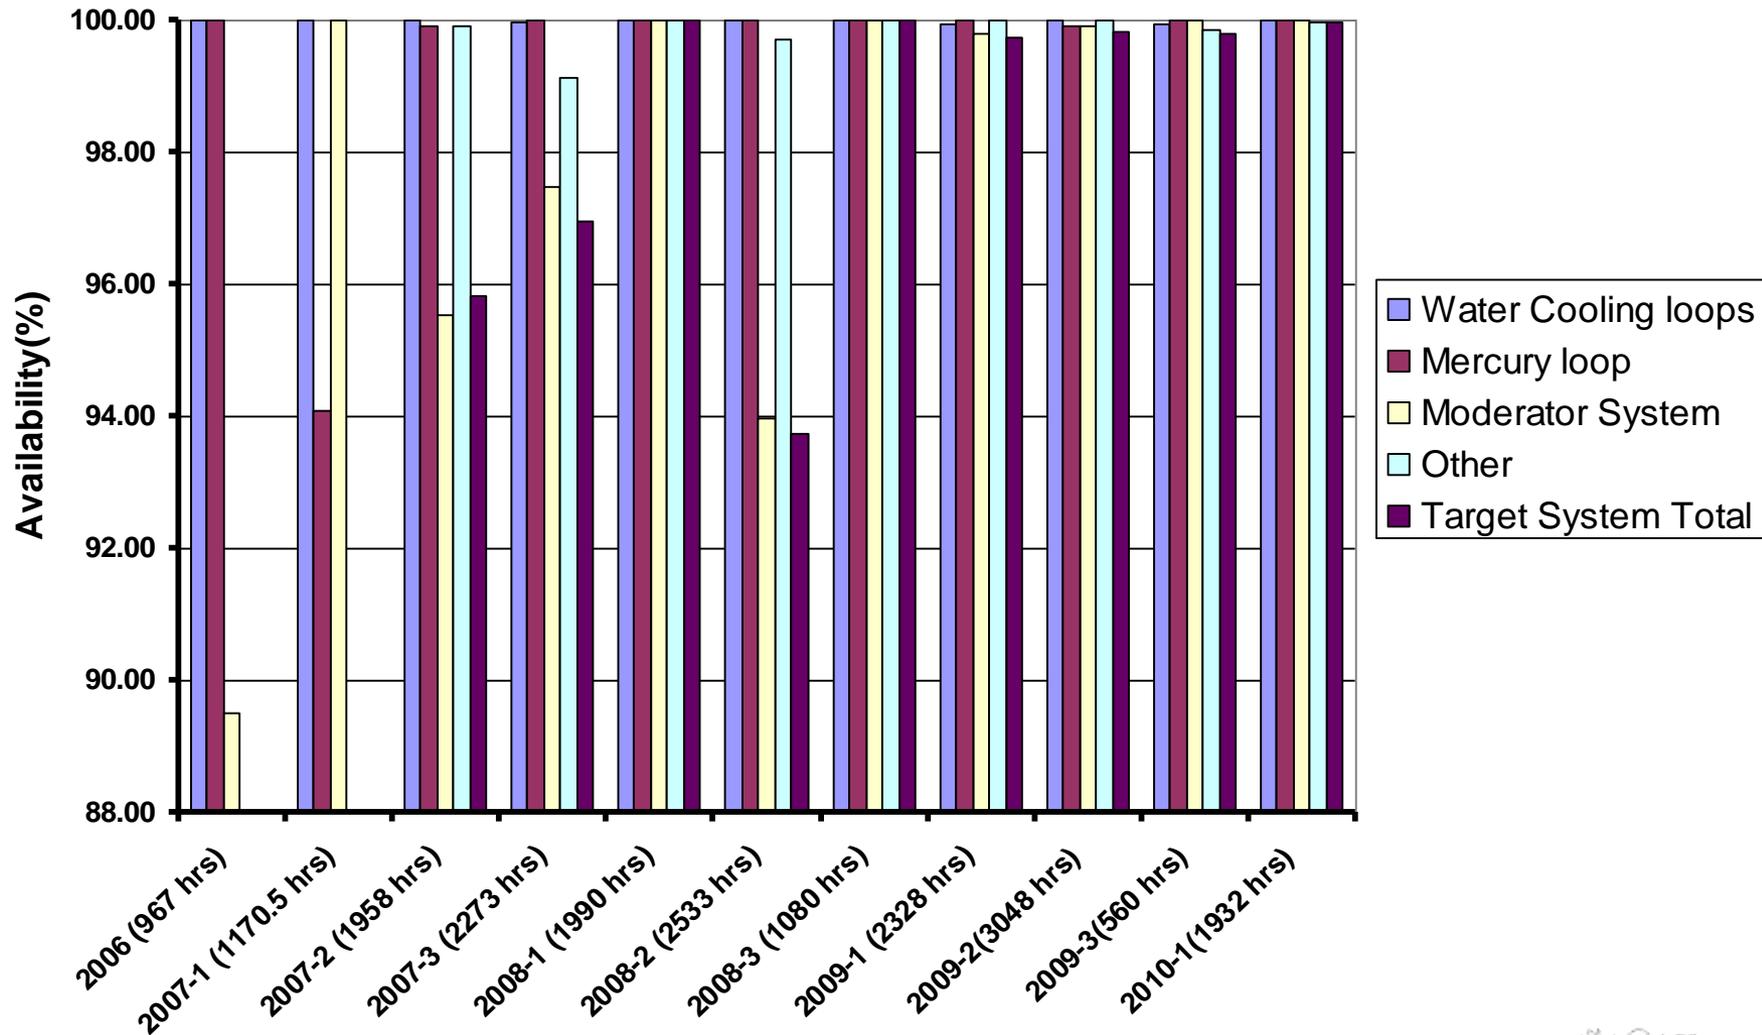
Target System Availability from 2006

Target Systems are meeting the goal of < 1% hours of unscheduled downtime

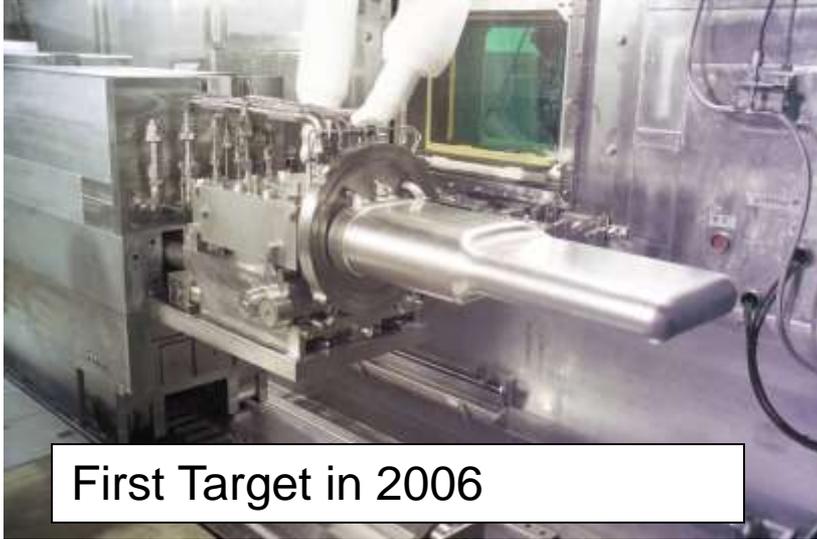
First target replacement

- The first target module reached 7.5 dpa peak on the mercury vessel, a peak fluence of 1×10^{19} protons/mm² with a peak power of 800 kW and an accumulated energy of 3055 MW-h
- Target replaced during shutdown to avoid exceeding 10 dpa on the water shroud prior to the next scheduled shutdown

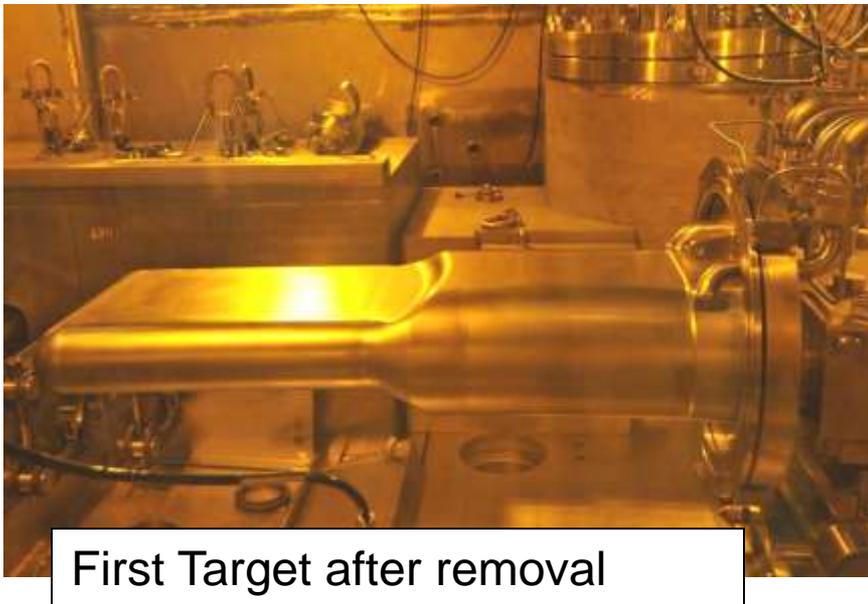
- No observed external corrosion

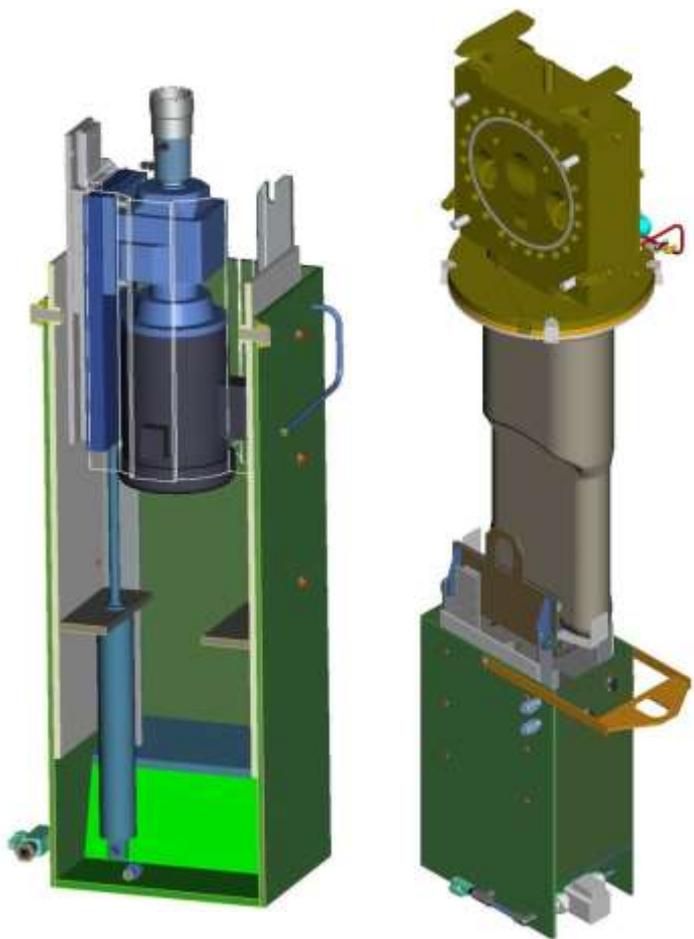
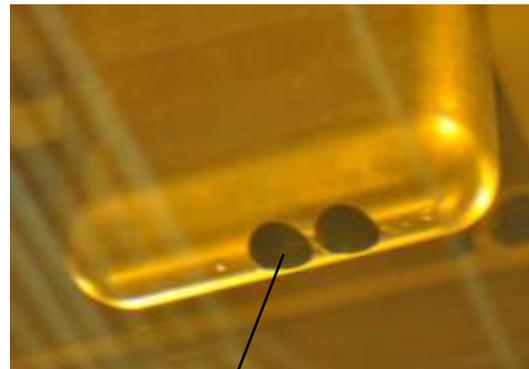
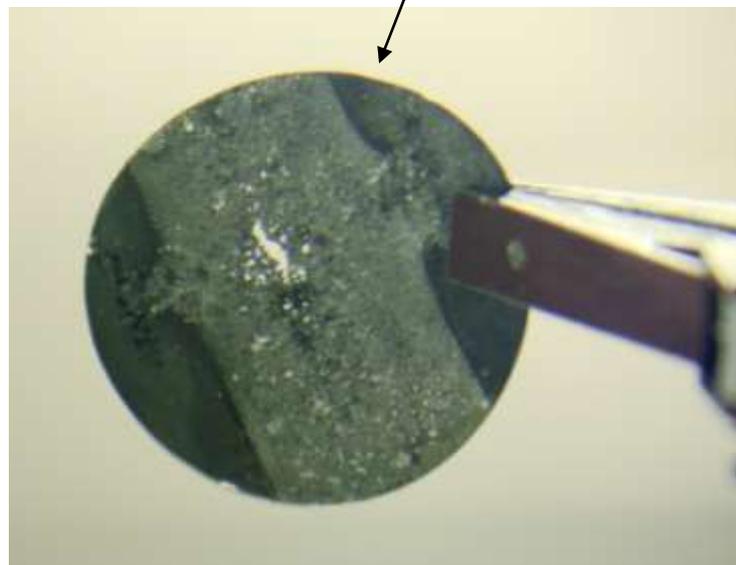
Nose Region Sampling

- Sampling Cutter used to remove complete samples from the target nose (two water shroud, two mercury vessel) in two locations.

Damaged inner Hg Vessel wall- bulk flow side

- **The first target had circular samples cut from the nose region**
 - **Samples showed severe pitting damage to the inner wall which separates the window flow channel from the bulk flow**

- **The damage was strongly peaked near the nominal bulk flow stagnation point**
 - **Little or no damage was observed on other samples where there was good mercury flow across the surface**

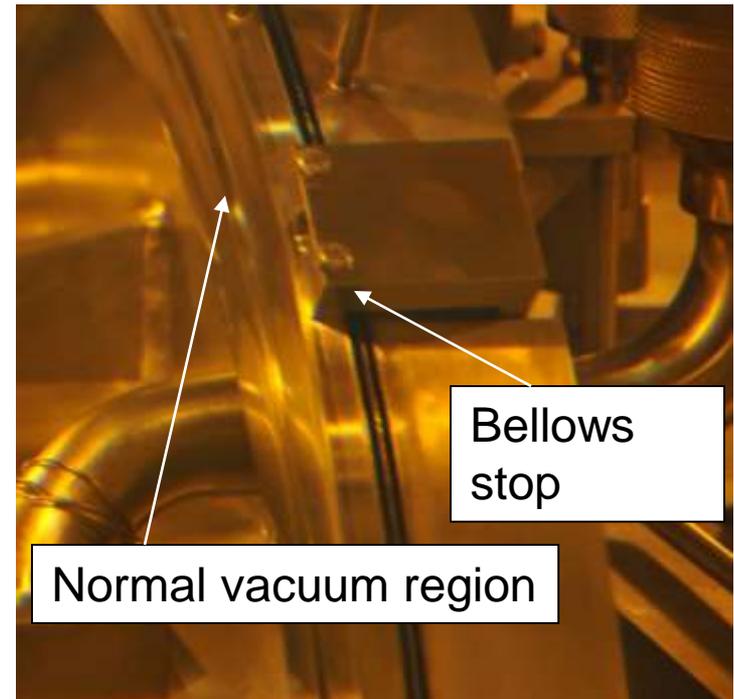
Target inflatable seal
and one bellows stroke
limiting bracket

- During operation the interstitial vacuum in the target inflatable seal was lost causing the helium concentration in the core vessel to go below 98%
- The cause appears to be an incorrect setting for the brackets on the seal which limit the stroke of the included bellows
- By feeding a small flow of helium to the middle region instead of pulling vacuum and by operating at close to atmospheric pressure, the core vessel helium concentration has been maintained at > 99.9%
- The target will be run in this mode until the next replacement

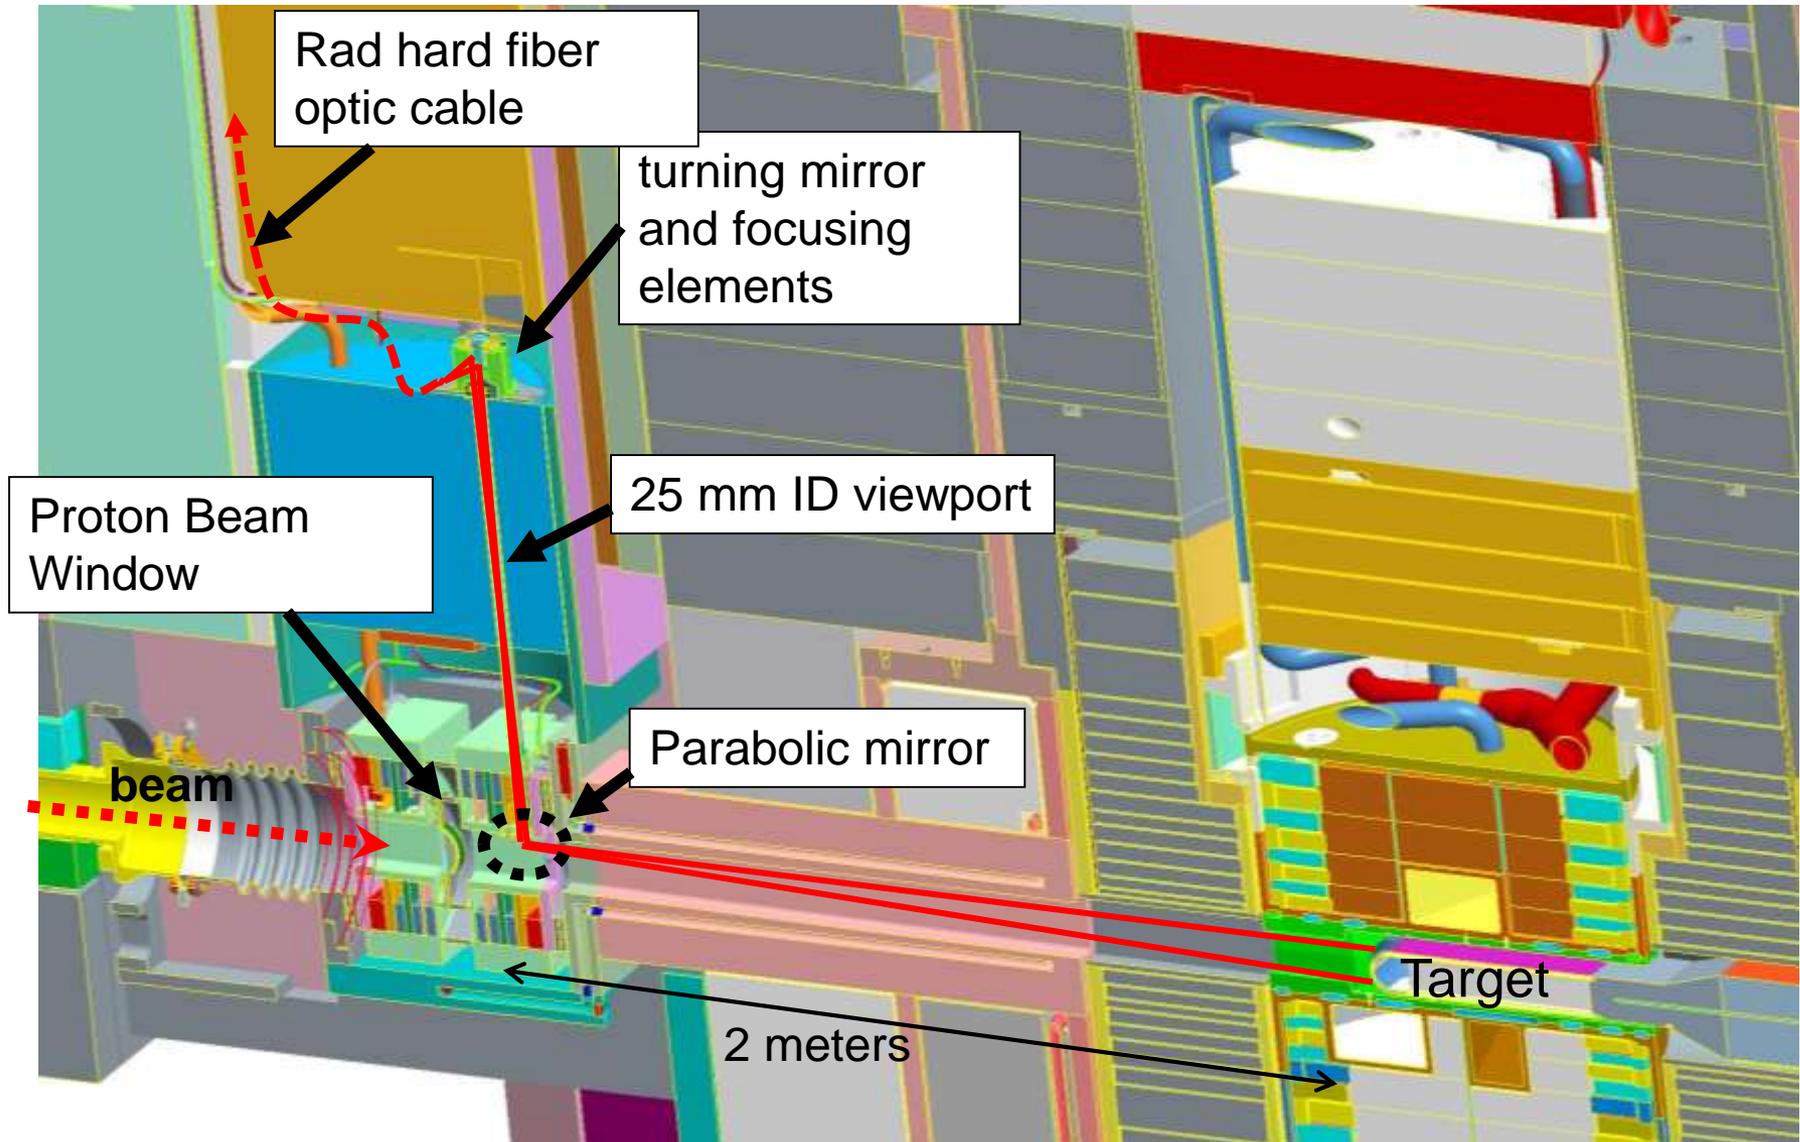
Target Imaging System Optical Path

- The first proton beam window reached 6.5 dpa and was replaced during the July shutdown
- The second proton beam window included the optical components used in the target imaging system to view a phosphor coating and beam image on the target
- Proton Beam Window Procurement Status
 - Delivery of the 3rd PBW is expected by March, 2010
 - The option for procurement of the 4th PBW modules has been exercised

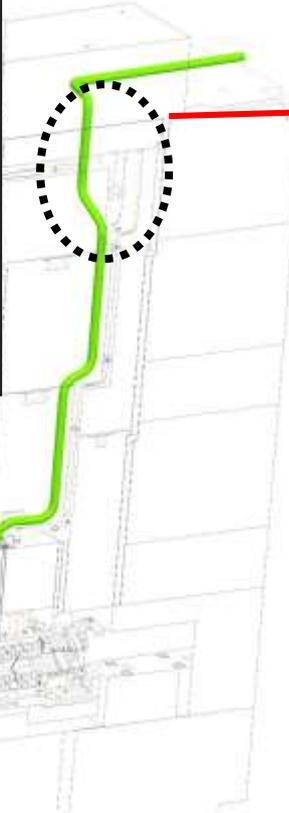
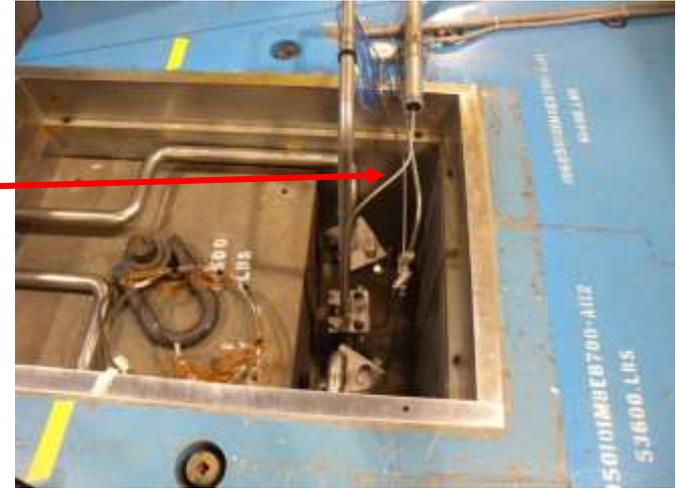
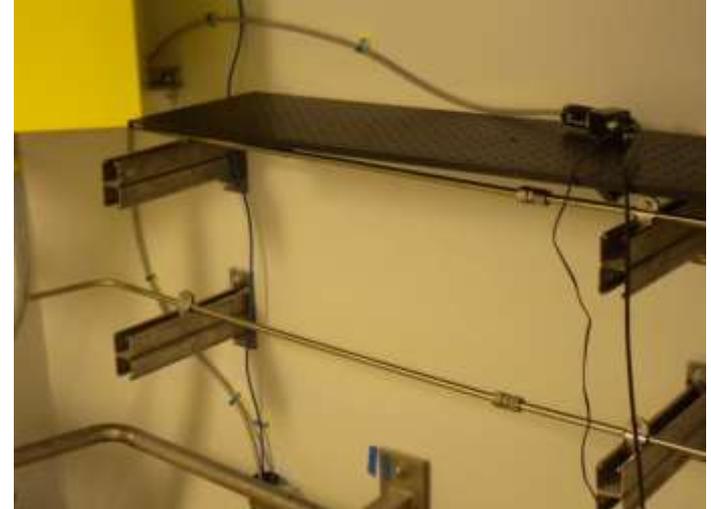
Imaging Fiber routing

Radiation Hard Fiber 38 ft overall length

10,000 fibers, ~1 mm diameter

Camera located outside of shutter drive equipment room

Standard camera with GigE interface used

Camera mounted outside shielding

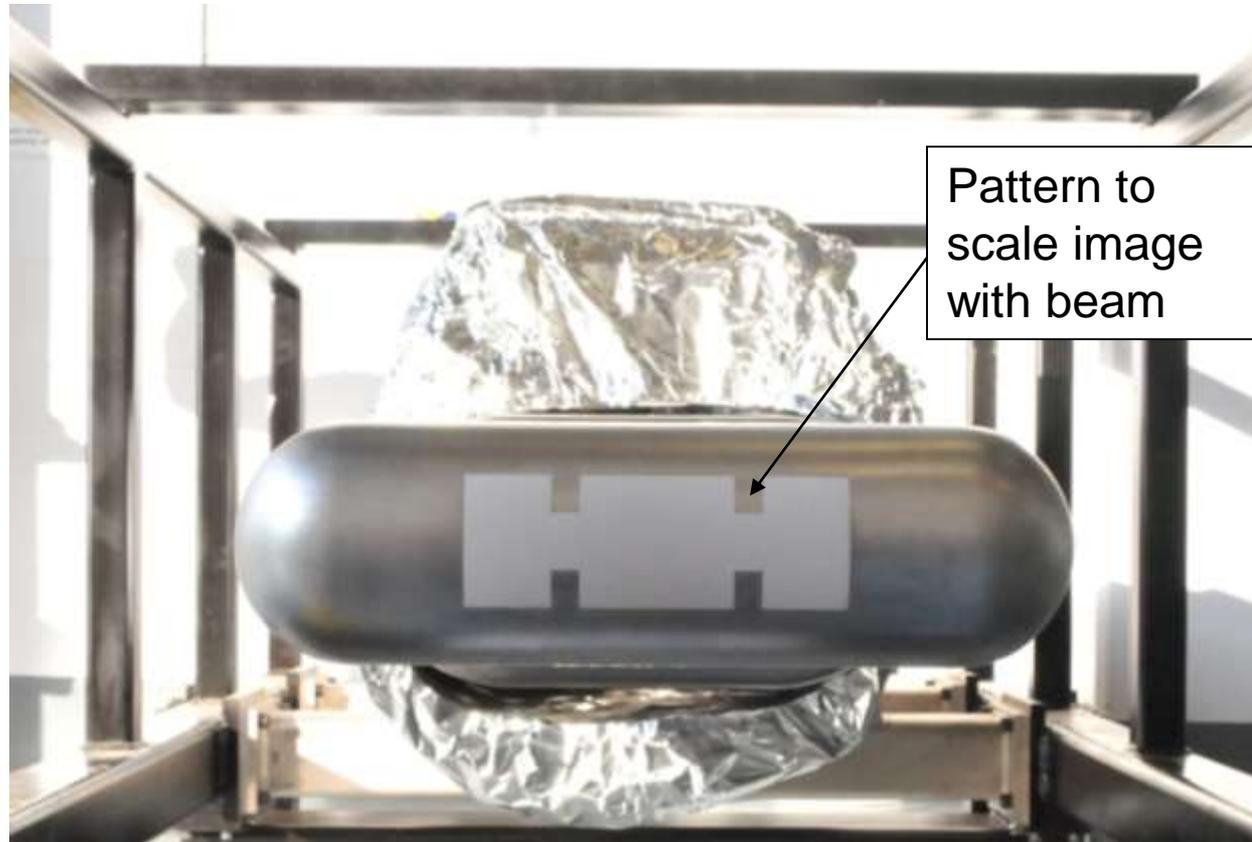
Completed Target Coating

Nominal Thickness 0.25 mm, 200mm x 70 mm pattern

Mockup testing established parameters and showed substrate temperatures were < 120 C with air cooling

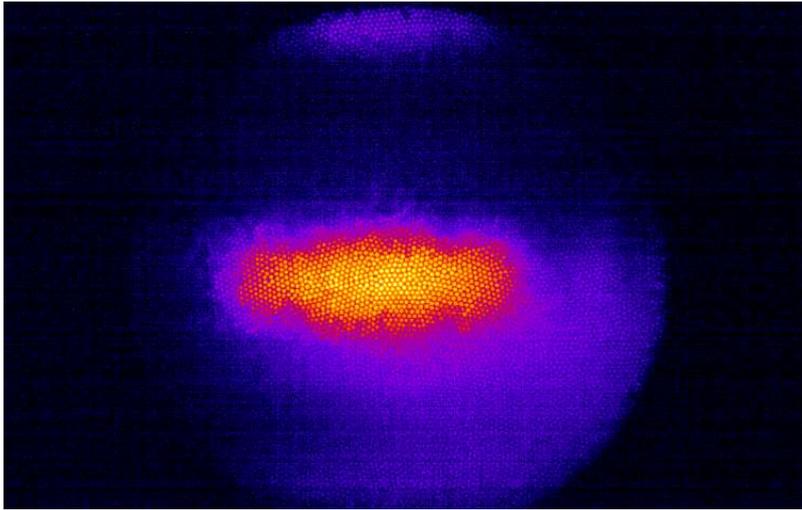
Case 1: image with potential gas scintillation

- No beam tilt observed
- Initial comparison of TIS with RTBT Wizard gave peak densities $\sim 10\%$ higher from TIS
- On line TIS fits show lower peak density than projections from harp
- Detailed comparison study of the two methods is needed for single pulse and at power and is planned for the next startup

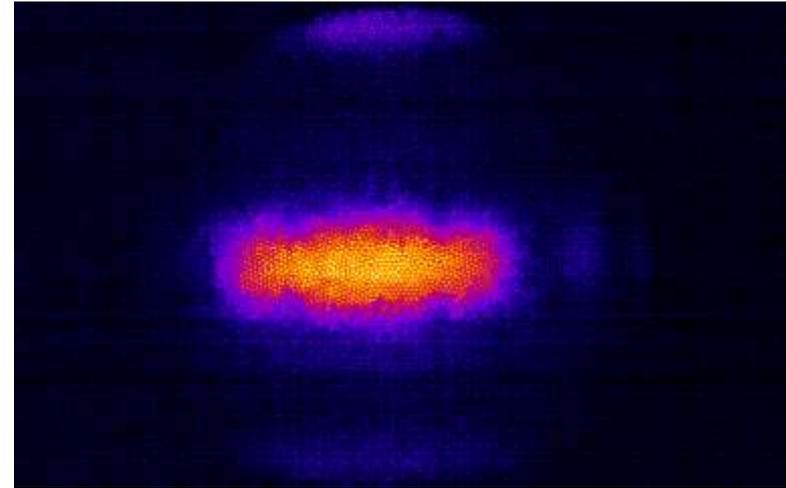
Case 2: image with shutter delayed by 4 microseconds to gate out suspected gas

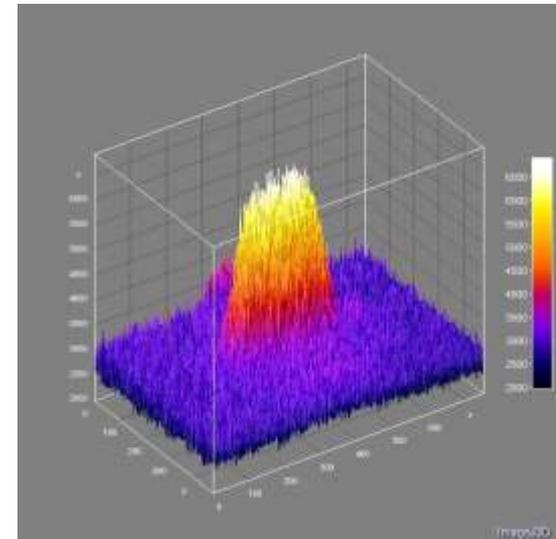
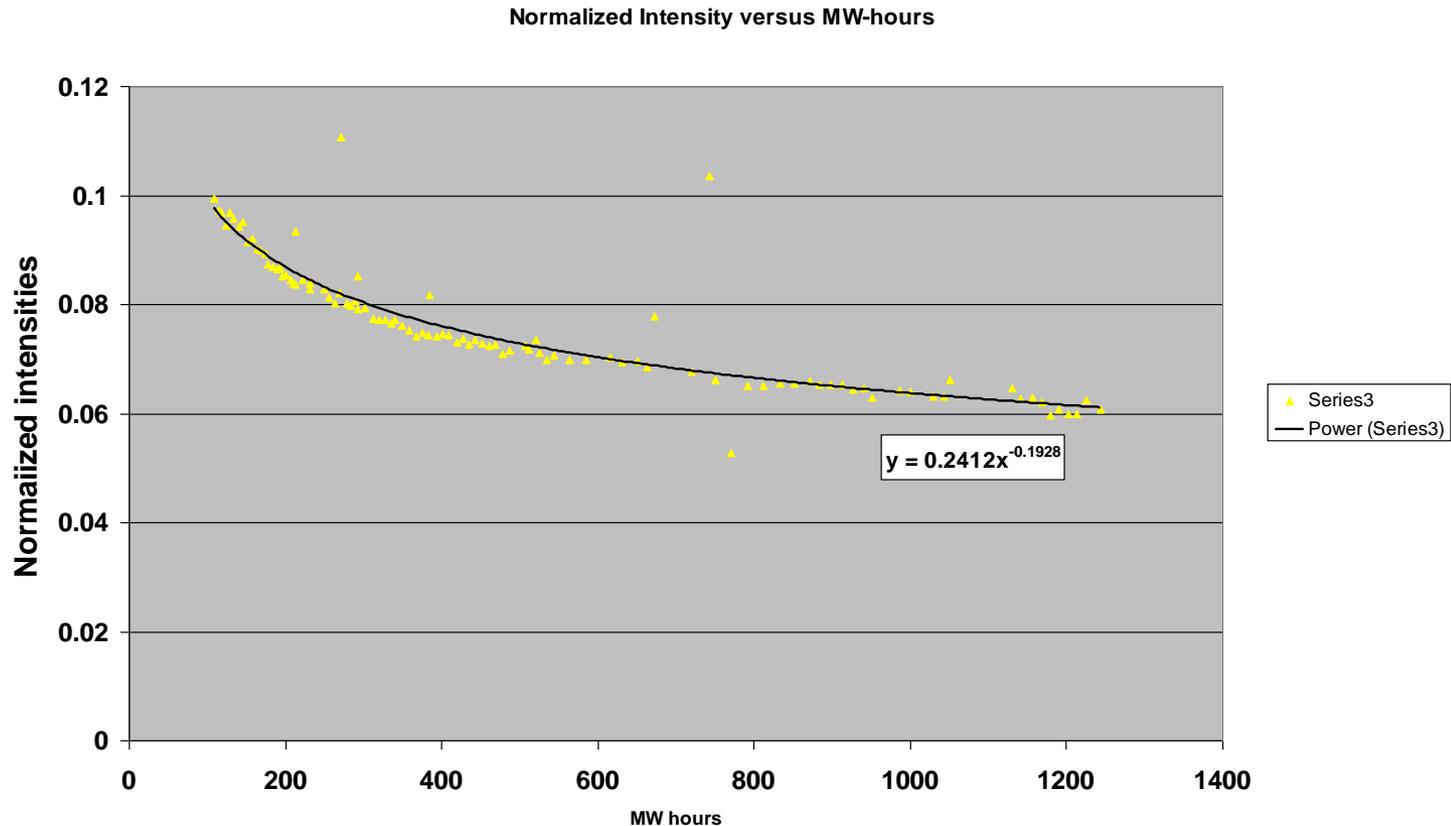
Intensity normalized to start on 9/7/09

- An initial 90% drop in intensity over the first 100 MW-hours was observed, but it now appears to show a very slow reduction
- Current intensity is acceptable for developing beam profiles and projections to 5000 MW-hrs (10 dpa) also appear acceptable
- Loss is believed due mainly to neutron damage producing “F centers” (Oxygen atom dislocations) which saturate at $\sim .1$ dpa (100 MW-hrs)

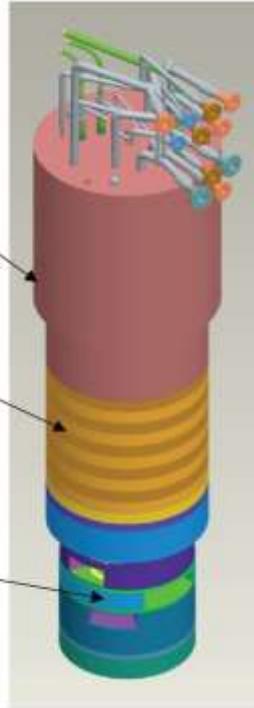
Spare IRP Assembly

- **Upper IRP**
 - Passively cooled shielding
- **Intermediate IRP**
 - Actively cooled shielding
- **Lower IRP**
 - Actively cooled shielding
 - Integrated moderators
 - Be reflector
 - Moderator beam tubes
 - Target opening

- Spare IRP contract has been awarded to Metalex Manufacturing
- Contract is design / build – Thermal analysis and final design for manufacturability is included in the vendor's scope
- Scheduled delivery is July, 2010
- 1st IRP at ~ 4200 MW-hrs of 30,000 MW-hr life

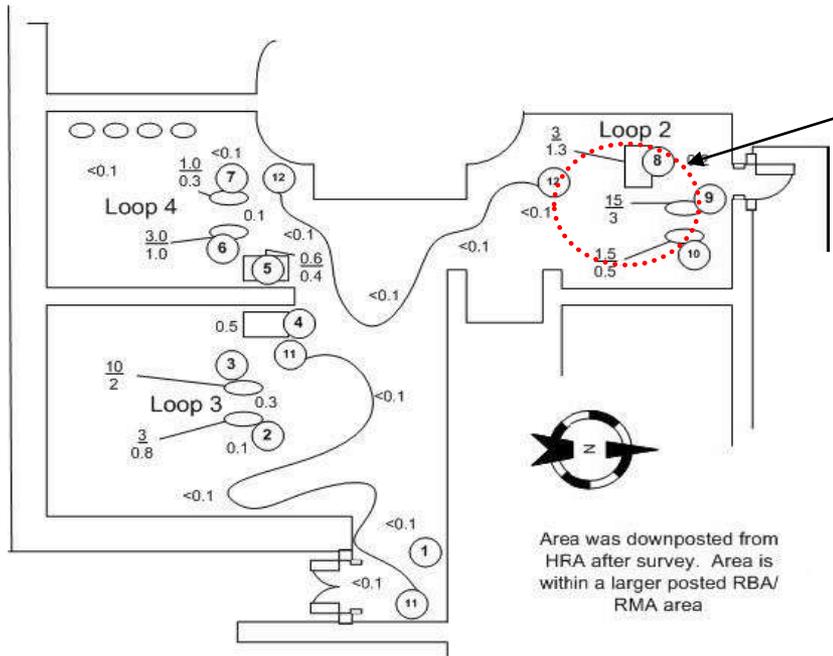
BNS-200410 on 10/27/09

- Beam on: at 800 kW beam, dose in PR4 ~800 mrem/hr (vs 100 R/hr predicted)
- Beam off data (10/27/2009):
 - The maximum dose rate is at the Loop 2 pump (15 mrem/hr on contact and 3 mem/hr at 30 cm)
 - All disc smears <1000 dpm/100 sq cm BG)

15 mrem/hour highest dose on loop 2 primary pump

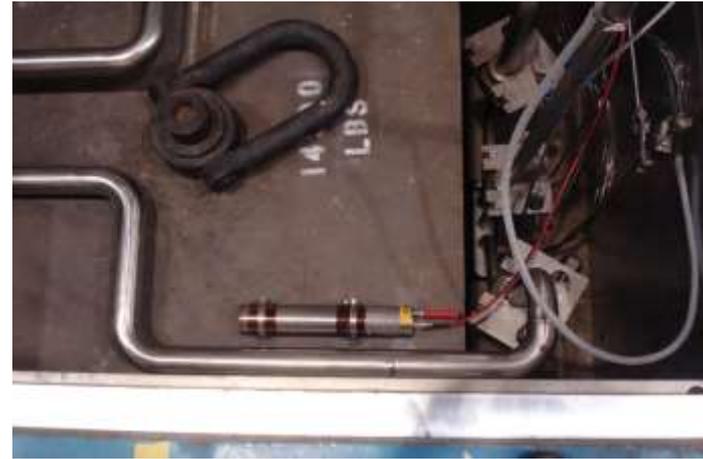
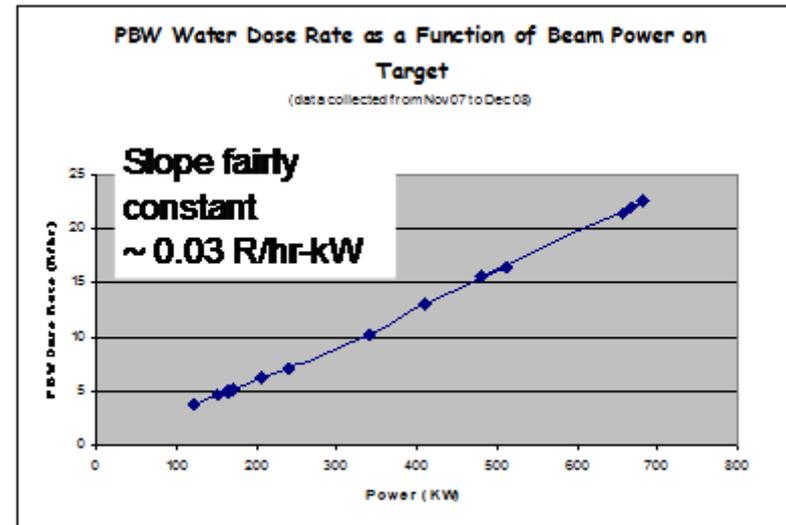
Radiation level measured on PBW return line water, Utility vault and tank cavities

- ~ 2 second water transit time from irradiation in PBW to top of shielding
- Measured dose rate are ~ 0.03 R/hr-kW
- Recent measurement at 1 MW was ~ 30 R/hr
- Utility Vault (ceiling pipe chase): 2.5 R/hr (.8 MW)
- Delay Tank Cavity: 22 R/hr (.8 MW)
- Separator Tank Cavity: 7.9 R/hr (.8 MW)

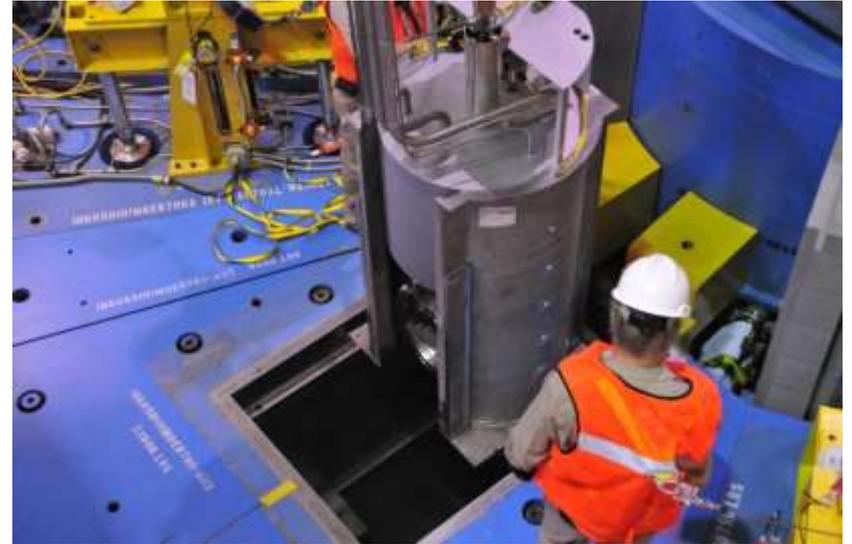
New PBW with guide can and counterweight being installed

Old PBW during retraction into cask →

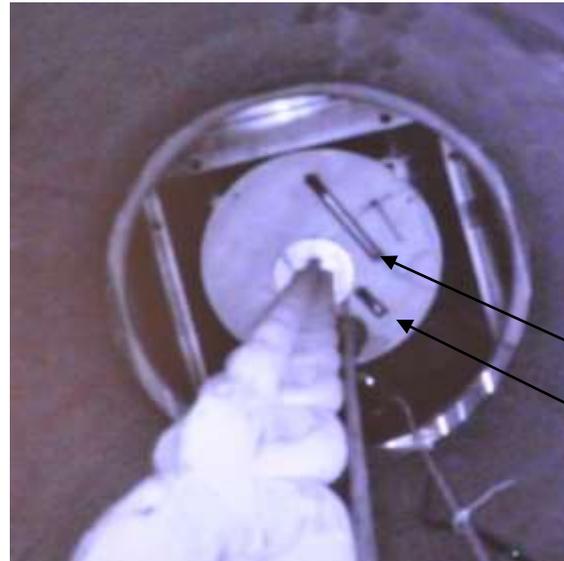
Cooling lines cut prior to removal with long handle tools

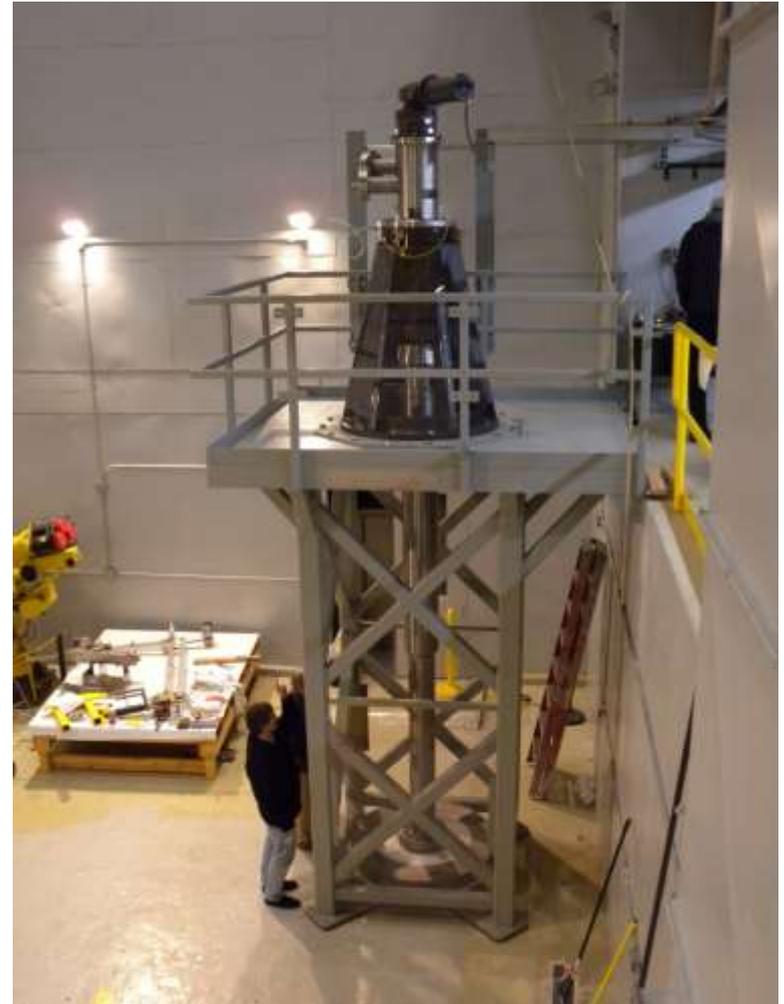
Rotating Target Mockup testing

- **Mockup testing**
 - The drive module was tested for over 1000 hours at 30 rpm with no water seal leakage in FY09
 - The ESS-Bilbao team delivered a 4 m shaft and 1.2 m diameter target and it was assembled with the drive unit Oct – Dec 09
 - Mechanical testing of the assembly has started and it is showing very good alignment with low run-out at the target outside radius (nominal $\sim .2$ mm and maximum $\sim .5$ mm @ 34 Hz)

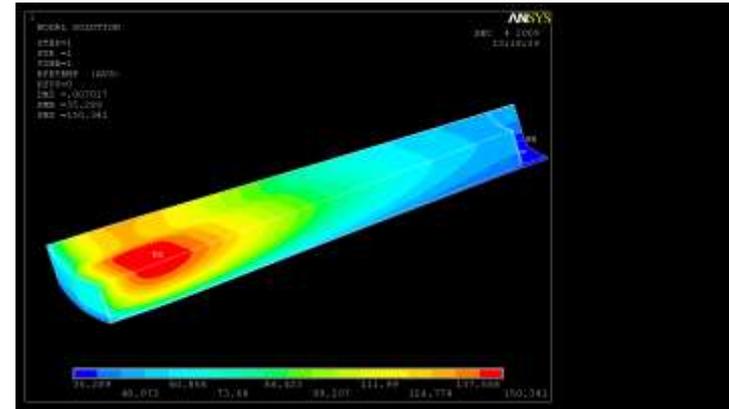
- Structural and thermal hydraulic analysis and optimization is in progress
- Wedges are cooled on top, bottom and front surfaces
- CFD flow modeling and analysis is starting
- Sensitivity to reduced tungsten thermal conductivity is being evaluated
- Temperatures and stress levels appear modest

Peak Temperature 155 C

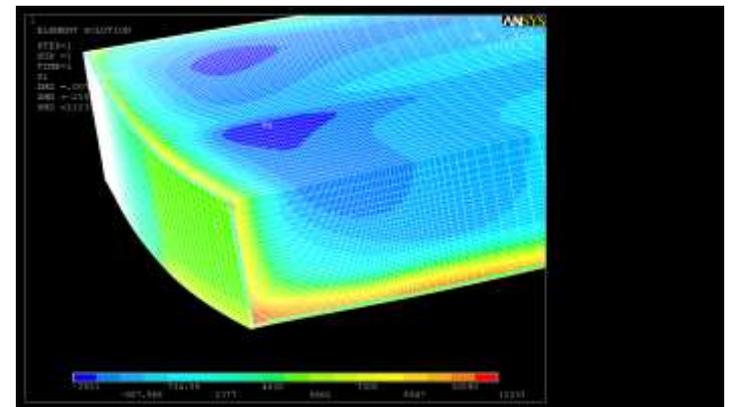
Peak 1st Principal Stress 122 MPa

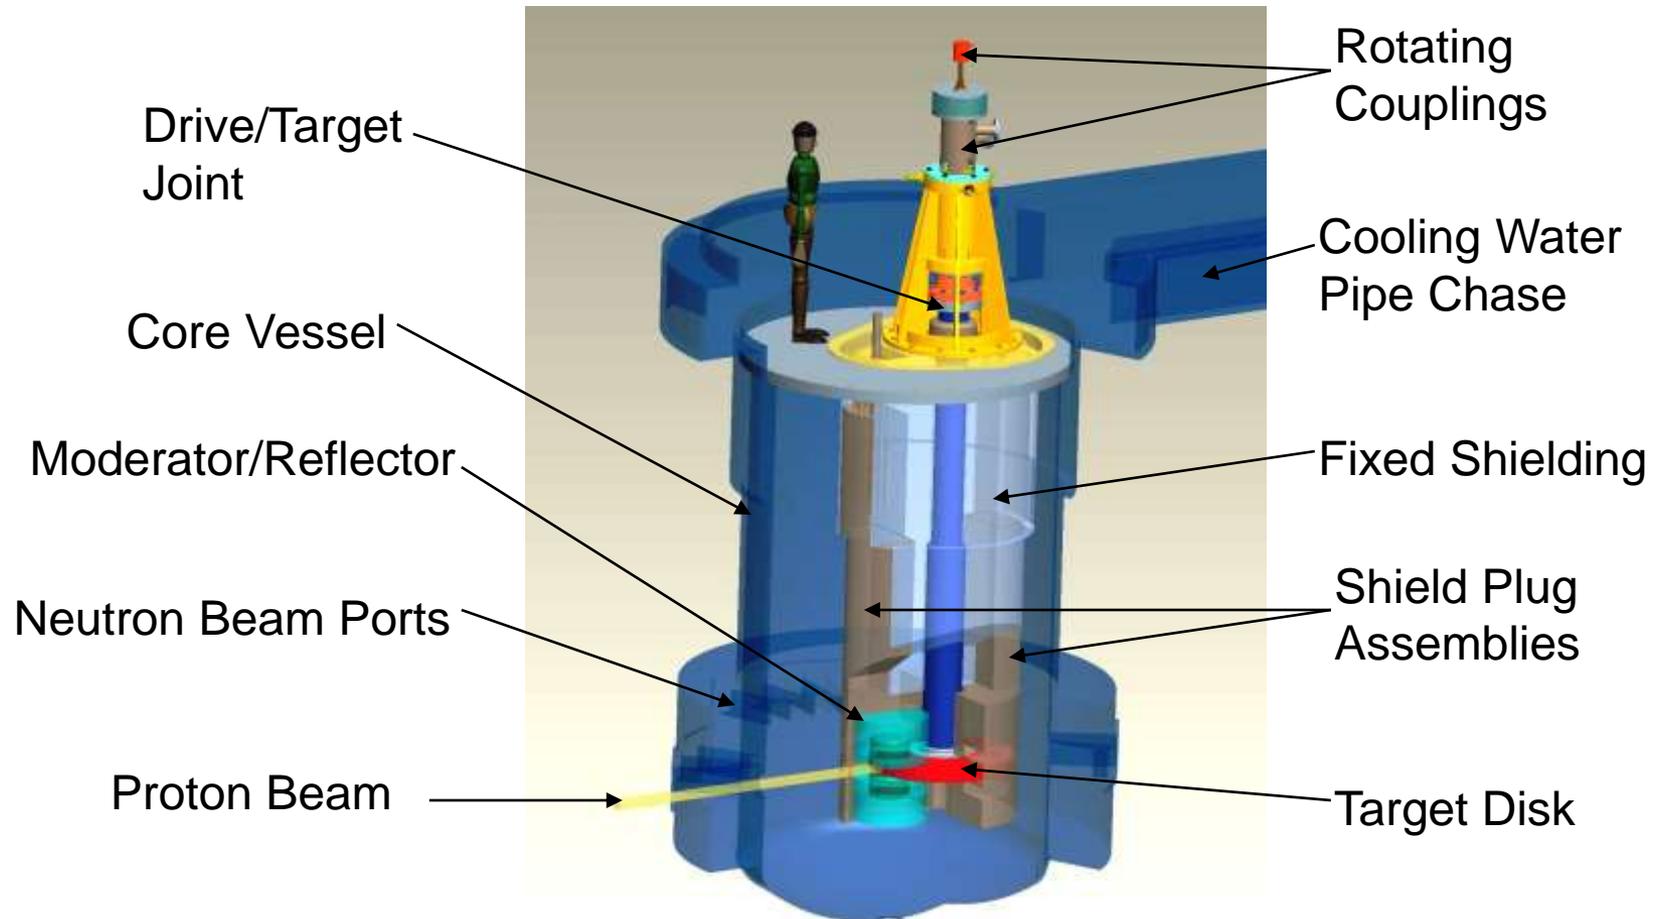
III. Target Assembly Description

Drive designed to be removed “hands-on” independently of the target module
