#### **Spare Cryomodule and Facilities Status**

J. Mammosser

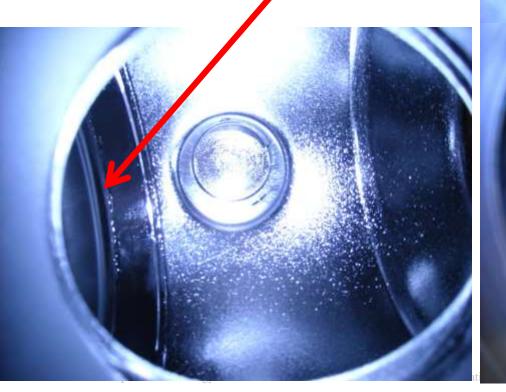
#### Endgroup Roughness

Cells have normal surface finish

Rough Surface to the First IRIS

- Internal inspections found that :
  - Cell surfaces were rather normal looking and no "smoking gun" defects were identified
  - Mode Analysis all pointed to end cells and end group
  - The end-groups were extremely rough in appearance and to the touch
    - End-group history reactor grade material RRR40, was formed into their final shapes and then were heat treated at 1250C for 6 hours to improve the RRR
    - Visual inspection showed very sharp edges and features all the way up to the first iris
    - BCP was increasing the roughness of the end groups
    - Surface roughness increases the difficulty in cleaning end group surfaces (Including HOM coupler)

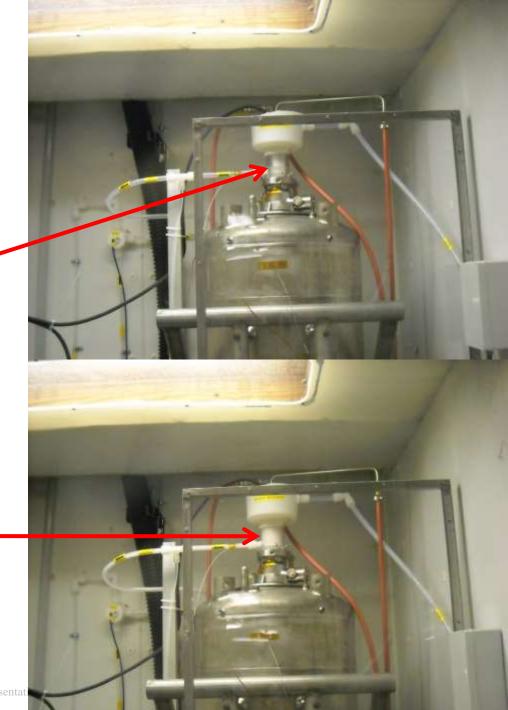
#### Hydrogen Gas **Bubbles During** Processing

With power off acid level and flow shown here

With power on top beampipe completely filled with gas and no flow, temperature on cavity endgroup was >35C and rising

- What was learned:
  - First attempts with full (traditional style) cathode showed that the hydrogen gas bubbles were filling the end-group and causing excessive etching not polishing in the upper endgroup

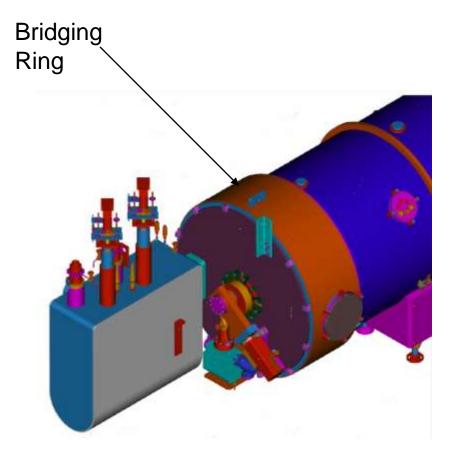
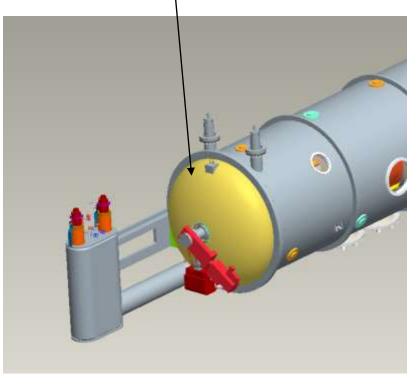
# **New Design:**

• Removed Bridging Ring and Added an Elliptical Head

#### Old Design

#### New Design

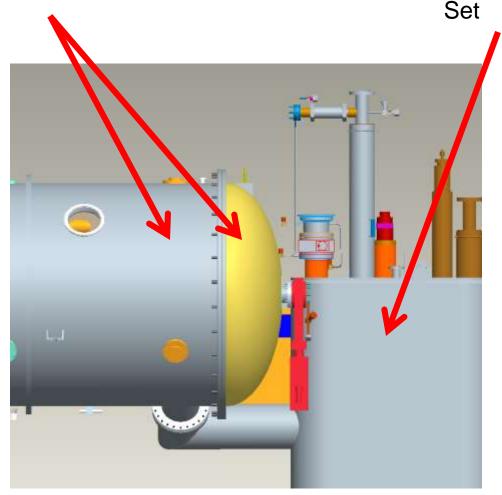
# **Pressure Stamped Subcomponents for Industrialization:**

Vacuum Vessel and Dish Head Fabricated as a Set Supply and Return End Can Fabricated as a Set

- Supply and Return End Cans
  - These will be produced in industry, pressure tested and code stamped
- Vacuum Vessel
  - This will be produced in industry, pressure tested and code stamped

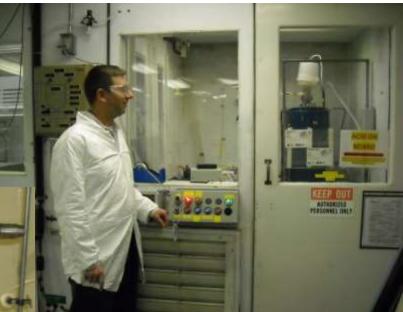
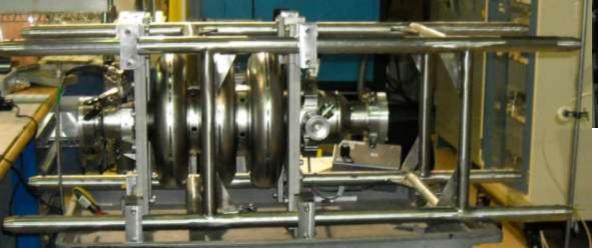
#### • MB3C

- Cavity modified to remove HOM flanges
- Cavity Processed by Vertical EP
- Currently undergoing baseline testing at JLab
