TARGET IMAGING SYSTEM (TIS) STATUS

AAC Meeting February 2 -4, 2010

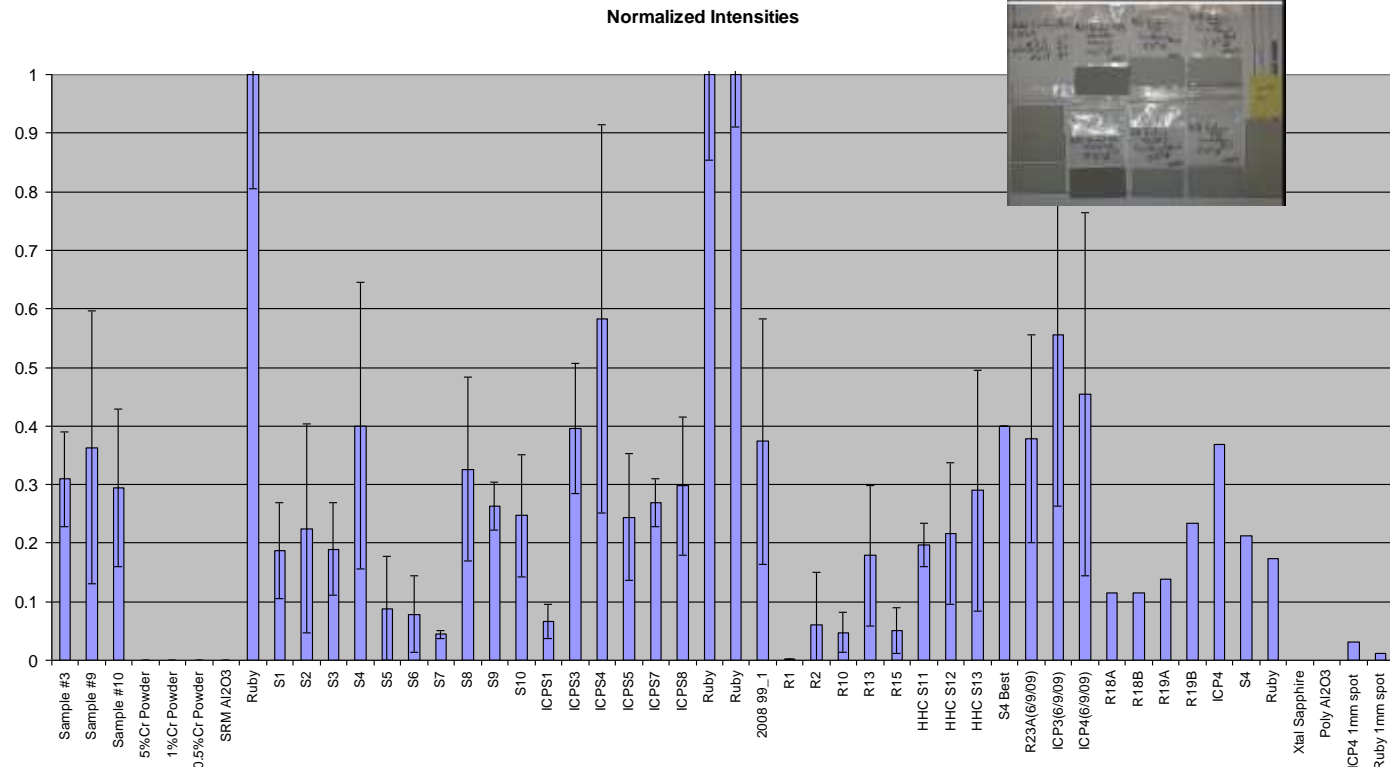
Flame Spray Process Development

- Center for Thermal Spray Research at State University of New York, Stony Brook fabricated multiple samples to evaluate process
- ORNL measured emission intensity at ~ 690 nm after excitation by green laser

- Relative intensity of ~ 60% compared to chromox plate achieved
- Particle size, % Chromia and pre-reacting mix important

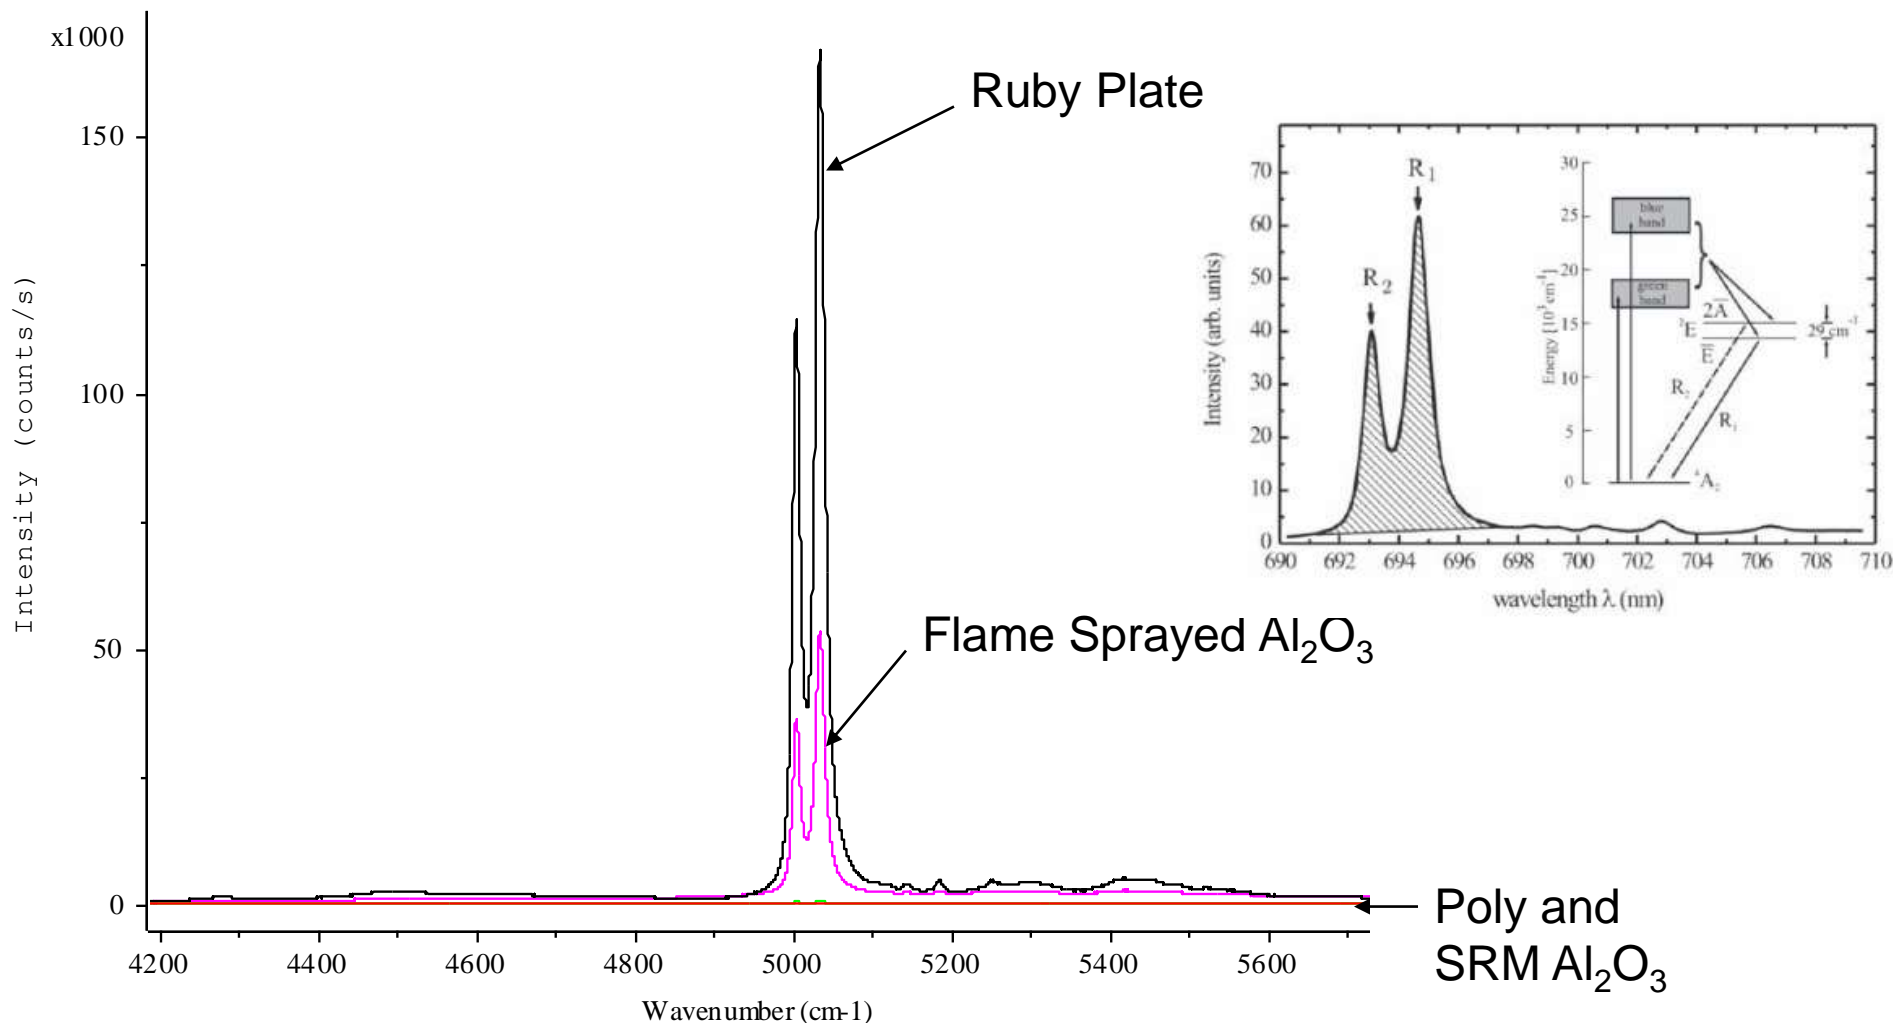
Photo Stimulated Luminescence

- Early sample shown; efficiency improved throughout spray development program
- The x-axis are in terms of Raman cm^{-1} ; subtract the values from 19435 cm^{-1}

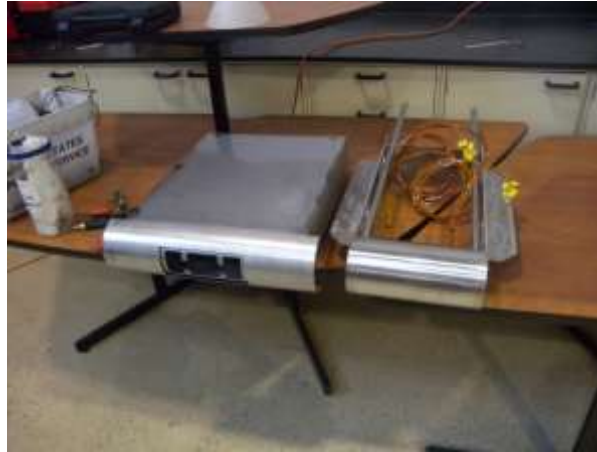
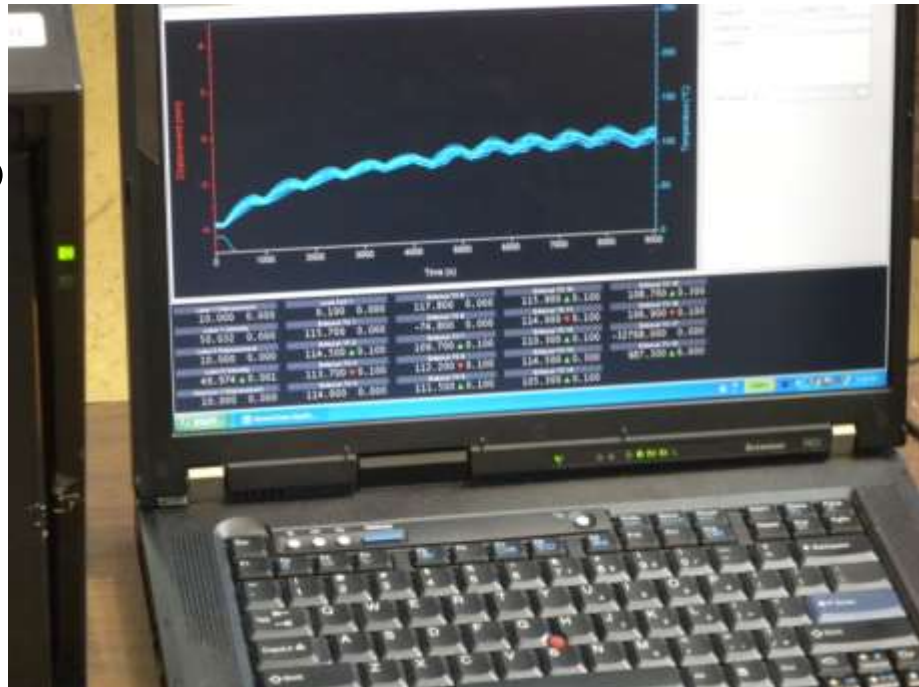
Mockup testing was done to validate process

- Automated spray system developed
- Mockup targets with thermocouples used to measure substrate temperature
- Peak substrate temperatures < 120 C achieved
- Application temperature is close to operating temperature which reduces stresses in the coating

Mockup testing established parameters and showed substrate temperatures were < 120 C with air cooling

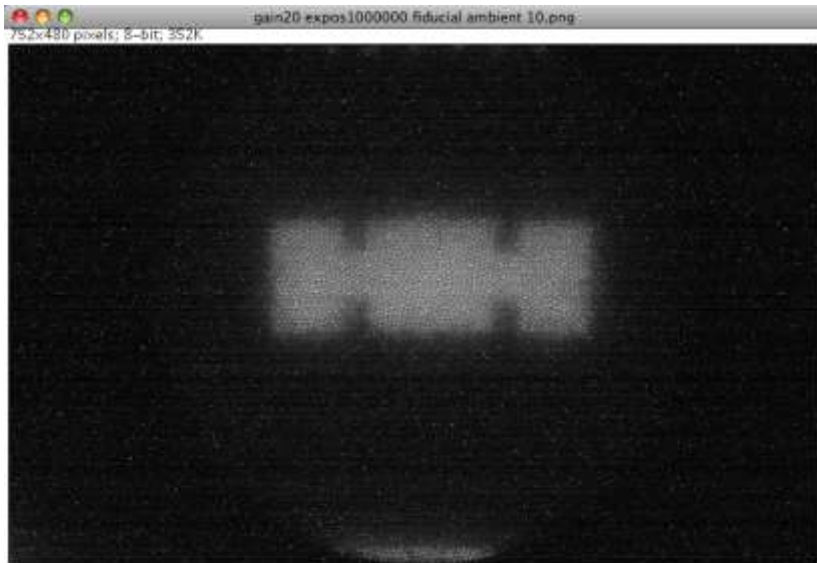
Image of simulated target prior to PBW/optics installation:

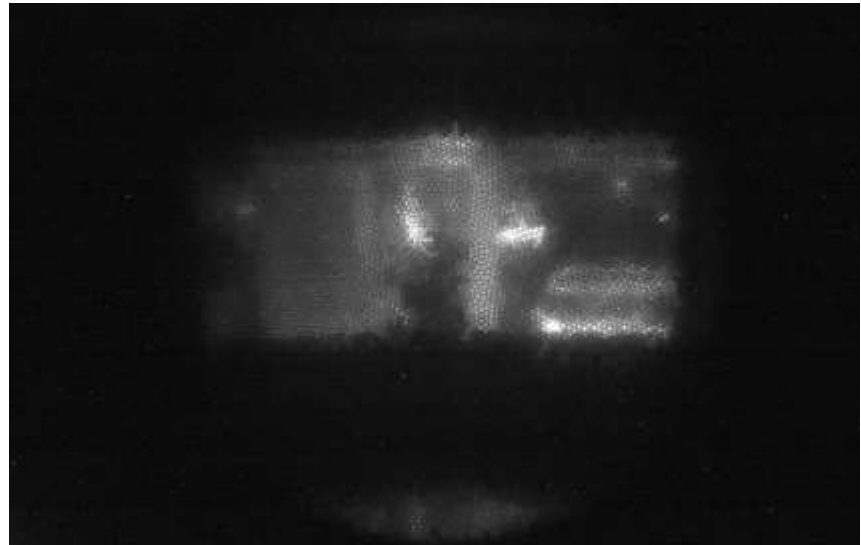
Image of actual retracted target after PBW/optics installation:

- Resolution was poorer than would be expected from the fiber spacing
 - On-line calibration from fiducial pattern difficult
 - Spherical aberrations in the focusing lens assembly seem to be the cause

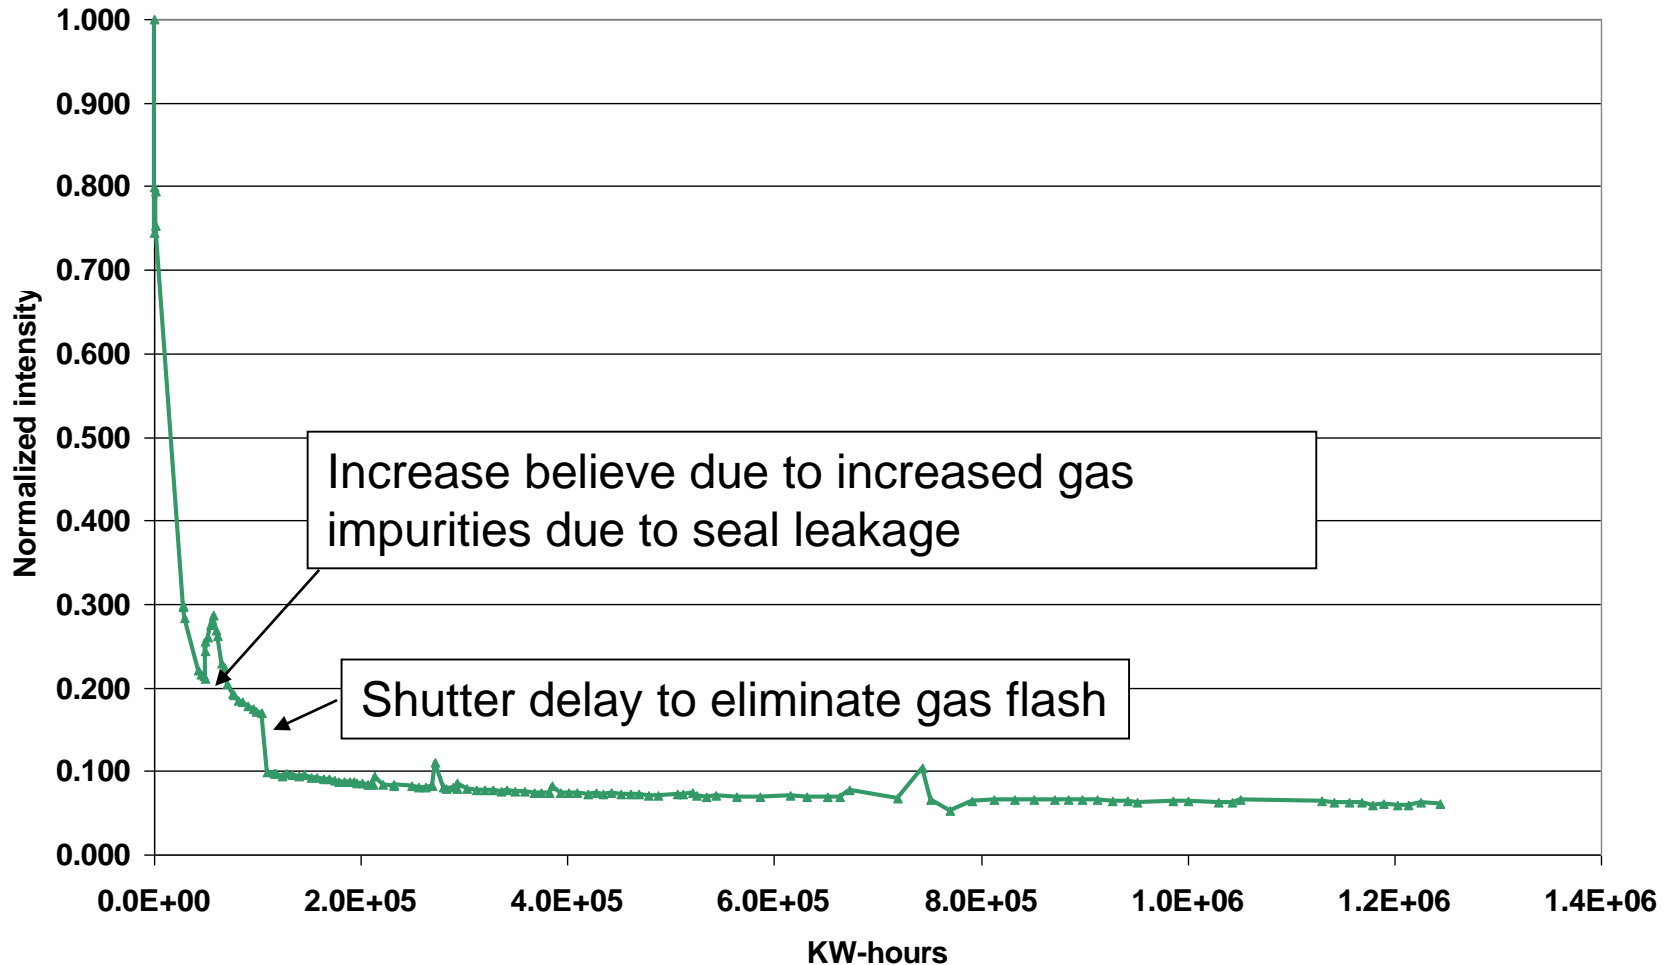
Observed intensity vs. kW-hrs on target

An initial drop in intensity was observed, but degradation has slowed dramatically – should last for life of target

Loss of intensity believed to be from production of oxygen dislocations-F centers which saturate at ~ 0.1 dpa

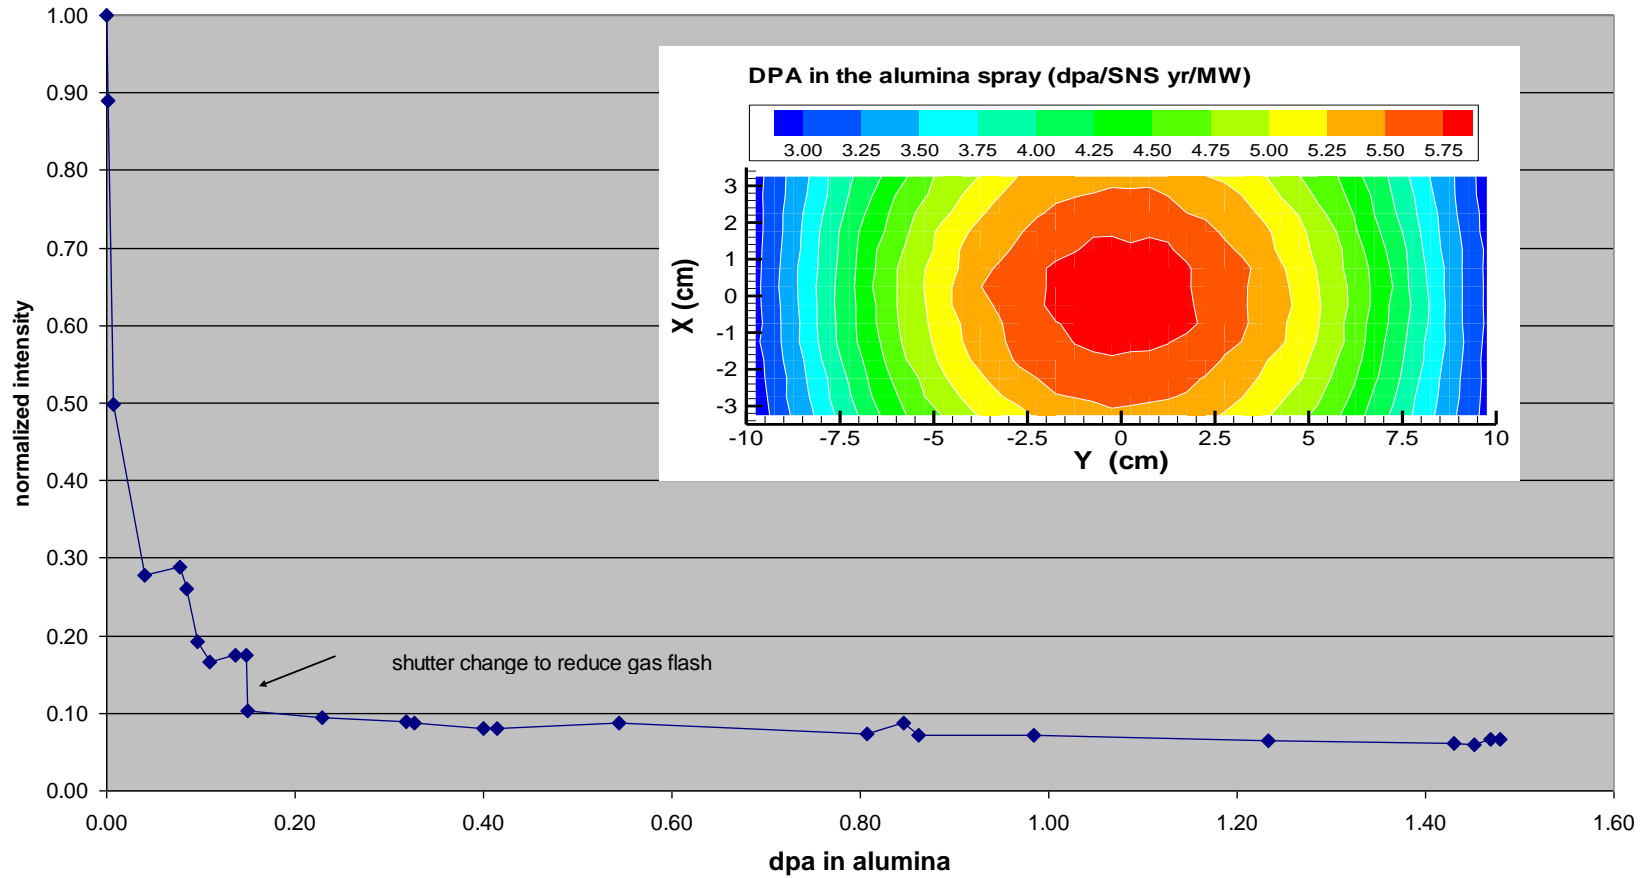
Intensity vs Alumina dpa (rough estimate)

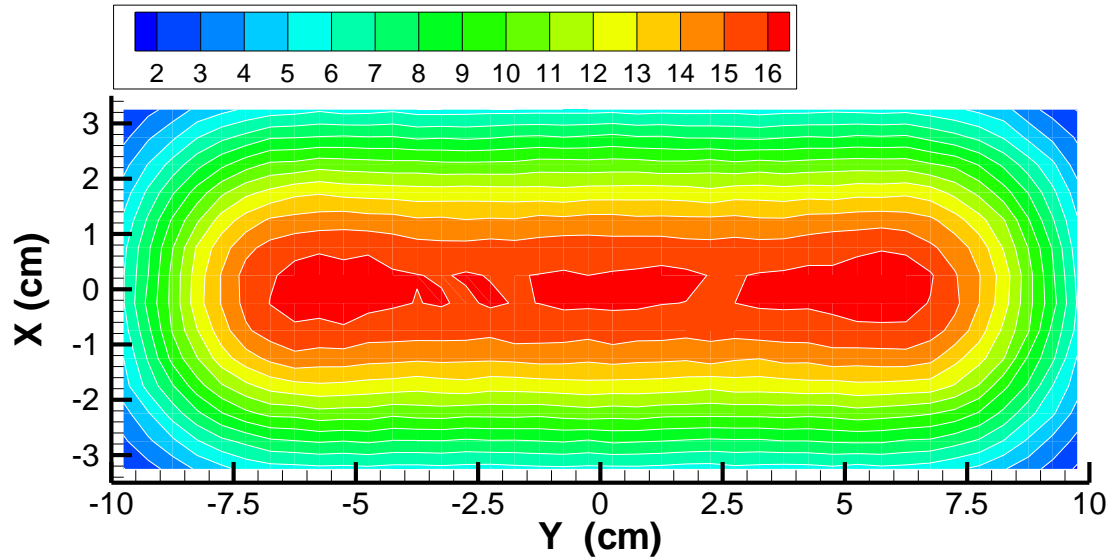
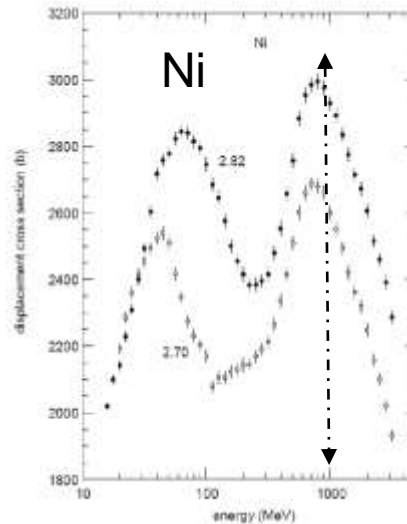
Small Proton Contribution to DPA in Alumina

Contribution of protons to DPA in the alumina layer (%)

Contribution is low because the cross section for damage in Al is low at 1 GeV and the neutron flux is approximately 3 times the proton flux

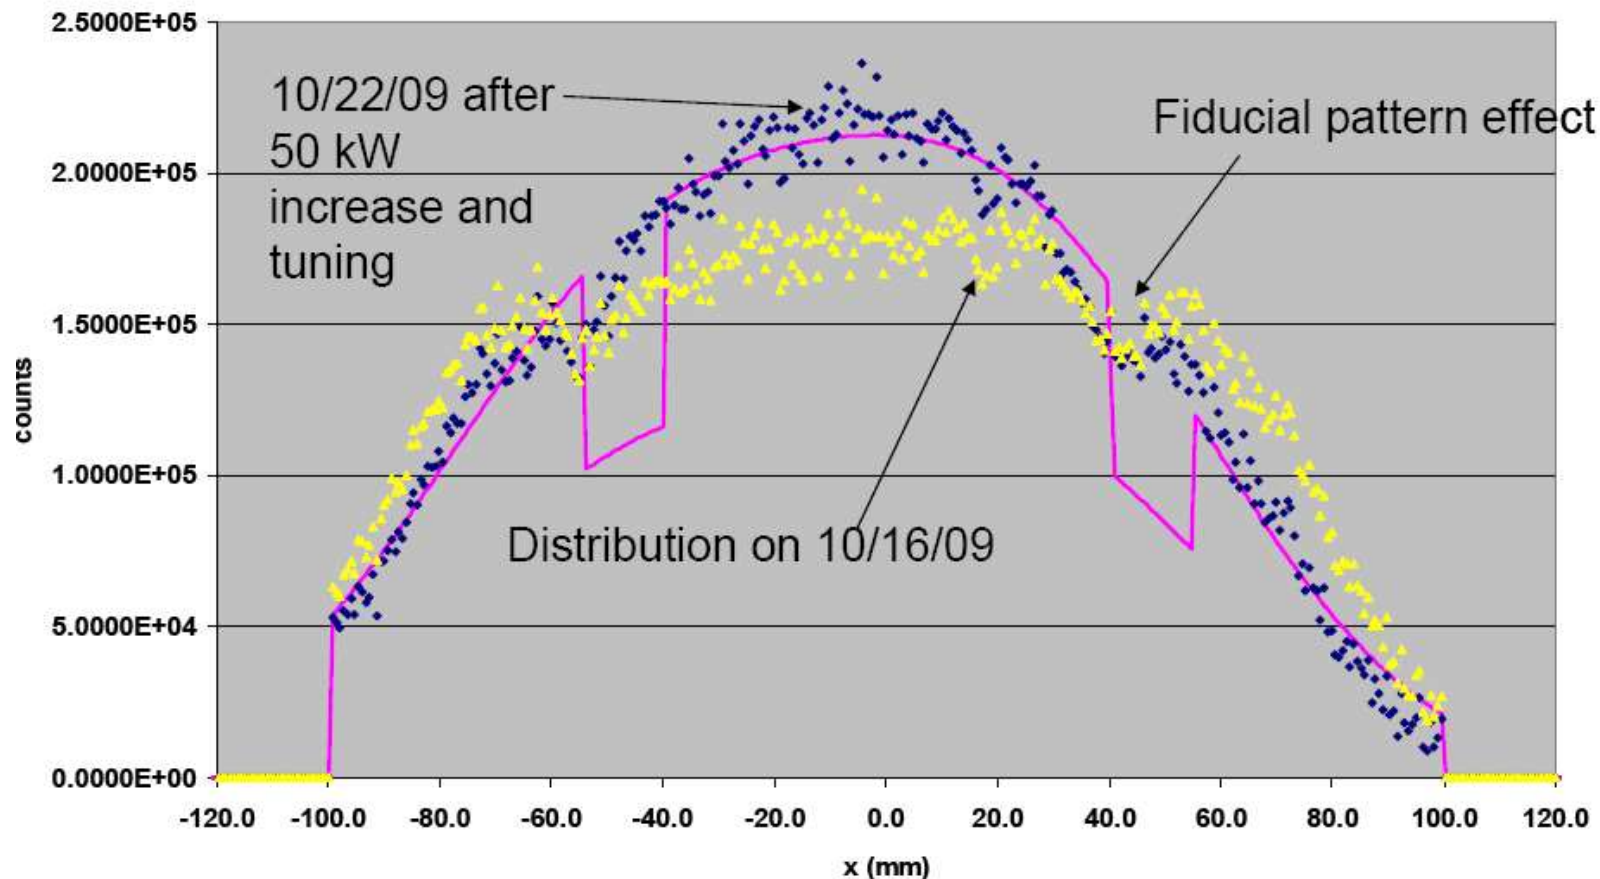
Horizontal Projection

20% increase in peaking easily detected on TIS but operators were not aware because harp was not updating - corrected later

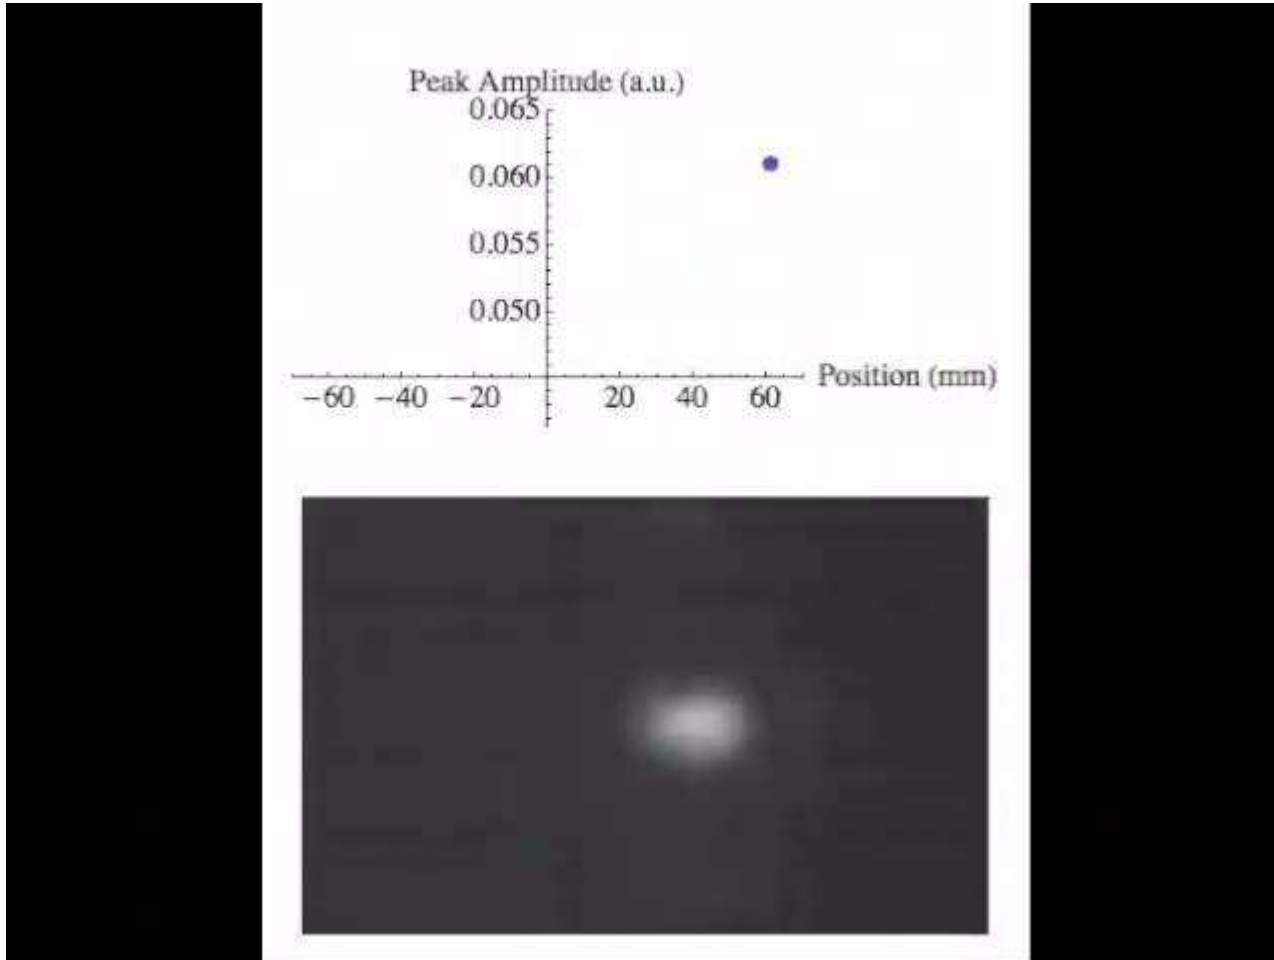
Uniformity Scan with Small Beam

Uniformity scan results

- A small beam spot was moved across the approximate horizontal and vertical center lines and the relative peak intensity measured
- Horizontal variations were $\sim \pm 5\%$ and the vertical $\sim \pm 8\%$

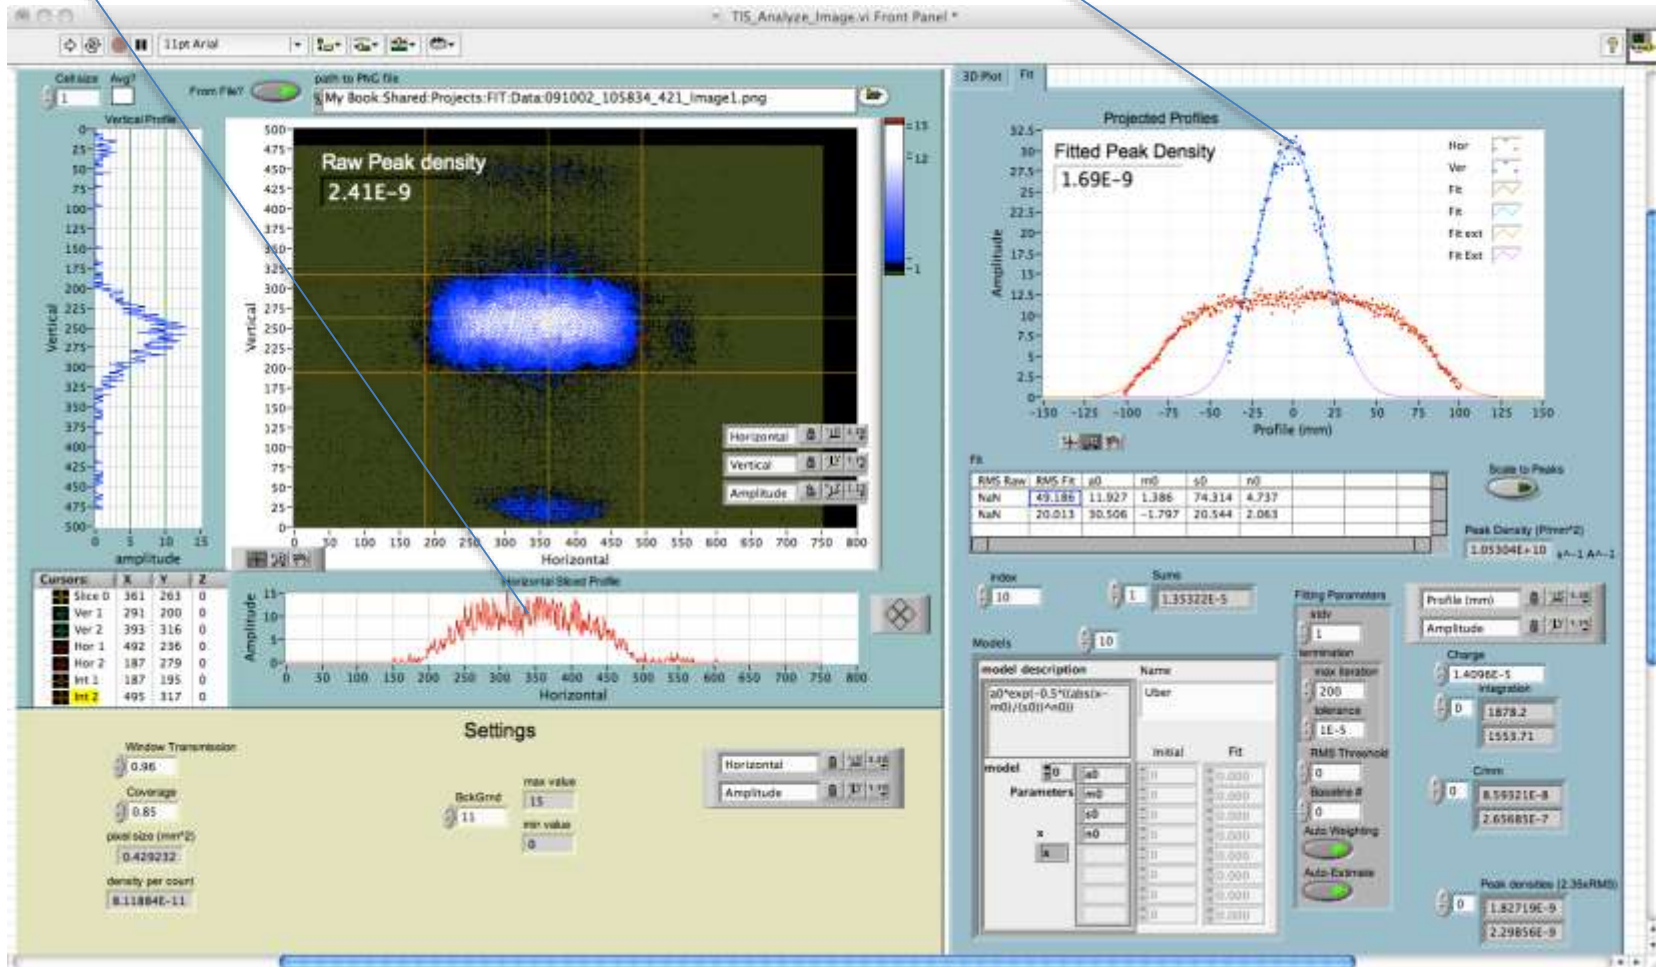
Note up and down from optical fiber

Even the projections show this

Original Data

Fiber pattern reduces total light -> higher peak density

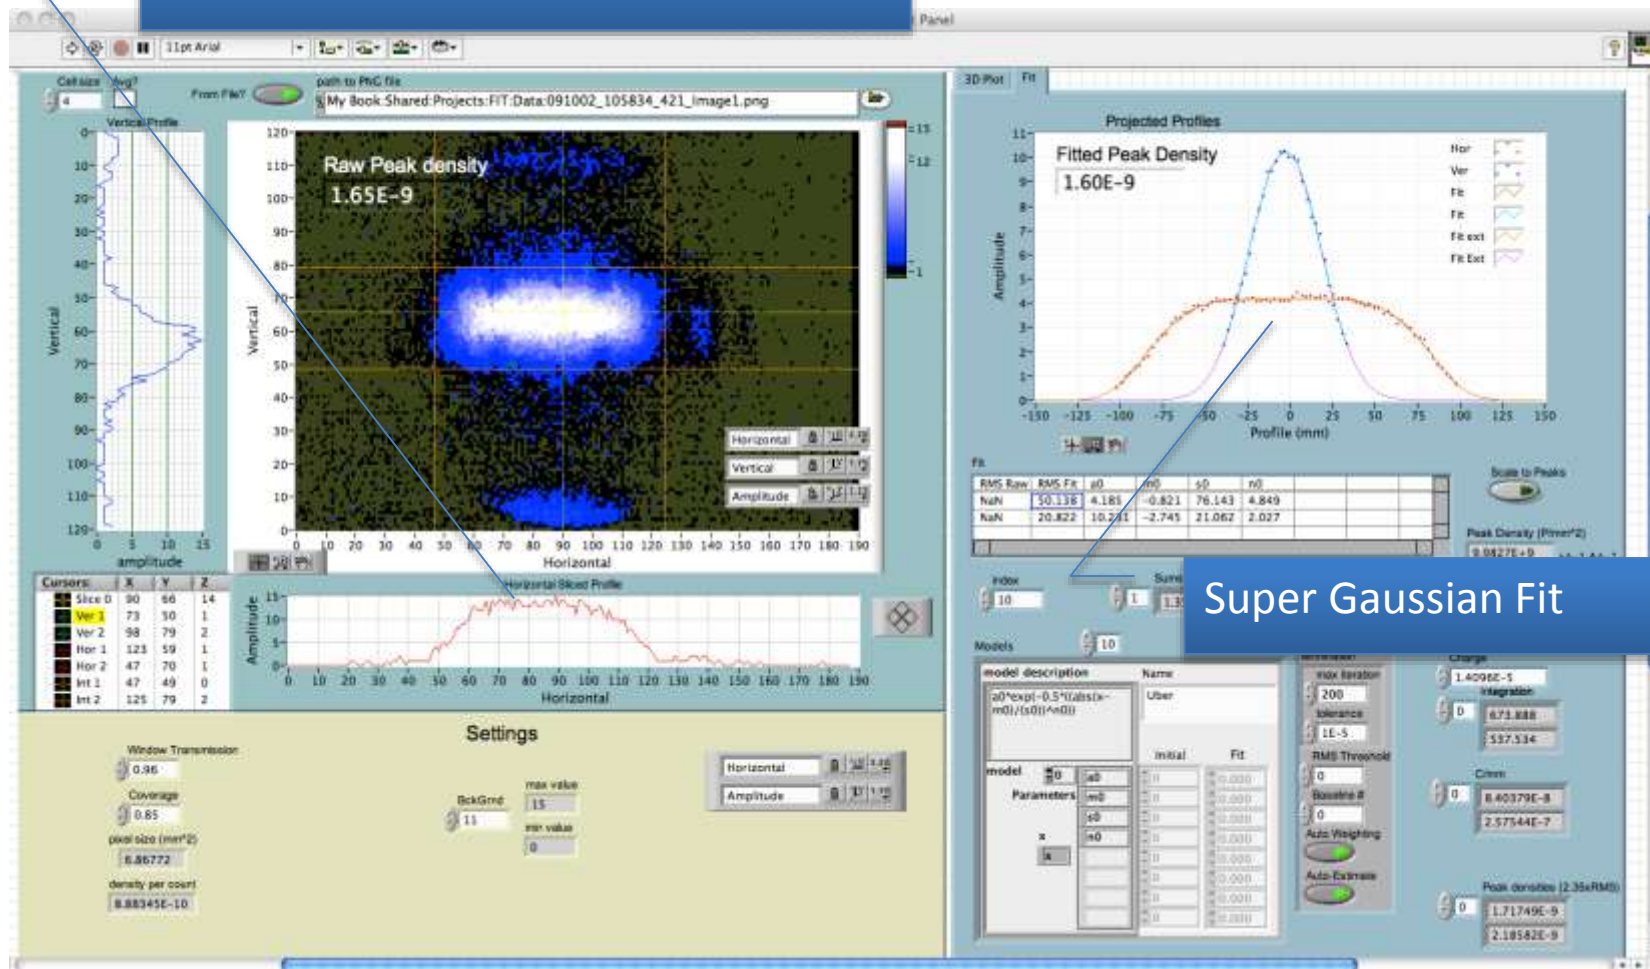
Processed with 4x4 cell

Note up and downs gone

Super Gaussian Fit

Reduce the image by using a 4x4 cell : Raw Peak density correct and fit peak density went down slightly

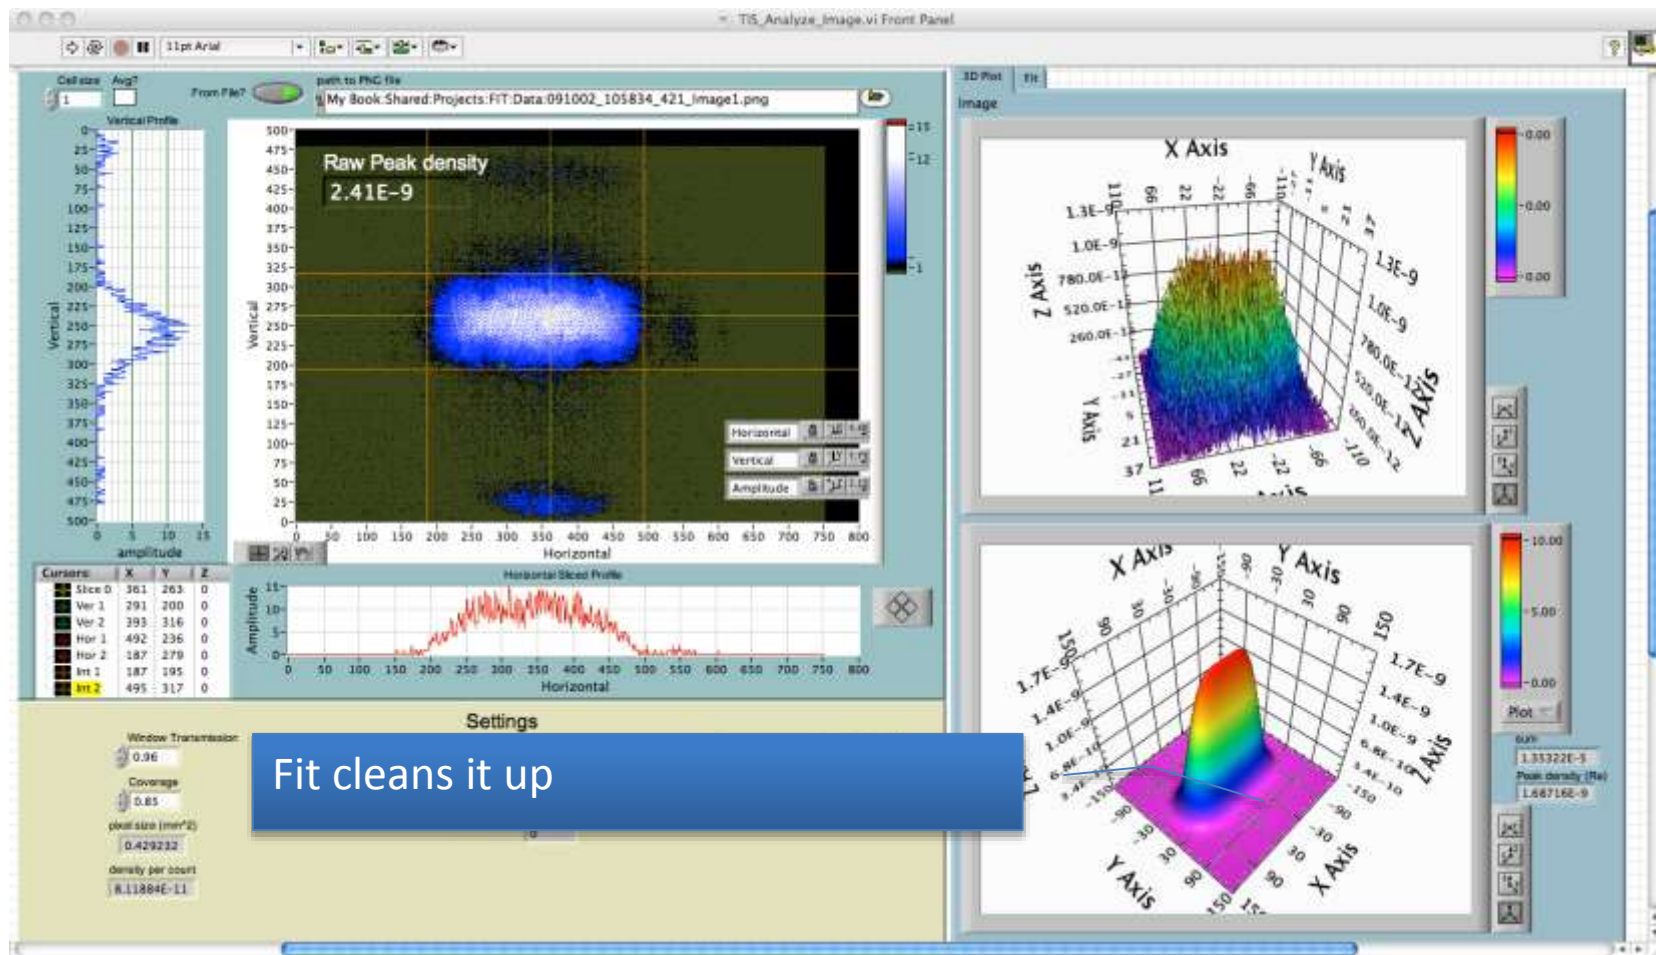
3D image before cell processing

Correction for increased background: important as the fit assumes zero background

- Cell processing cleans up raw image but 3D reconstruction cleaner (of course)
- The fitted results don't change much depending on the cell processing
- Cell Processing gives a quick and dirty Peak density without requiring fiber pattern calibration (calibration can be more accurate)

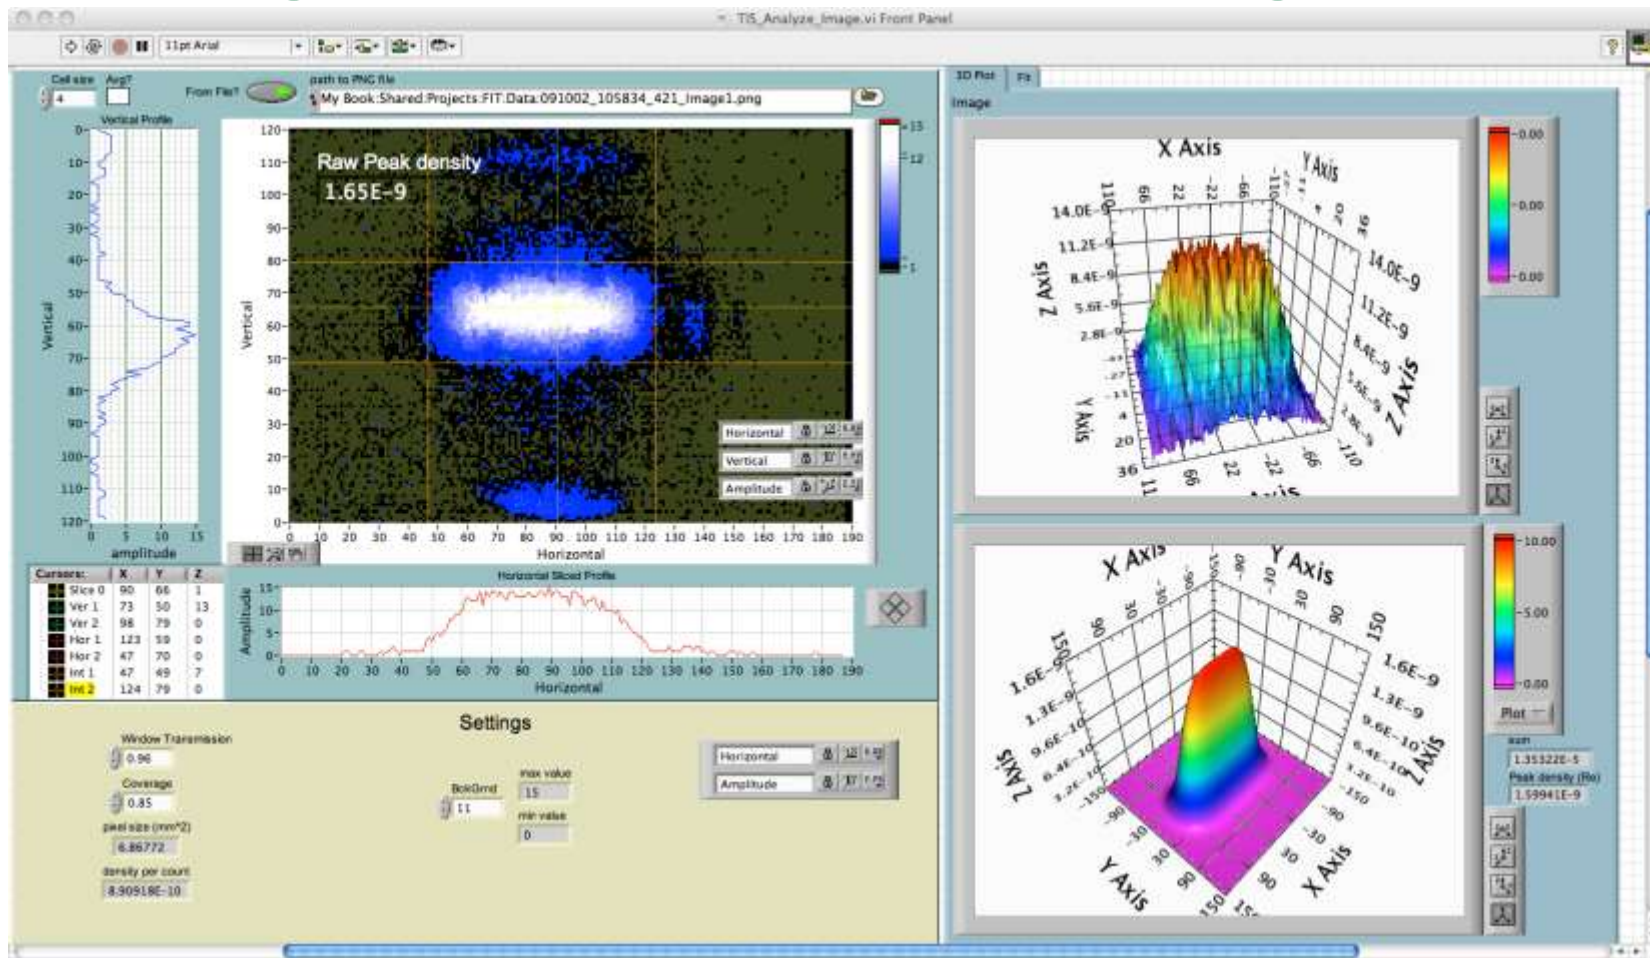
3D image after cell processing
