Operations Experience/ Remote Handling

Remote Handling Operations at SNS

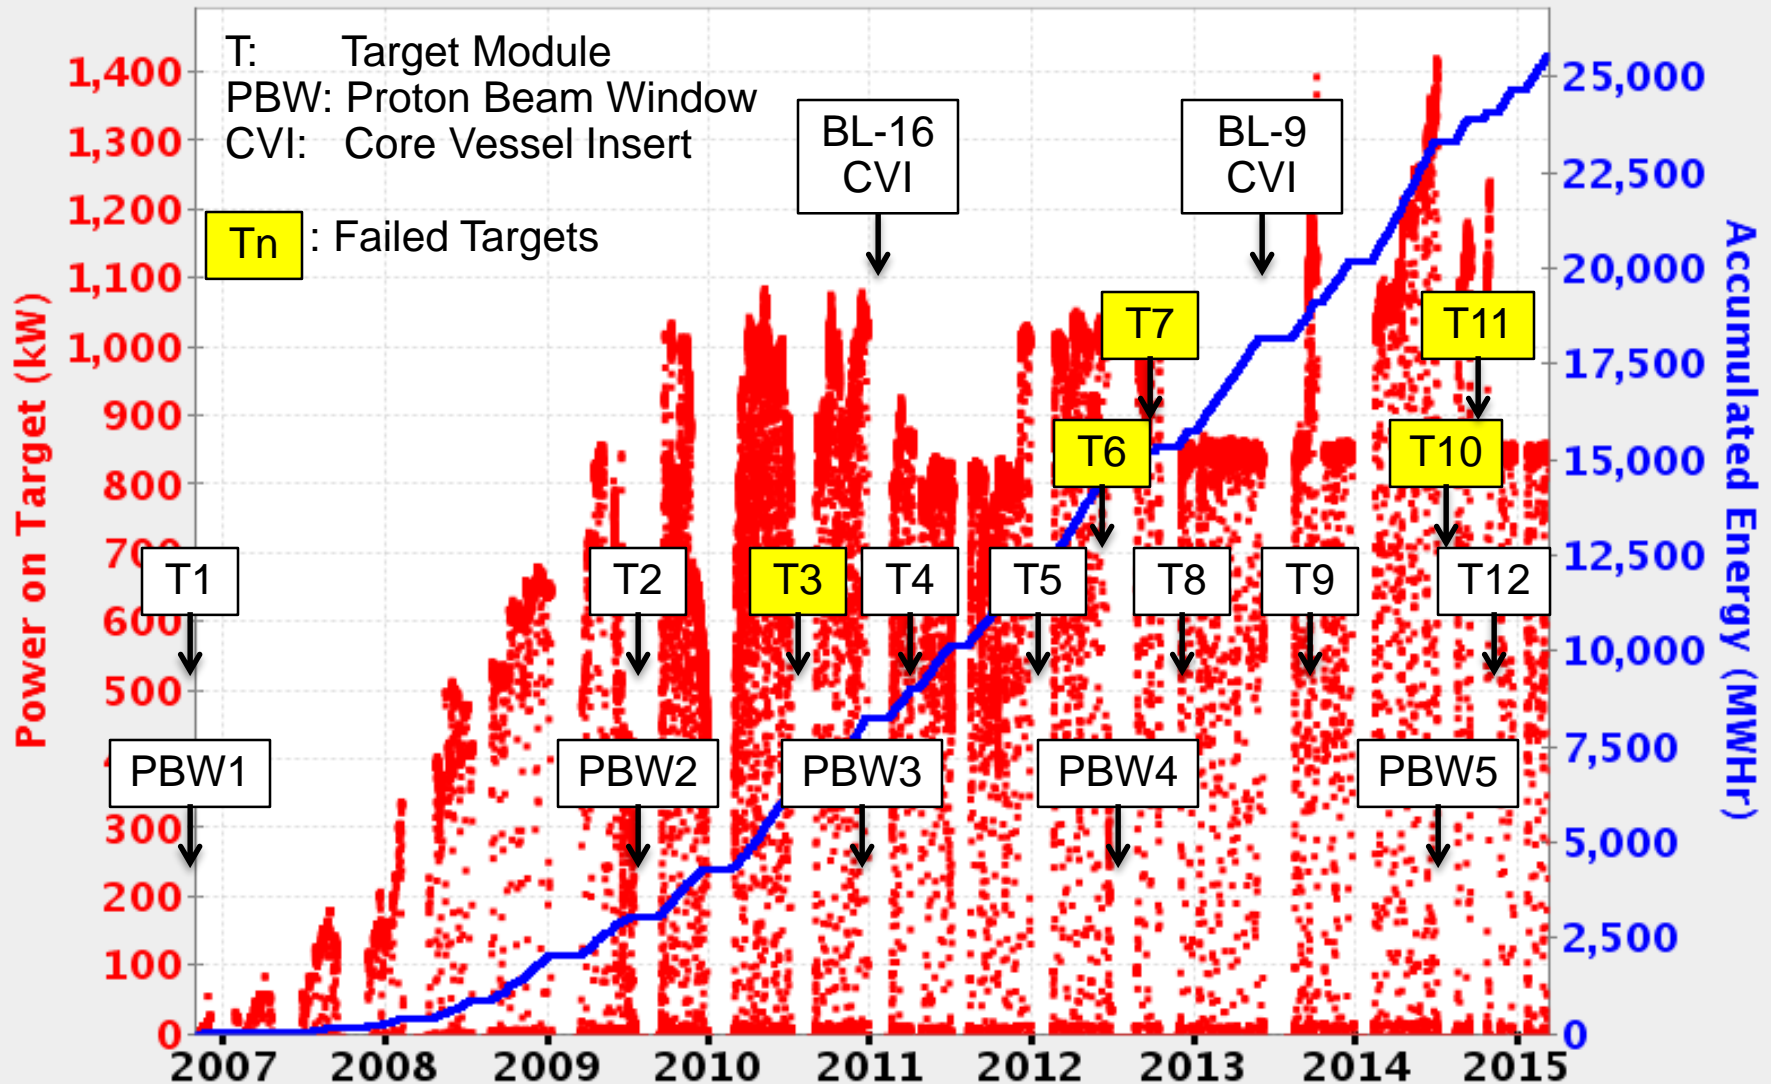
Power and Energy on Target
History: from 01-Nov-2006 to 13-Mar-2015

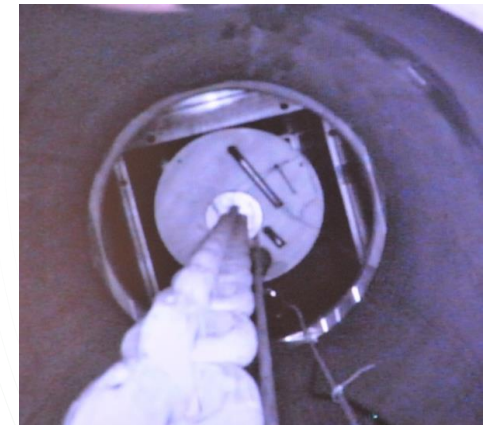
PBW Lead-shielded Cask in Position

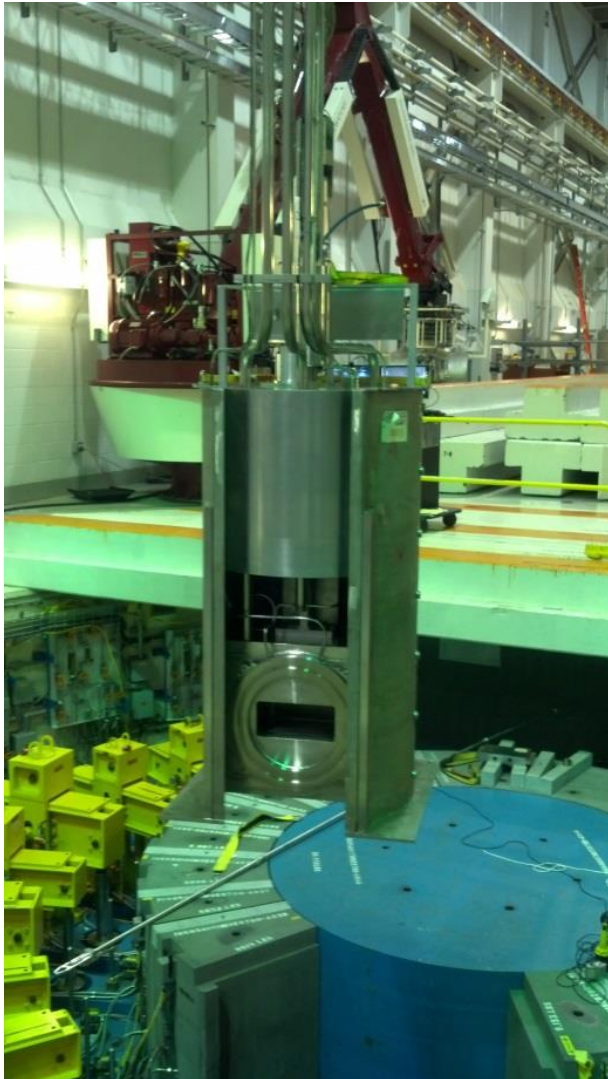
PBW Being Pulled into Cask

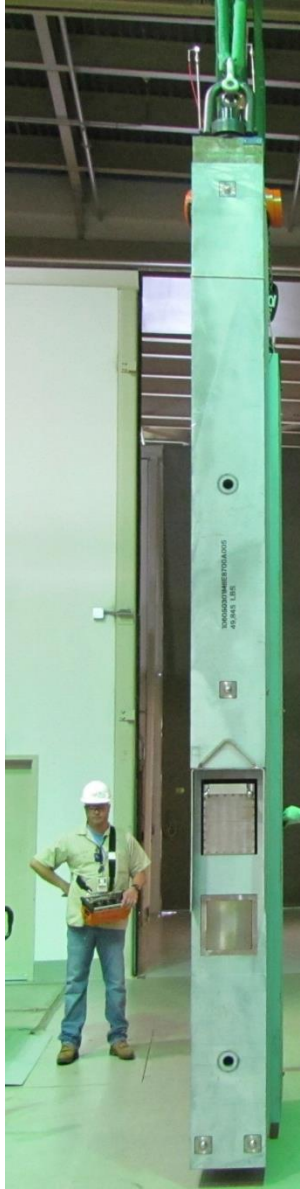
BL 9 Shutter

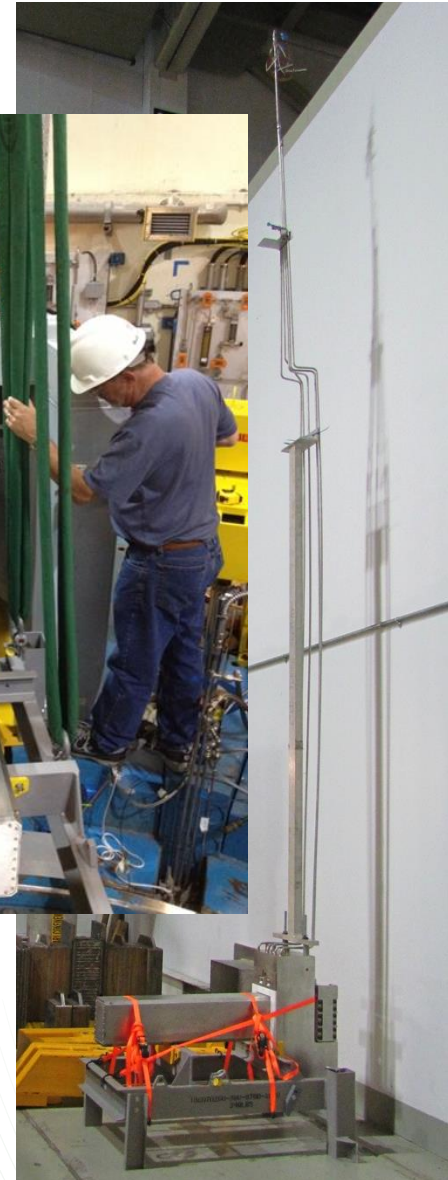
BL 9 CVI

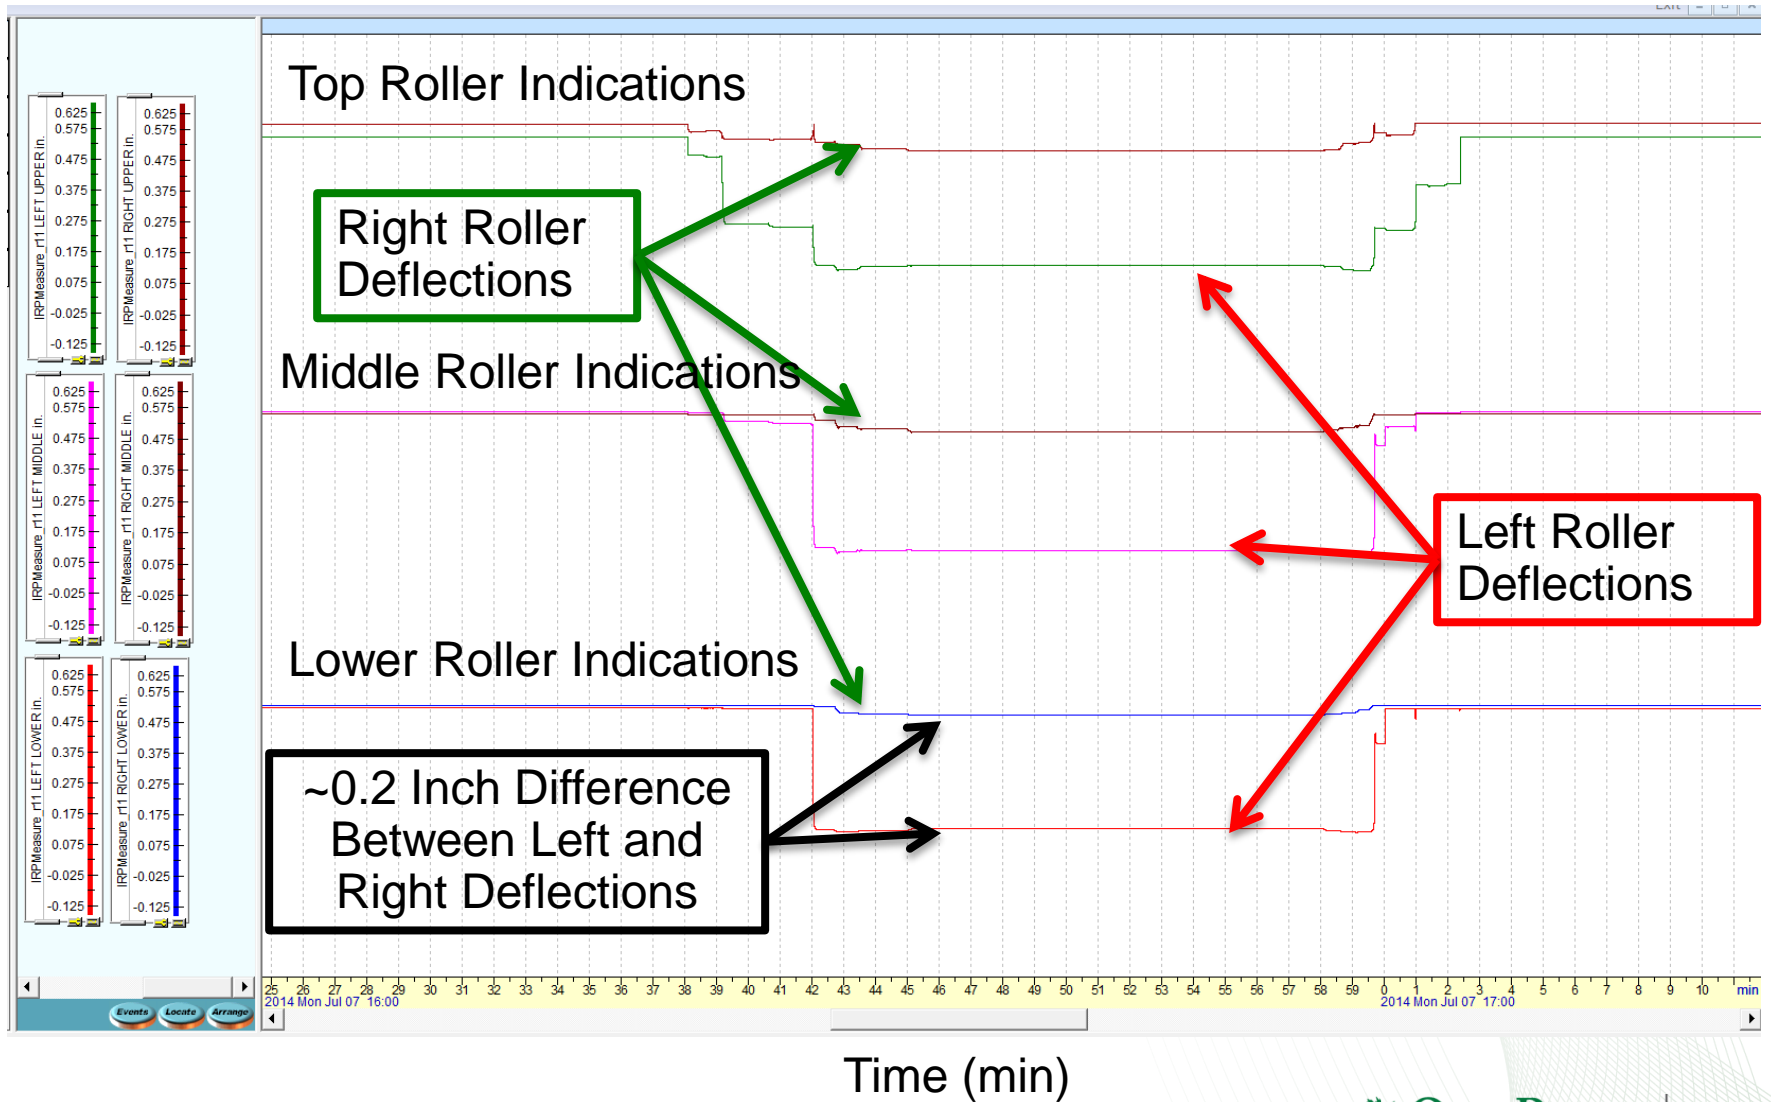
IRP Inspection Tool Roller Deflection During Insertion & Extraction

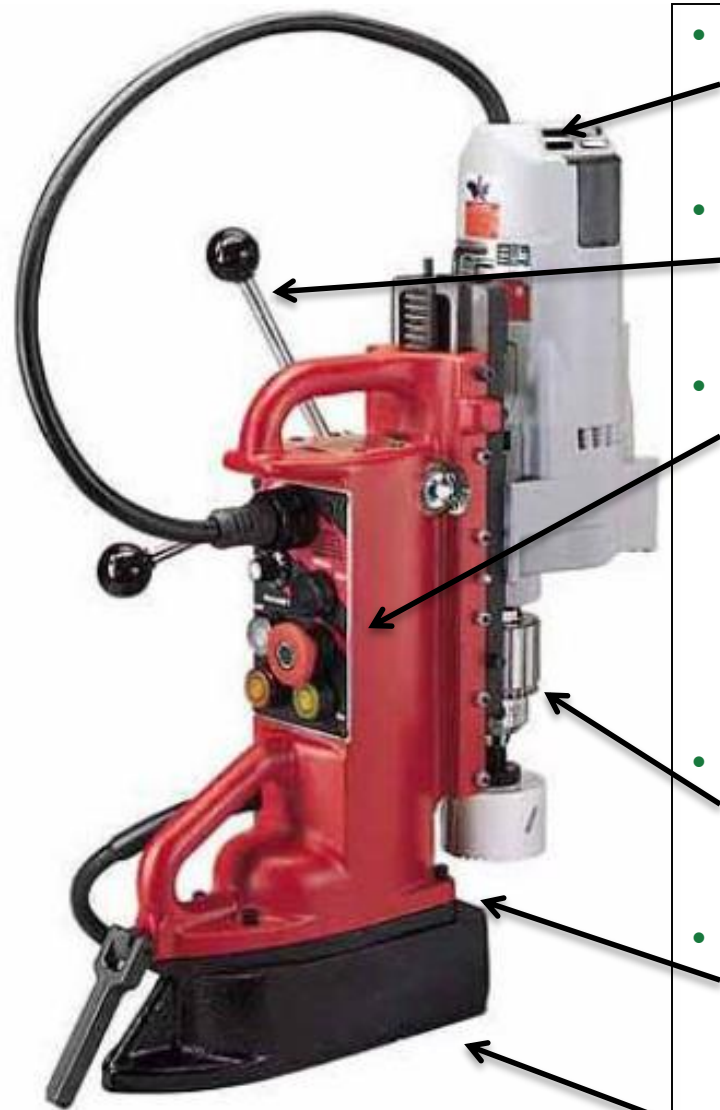
- Incorporate modifications to enable drill assembly to be handled remotely
- Remove manual handle & incorporate a motor-driven feed and retract system
- Remote out the electrical connections for:
 - Motor on/off
 - Motor feed/retract
 - Motor speed?
 - Motor travel?
- Modify chuck to enable remote replacement of cutters
- Mount drill assembly to some sort of base plate to enable clamping/alignment/etc.
- Remove Magnet Base

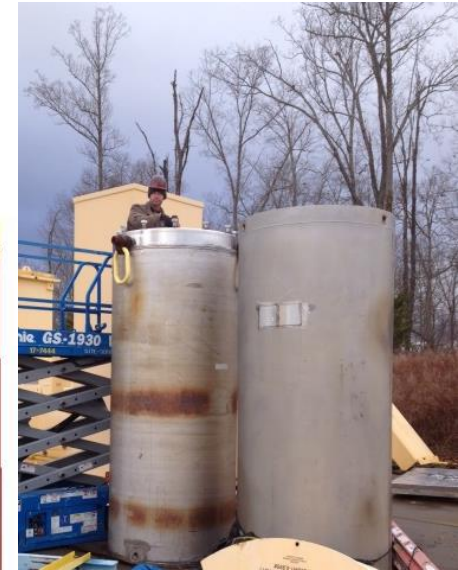
Recent Inspection of the
Target Holding Containers
at the Hot Pad

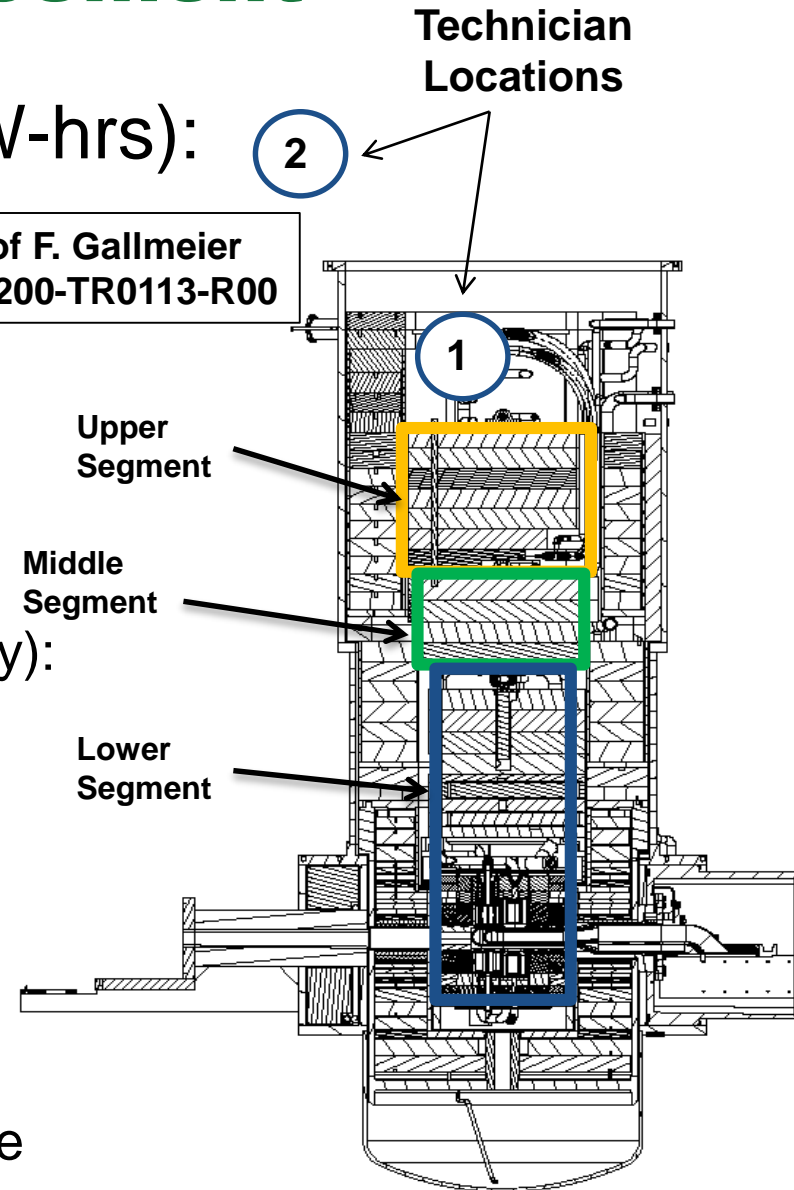
- Calculated dose rates (30 GW-hrs):

- No segments removed:

- Location 1: 9 mR/hr
- Location 2: 0.14 mR/hr

- Upper & Middle segments removed:

- Location 1: 2,135 mR/hr
- Location 2: 3.2 mR/hr

- Lower segment removed (empty cavity):

- Location 1: 49,258 mR/hr
- Location 2: 200 mR/hr
