Remote Handling

Mike Dayton

NFDD Mechanical Engineer

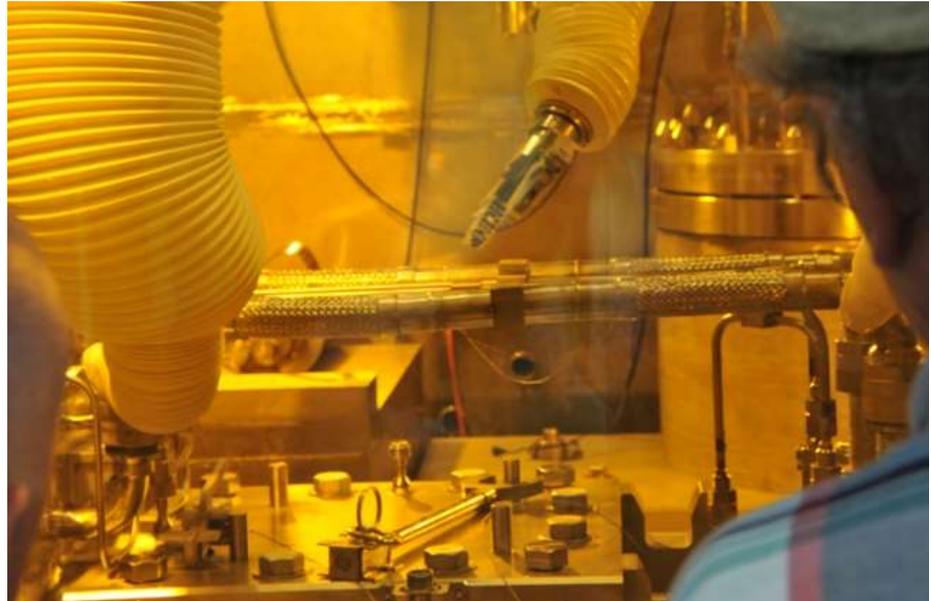
**Coolant Loop Jumper
Removal
using the servo-
manipulator and
master-slave manipulators
simultaneously**

- Leak detection activities were impacted as only three of the five mercury process loop connections are accessible with the Target inserted. Retraction of the Target to access the remaining two connections precluded testing due to the open process loop.
- Test fixtures and procedures were developed real-time to enable the leak to be identified. It was ultimately fixed by simply re-torquing a Hiltap fitting.

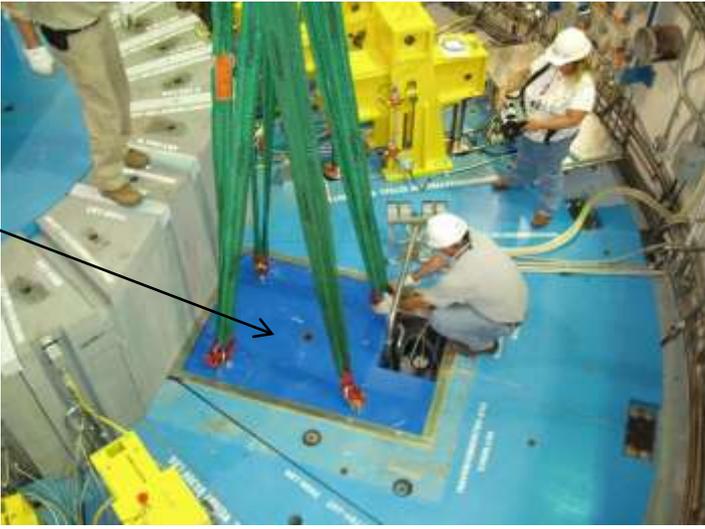
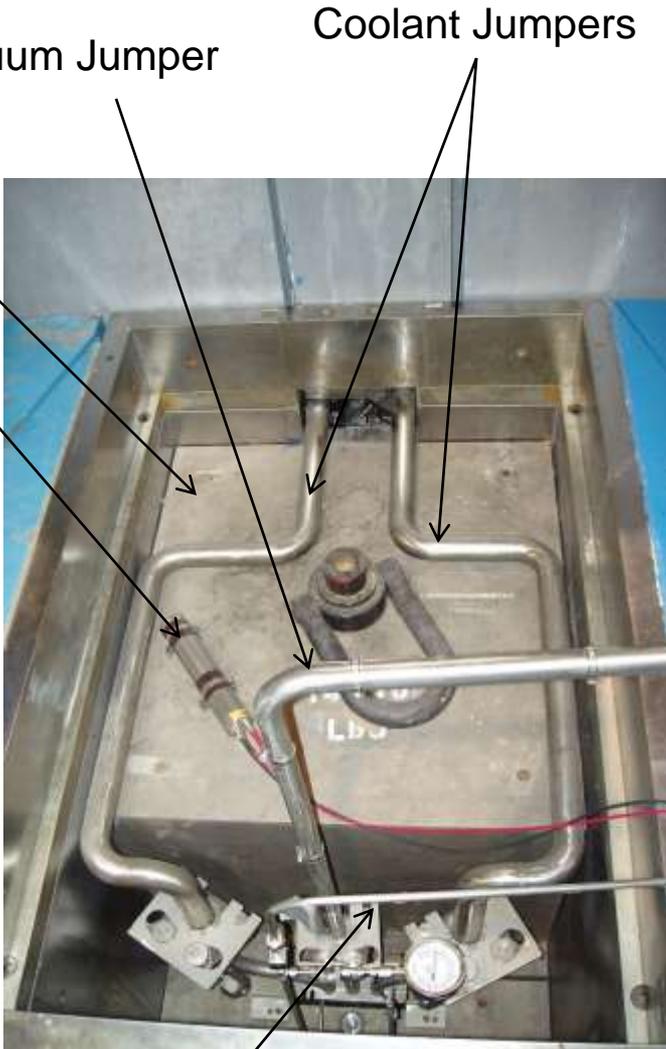
Shielding Removal to Expose Jumper Cavity

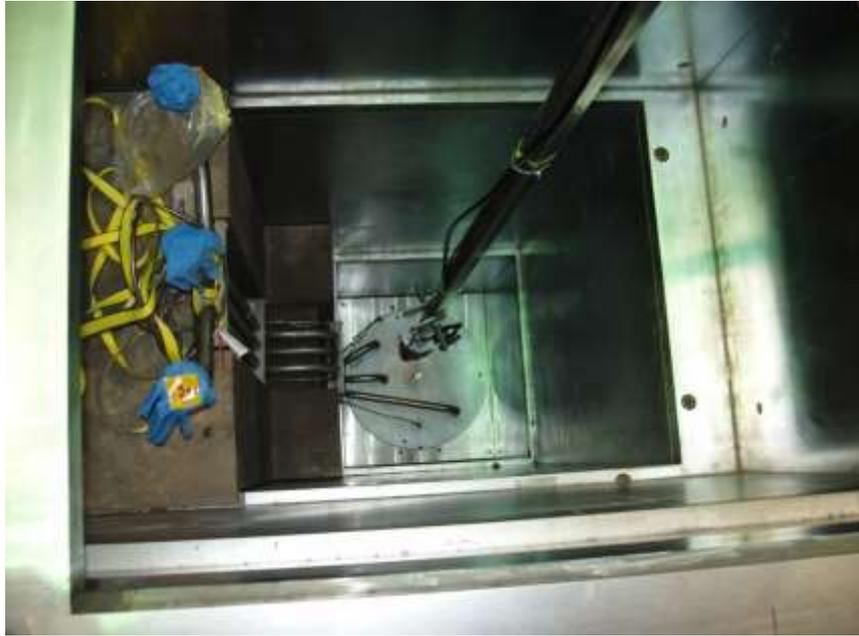
**Long-Handled Tubing Cutter
Lowered into PBW Cavity**

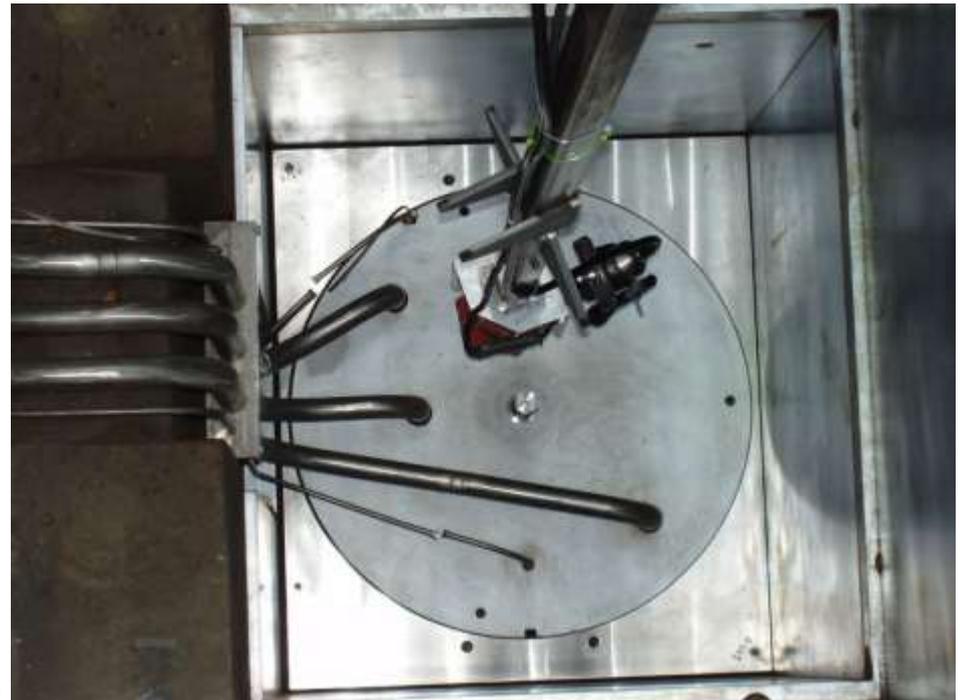
**Severing of Helium Line
and Air Sampling Tube Completed**

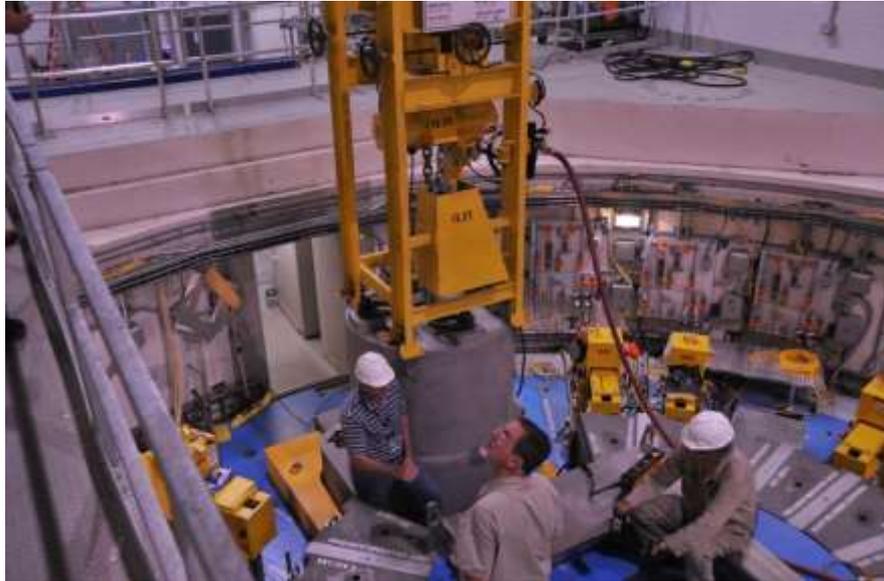
PBW Cask In Position

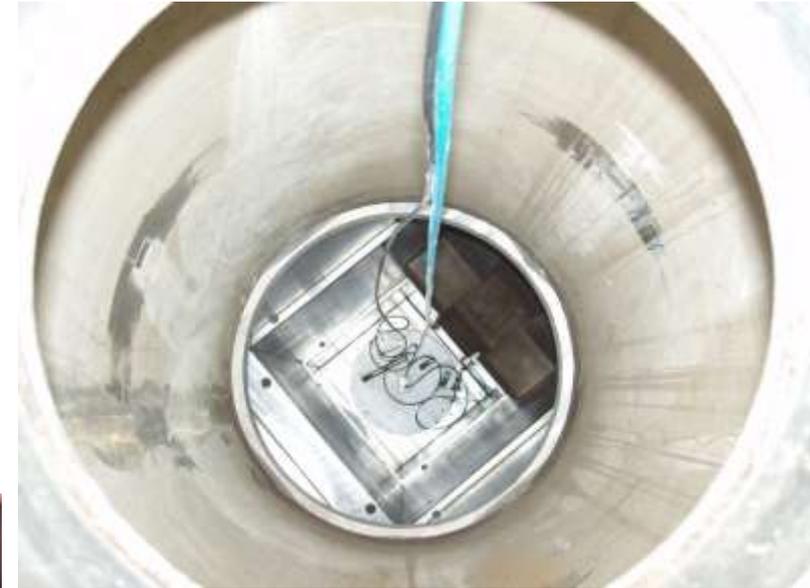
Vacuum Lines Installed to Retract Seal During Removal

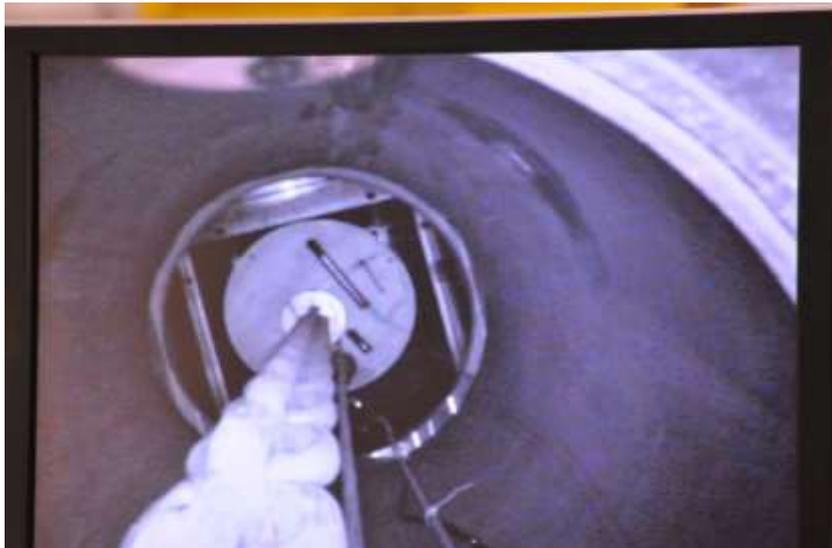
Video Image of PBW Being Pulled into Cask

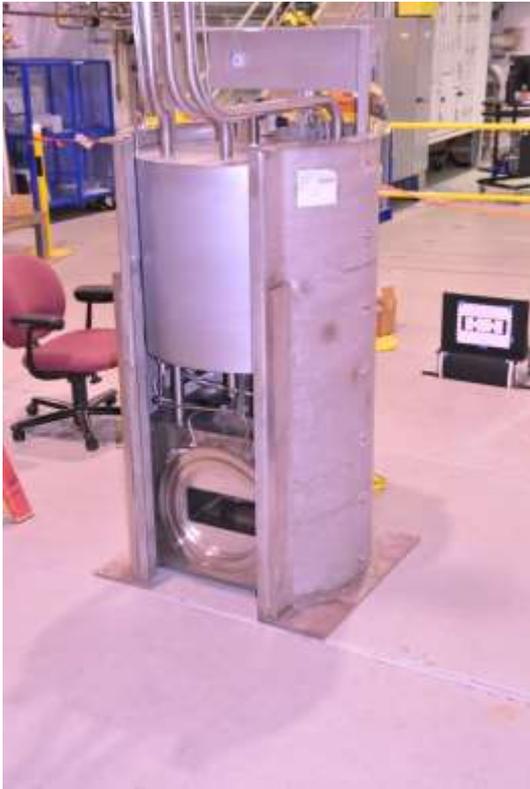
New PBW Ready for Installation

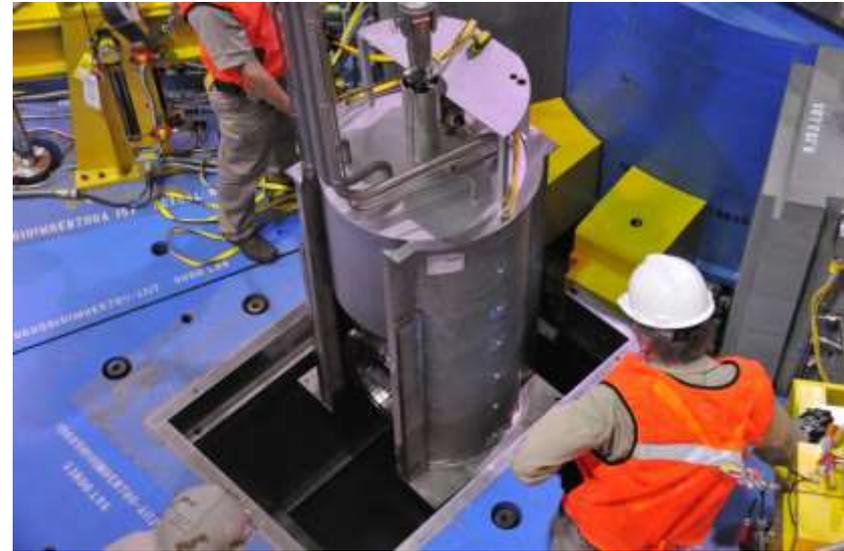
New PBW Being Lowered into Position

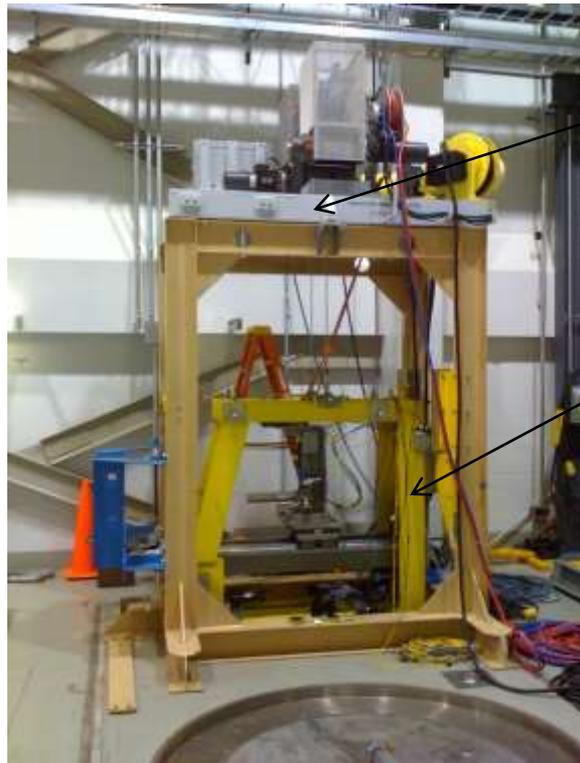
CVI Robot Lift Plate

- The location of the CVI within the Core Vessel in addition to the high activation levels of the removed CVI plug have necessitated development of a “robot” to perform the replacement operation

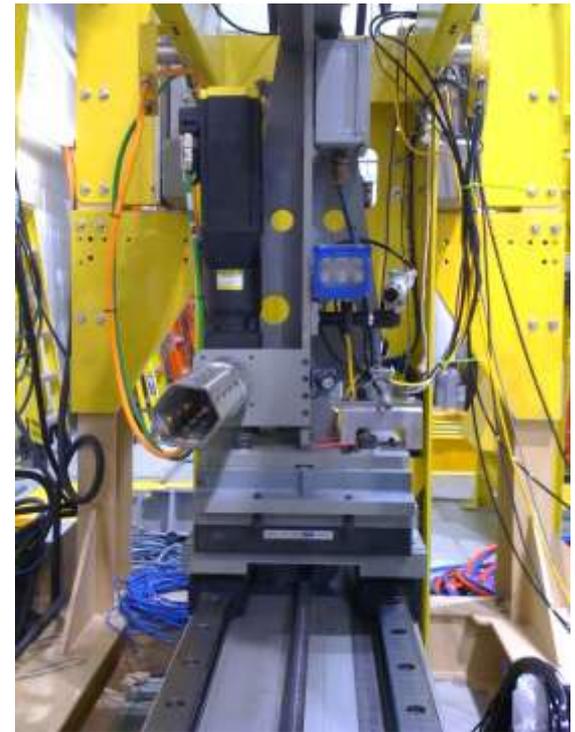
CVI Robot Tower

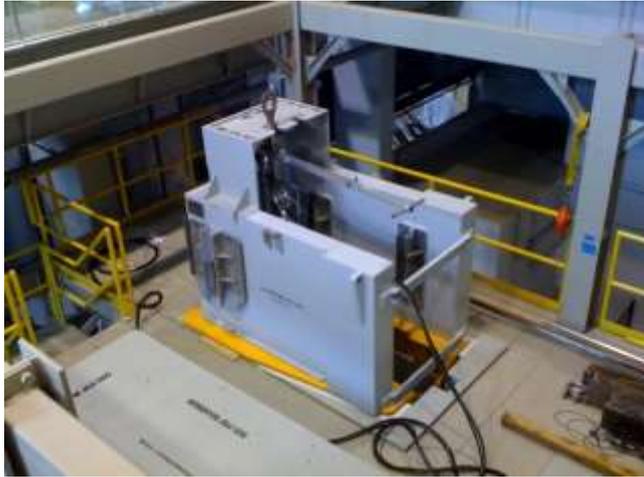
CVI lead-filled U-Block tool in position for testing

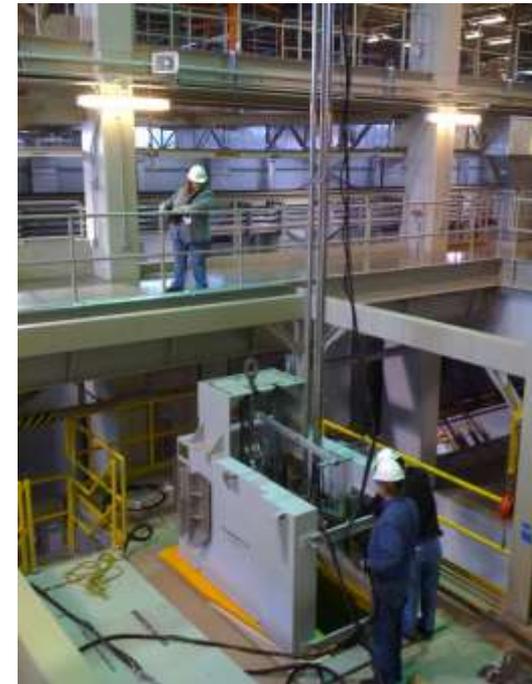
Long-handled tool testing

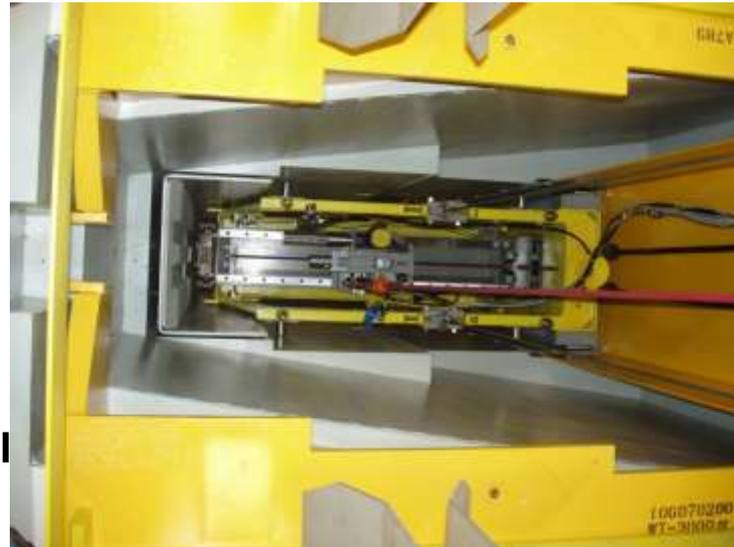
CVI Robot lowered into test stand to for functional testing
