# RFQ Performance and Status of Spare RFQ

Mark Champion, Group Leader  
Electrical and RF Systems

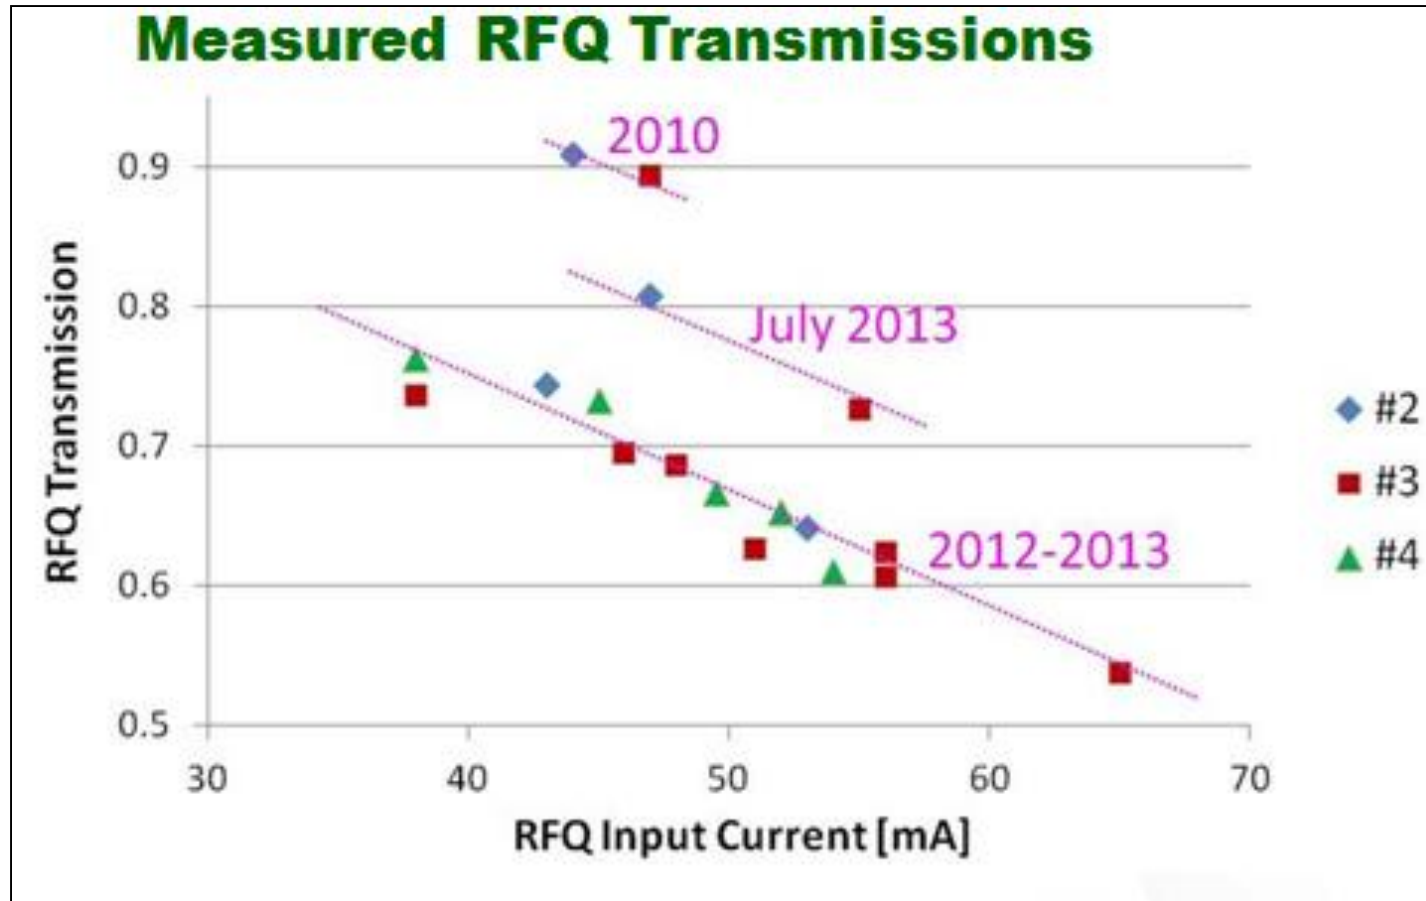
# RFQ Retune in June 2013 improved transmission by ~15%

- Oct 2012: Vacuum degradation during power outage. Impact uncertain.
- Jun 2013: RFQ retuned; transmission increased ~15%.  
Replaced B coupler due to flow restriction in the loop cooling circuit.
- Oct 2013: Replaced B coupler due to heating.
- Jan 2014: Replaced A coupler due to heating.  
The RFQ performance was adequate for sustained 1.3-1.4 MW beam power on target through Jun 2014.
- Jul 2014: RFQ accidentally vented and exposed to water vapor.
- Aug 2014: RFQ accidentally vented and exposed to water vapor *again*.  
➔ RFQ performance degraded as result of these events.
- Oct 2014: Removed and inspected B coupler.  
No damage observed ➔ reinstalled coupler.

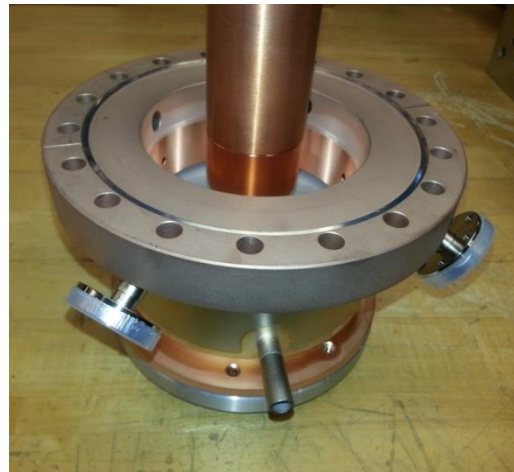
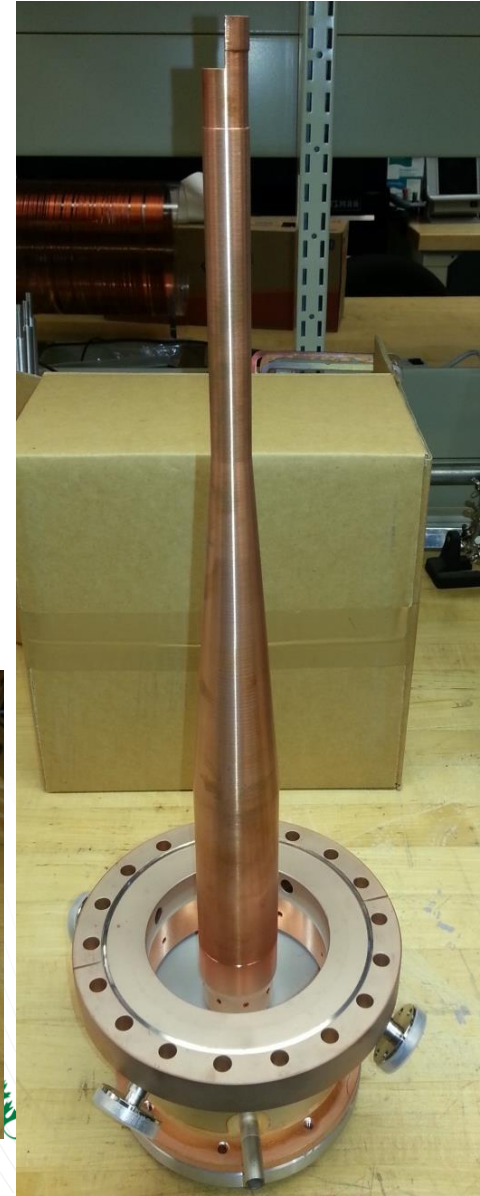
# Fabrication of two additional RFQ Couplers

- The coupler inner conductor assembly has been built as a single structure at the manufacturer.
- Two coupler inner conductors have been built by joining the antennas onto the ceramic windows
  - Two ceramic windows manufactured as prototypes have been available (on the shelf at SNS)
  - The antennas for the coupling loop have been separately manufactured
  - Joining Copper parts has been performed successfully for the two assemblies
  - Vacuum leak check has been performed successfully
  - High power RF conditioning is to be performed

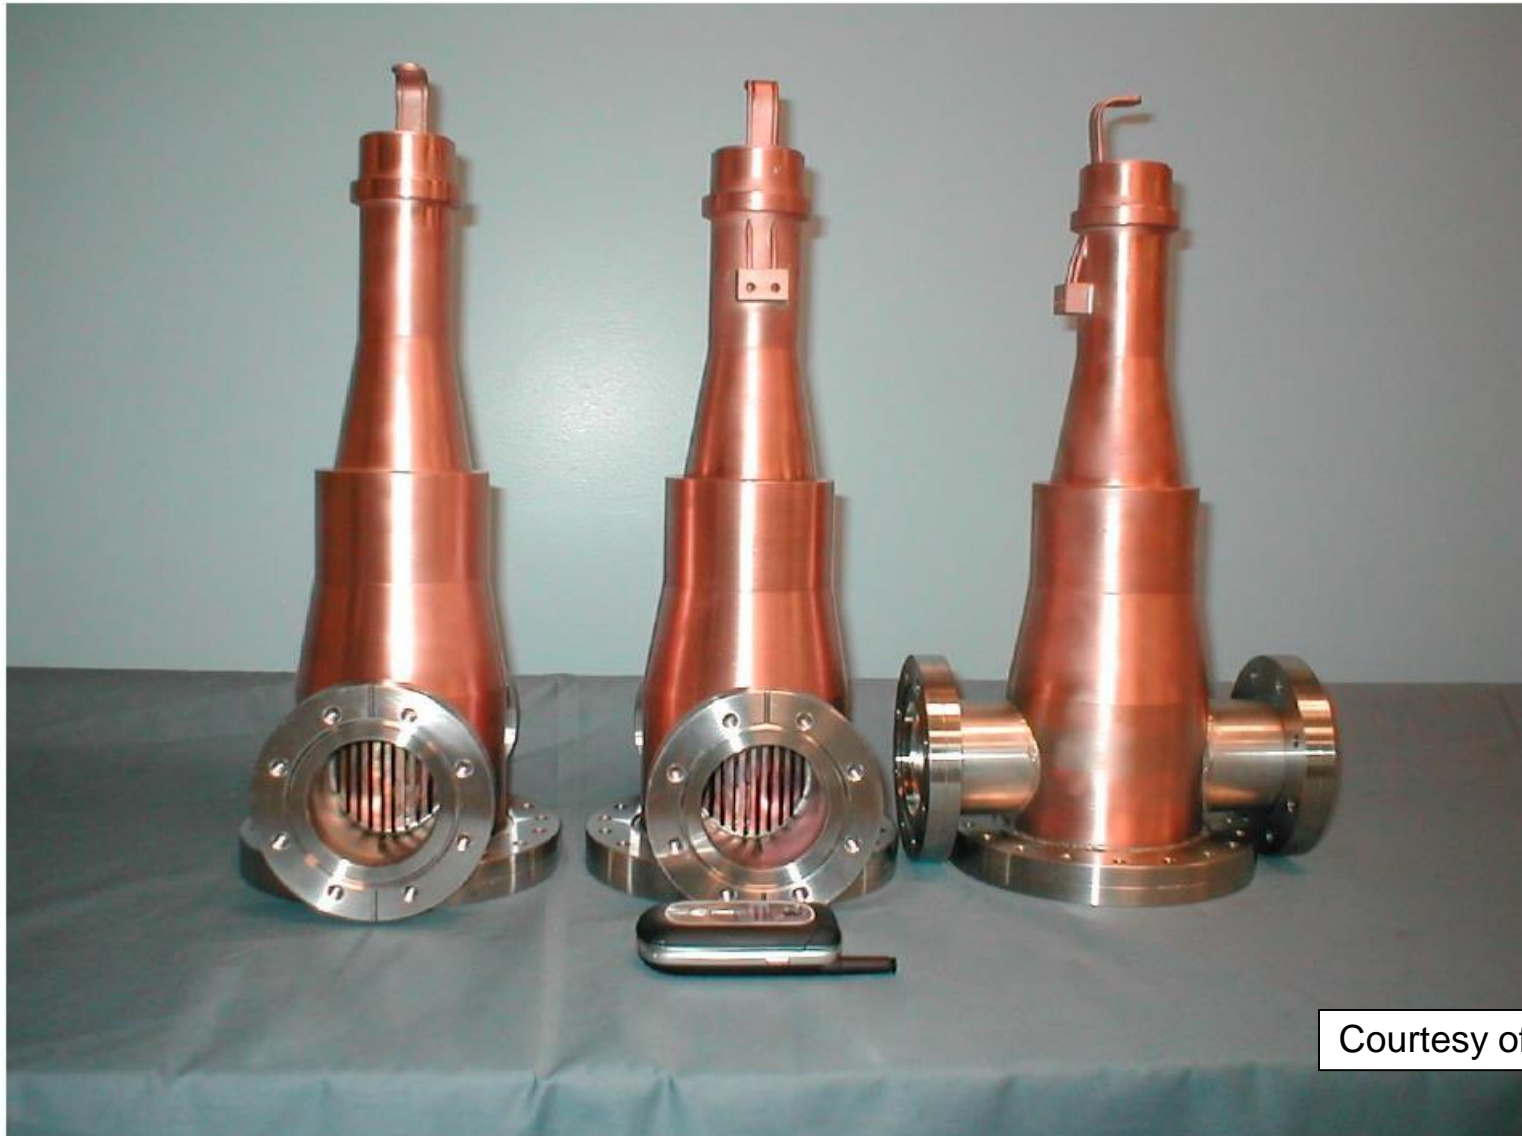
# RFQ Coupler Outer Conductors (on the shelf)

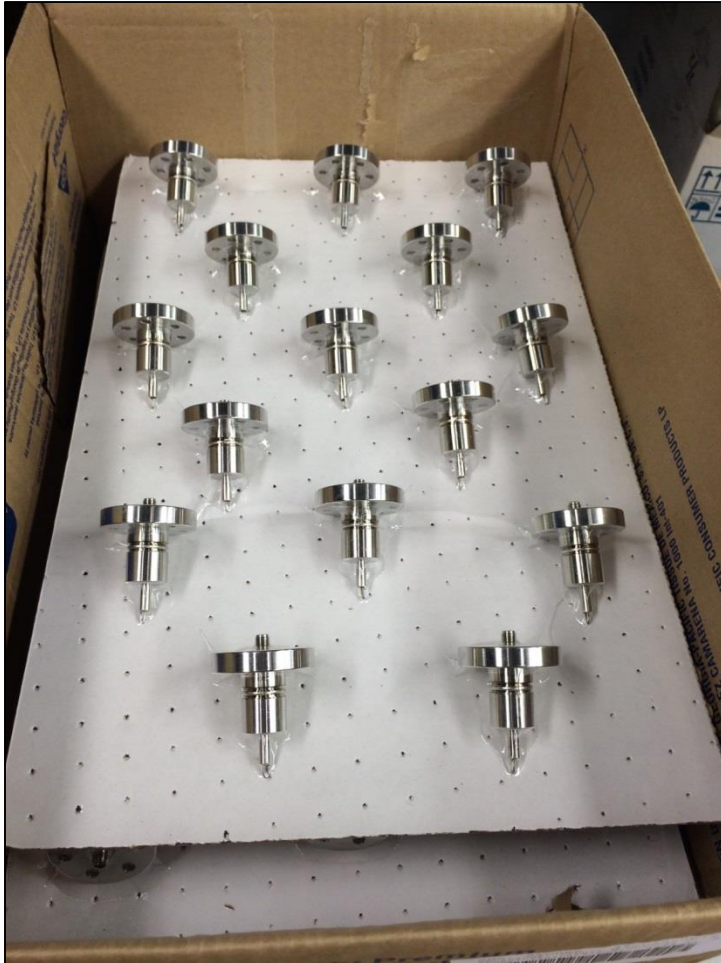
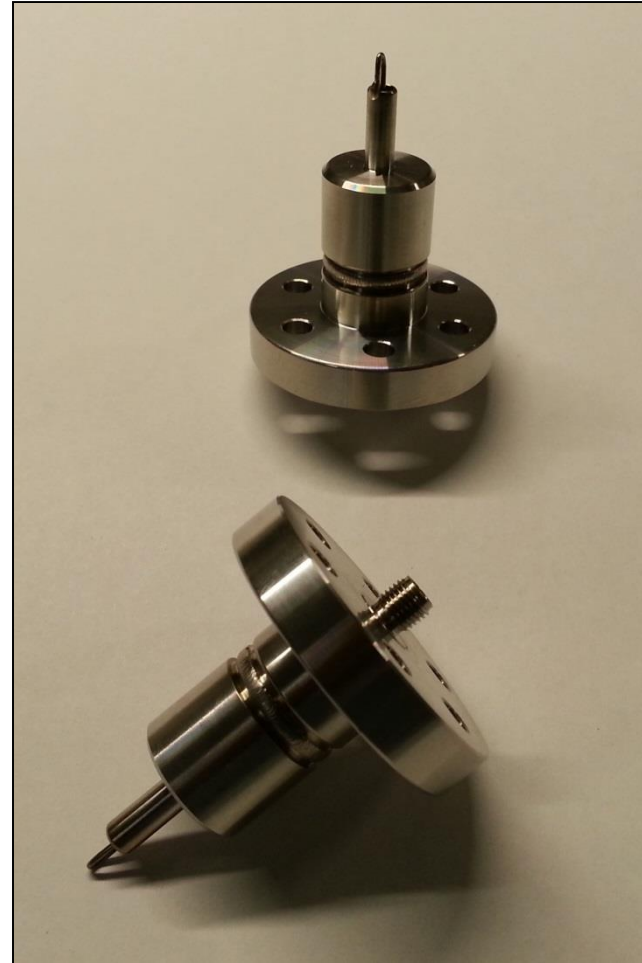
# New Field Probes have been developed and procured for RFQ and MEBT rebuncher cavities

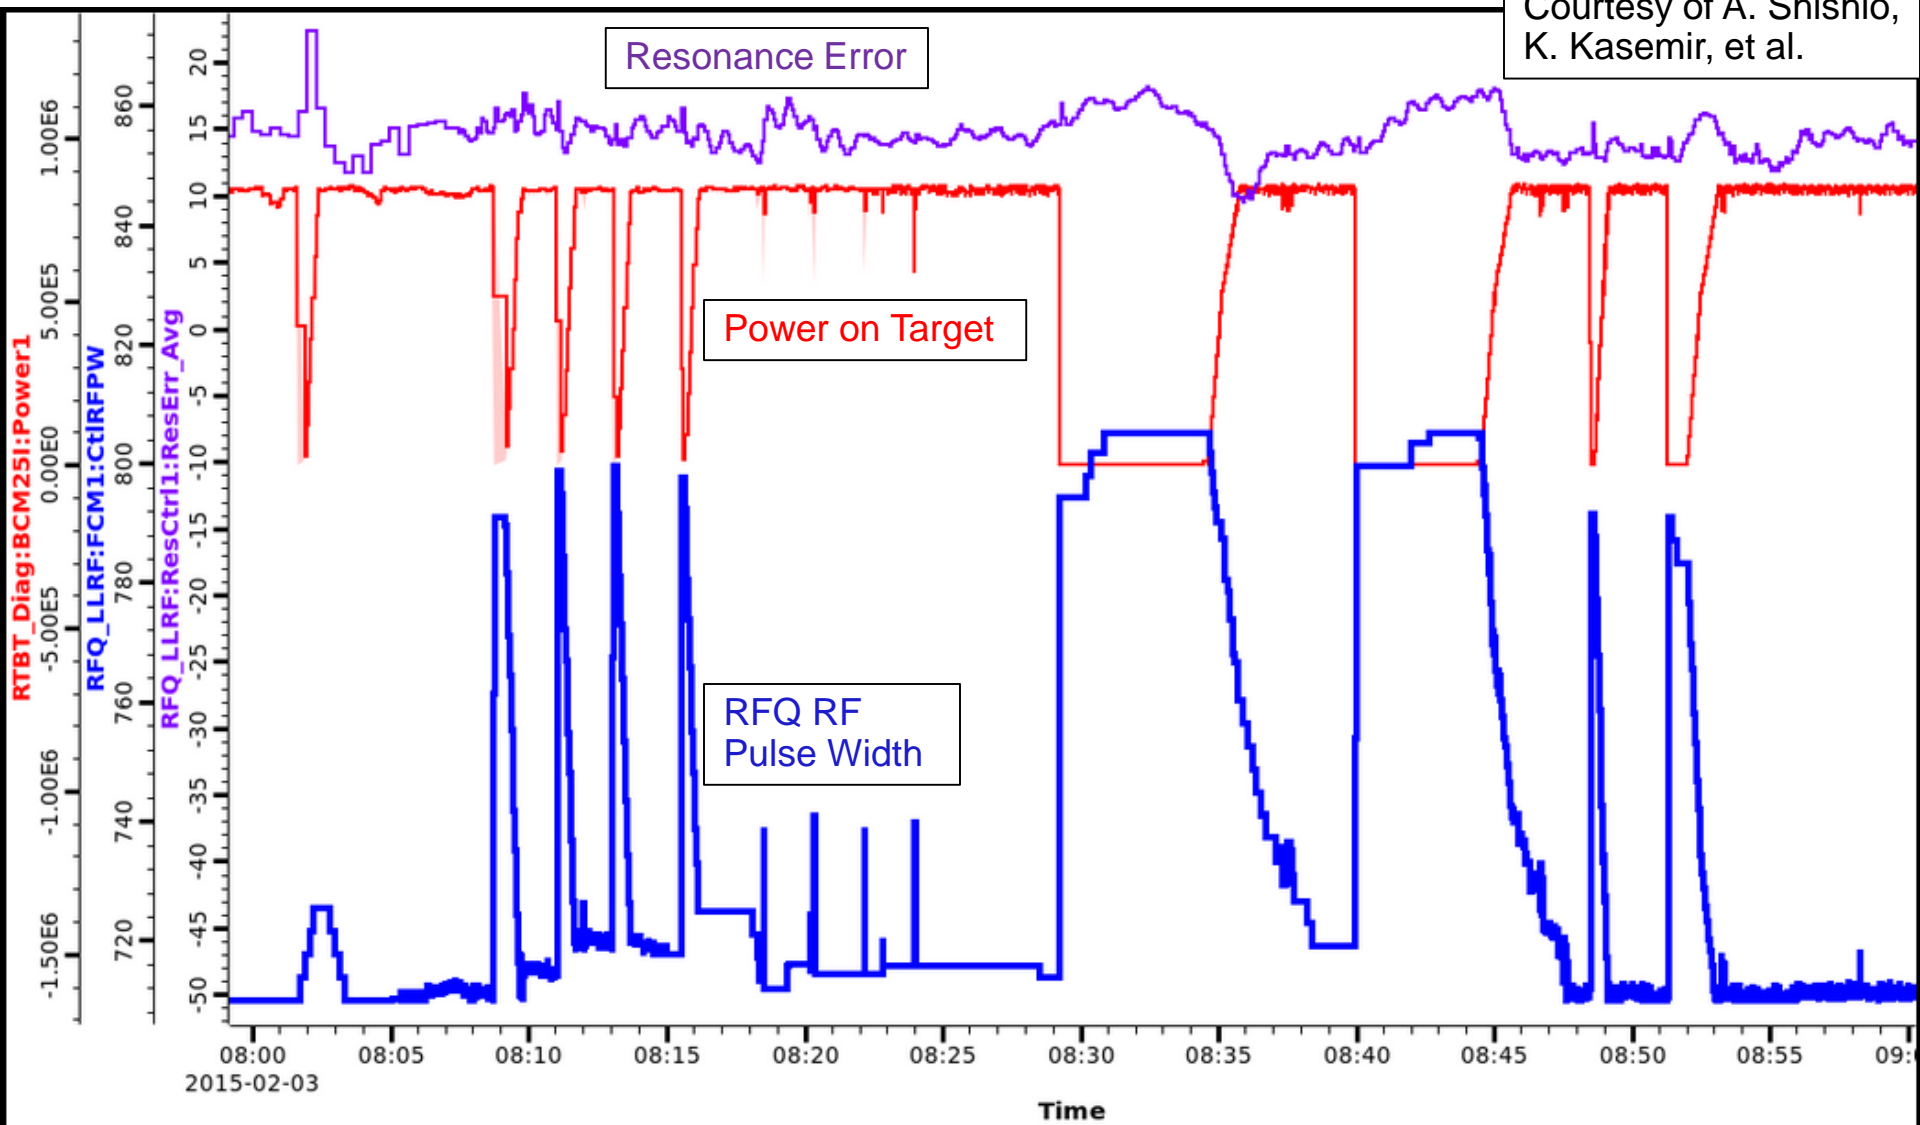
# RFQ Keeper modulates RF pulse width to maintain steady heat load during beam on/off transitions

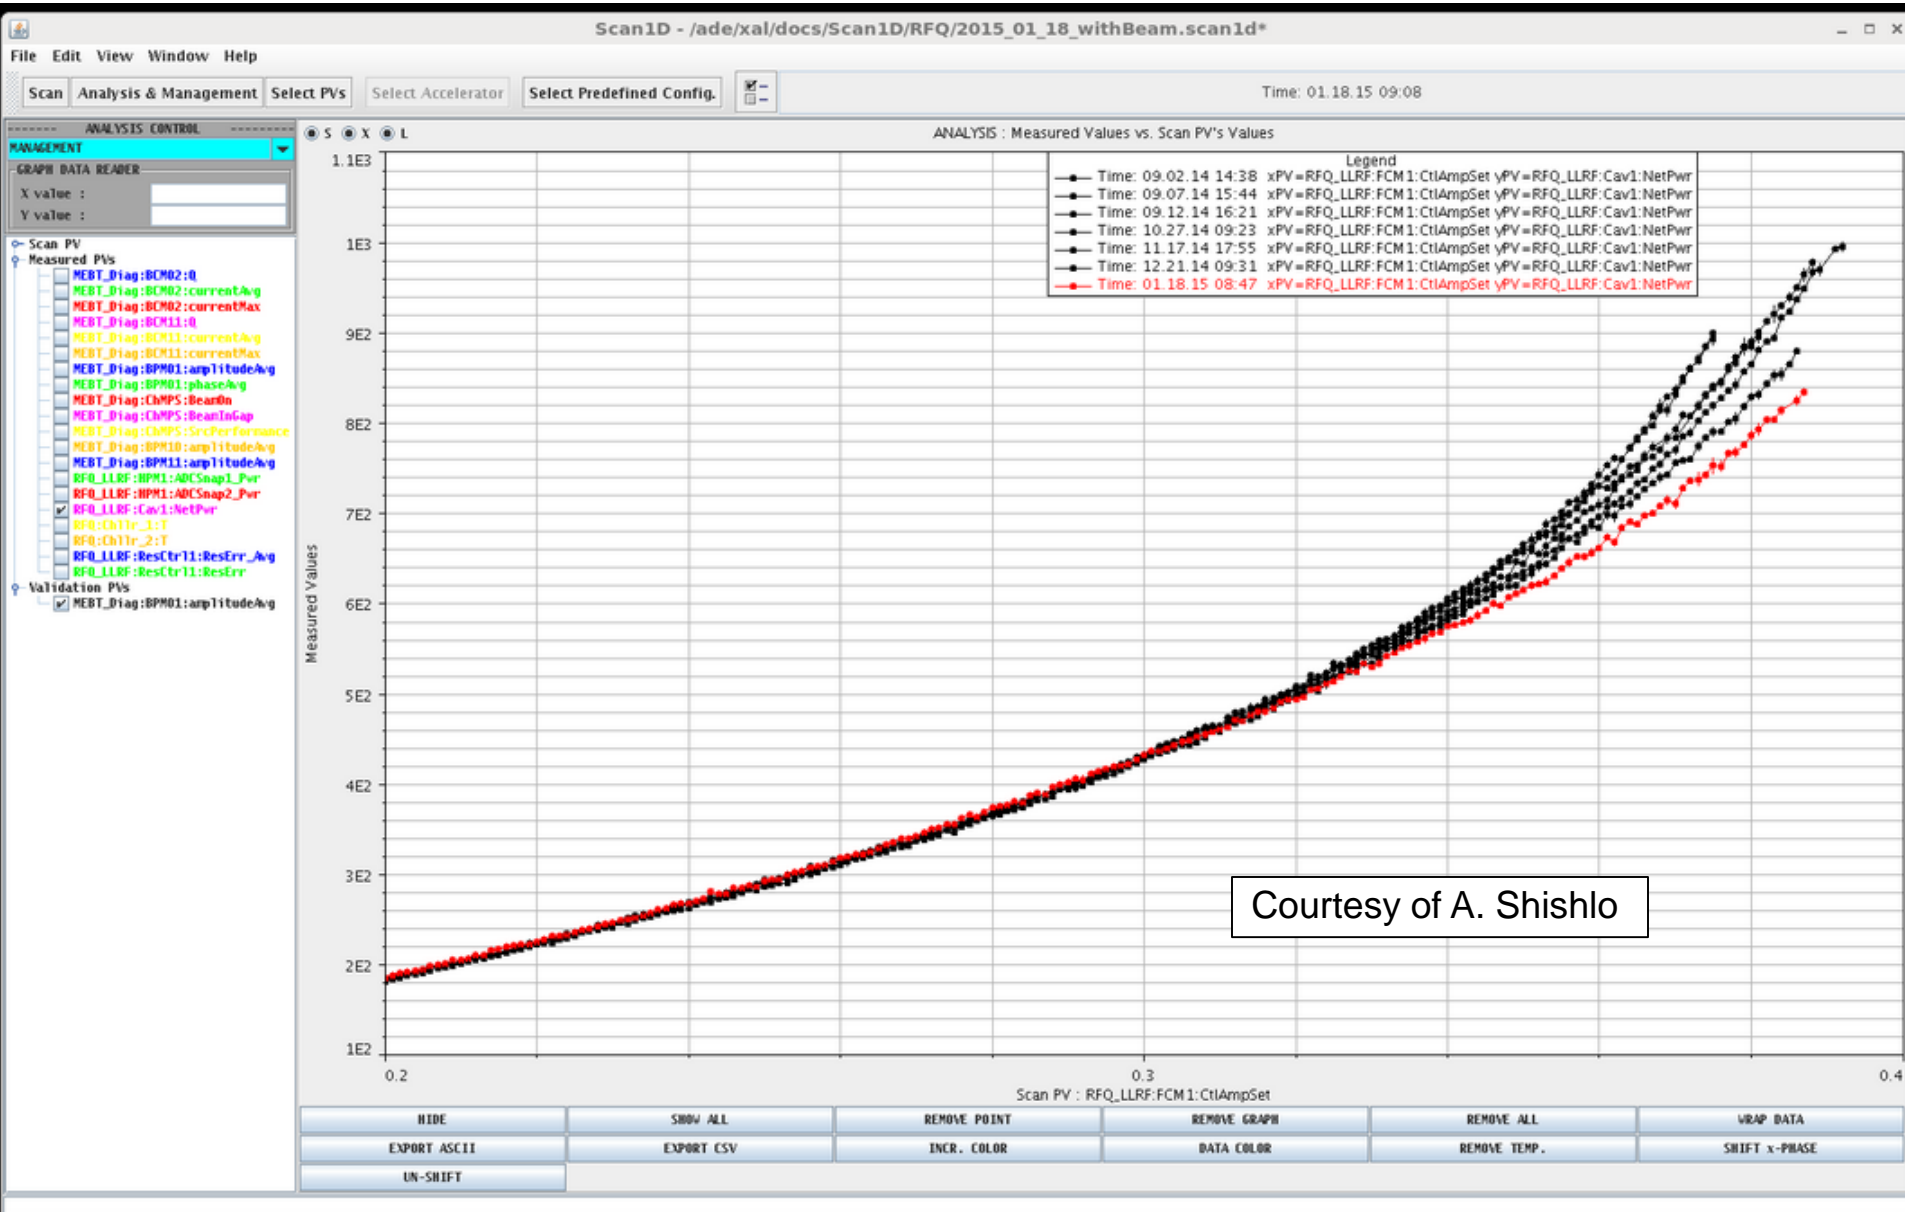
# RF Net Power vs. RFQ amplitude setpoint improving since last summer

Power vs RFQ Amp. The red is the latest data. It shows a big improvement.

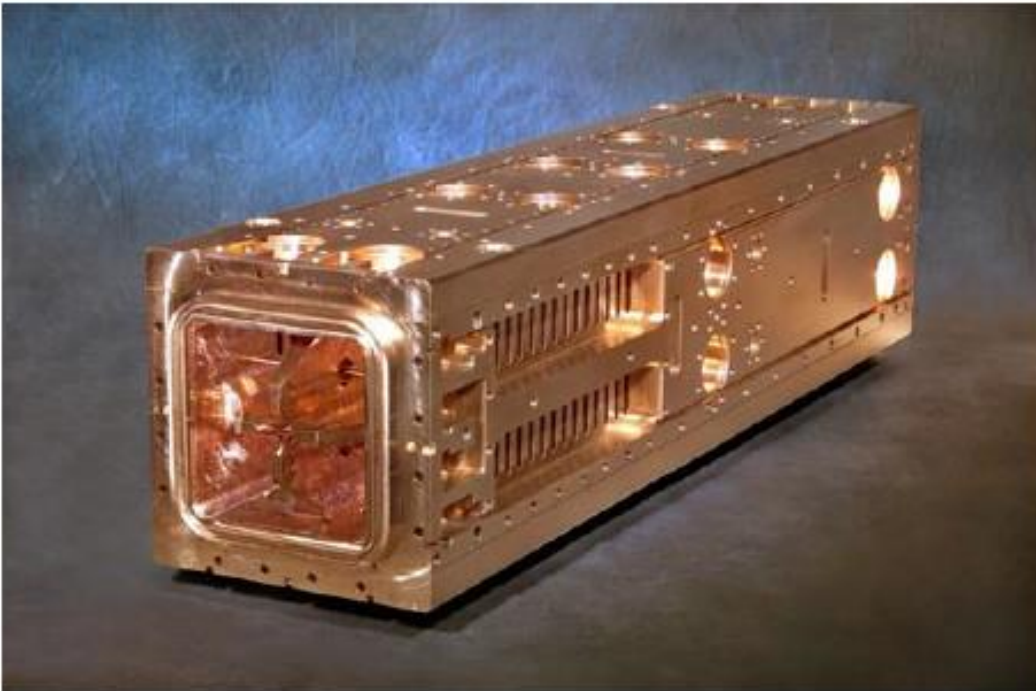
# Comparison of RFQ (Existing RFQ)

- 3.7 m length in 4 sections
- Two layer copper structure with GlidCop exoskeleton for strength
  - Strength needed to use minimally supporting kinematic structure design
- 4 vane type with PISL for dipole stabilizing
- 80 slug tuners (1.4" dia each) and 46 field probes
- 2 input couplers (originally 8)

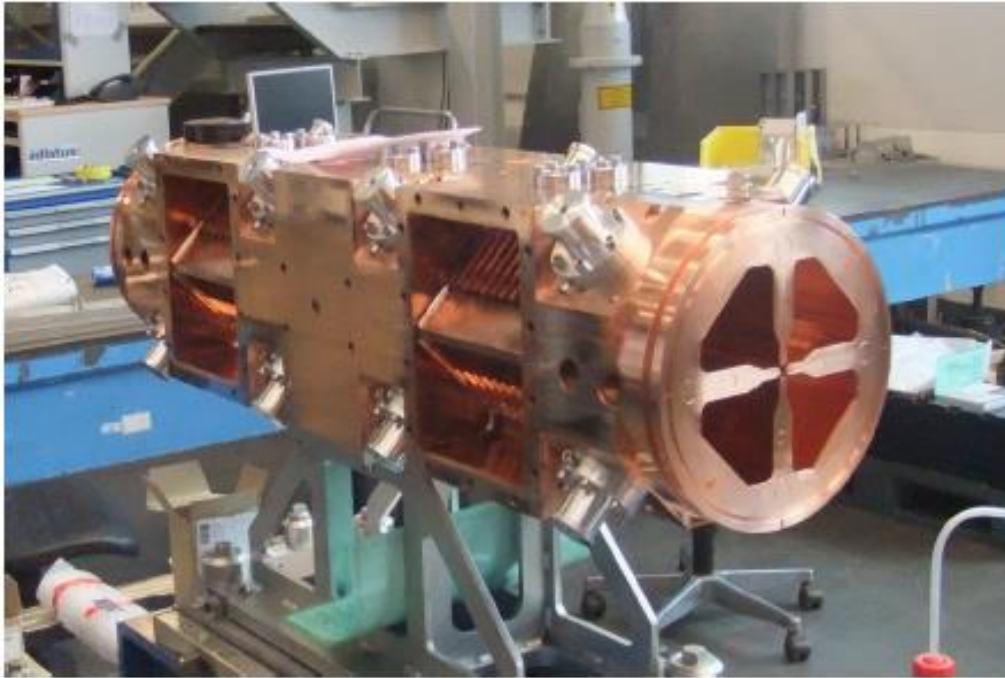
# Comparison of RFQ (New spare RFQ)

- 3.7 m length in 4 sections
- 4 vane type with end wall rods for dipole mode stabilizing
- Robust uniformly supported structure
- 64 slug tuners (1.4" dia each) and 48 field probes
- 2 coaxial input couplers
