RF System Performance

Mark Champion, Group Leader AAC Meeting, 7-9 May, 2013

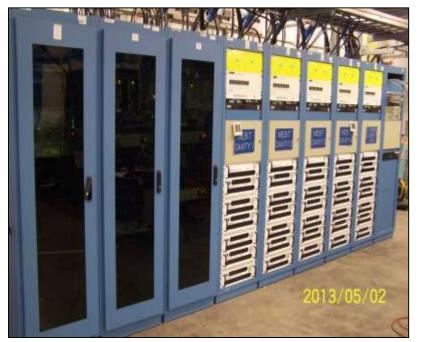
MEBT Rebuncher RF System was upgraded in September 2010 and has performed flawlessly

4+1 systems, 25 kW each, 402.5 MHz

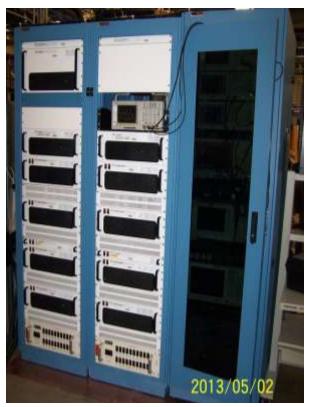
2 MHz, 120 kW amplifier is presently being tested on the ion source test stand

- Ability to survive ion source sparking has been demonstrated
- Presently working to improve load mismatch capability

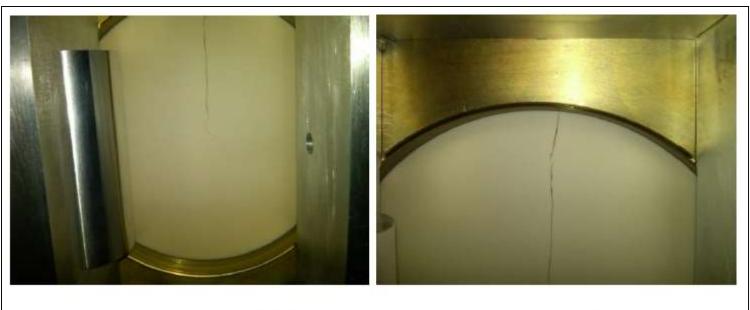
Figure 3 - CCL Window with fracture of ceramic window.

- CCL2b window broken 11/2/07
- CCL3b window broken 2/3/11
- CCL4b window broken 1/28/12
- CCL1b & CCL4b windows replaced due to excessive arcing and vacuum activity July 2012

- RF Structures team commissioned to investigate problems and create a Risk Mitigation Plan → Completed June 2012
- Key elements:
 - Order additional spares from Thales (3 each for DTL and CCL)
 - Develop alternative window designs with experienced RF vendor
 - Implemented more conservative procedure for in situ RF conditioning
 - Develop interlock based on infrared measurement of window temperature
- Significantly, nearly all of the CCL ion pumps were replaced during the summer 2012 shutdown due to poor performance
- Numerous vacuum system improvements are planned for the DTL
