Operations Experience/ Remote Handling

Mike Dayton

Remote Handling Critical to SNS

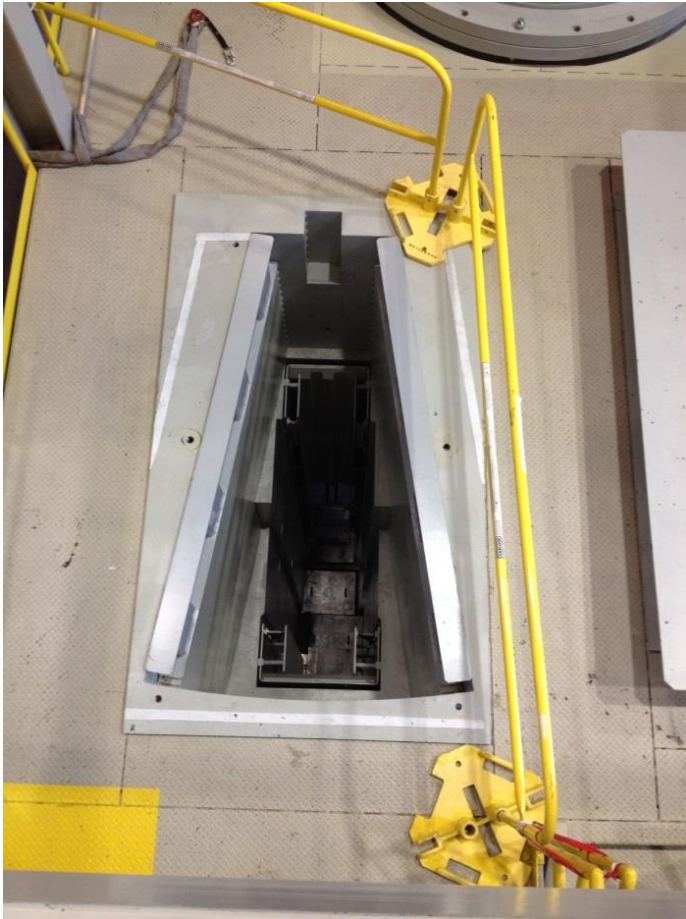
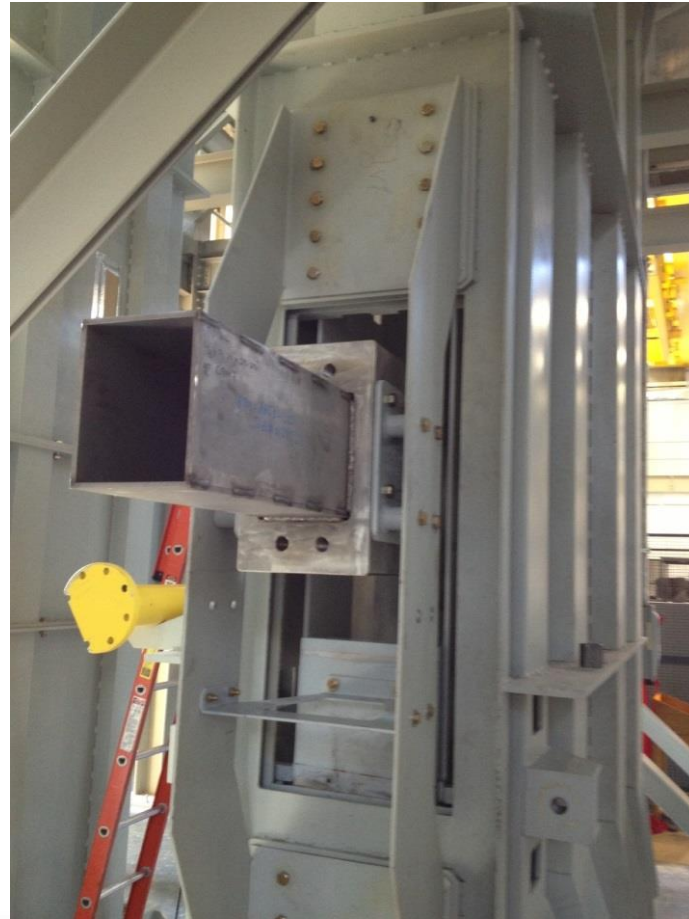
- The Mock Up Test Stand (MUTS) has been reconfigured to replicate a single channel shutter cavity:

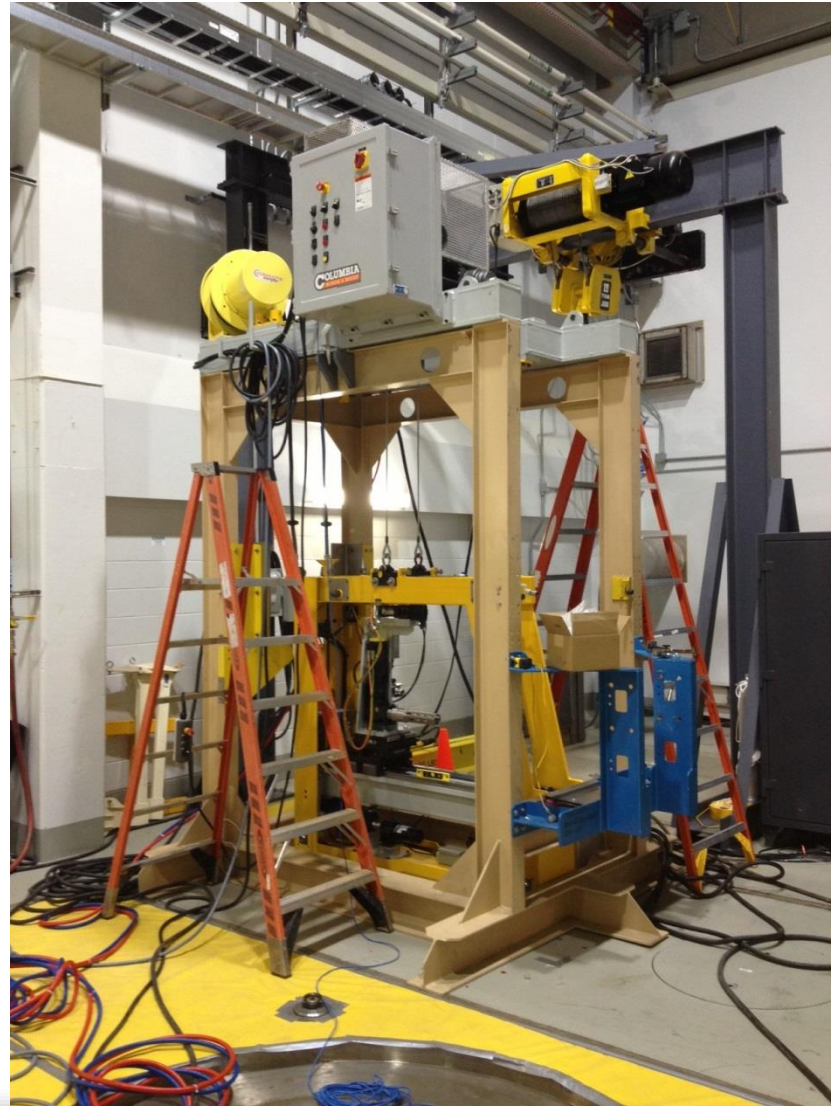
CVI Robot Mounted in Maintenance Frame and Integrated to New Hoist Plate Undergoing Operational Testing

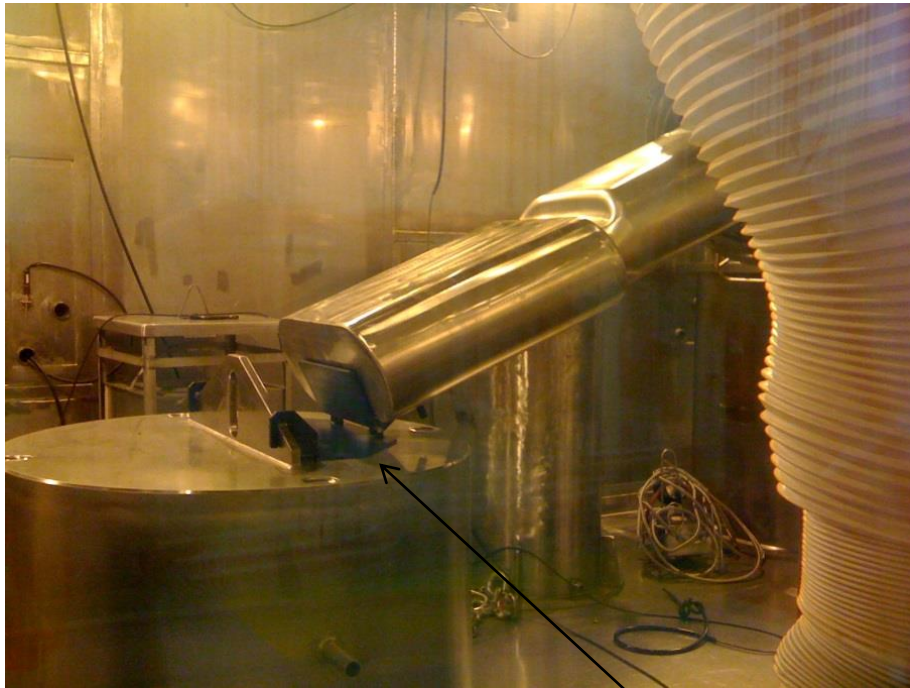
Rotation utilizes existing structures within the Service Bay in addition to a simple Rotation Fixture

- **Spent targets are stored in a vertical, nose-down orientation following removal from service**
 - Pooling of residual mercury in the nose region prevented video scope inspection of the nose region prior to cutting the nose samples
- **A process and tooling was developed to rotate spent targets into a horizontal orientation in the Service Bay for video scope inspections**

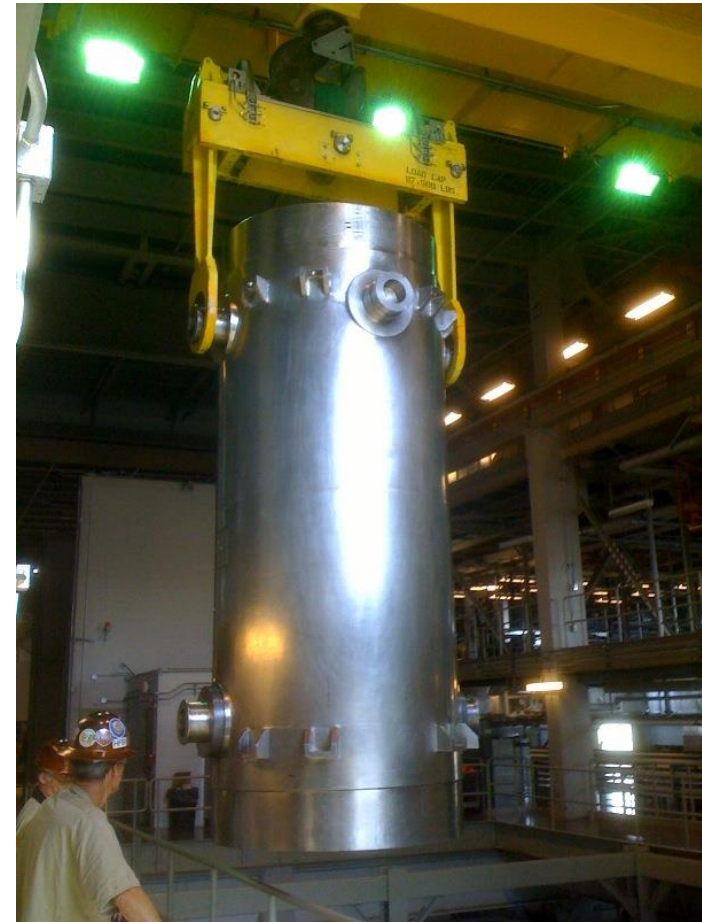
- The SNS facility is designed to utilize the TN-RAM Cask
 - The TN-RAM is the largest waste cask certified for over-the-road use
 - There is only one TN-RAM in existence and must accommodate many customers
 - Four shipments were made in FY2012
- SNS shipments must be coordinated with all other customers

TN-RAM being moved through the Target Building

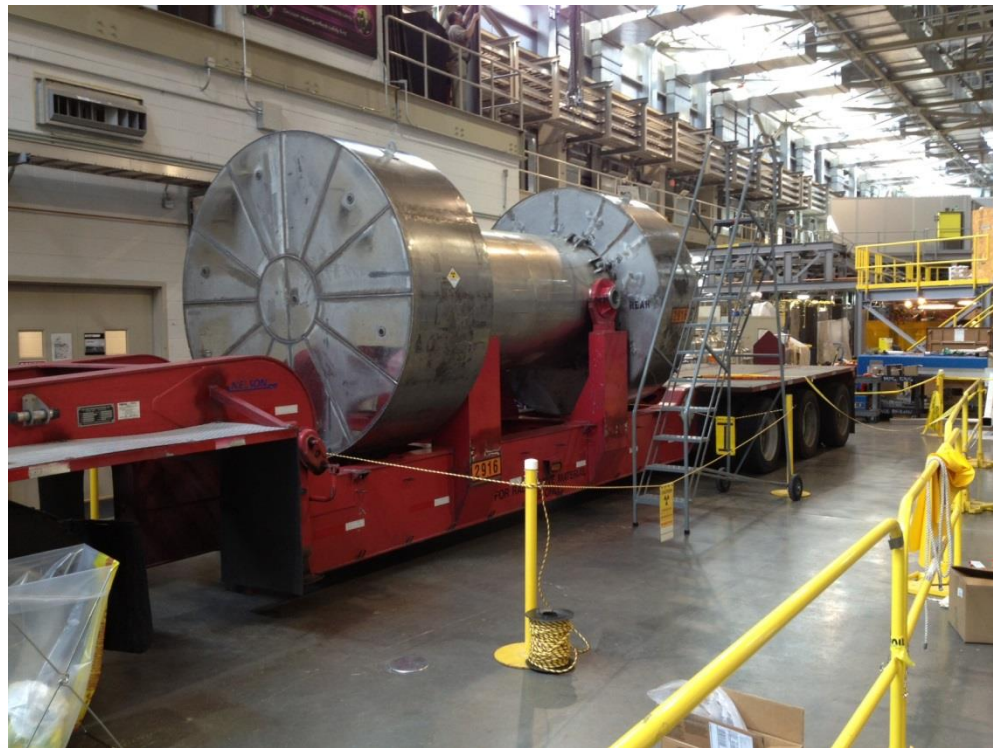
- A recently planned TN-RAM shipment was delayed due to excessive external contamination
 - Cask is currently undergoing decontamination efforts to attempt shipment of Target T7 prior to the upcoming outage
