Cryogenic Moderator System Performance

Allen Crabtree

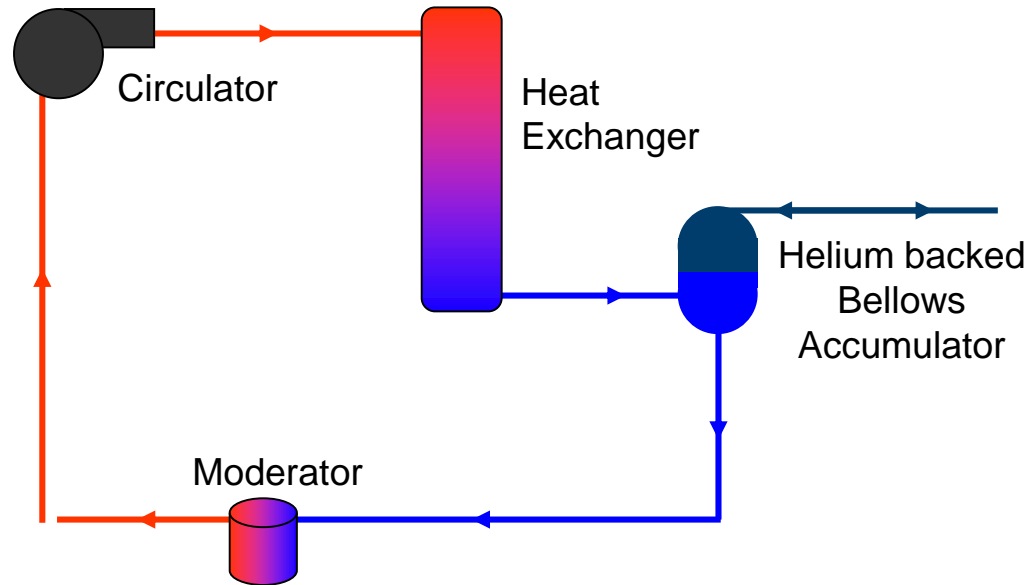
Hydrogen System Description

- The Hydrogen Moderator System is a series of three independent cryogenic loops each consisting of:

- Moderator
 - load
- transfer lines
- Circulator
 - Flow control
- Heat exchanger
 - Thermal control
- Accumulator
 - Pressure control

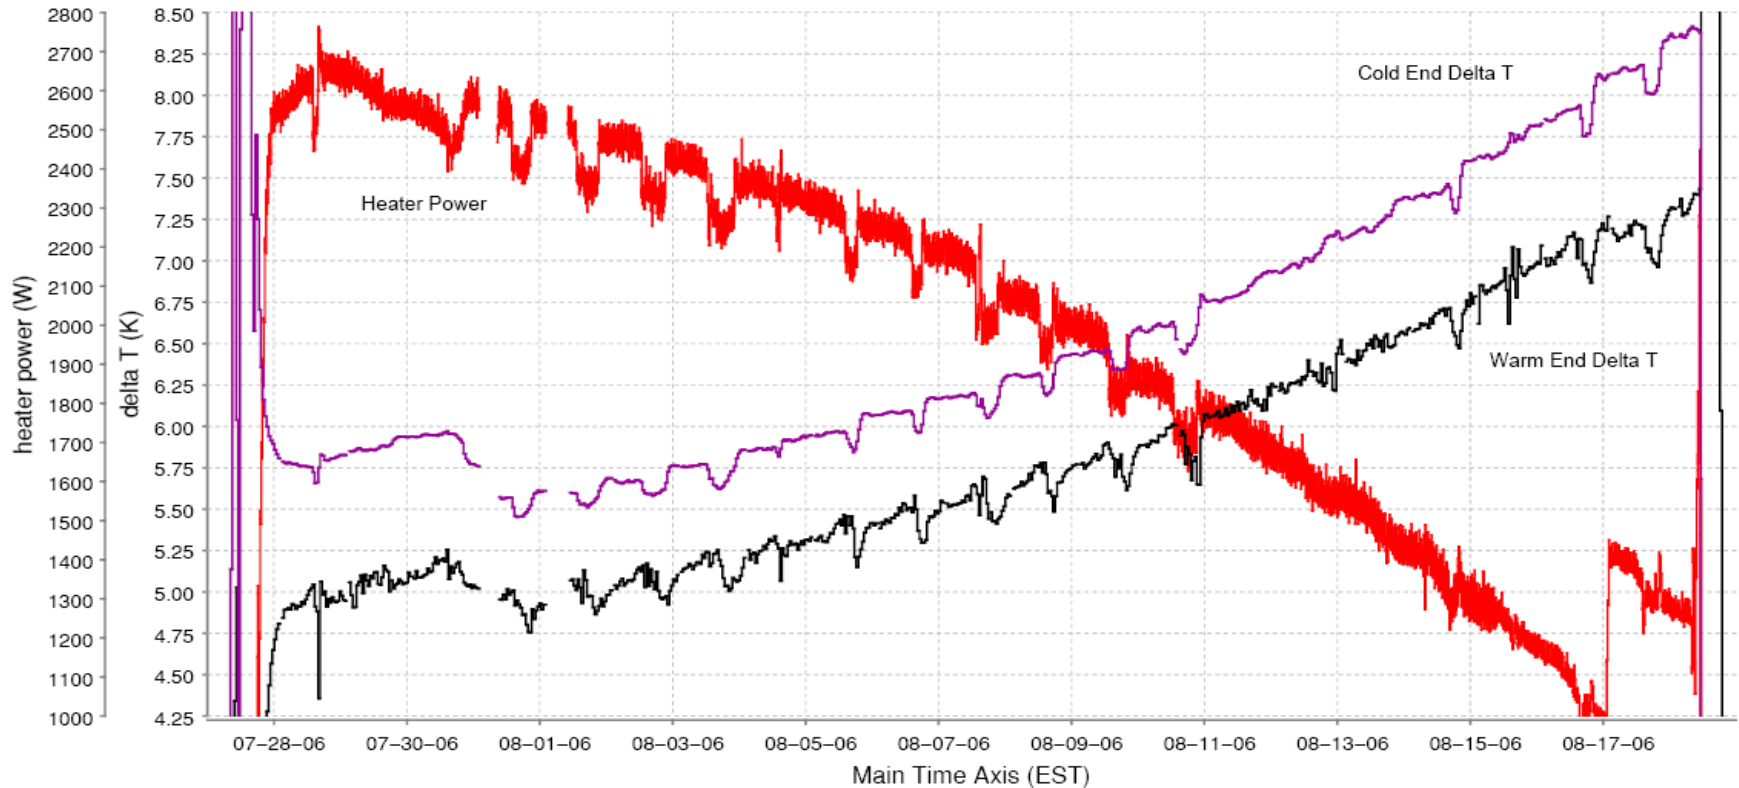
Helium Refrigerator Operation

- Early in operations, however, it was discovered that the system mysteriously suffered from a steady decline in cooling capacity.

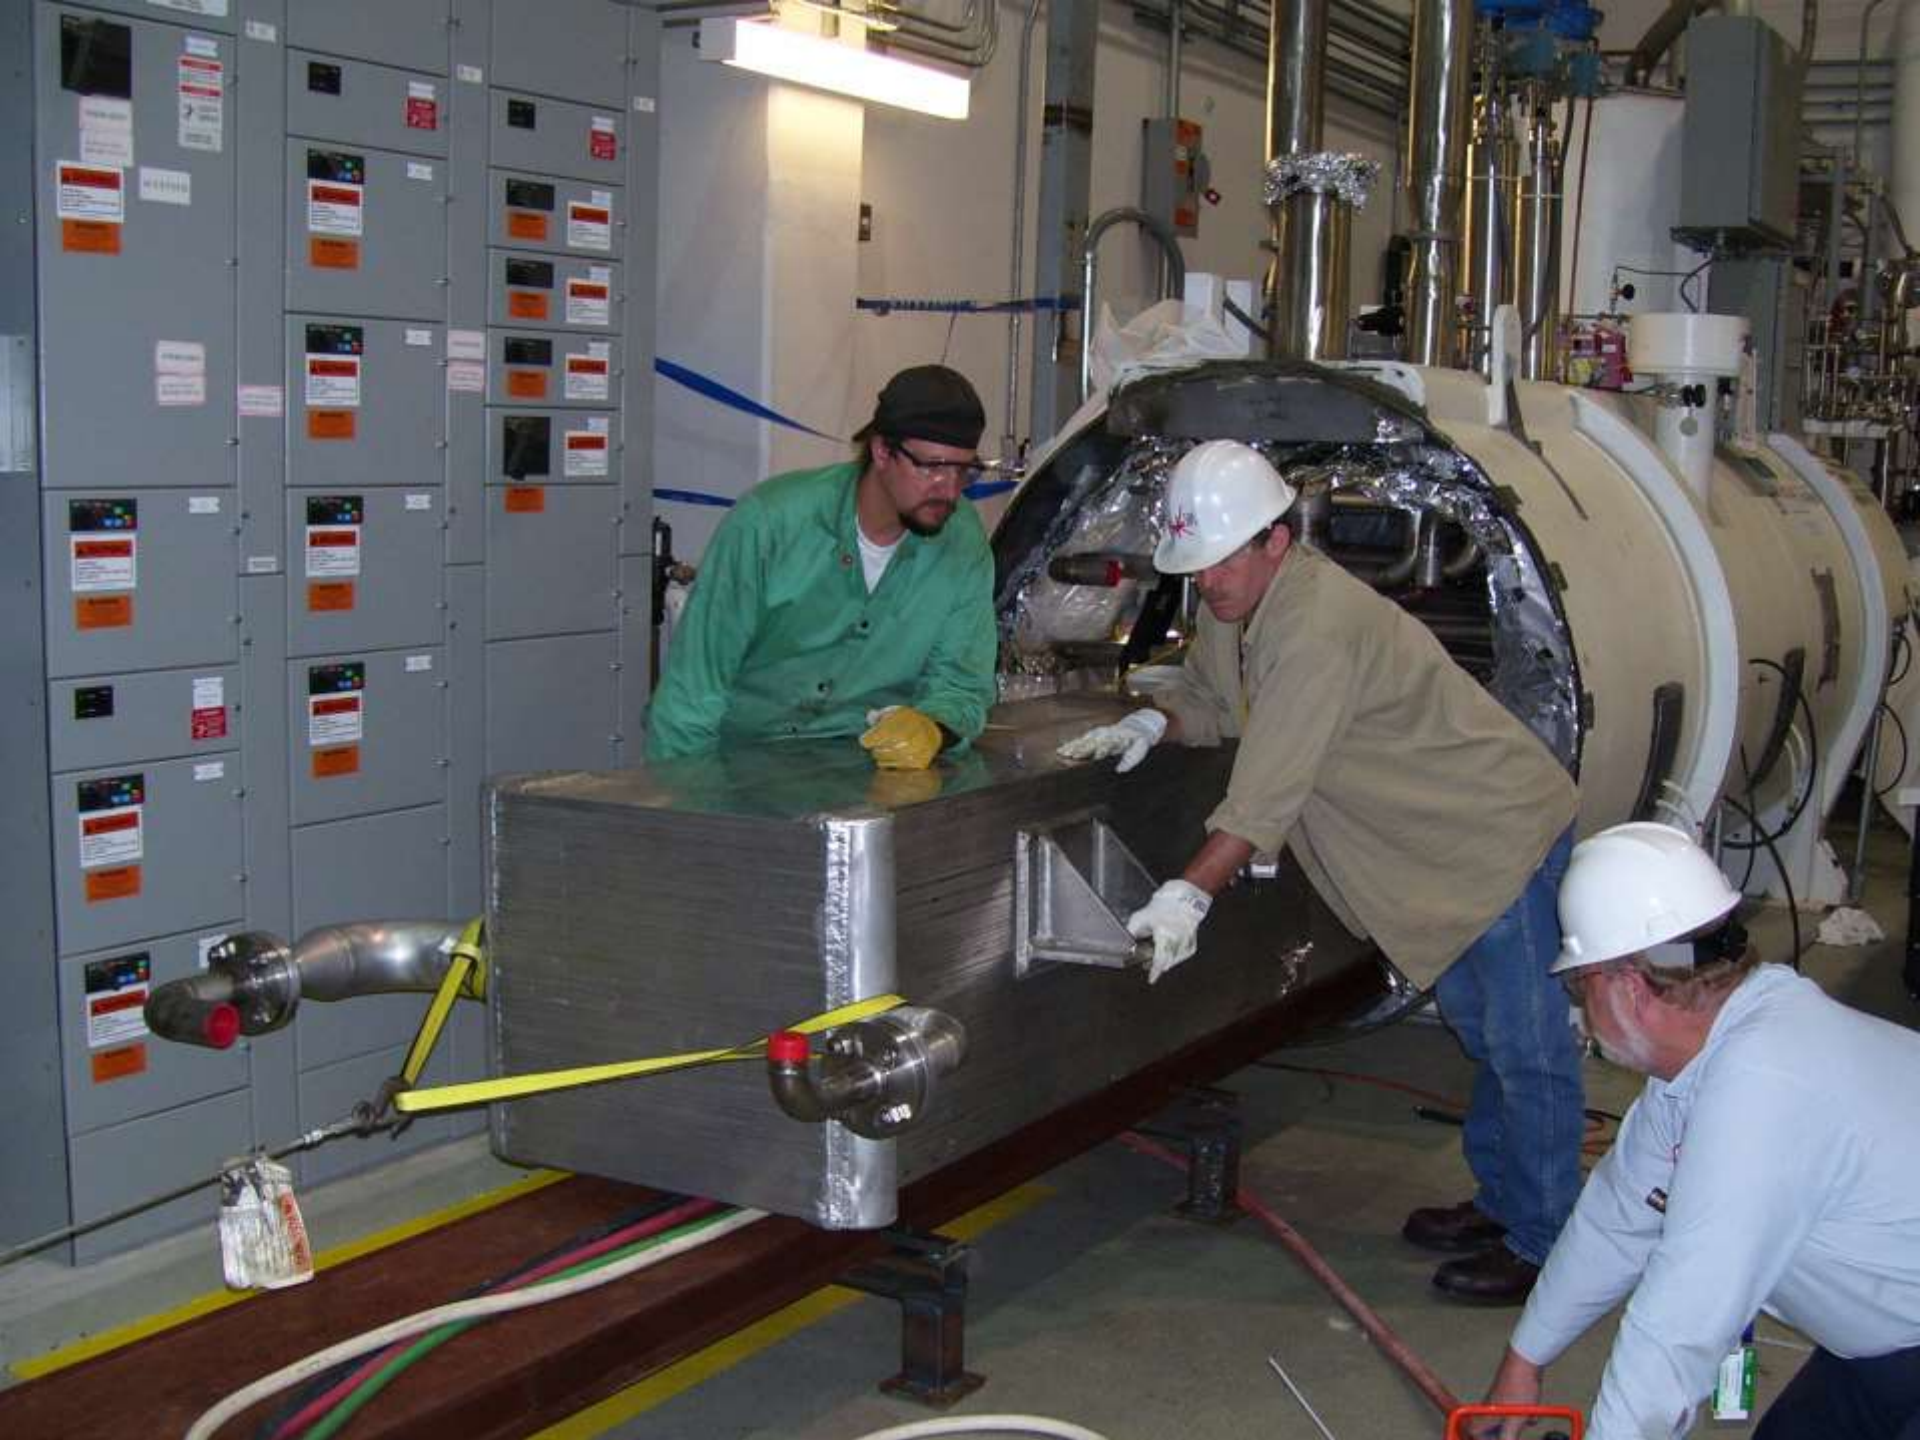
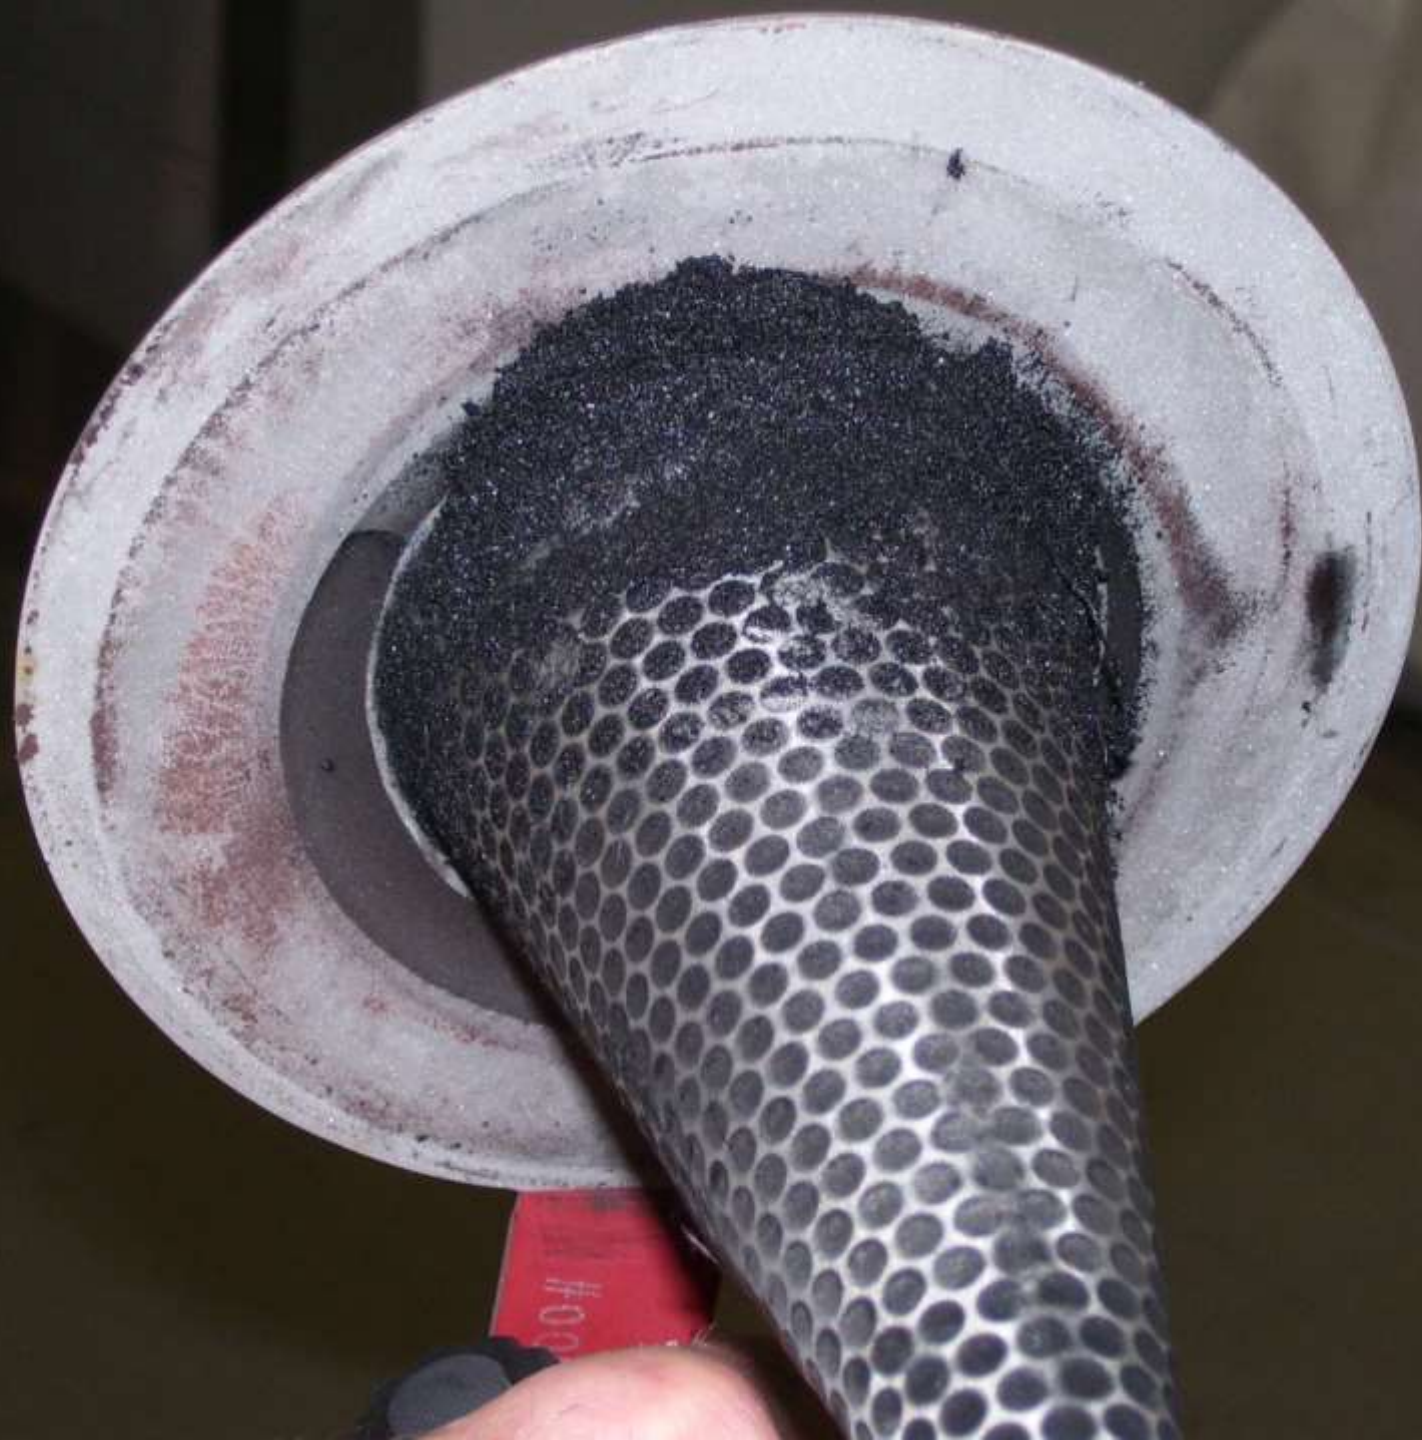
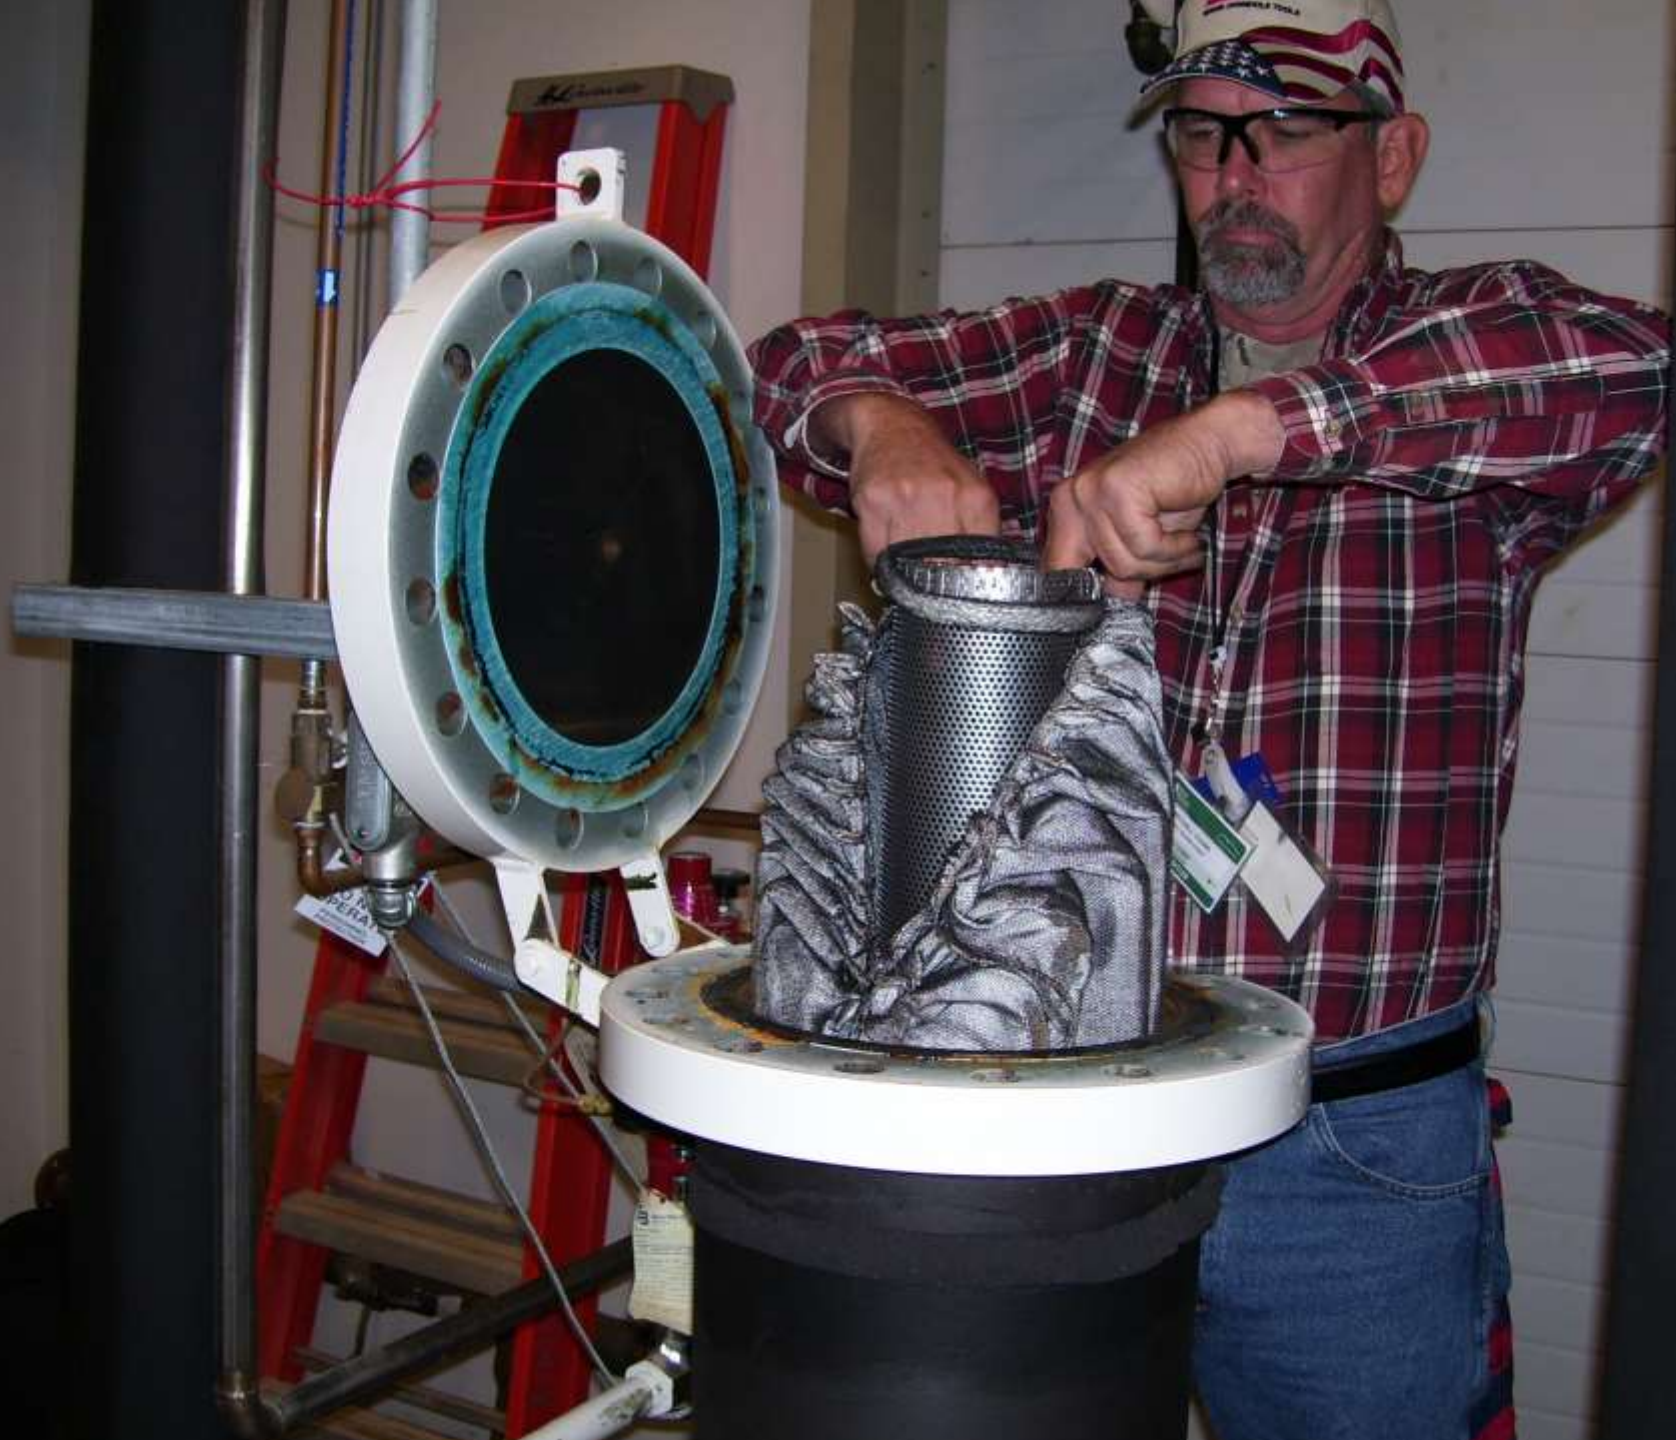
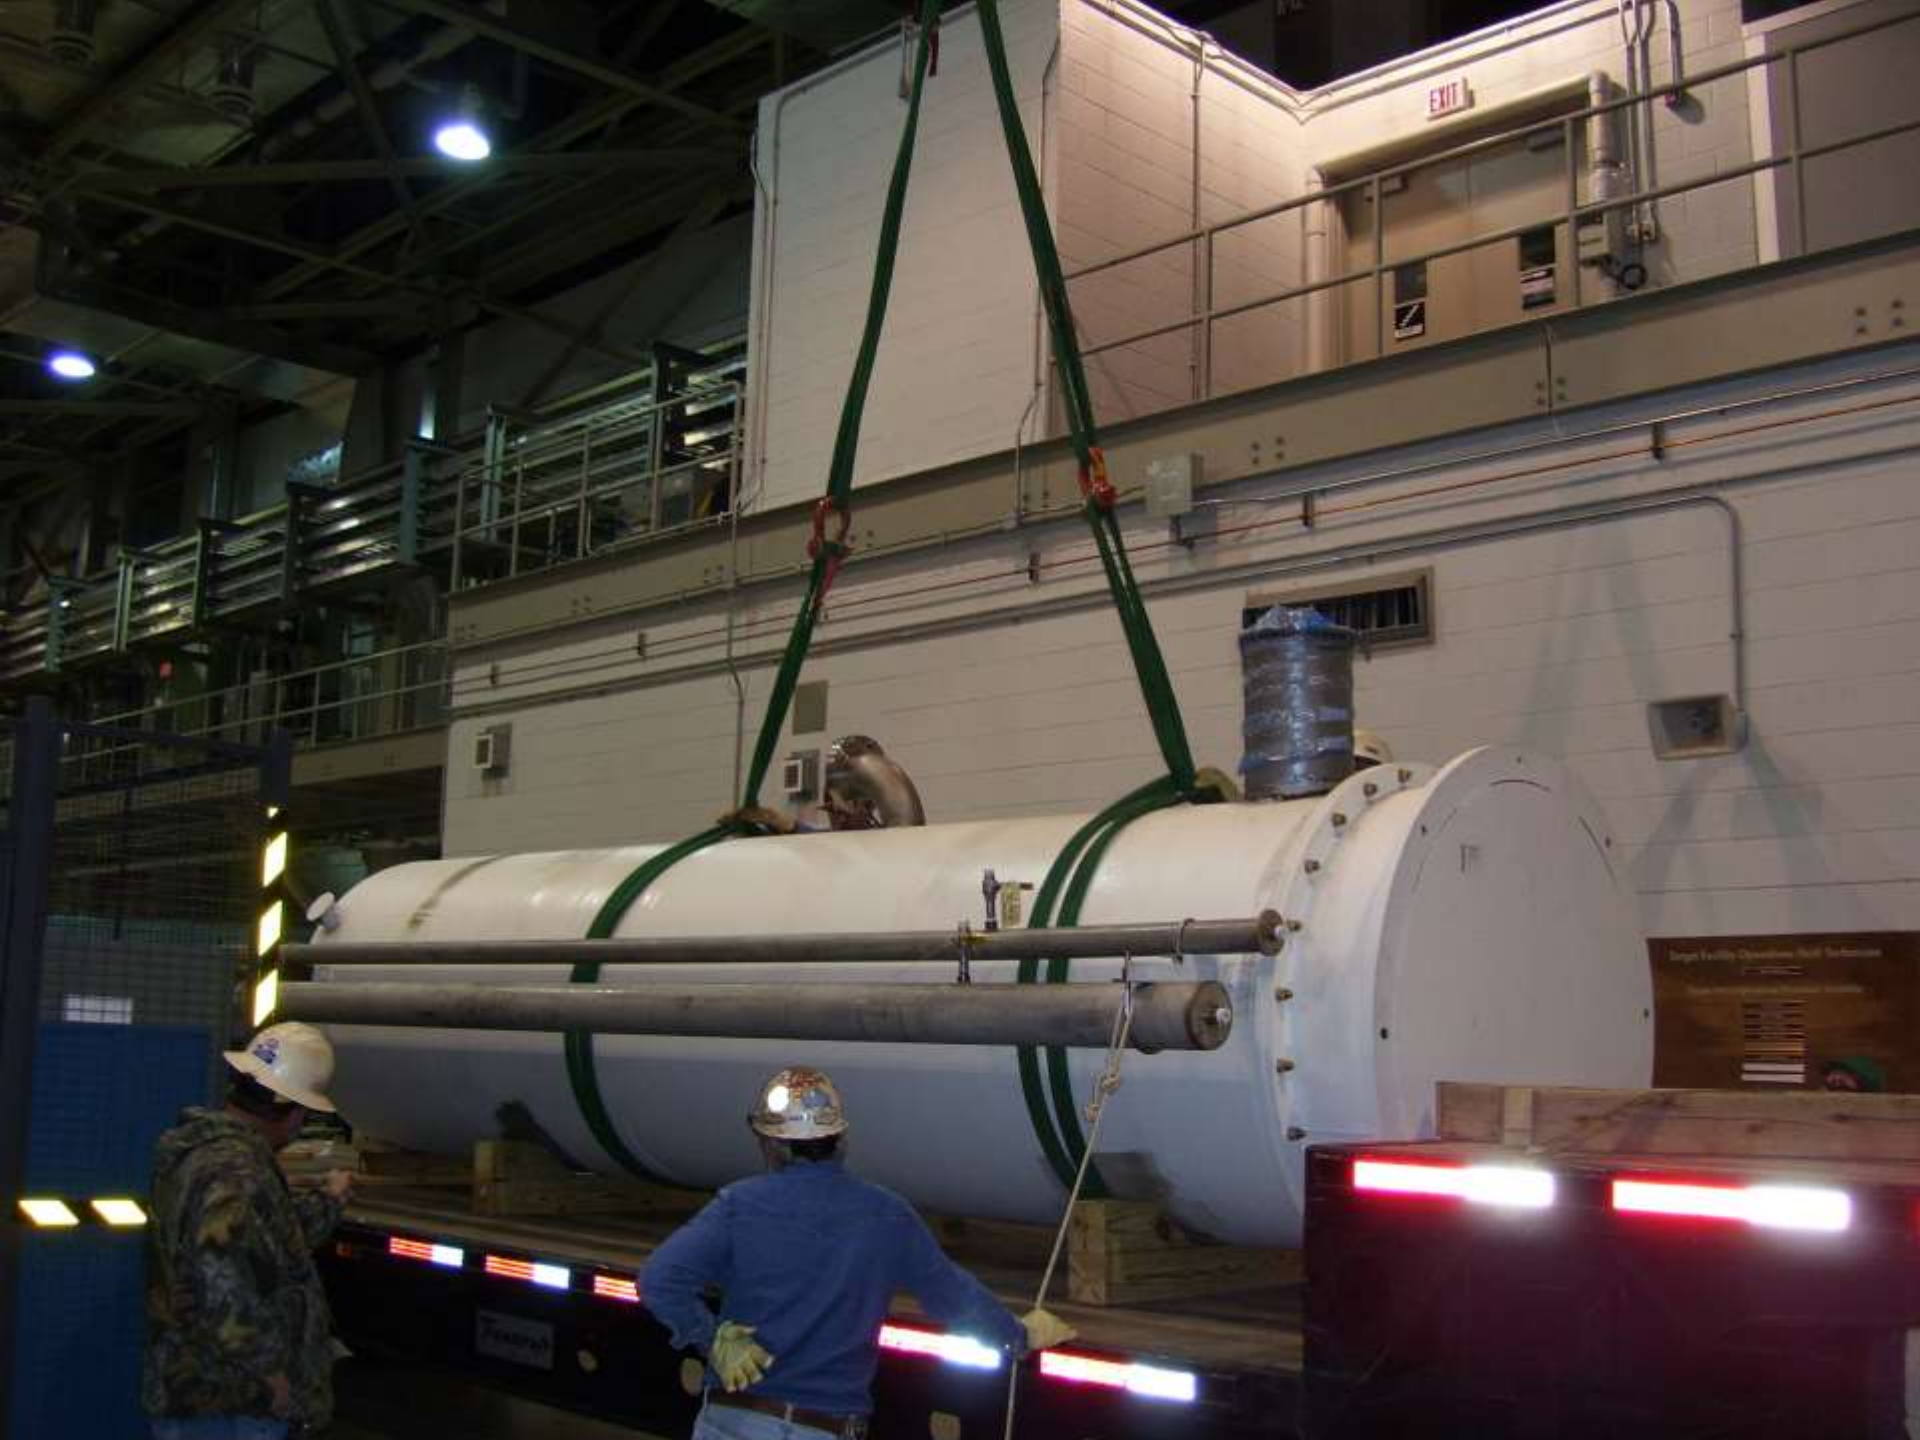
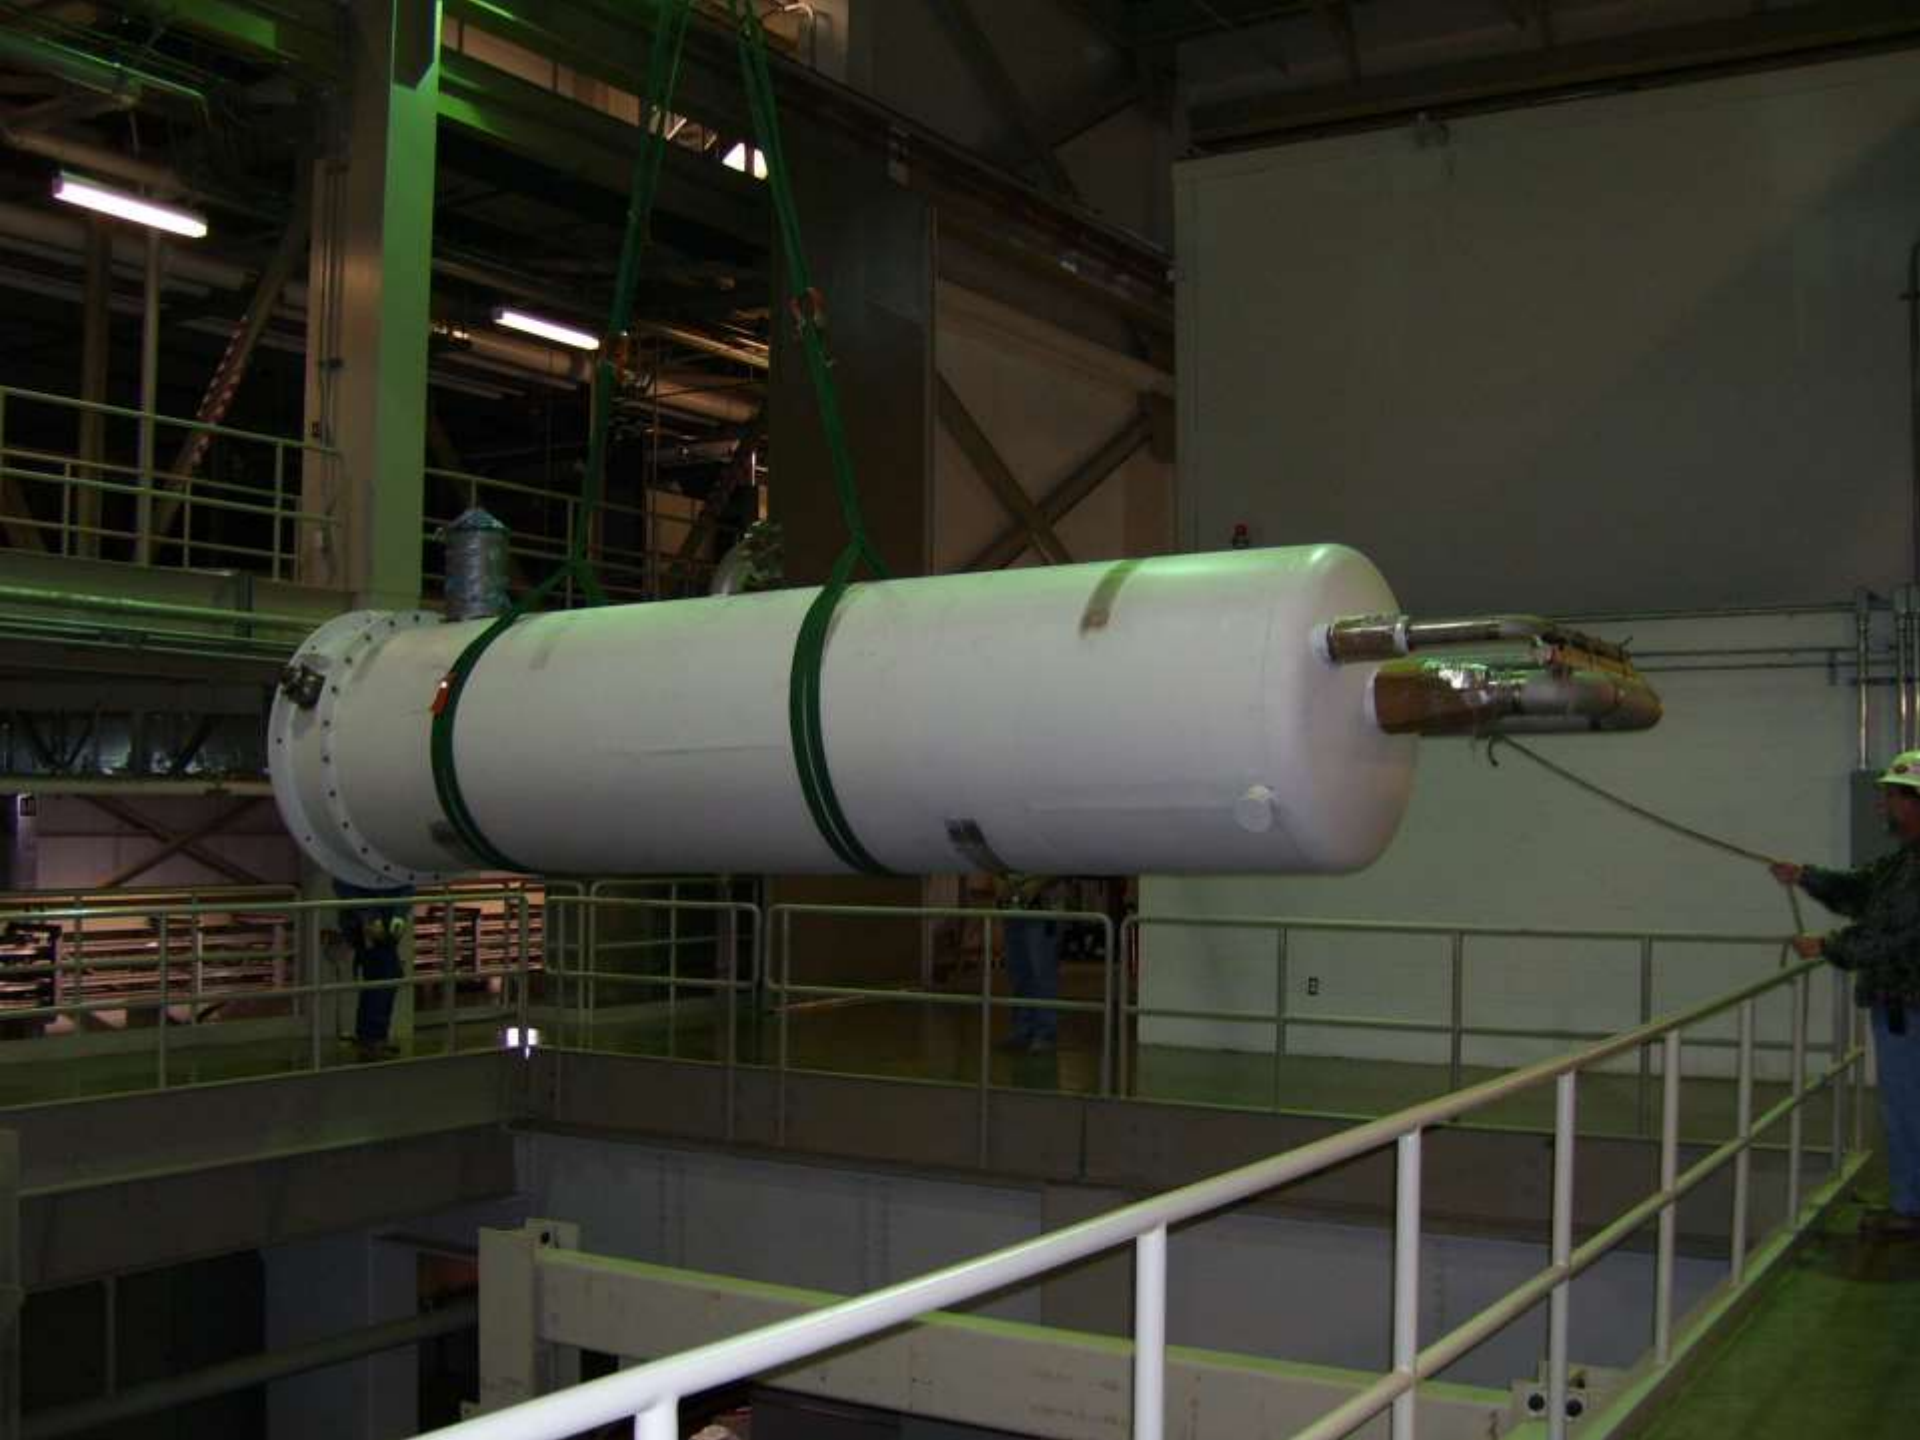
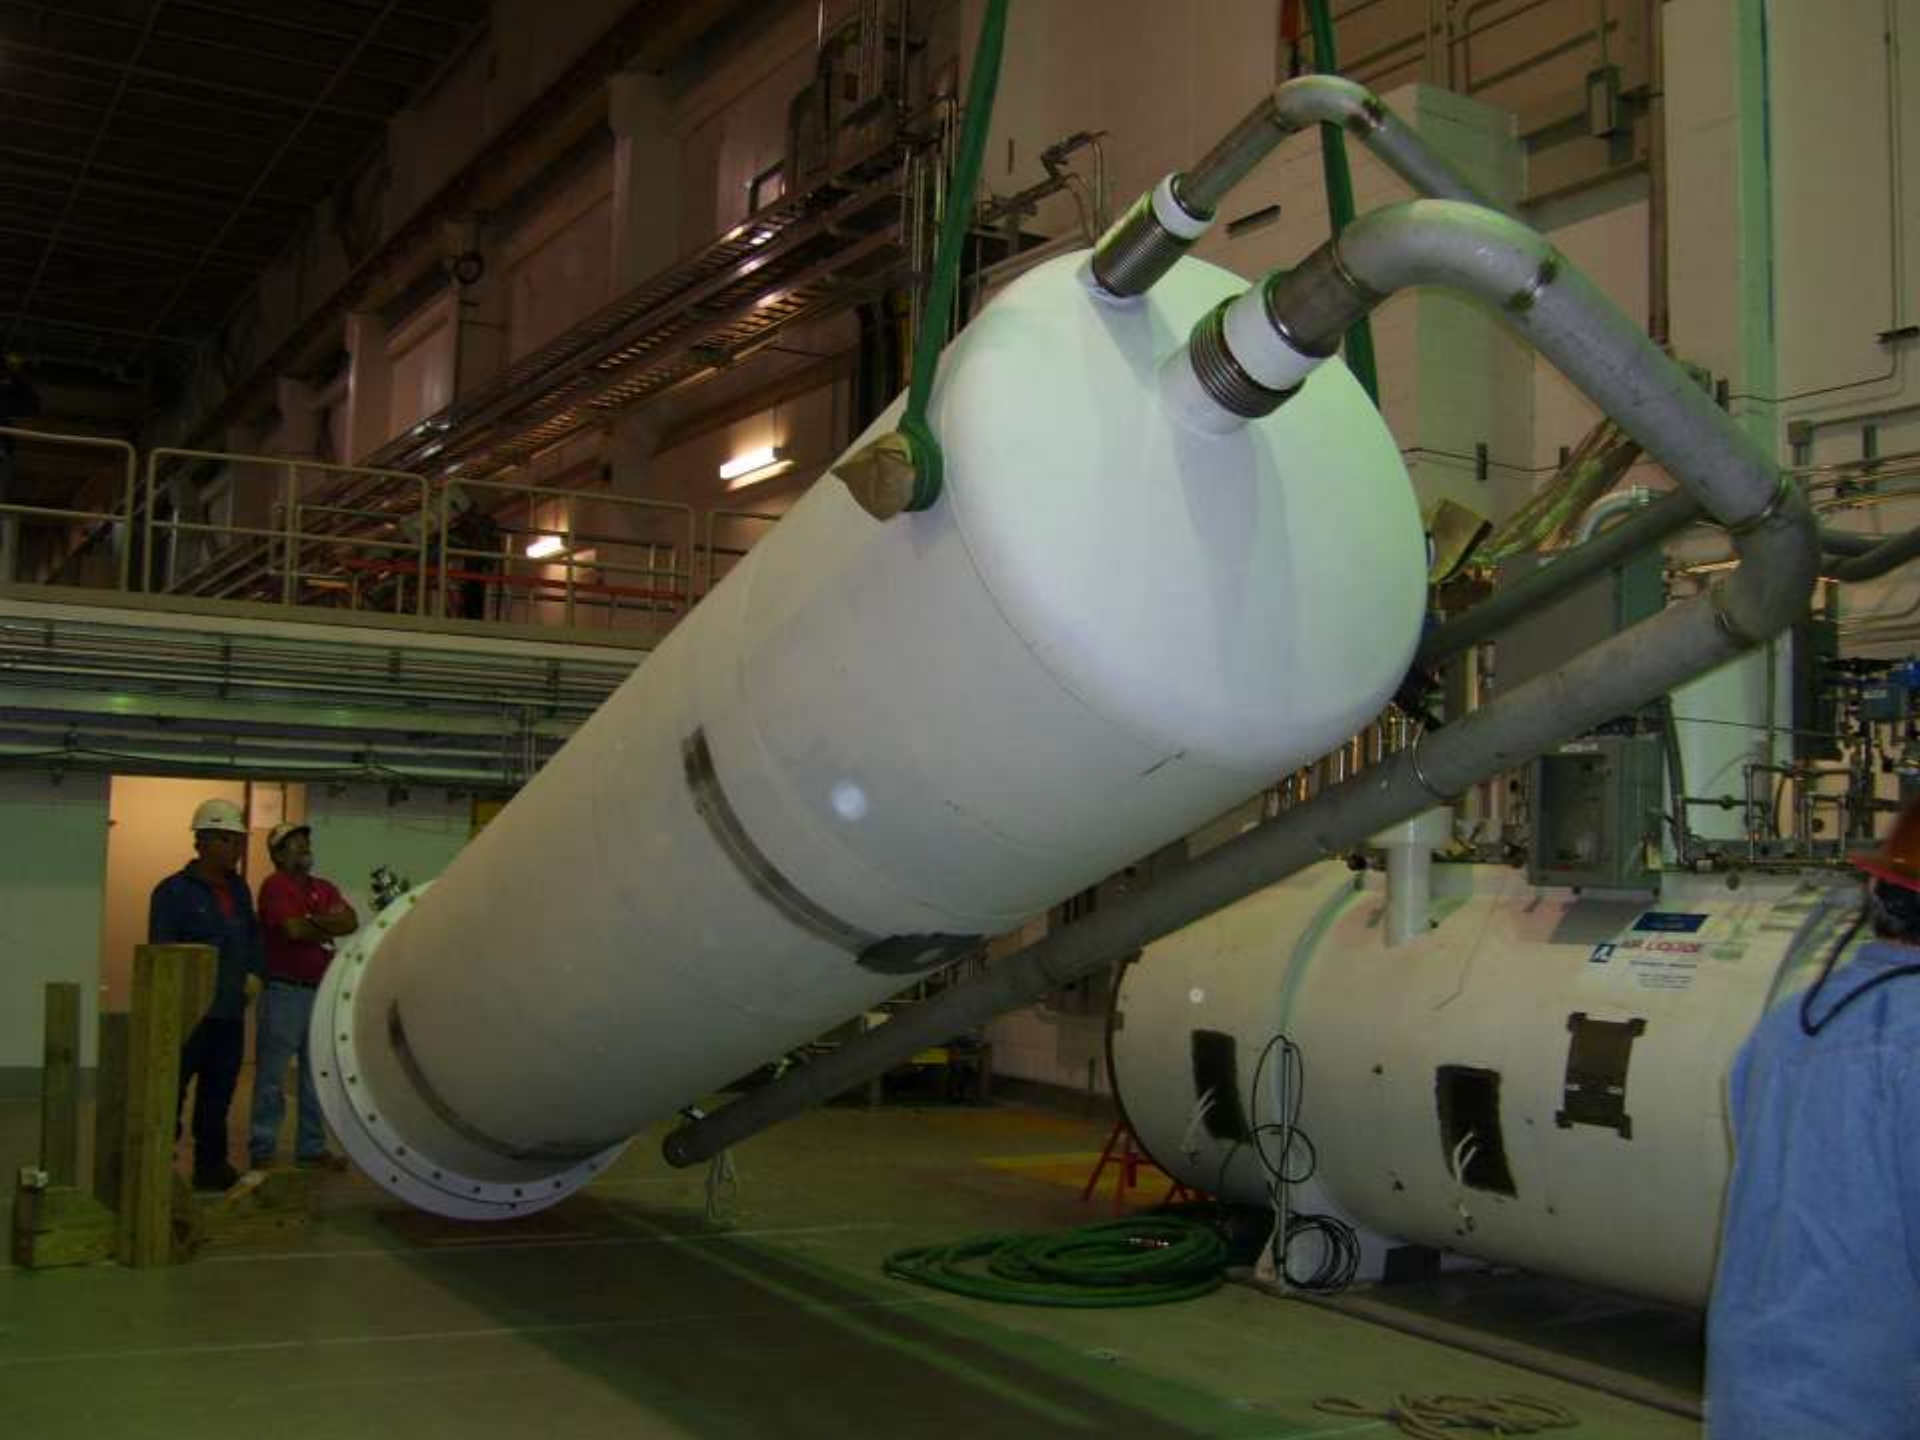
HX Re-orientation Schedule of Events

- **The extraction process started on October 4.**
- **HX shipped to AET on October 7.**
 - **Oil found in process piping at AET on October 10.**
 - **Sent to Consolidated Science for Analysis.**
 - **Control sample of our compressor oil sent for comparison**
 - **Analysis repeated by Consolidated confirms presence of compressor oil in cold box piping.**
- **Witch's hat inspected on October 22.**
 - **Presence of charcoal and oil indicate failure of the Oil Removal System.**
 - **Oil Removal System Rebuild started on October 24.**
- **Methanol flushing of process piping began on October 26.**
- **The new cold box arrived on October 31.**
- **Refrigerator was re-started on November 5.**
