# AAC - HEBT/Ring/RTBT Overview

Feb. 2 - 4, 2010

by Mike Plum

Ring Area Manager

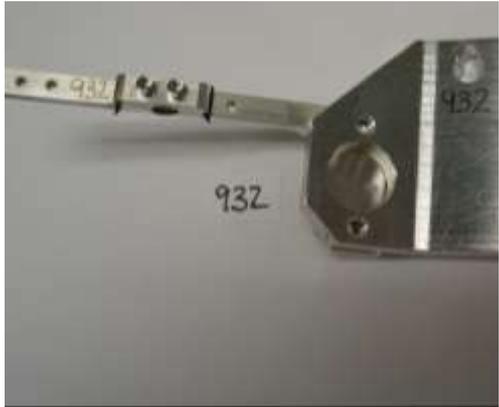
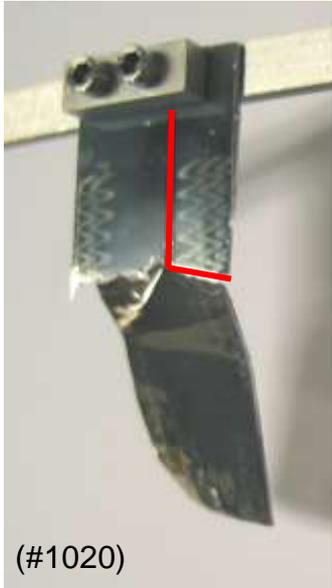
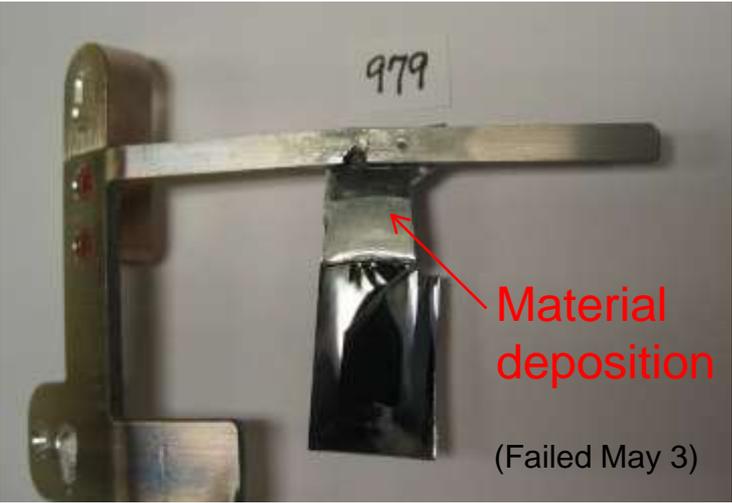
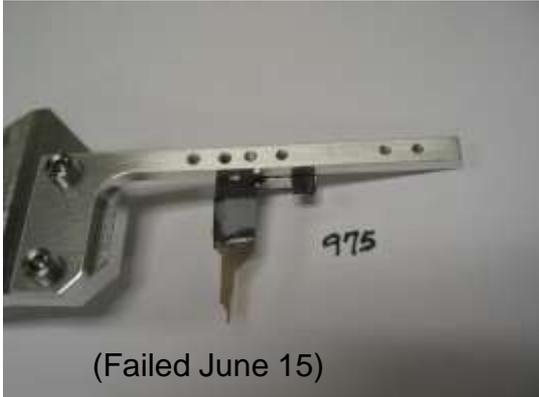
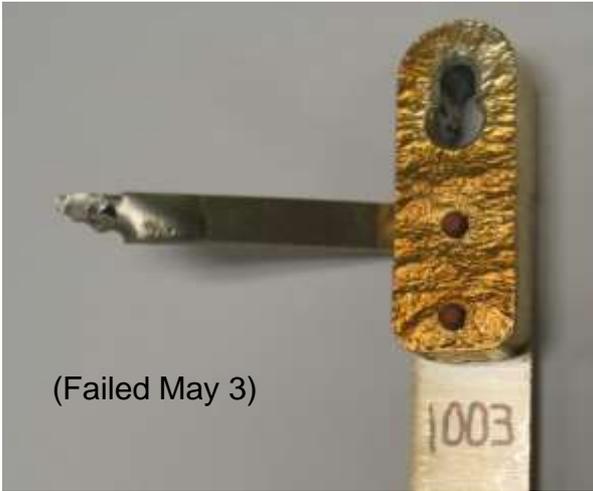
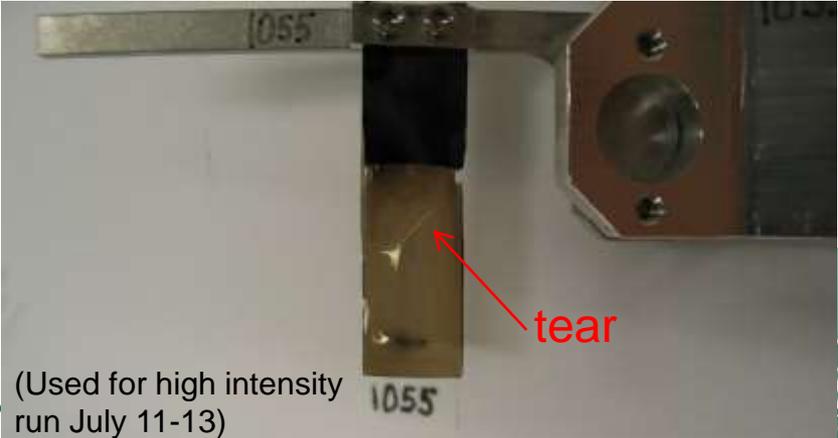
# Foil failures

- Counterweights falling off
- Bracket melts where foil is attached
- Foils break where foil is attached to silicon, and where the silicon meets the bracket
- Foil flutter
- Glow from bottom edge and occasional spots on foil
- Foils sometimes have bright beam spots
- Material deposited / evaporated on foils, brackets, and other nearby components
- Foil brackets stick to the foil-changer pin that they hang from
- Some foils have much higher A13b losses
- Foil corner curls up after a while

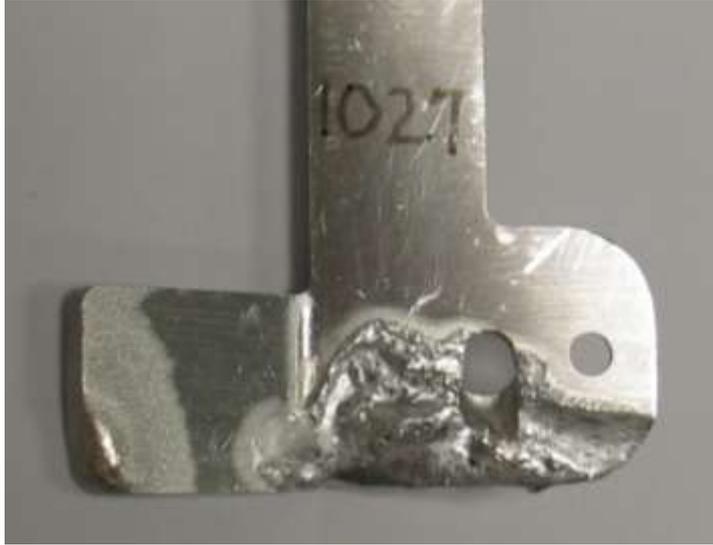
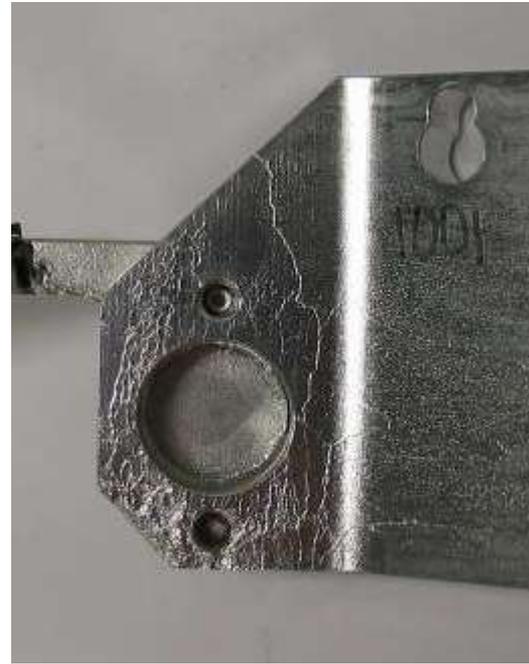
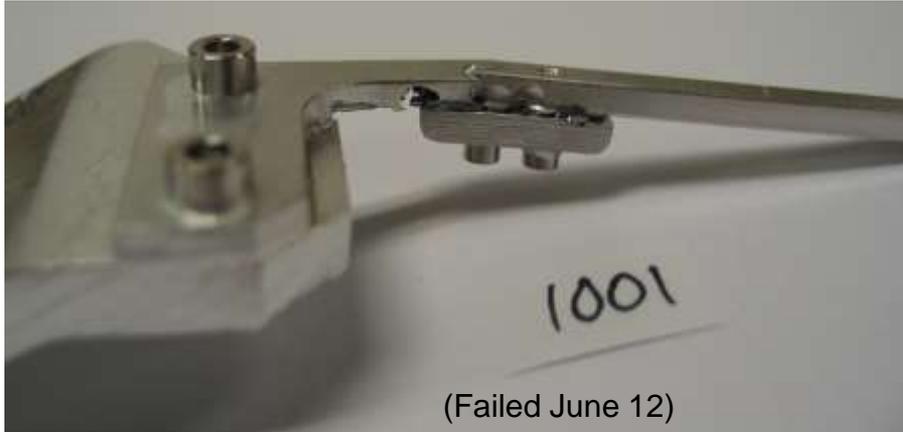
# Foil failures (cont.)

(Failed June 12)

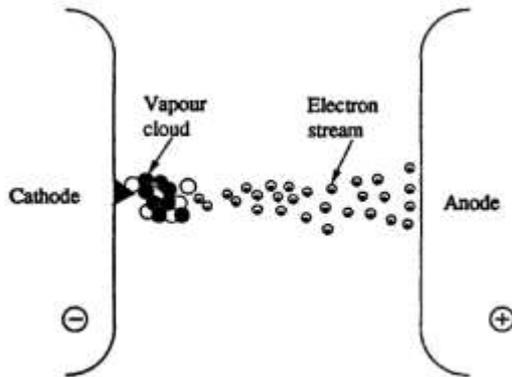
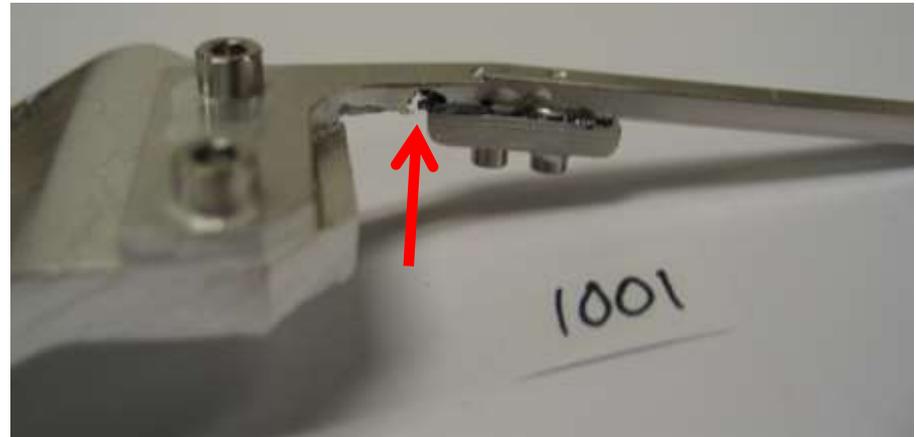
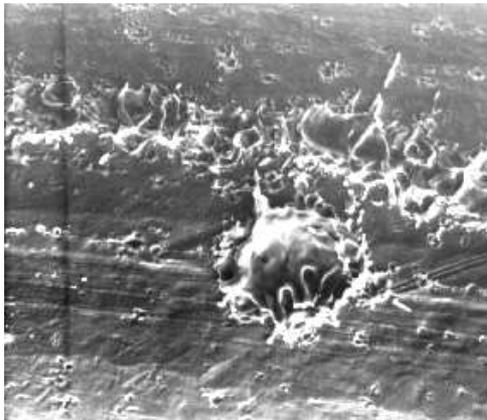
# Cathode spot in-vacuum breakdown

“Vacuum arcs, also referred to as cathodic arcs, are high current discharges between cold electrodes. Typical currents are 100 Amperes or more while the voltage between anode and cathode is only about 20 Volts... This leads to "micro-explosions," and one can observe microscopic craters left on the cathode surface.”

*Crater traces left by cathode spots  
(Picture taken with an electron microscope).  
From [http://pag.lbl.gov/Proj\\_VacArcRes.htm](http://pag.lbl.gov/Proj_VacArcRes.htm)*

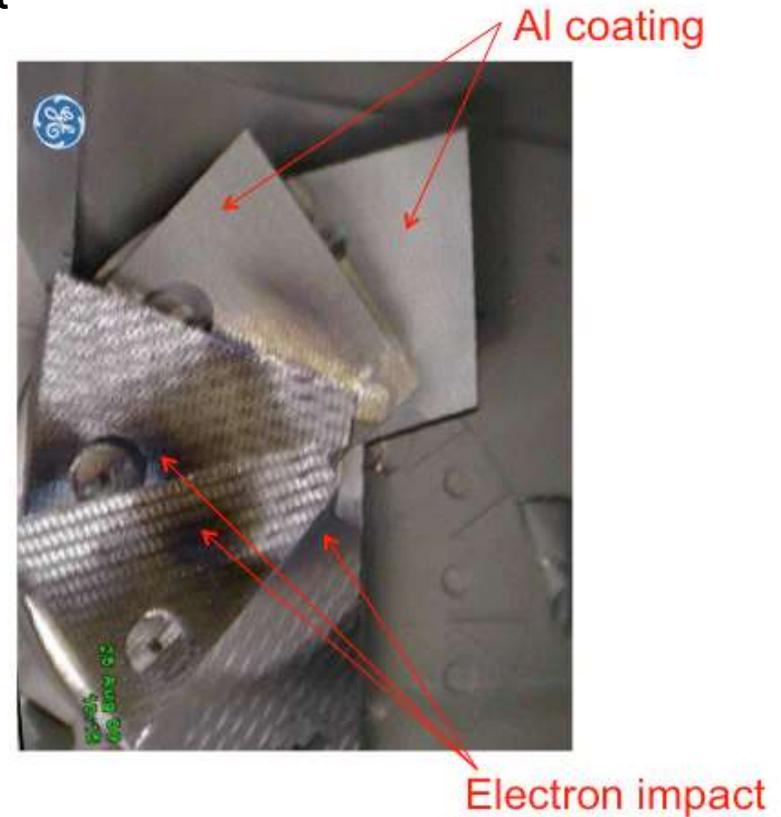
# Reflected convoy electrons

- If the electrons do not hit the catcher just right, they can be reflected, travel back up, hit the foil and/or foil bracket, and cause foil failure
- The electron catcher is made of carbon to minimize the probability of reflection
- Interior surfaces of the vacuum chamber were coated with aluminum due to the bracket melting problems
- The foil is probably not optimally aligned w.r.t the catcher
- All of the above contributes to convoy electrons reflecting off the electron catcher, rather than being absorbed by the catcher

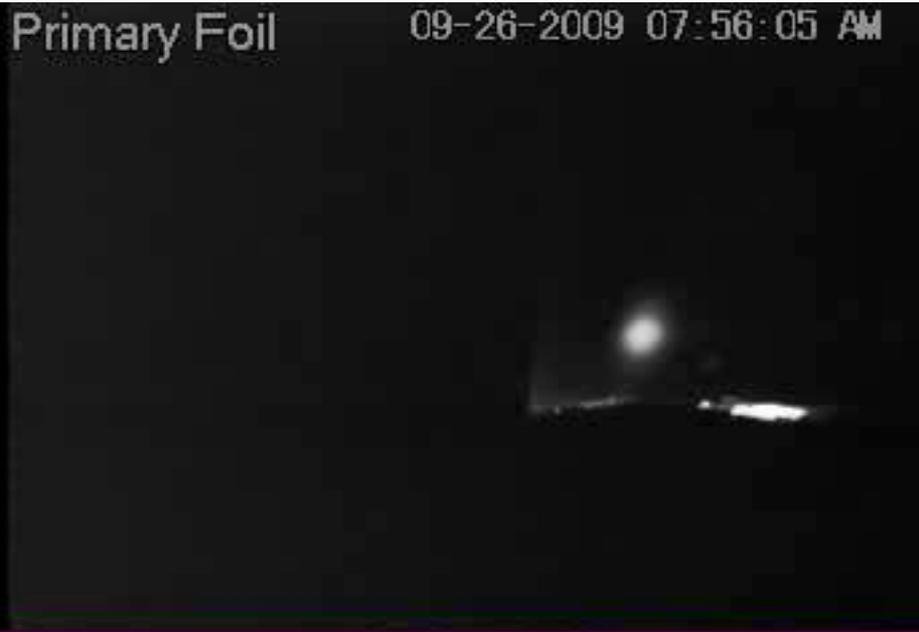
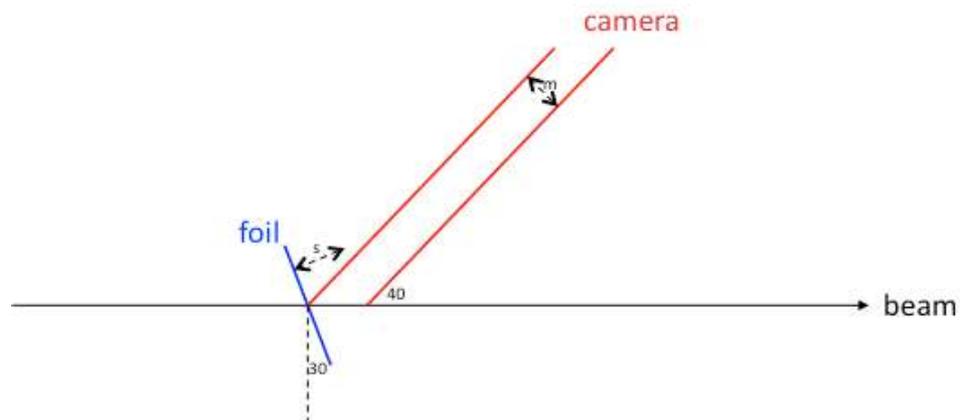
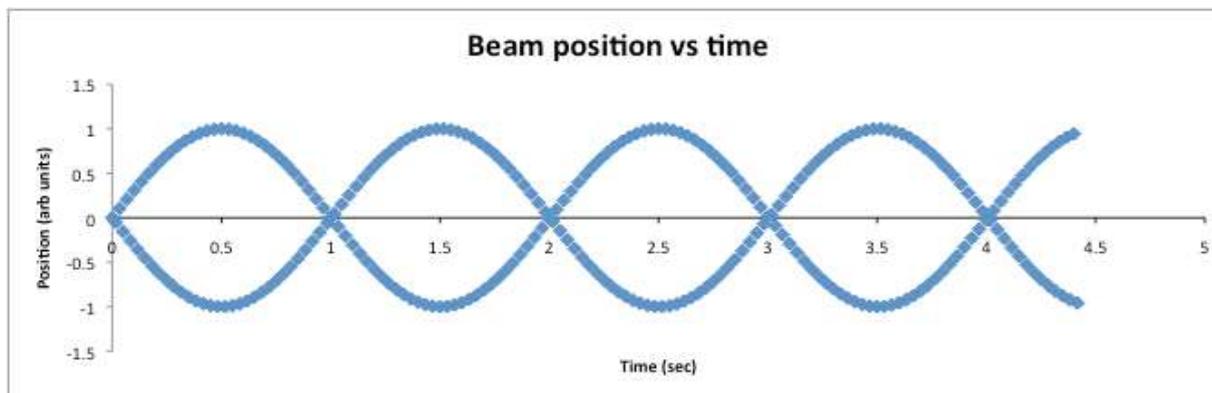
# Foil flutter

29.5 Hz sine wave sampled at 60 Hz (30.5, 89.5, 90.5 Hz ... also work)

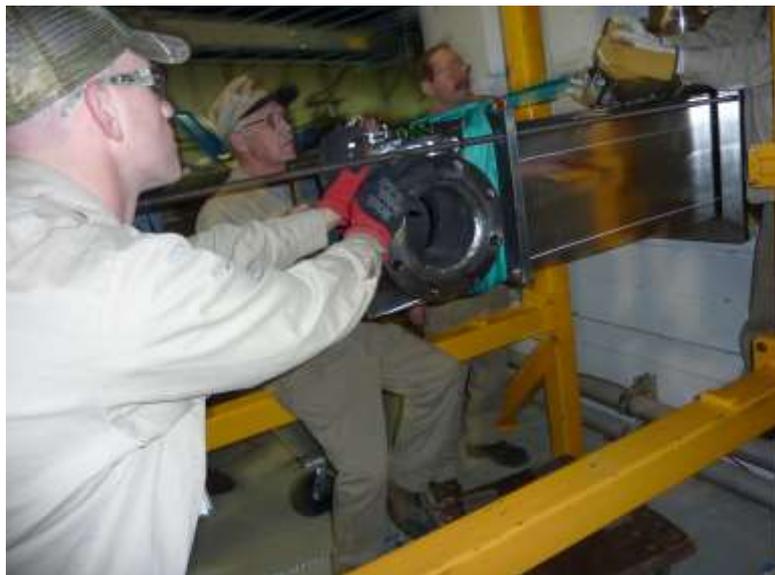
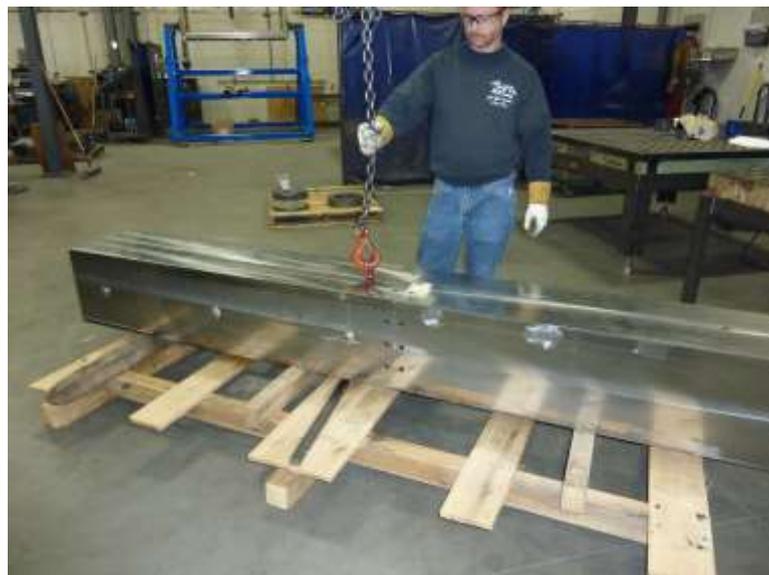
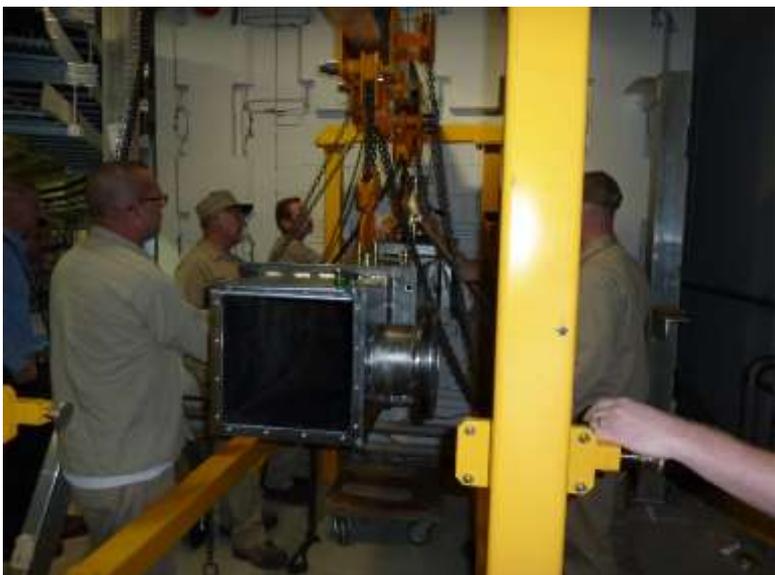
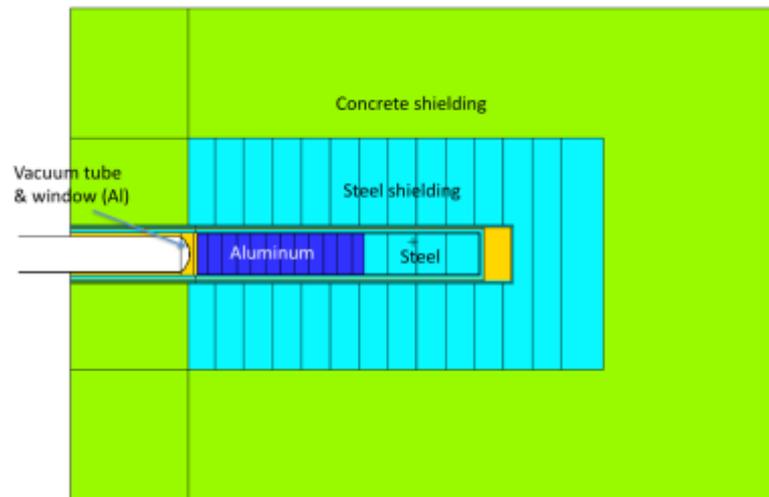
# Momentum dump (cont.)

- In April 2008 the dump failed due to excessive pressure in the cooling loop, caused by a combination of excessive beam power (~9 kW for ~36 hours vs. 2.5 kW design power), and unanticipated gas creation from the beam passing through the cooling water
- Once the gas creation problem was discovered the dump was removed from service since this is an issue at any beam power
- A new dump was designed and installation is now in progress
  - Capable of 5 kW vs. old design of 2.5 kW
  - Air cooled to avoid radiolysis issues
  - Beam diagnostics added to allow measurement of beam power, profile, position, and loss
  - Redundant blowers for high availability
  - Not quite ready for start of next run cycle

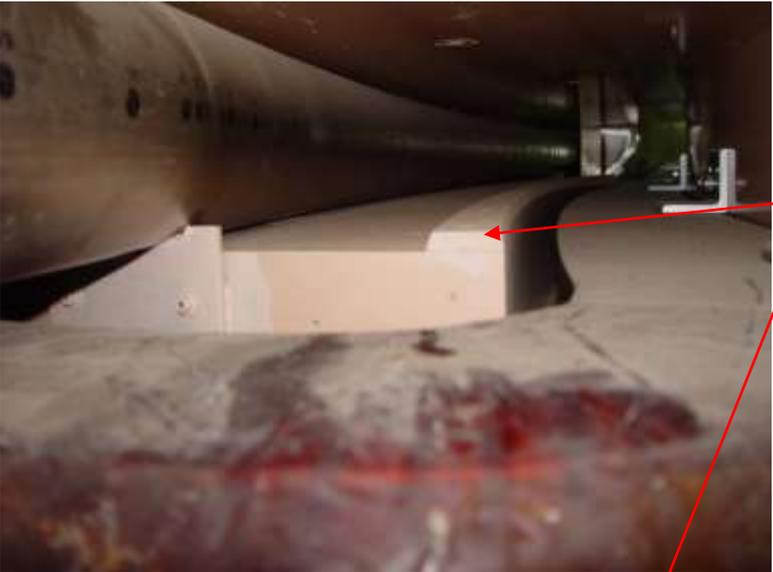
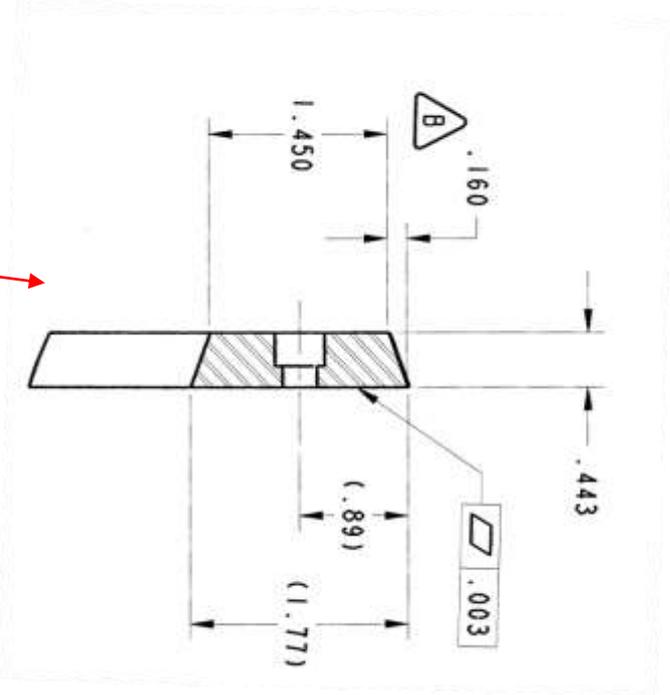
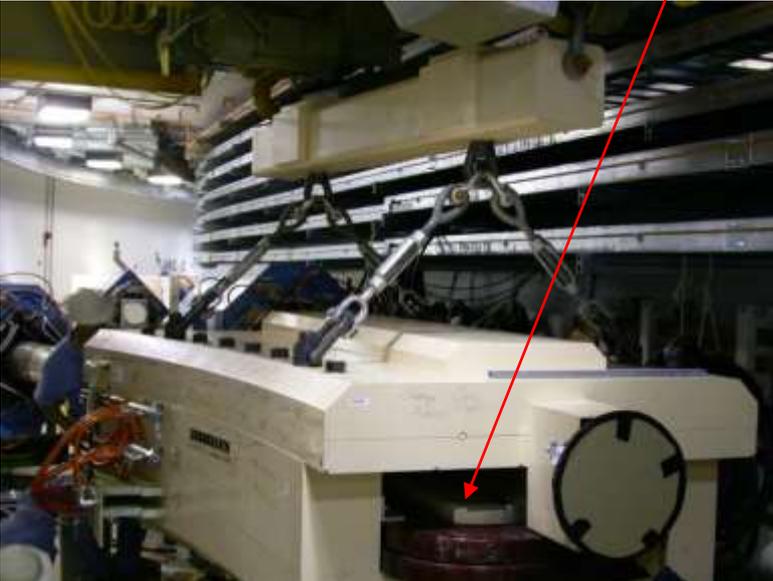
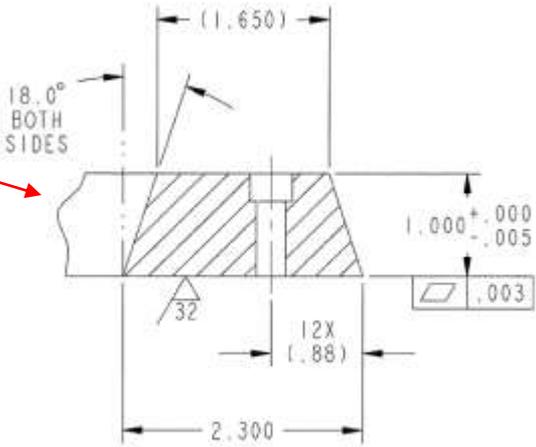
# Extraction septum shim replacement

- After replacing shims in February 2009, the single minipulse reconstruction measurements were repeated
- Cross plane coupling is now below measureable limit!

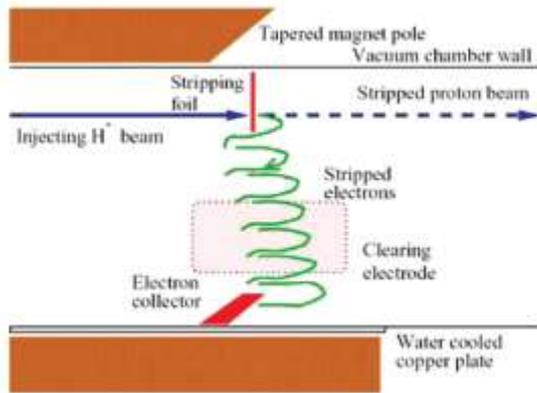
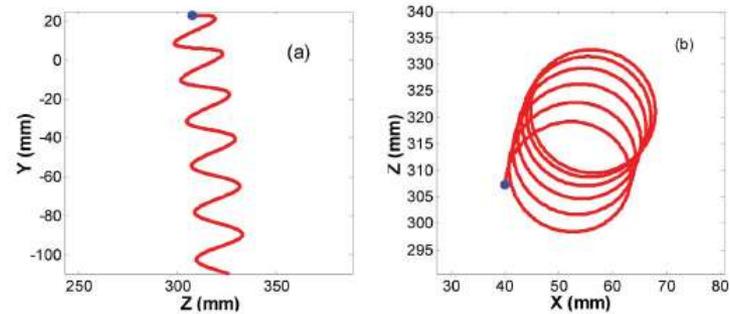
- Prior to May 18, when we installed a new type of foil bracket, the main cause of foil failures was due to convoy electrons hitting the foil brackets

FIG. 2. (Color) Trajectory of a stripped electron from the foil's center. (a) Orbit in vertical and longitudinal plane and (b) in horizontal and longitudinal plane. The blue point is the position where the electron was emitted.
