SNS Linac Modulator Operations and Performance

V. Peplov

January, 2012

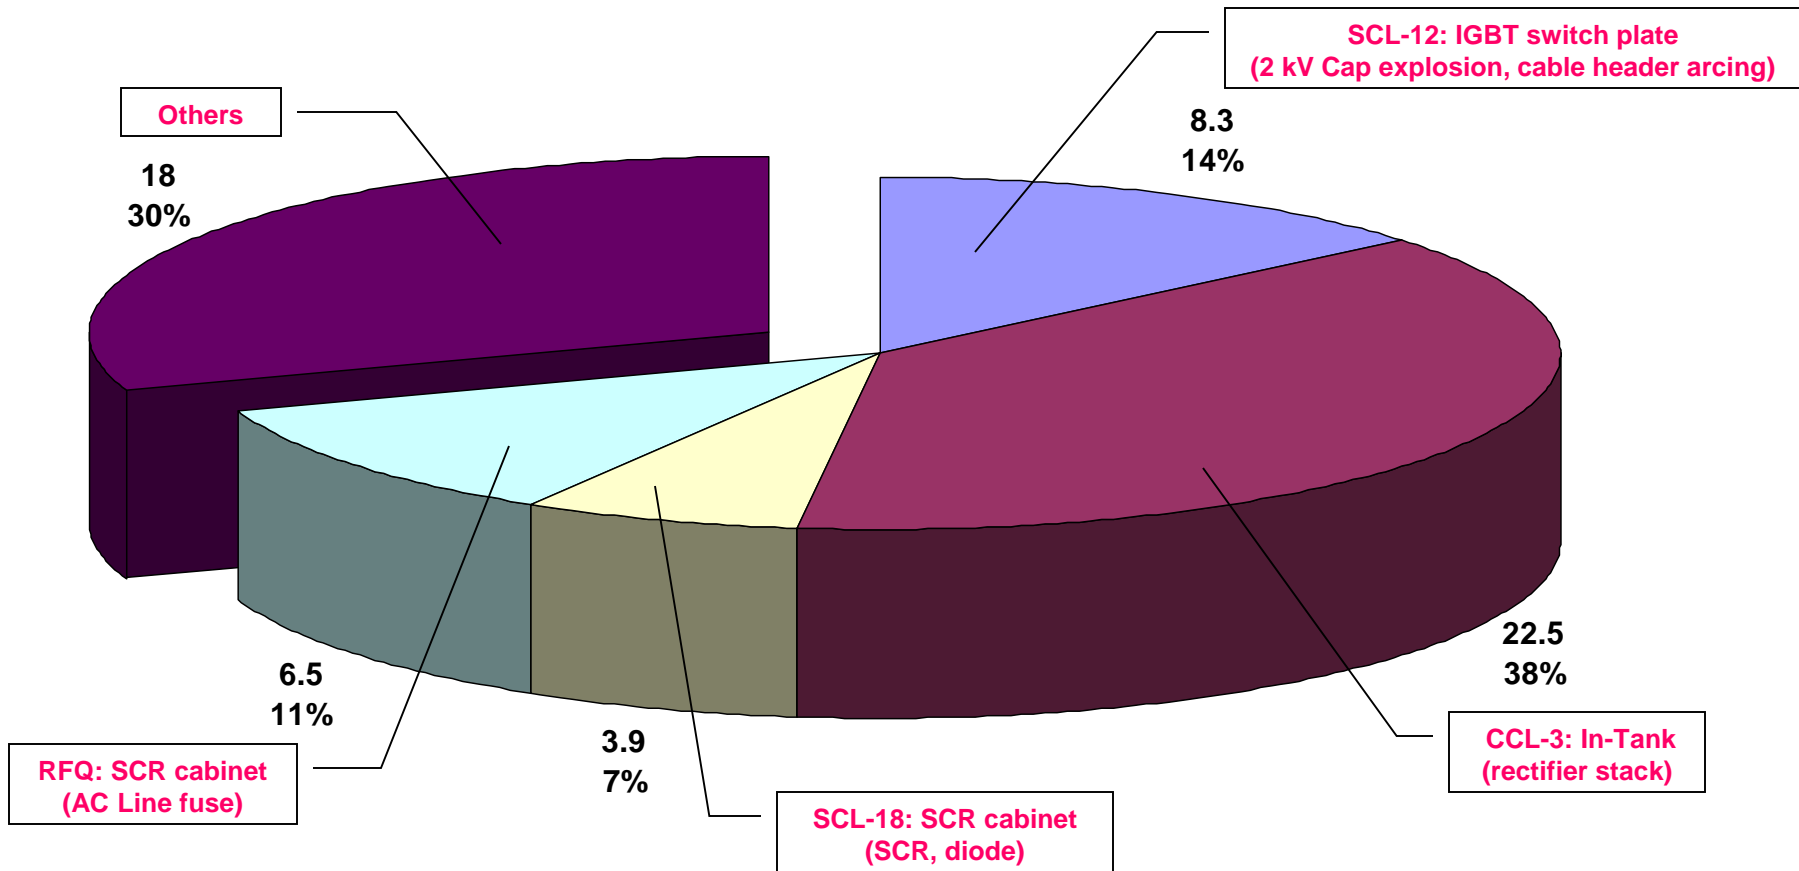
HVCM Downtime (2010-1)

$\Sigma = 59.2$ Hours

- 4 events – 70% contribution
- More than 1 hour downtime shown separately
- Others: different types of faults; each less than 1 hour

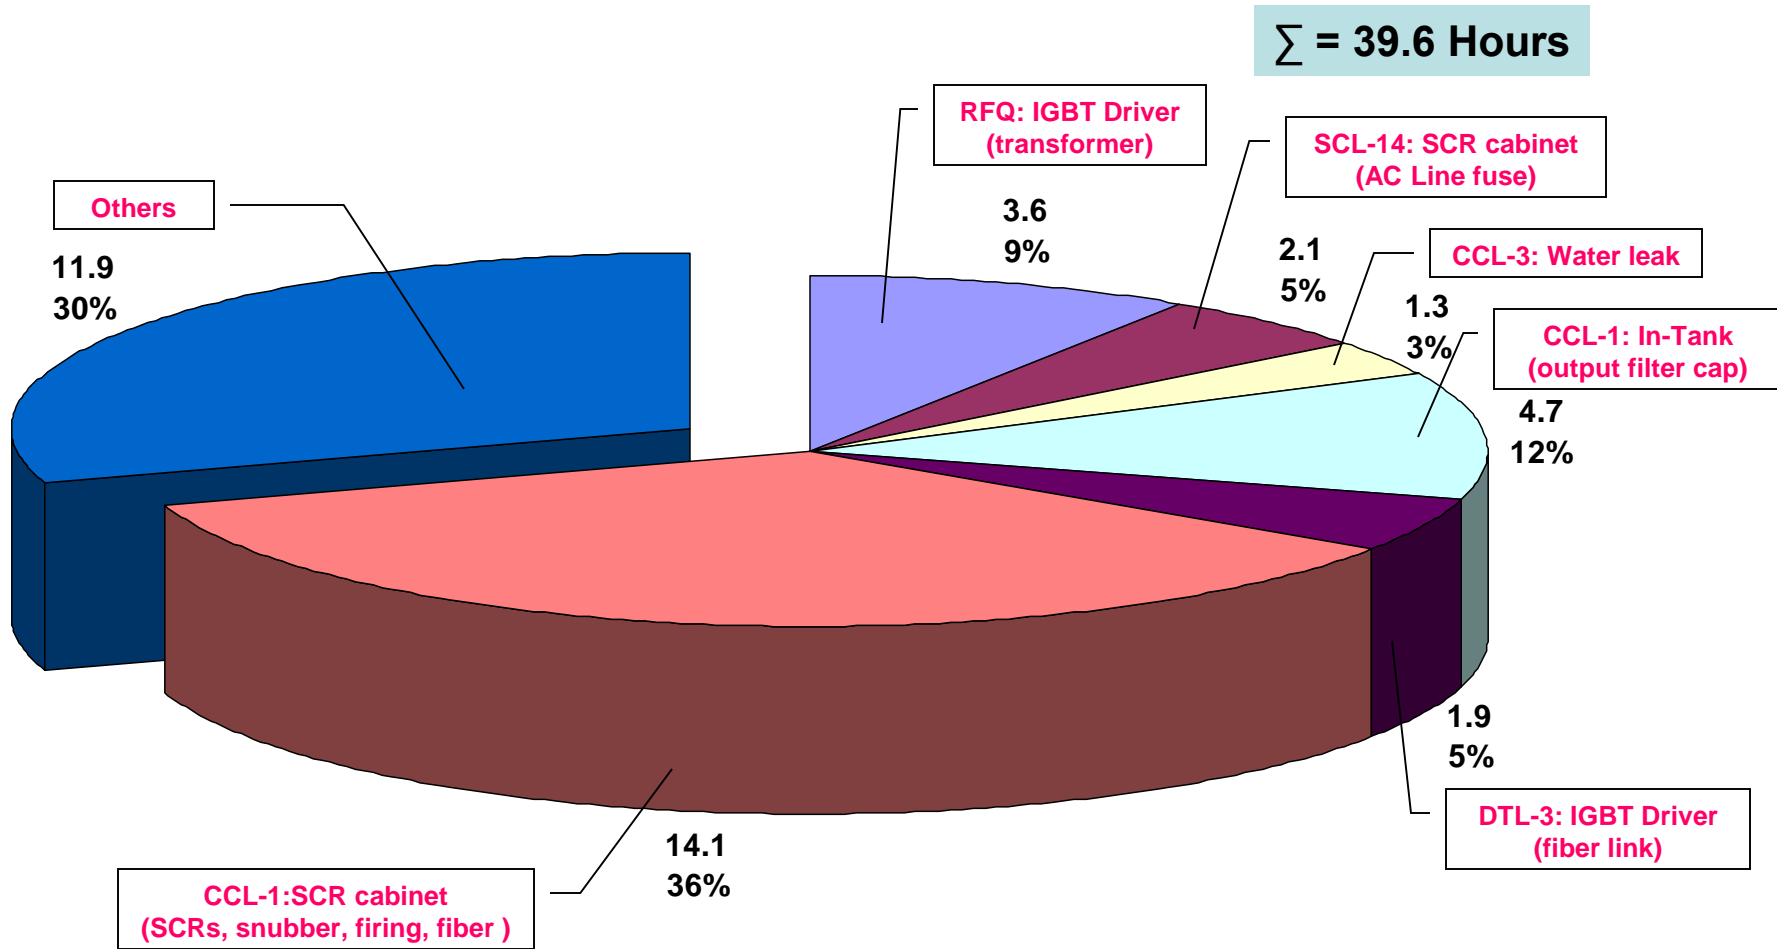
HVCM Downtime (2010-2)

- 2 events – about 50% downtime
- More than 1 hour downtime shown separately
- Others: different types of faults; each - less than 1 hour

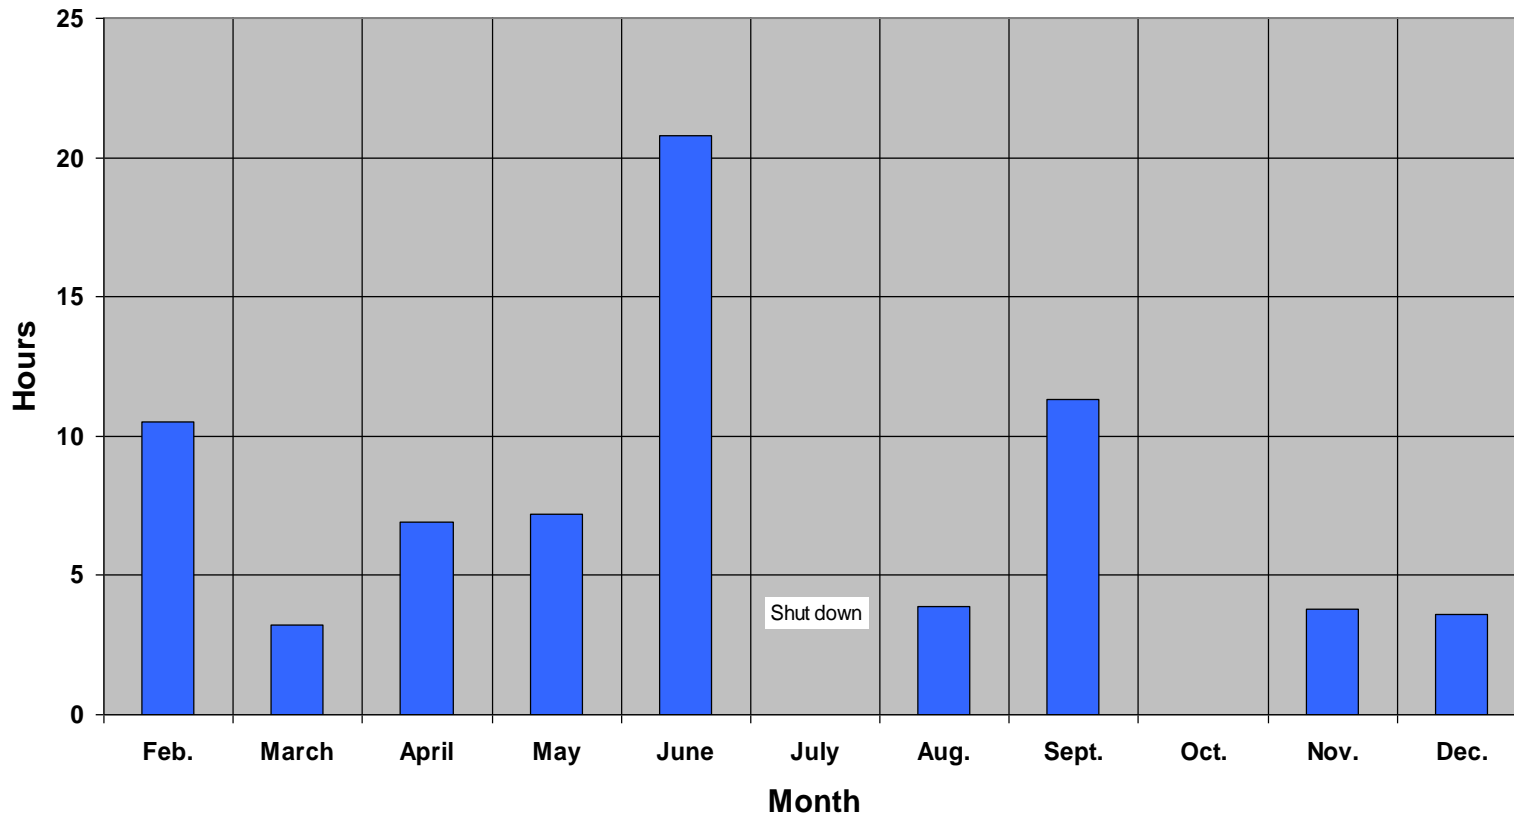
HVCM Downtime in CY-2011

Run	Hours
2011-1	
Feb.	10.5
March	3.2
Apr.	6.9
May	7.2
June	20.8
	$\Sigma=48.6$
2011-2	
Aug.	3.9
Sep.	11.3
Oct.	0
Nov.	3.8
Dec.	3.6
	$\Sigma=22.6$
Σ	71.2

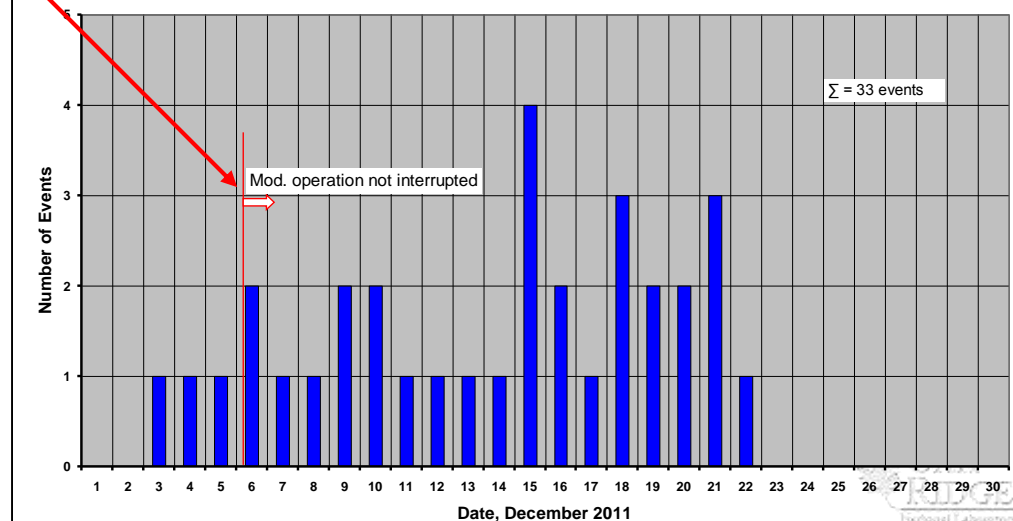
RFQ Mod: Dynamic Fault Statistics

- Harmonic trap capacitors (1.8 nF & 180 kV)
 - One cap looks good and passed 180 kV hipotting test
 - Two caps - internal breakdown at 100 kV and 120 kV
- Return HV cable – signs of pinch through breakdown
- Two bad capacitors on the rectifier stack
- Boost capacitors : one failed, two have split cases

- 3 new spare boost capacitors installed
- Caps tipped to avoid internal air bubble
- New spare harmonic trap capacitors installed
- Caps on rectifier stack replaced
- HV cable replaced

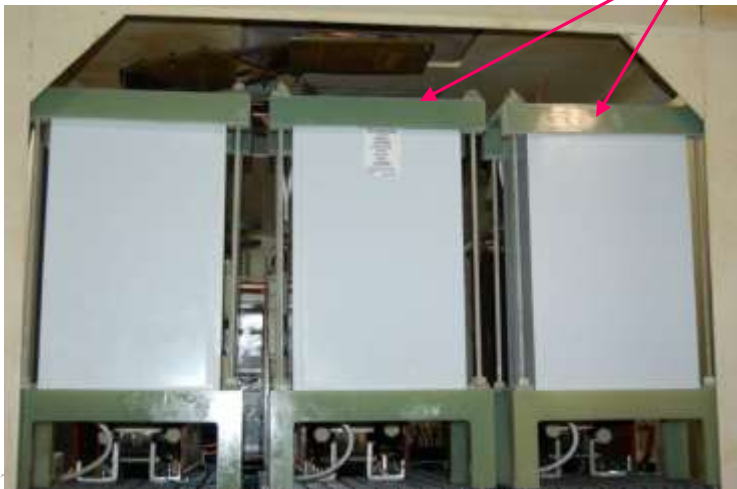
New 150 kV / 3100 pF CSI capacitors with brackets;
Installed in Summer 2010

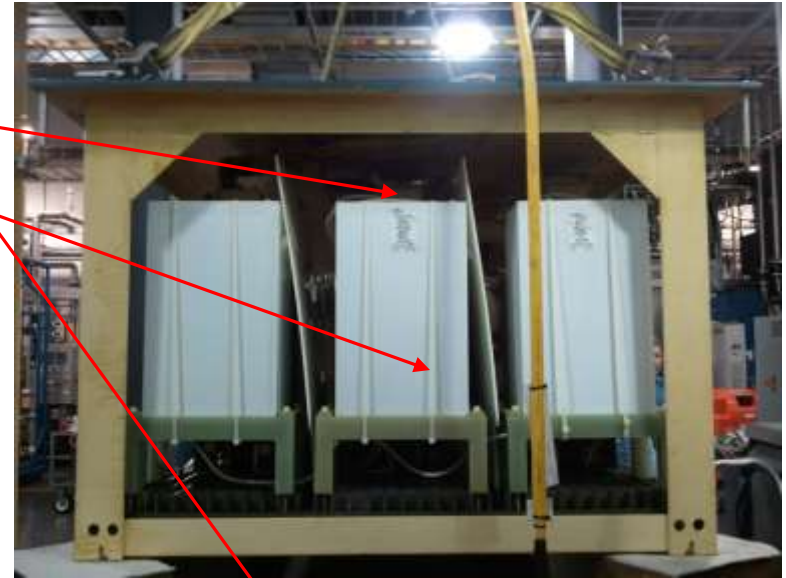
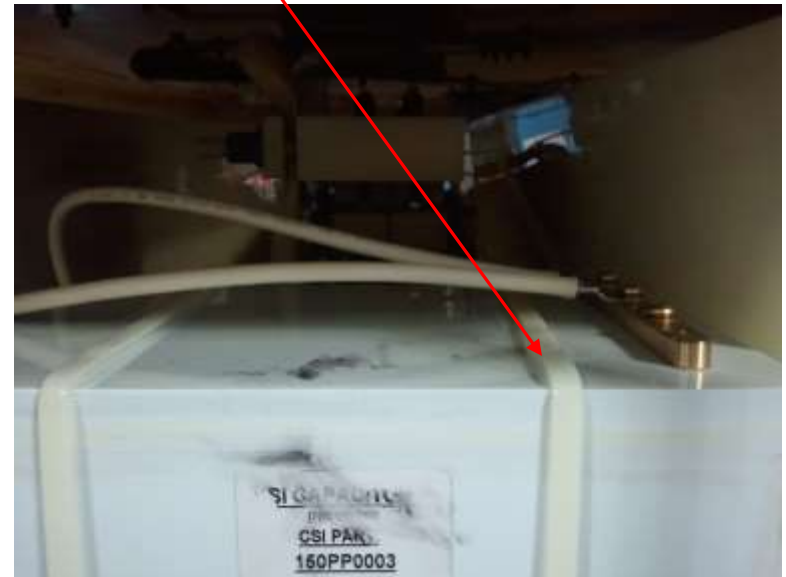
- RFQ tank inspection
- Failed caps found - still remain the problem

- 3 caps from RFQ – send to manufactory
- Inspect another tank in Jan. 2012
- 3 new SCL capacitors tested at full power
- Install into SCL tanks (Summer 2012 or regular maintenance days)

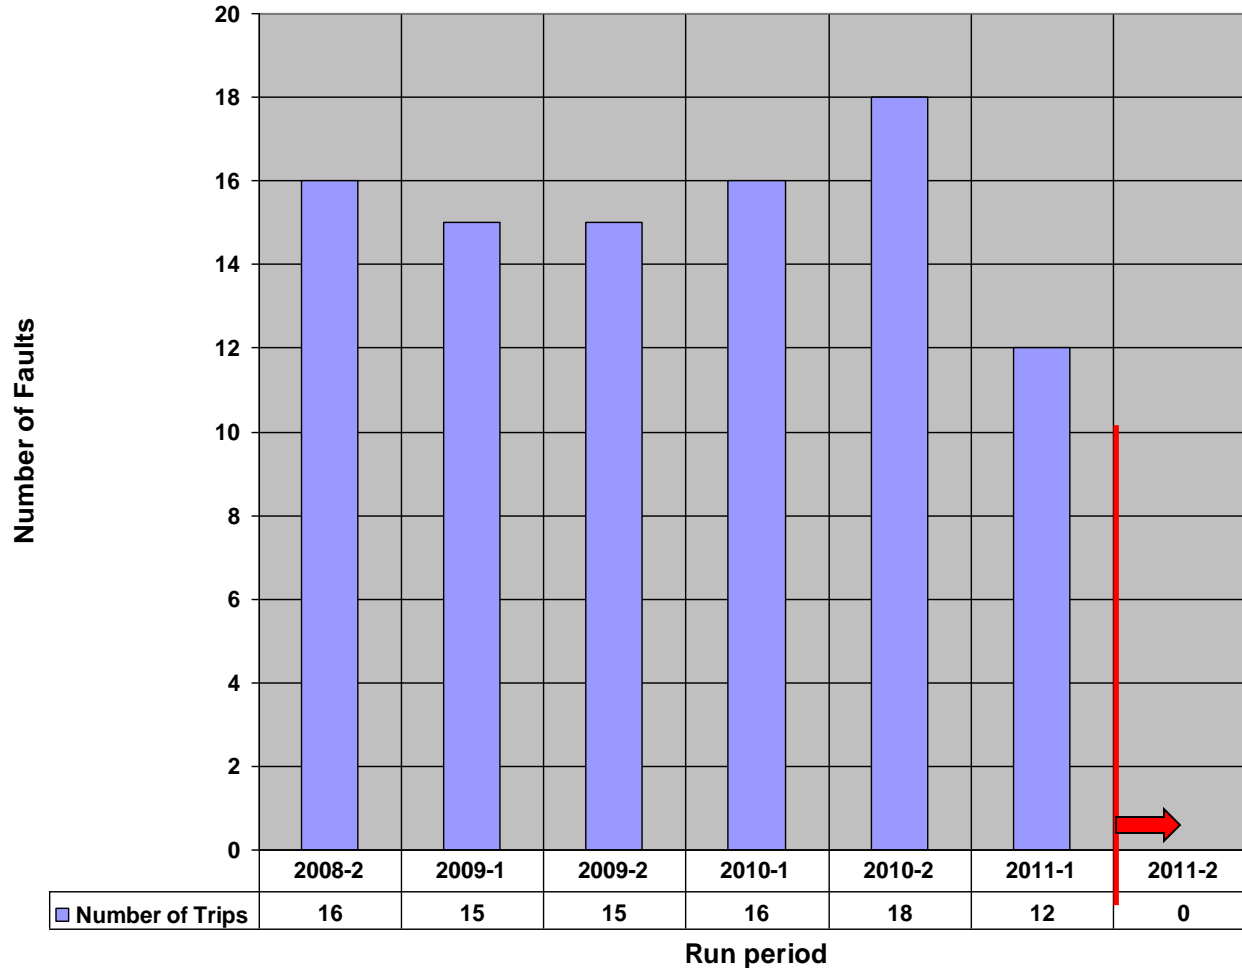
Timing Trips Statistics

Timing Faults:

- Pulse Repetition Interval
- Duty Cycle
- Gate Input Pulse Width
- Inter-Pulse
- ~0.2 hours recovery each time

- Input gate noise filtering board installed
- All old coax cables replaced with new
- Loads moved from chassis onto PCB

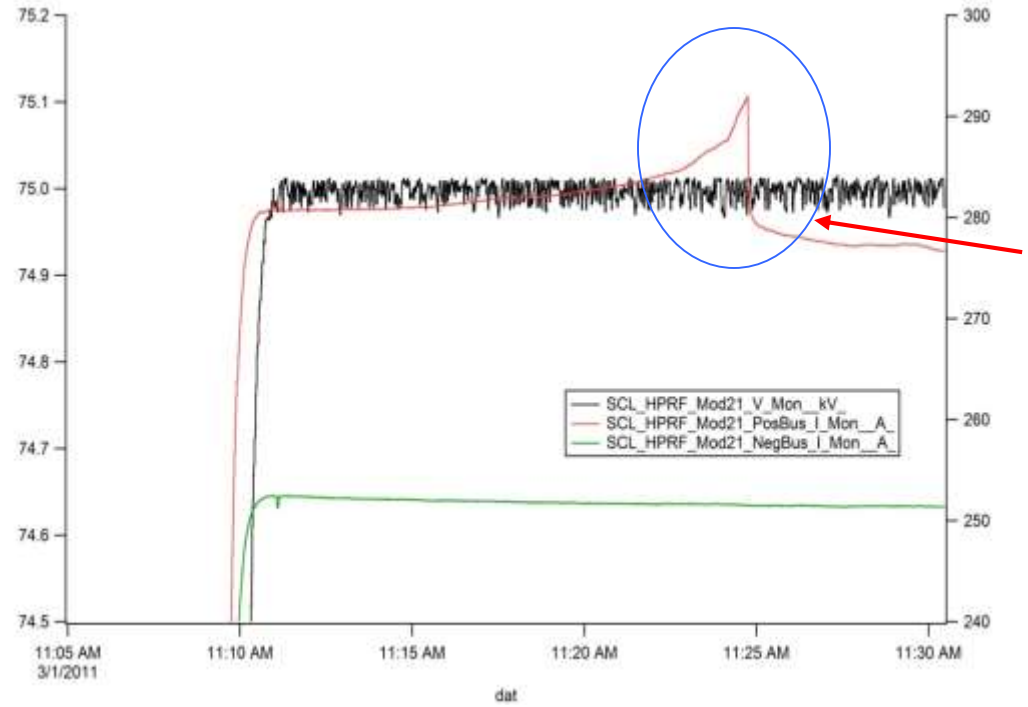
Start up Feb. 28, 2011
7 Amp step in Pos Bus Current
causes 200V jump in Mod V

SCR Feedback signal moved from Positive Bus Current sensor to Negative

- SCL-21:**
- Positive Current feedback signal drifts and has sudden steps
 - Changed to Negative Current feedback signal for regulation – no Voltage jumps
 - Current sensor on Positive Bus replaced

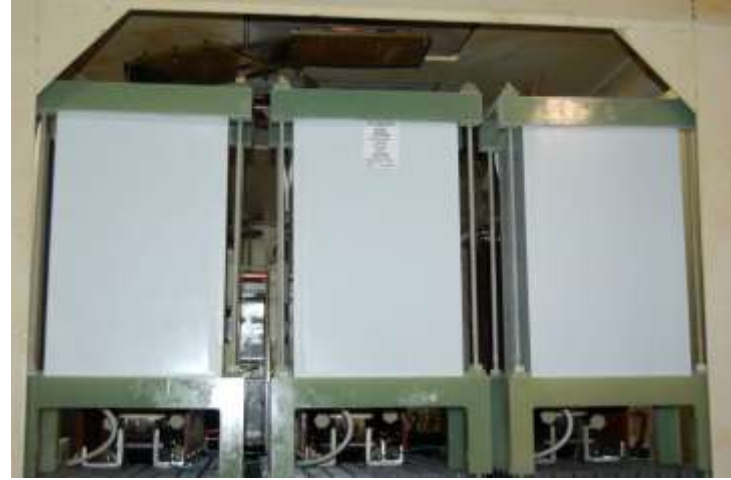
New 150 kV / 3100 pF CSI capacitors with brackets

- Inspection in Jan. 2011 revealed the problem
- Analysis and simulation done (SNS and CSI)
- Mounting brackets changed

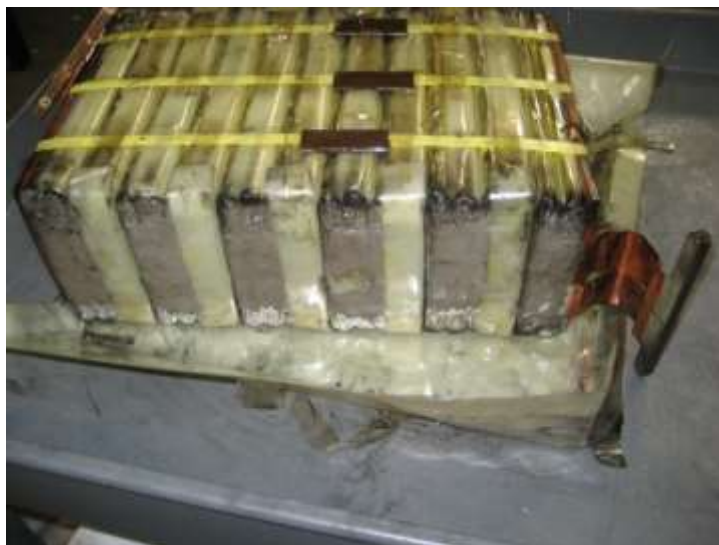
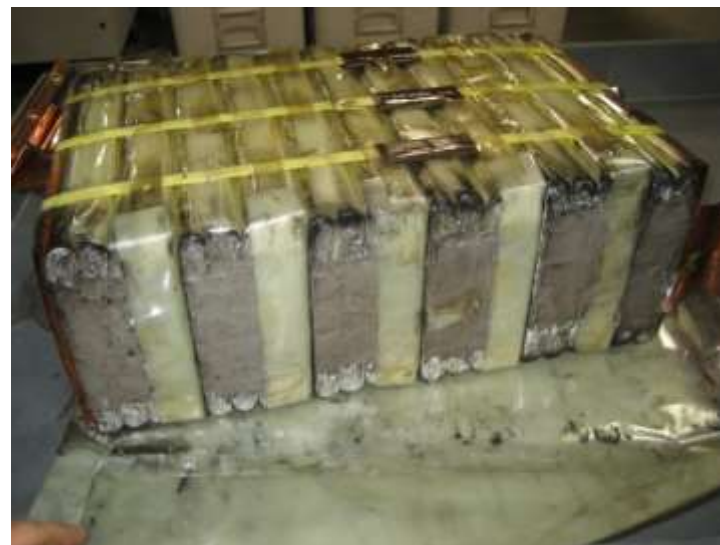
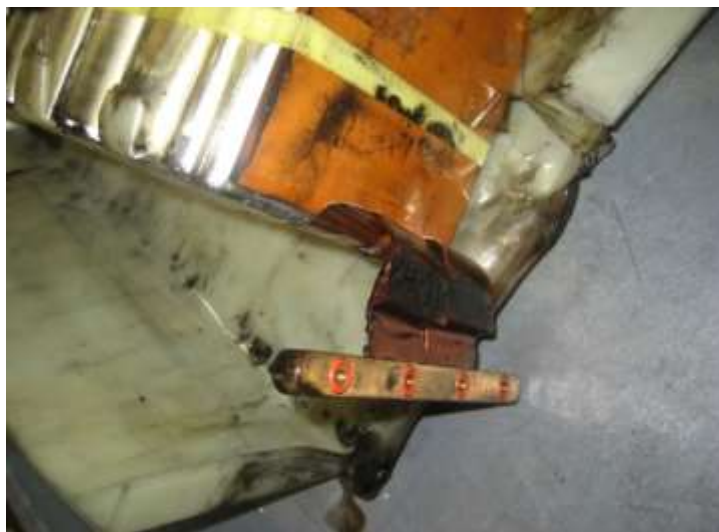
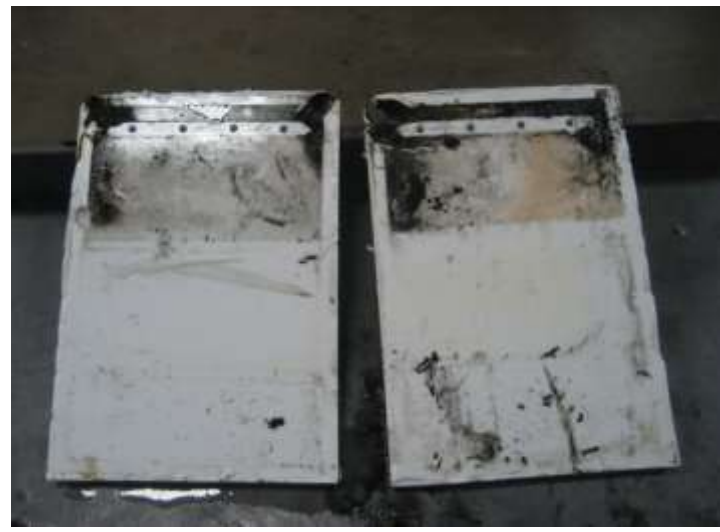
CSI Failure Analysis of RFQ/ CCL4 Caps

- Presence of air bubbles either inside or external to the capacitor creates a problem where corona inception will eventually cause degradation of the surrounding insulation system and lead to catastrophic failure
- The upper brackets should be replaced with another style of bracket less likely to trap air
- The capacitor should be mounted at a slight angle to force any air that may be trapped internally away from the electrode since the manufacturer cannot guarantee that the unit will be bubble-free
- A follow-on inspection should occur at the next available opportunity to conform the mitigation strategy employed during the recent winter shutdown
- Further testing should continue on the virtually-equivalent SCL boost capacitors in the HEBT modulator for as much time as operational and other developmental demands will permit.

- Pictures from CSI
- All 7 capacitors repaired

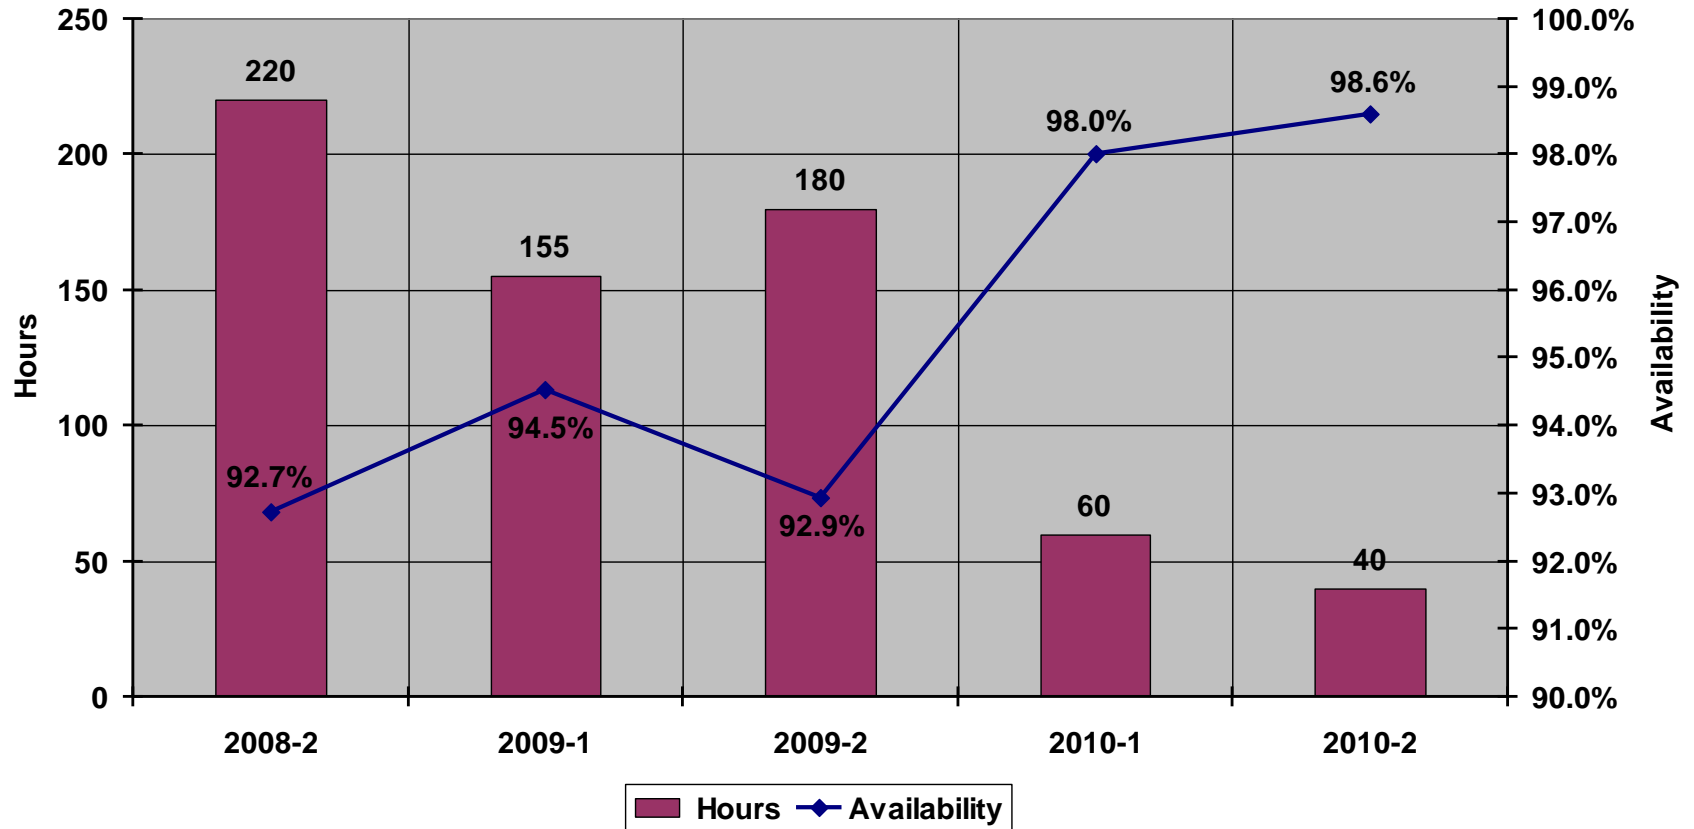
HVCM Downtime and Availability

- The HVCM system was a major contributor to the accelerator down time until 2009
- Thorough failure mode analysis done
- A lot of upgrades and modifications during last two years
- HVCM downtime reduced about factor of 10 (!) from 220 hours in 2008-2 running cycle to 23 hours in 2011-2
- Overall HVCM system availability increased from 93.7% in 2009 to 98.7% in 2011

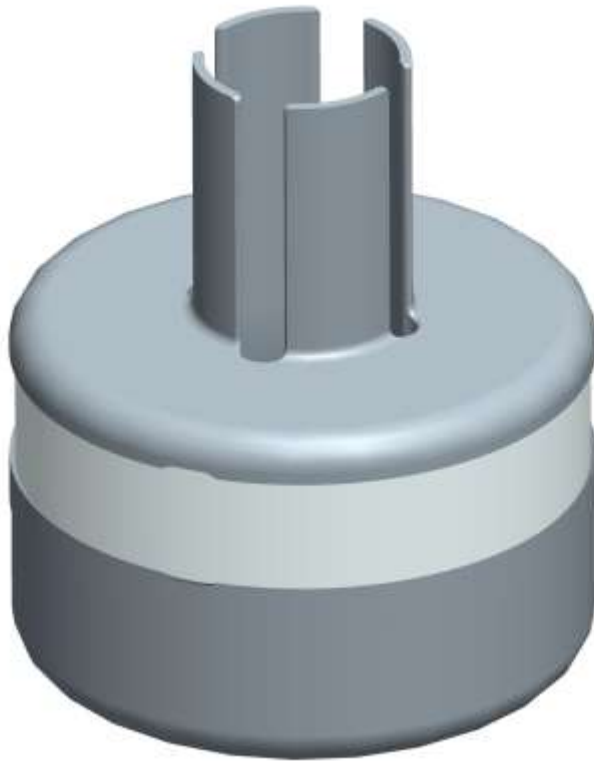
Modulator Tank HV Output Receptacle Return Connector

HV output cable damage

- Long time in service
- Swelling in the oil
- Air bubble possible
- Insulator degradation

Result: Shorted / Arcing Cable

- Damaged cables replaced and re-terminated
- New cables in 7 NCL modulators (Summer -2011)
- New cables in 4 SCL modulators (Jan. 2012)
- Improved receptacle return connector (larger radius, no sharp edges) designed and manufactured
- Testing on RFTF

- Complete replacement in SCL (Jan. 2012)
- Re-terminate cables with improved receptacle return connector
