Target Development

Target cavitation damage mitigation R&D efforts have been suspended

Five hole cuts were made in T3 beam entrance window – Where's the leak?

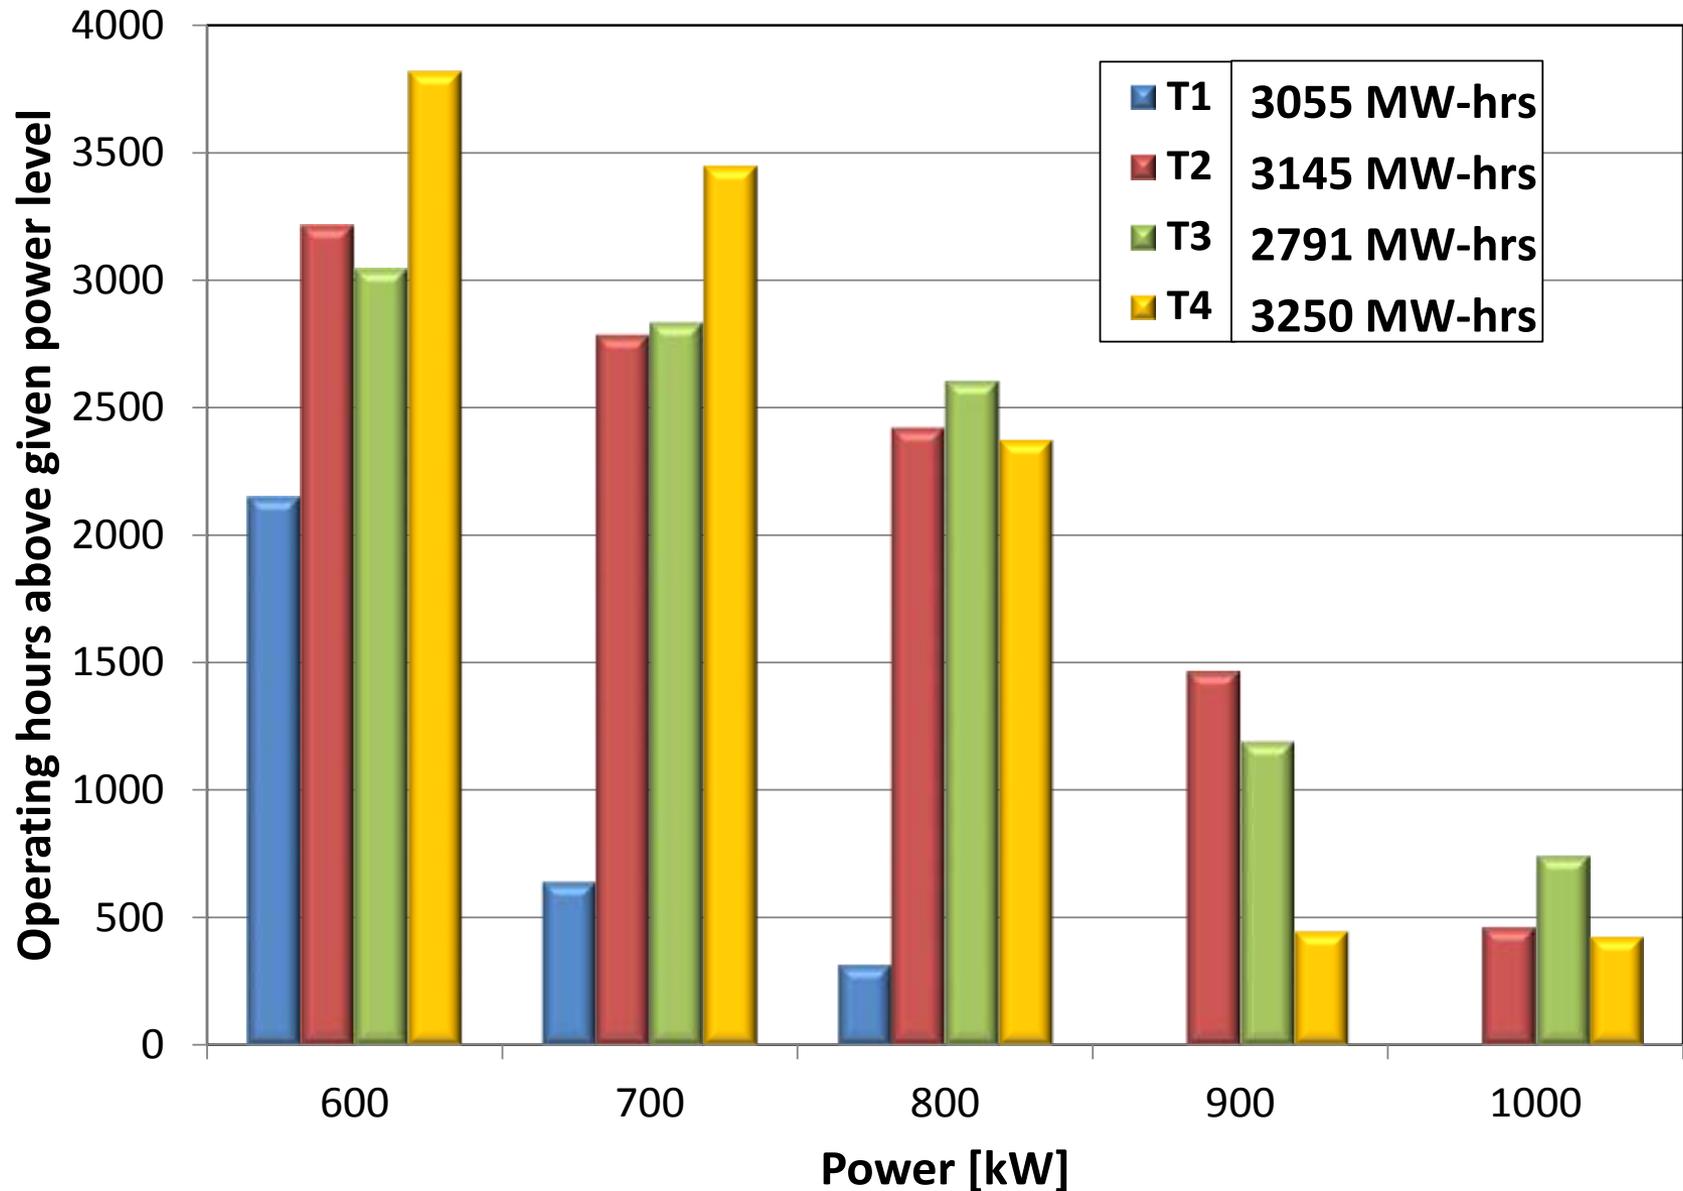
Operating hours above power level

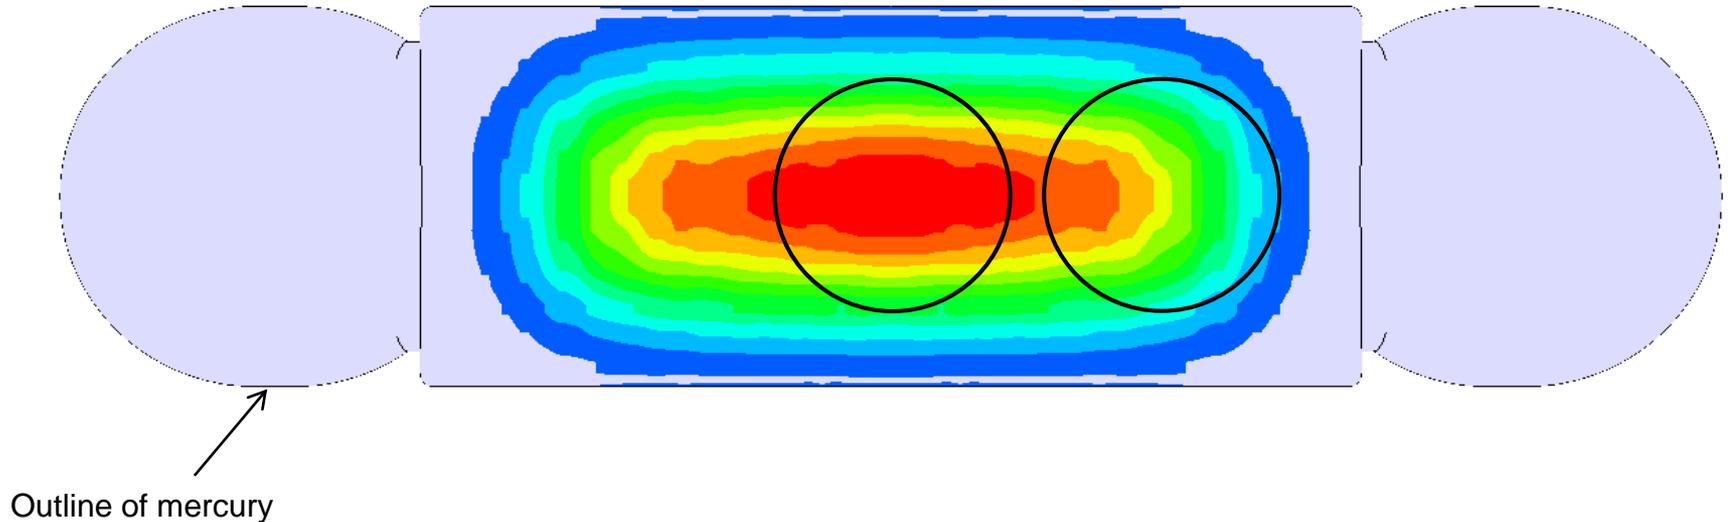
Relative deposited beam energy density at center and off-center specimen locations

- Based on “nominal” proton beam incident profile on target

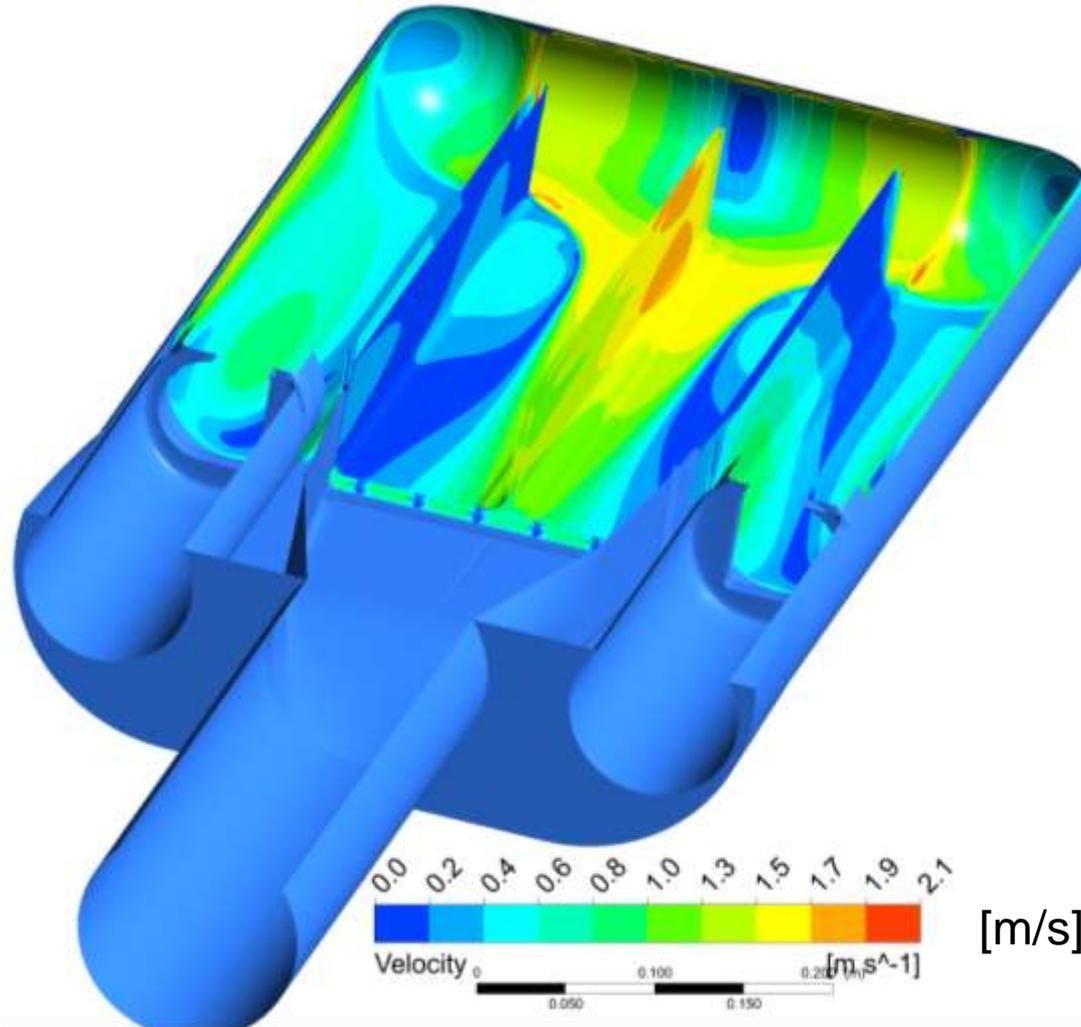
Mercury flow near the wall is a likely mitigating mechanism

- Higher velocity at the wall → greater damage *mitigation*

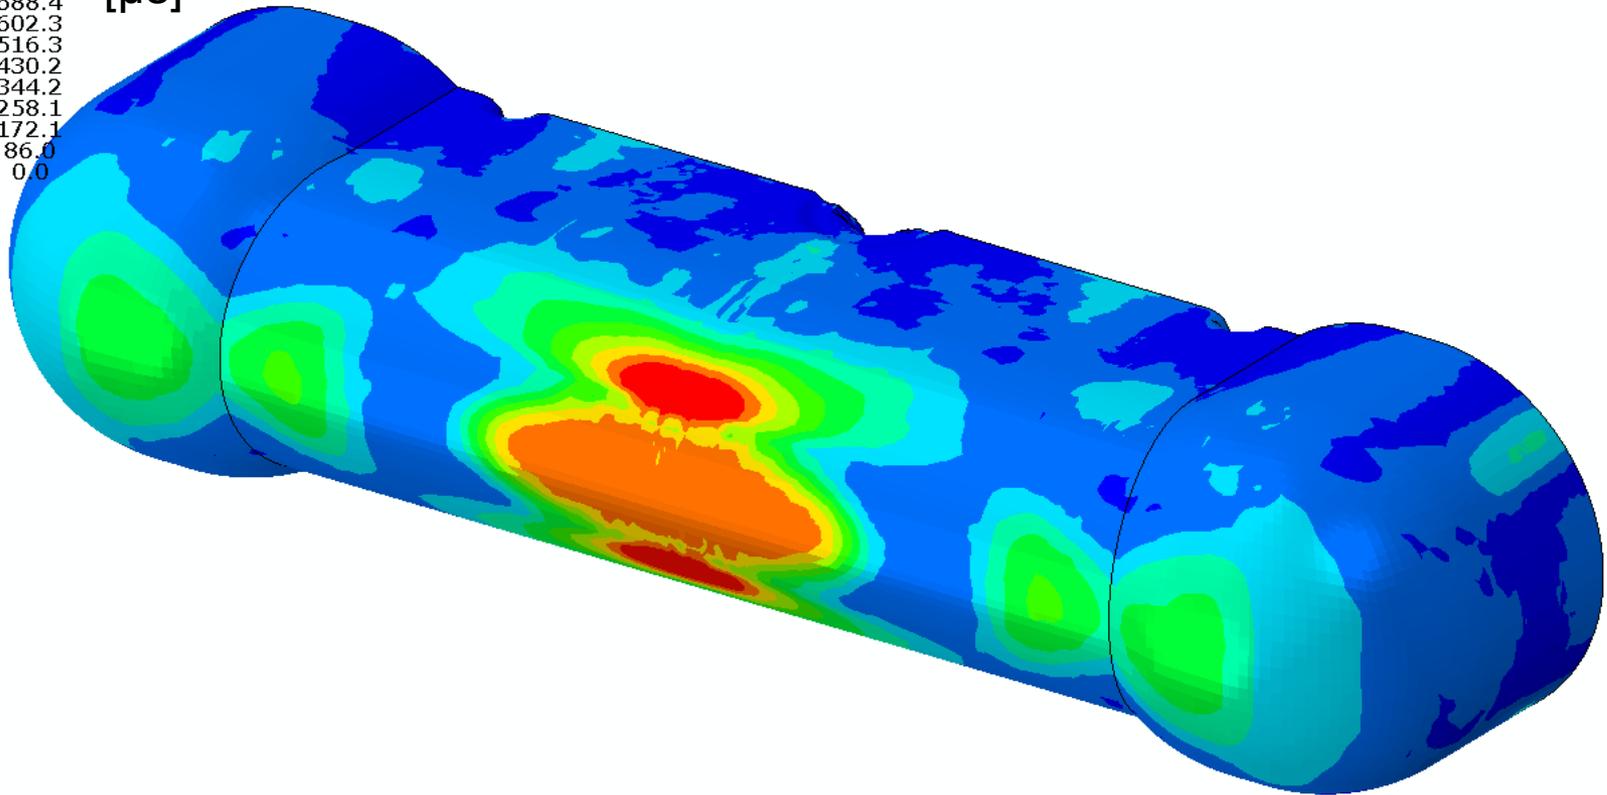
Saturation time on bulk mercury at 1 ms from pressure pulse simulation

Higher saturation time at the wall \rightarrow increased damage *potential*

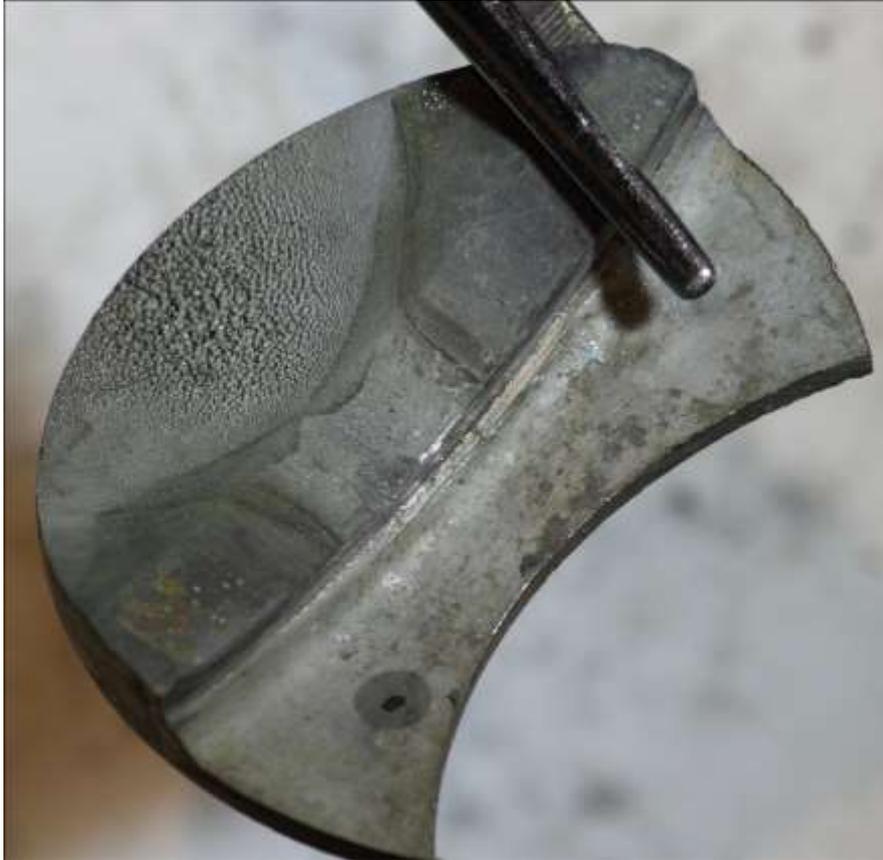
Disk 14 – driver side supply

T3 far outside cuts
