# Linac Modulator Operations and Performance

V. Peplov

Feb. 2010

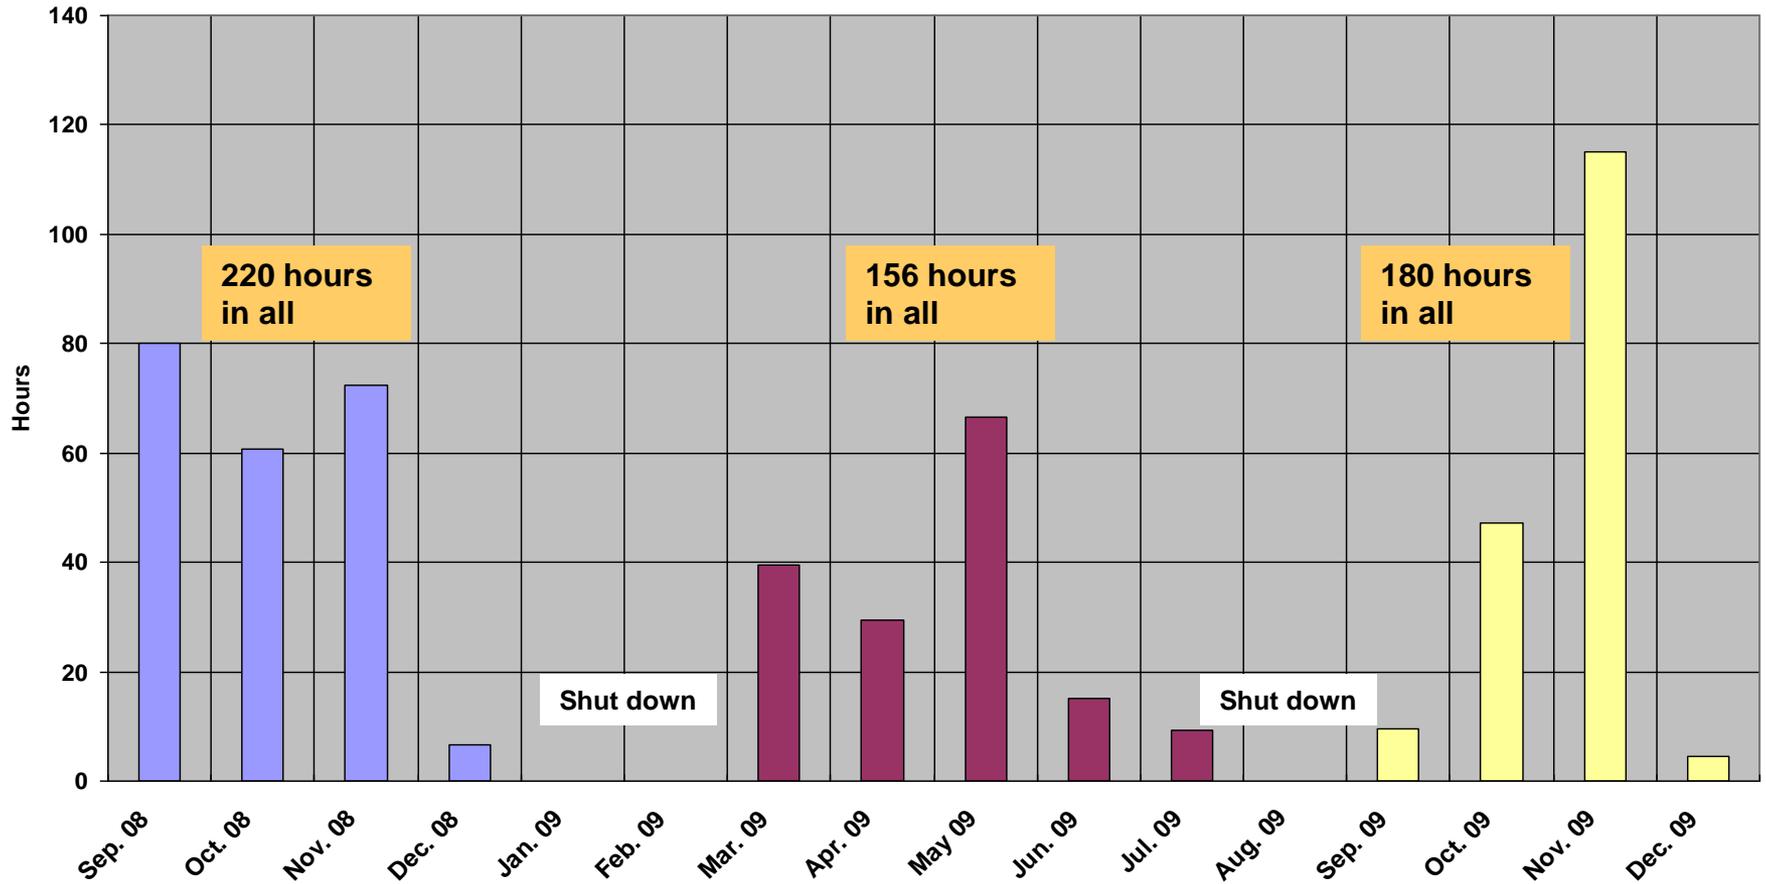
## HVCM Downtime by Months (Sept. 2008 - Dec. 2009)

Month	Hours	% of total downtime
Sep. 08	80	14.4
Oct. 08	61	10.9
Nov. 08	73	13.0
Dec. 08	7	1.2
Jan. 09	0	0.0
Feb. 09	0	0.0
Mar. 09	39	7.1
Apr. 09	29	5.3
May 09	67	12.0
Jun. 09	15	2.7
Jul. 09	9	1.7
Aug. 09	0	0.0
Sep. 09	10	1.7
Oct. 09	47	8.5
Nov. 09	115	20.7
Dec. 09	4	0.8
<b>Σ</b>	<b>556</b>	<b>100.0</b>

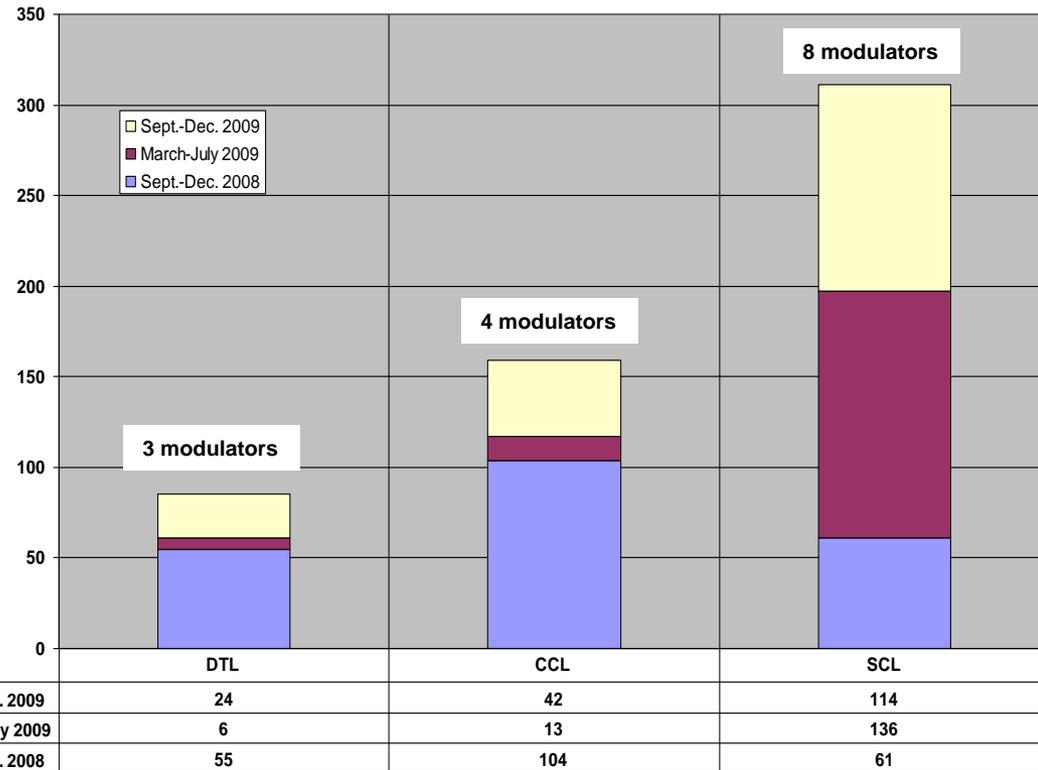
**HVCM Down Time by Area**  
(Sept. 2008 - Dec. 2009)

Sept.- Dec. 2008	March- July 2009	Sept.- Dec. 2009	Σ	% of all
DTL-1	18	4	18	40	7.2
DTL-3	6	1	6	13	2.3
DTL-5	31	2	2	35	6.3
CCL-1	25	4	35	64	11.5
CCL-2	26	0.5	6	32	5.8
CCL-3	26	7	1	34	6.1
CCL-4	26	3	0	29	5.2
SCL-1	2	1	13	16	2.9
SCL-5	0.5	4	0	5	0.9
SCL-9	23	6	0	29	5.2
SCL-12	11	19	38	68	12.2
SCL-14	0	56	21	77	13.8
SCL-15	0	27	16	43	7.7
SCL-18	26	23	28	77	13.8
SCL-21	0	0.5	0.5	0.5	0.1
Σ				556	100

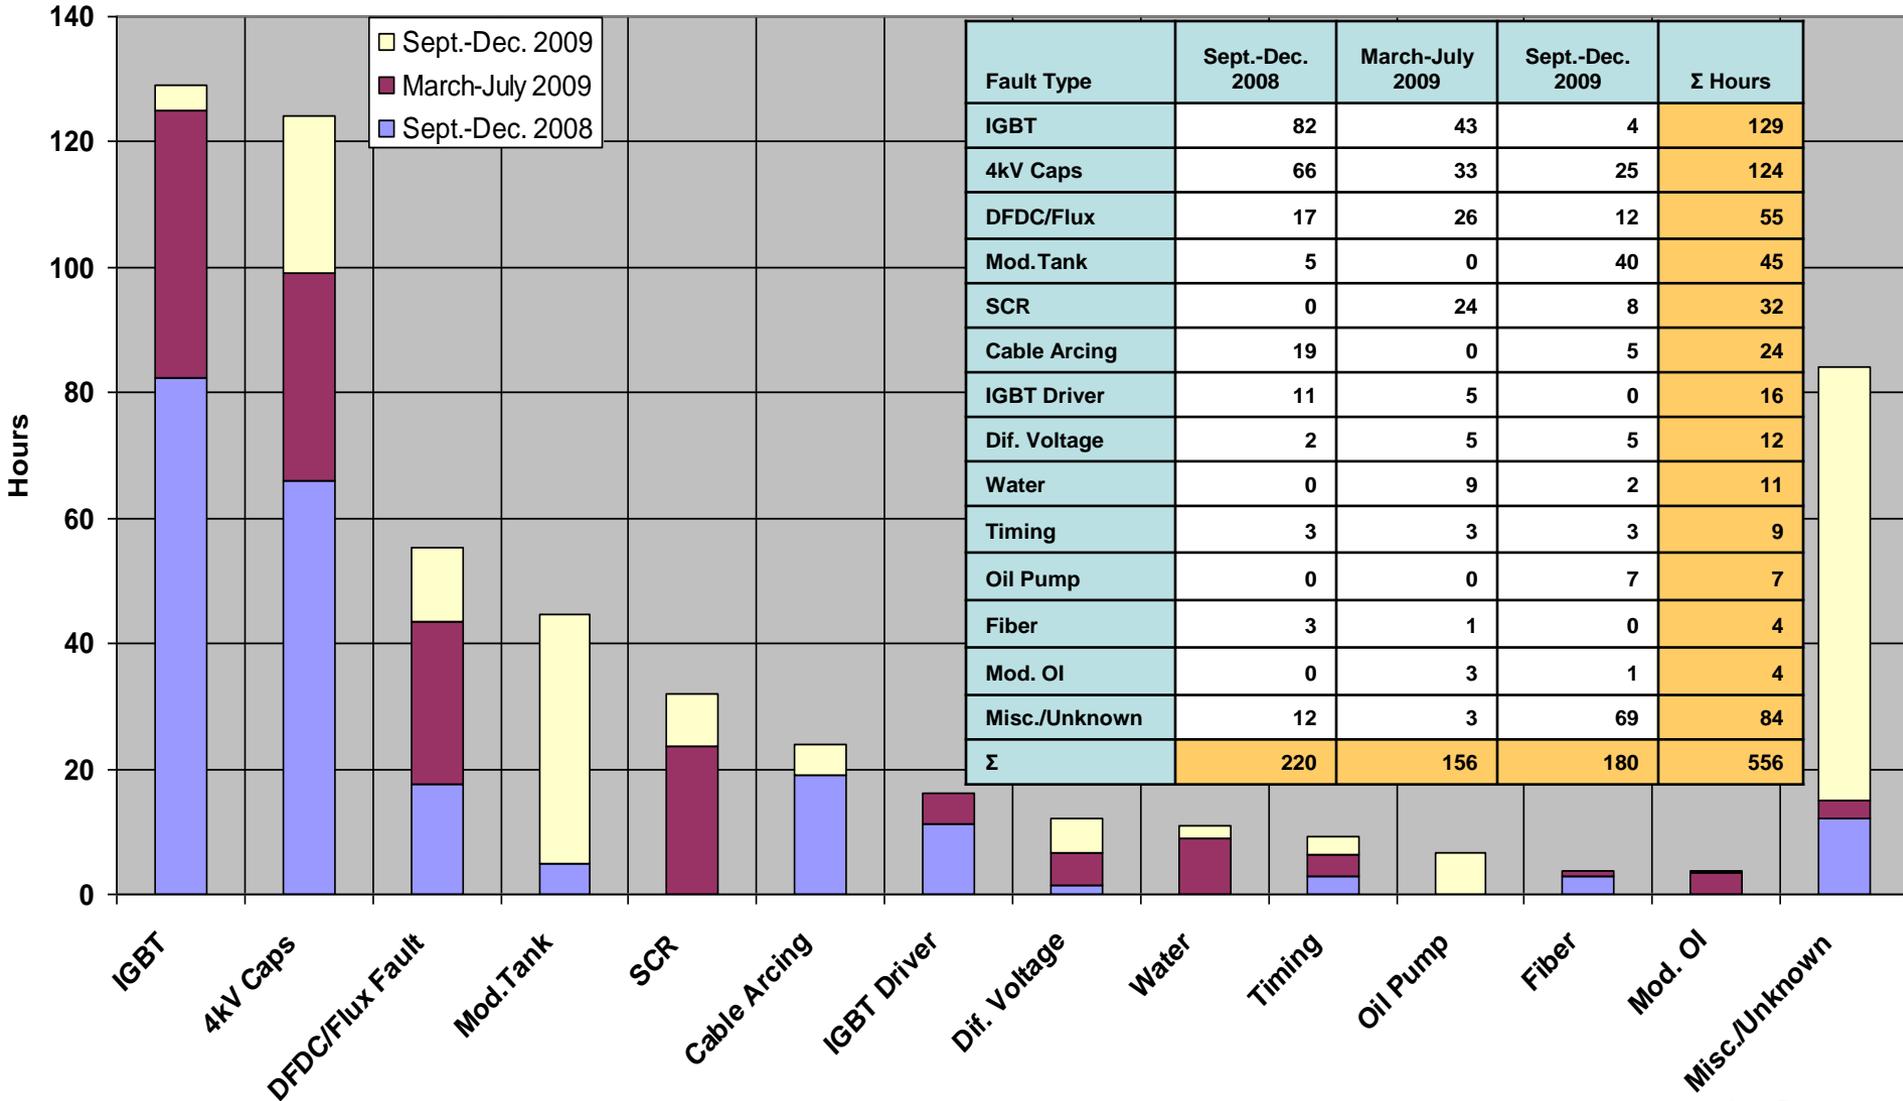
# HVCM Downtime by Fault Types

- Main contribution in Sept.-Dec. 2008;
- Then number of events and downtime reduced since end-of-pulse stress problem was resolved in March 2009;
- Only one event in Sept.-Dec. 2009 – down time reduced by 20X
- IGBT internal damage caused by previous operational stress;
- Shoot thru condition still may occur due to driver/firing failures;
- Slow change/drift of IGBT internal parameters and electronic delays (drivers)

- Downtime reduced since original small caps were replaced with new large caps;
- Use caps with canola oil impregnant instead of synthetic oil leads to less damage in case of explosion (no fire - reduced repair time);
- Only two events over last run (SCL-1 and SCL-15);
- Dry self-healing caps on CCL-4 - a year without problems - look promising

- Flux faults- long adjustment procedure (up to hours);
- Reason - drift of driver/IGBT parameters
- Most of dynamic faults - less than 0.5 hours down time each (RF recovery);
- Arcing in the load, in the tank, voltage spikes may cause this fault;
- Down time reduced over last run

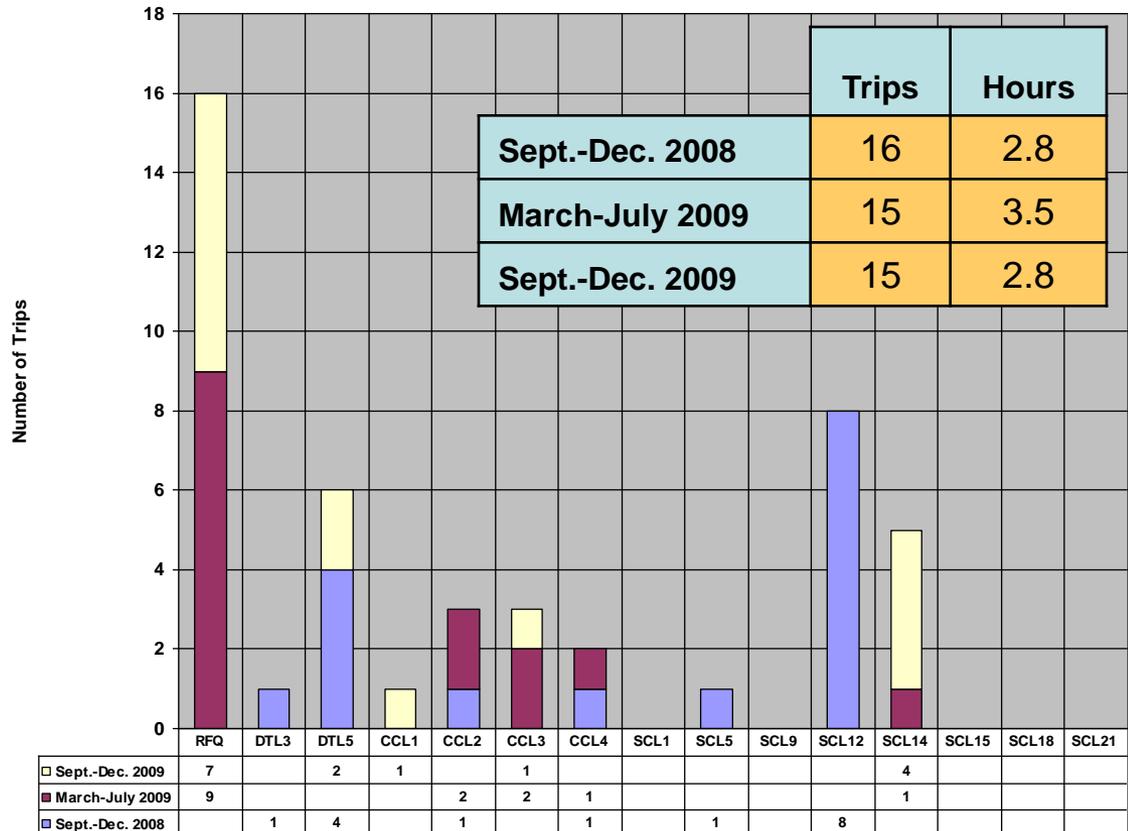
## HVCM Trips caused by Timing Faults

- Optic transceiver/receiver failure;
- Fiber optic damage/dirty fibers;
- Noise;
- Timing system faults

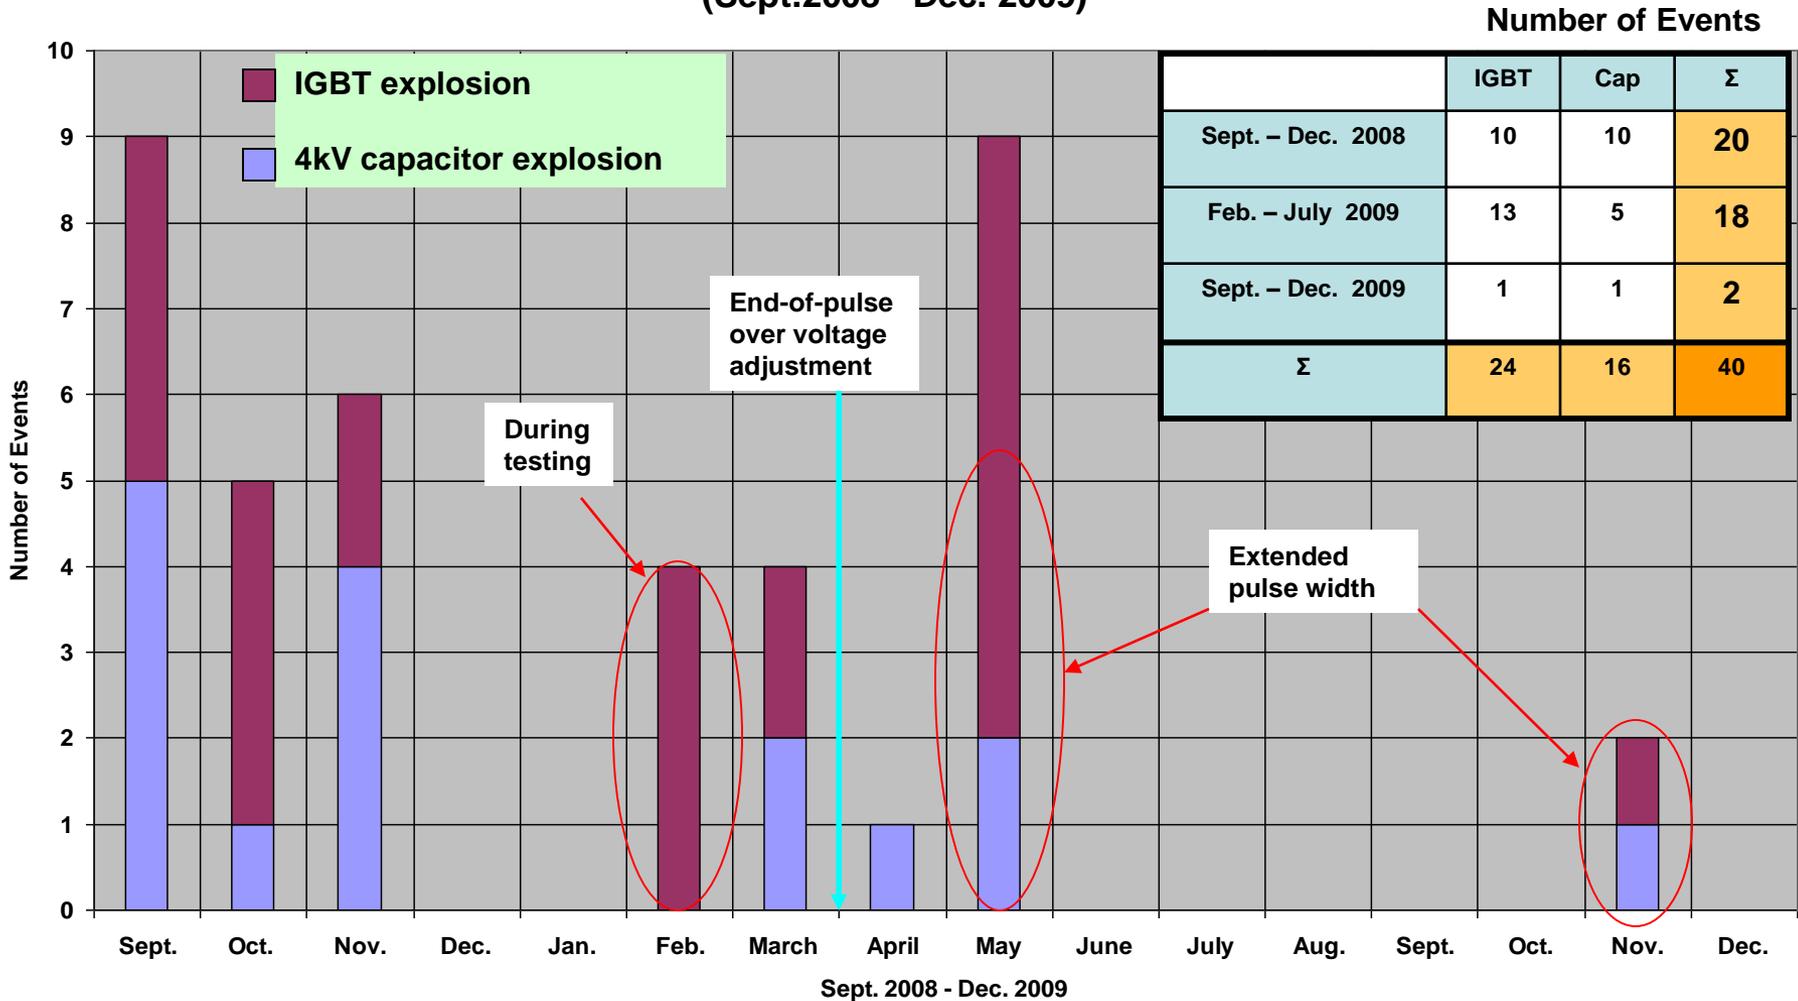
## HVCM Smoke Alarm Events by Months (Sept.2008 - Dec. 2009)

- Overheating, end of life of original small 4kV flammable oil filled capacitors;
- IGBT stress/internal damage (end-of-pulse over voltage)

1. IGBT:
  - Use new devices when replaced;
  - Improved thermal bonding procedures implemented;
  - Overvoltage problem solved, minimal problems since
2. Capacitors:
  - Original small caps were replaced with new large caps;
  - RSO filled instead of BTDP were used;
  - All oil filled caps replaced with dry self-healing caps during Jan. 2010 maintenance period
3. Implement Alarm Handler for smoke detector events
4. Old style header cables replaced with non-flammable and improved end connections
5. Inside enclosure: replaced combustible materials with flame-proof
6. Emergency Off modified to remove 2100 V primary energy source automatically
7. Installing shrapnel shields around capacitors to minimize collateral damage
