SNS Target Post Irradiation Examination Program 2012-2013

SNS Accelerator Advisory Committee

May 8, 2013

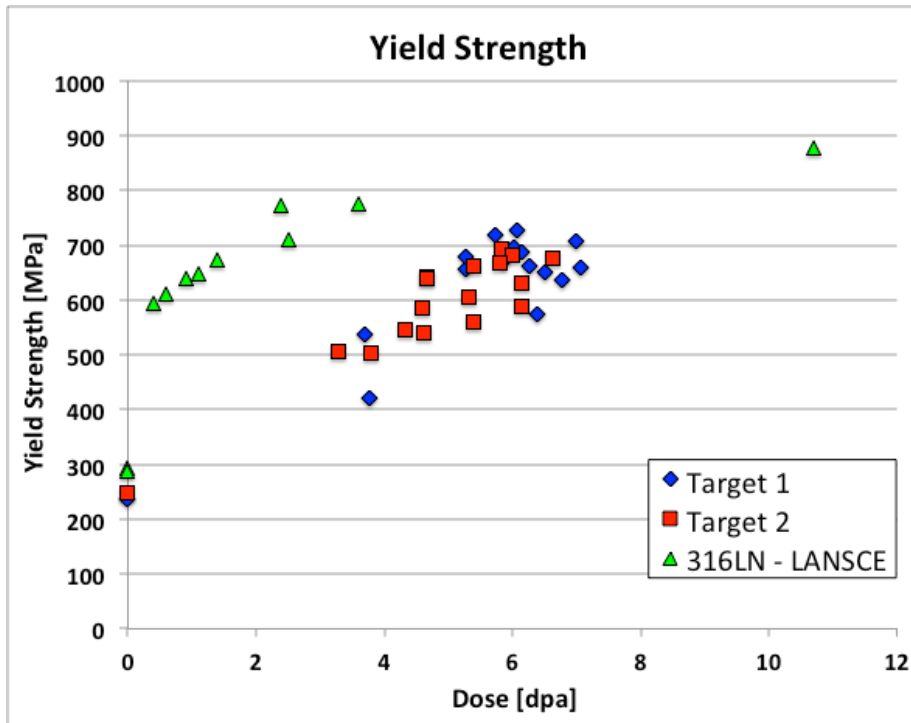
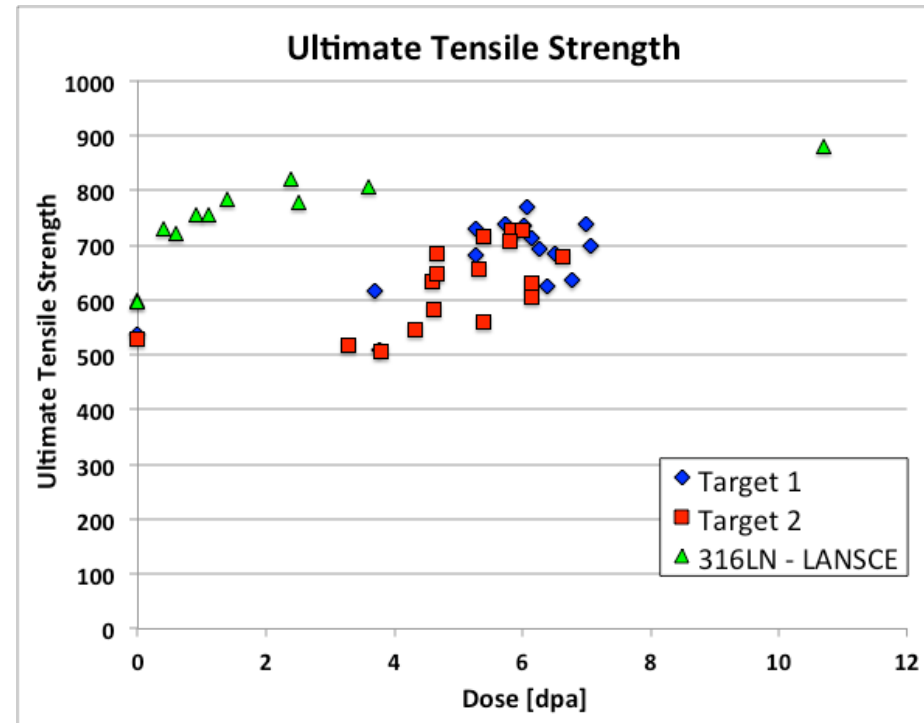
Tensile data show significant strengthening occurred during operation

- LANSCE irradiation was 316LN – slight higher strength expected due to nitrogen addition
- General hardening trend of SNS tensile data is consistent with data in literature

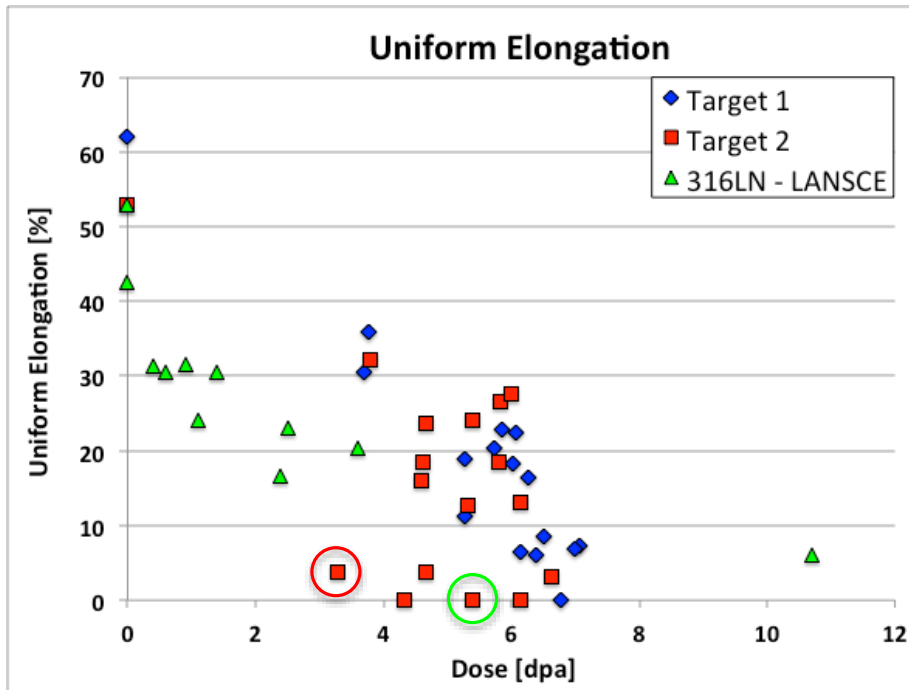
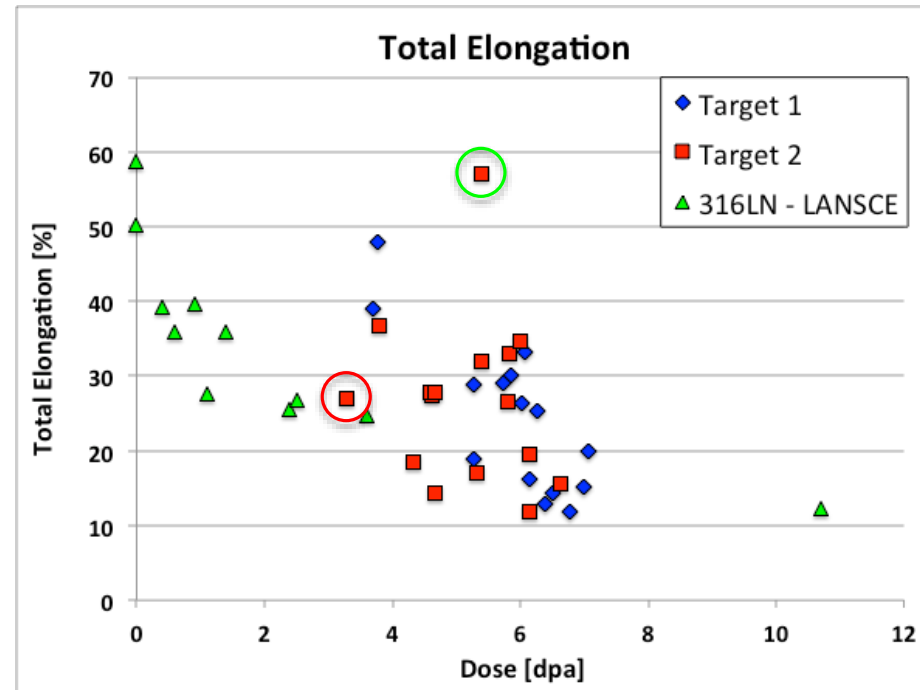
Tensile data show appreciable total elongation remained after ~7 dpa

- Reduction in uniform elongation observed in Targets 1 and 2 are generally consistent with previous LANSCE data
- Prompt plastic instability in some SNS specimens were attributed to nonmetallic inclusions and specimen geometry/surface roughness

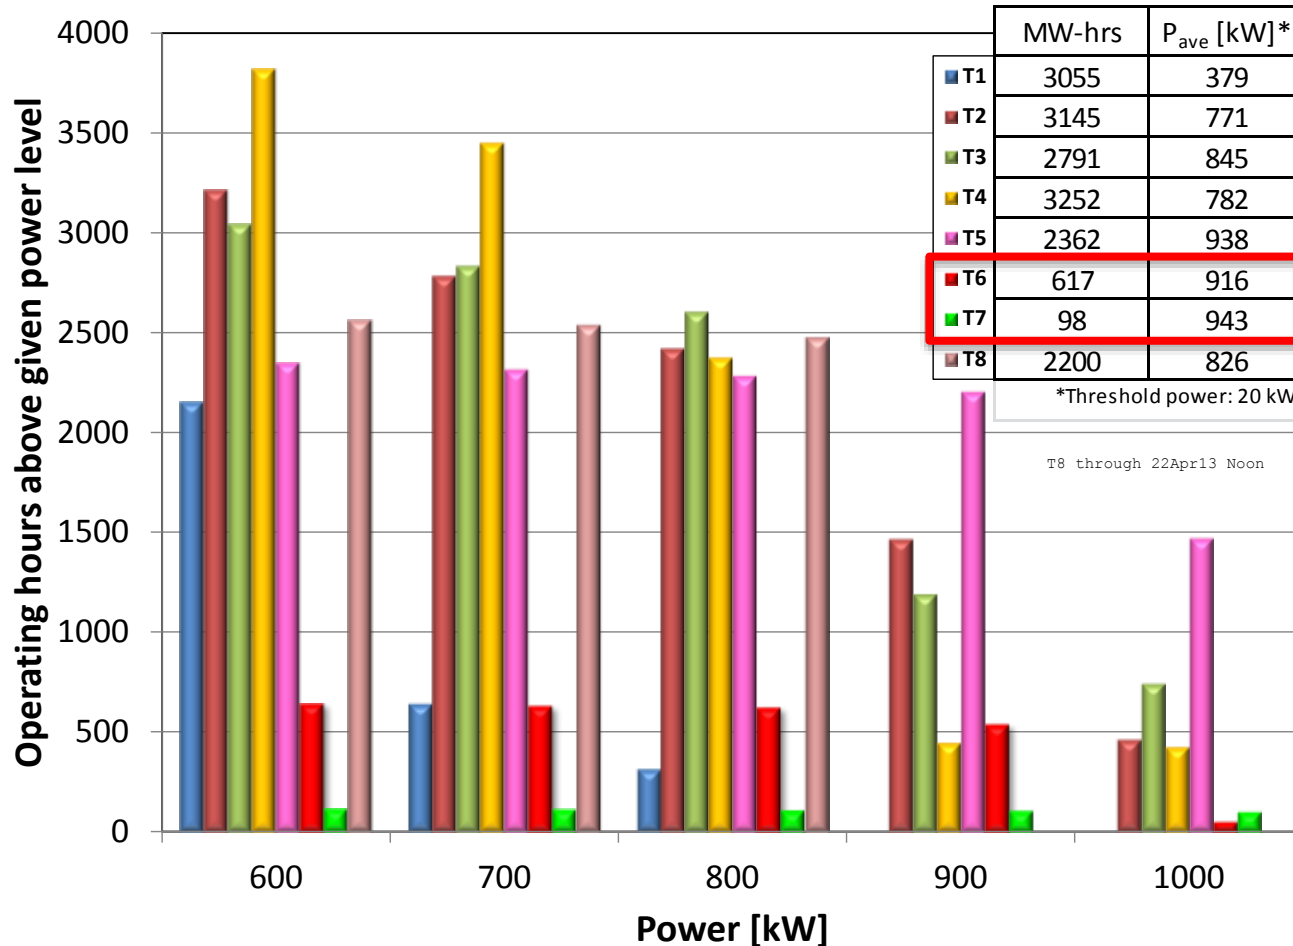
Targets 6 and 7 provided a glimpse at the early stages of erosion damage

- Early expirations of Targets 6 and 7 provided unique observations of the early stages of cavitation-induced erosion damage

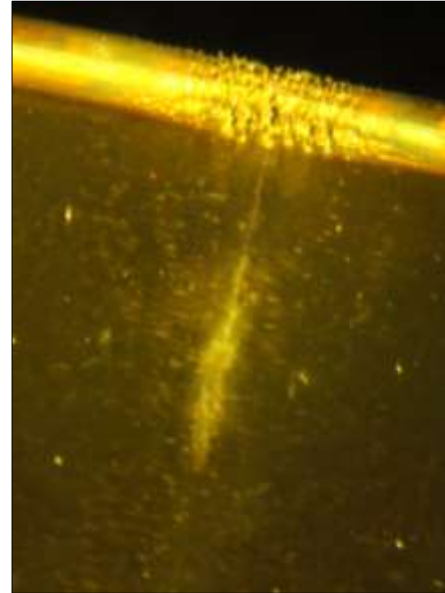
Center Baffle (after cleaning)

Erosion “hot spots” and crack-like feature on center baffle were observed on Target 6 after 617 MW-hr

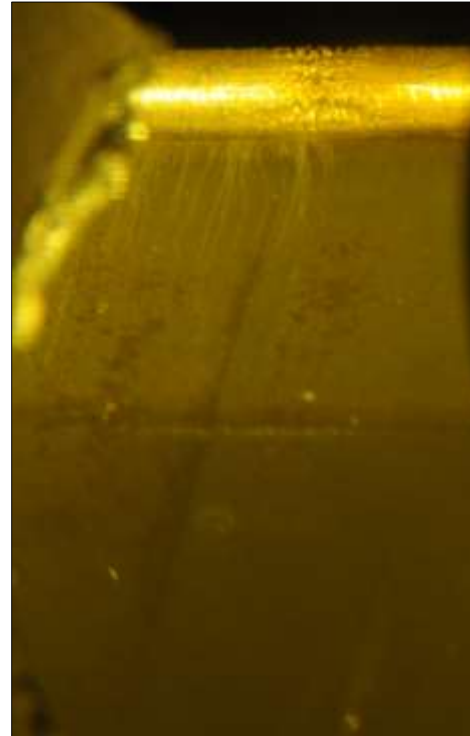
Center Baffle (after cleaning)

Erosion “hot spots” were observed on Target 7 – but no crack-like feature was apparent

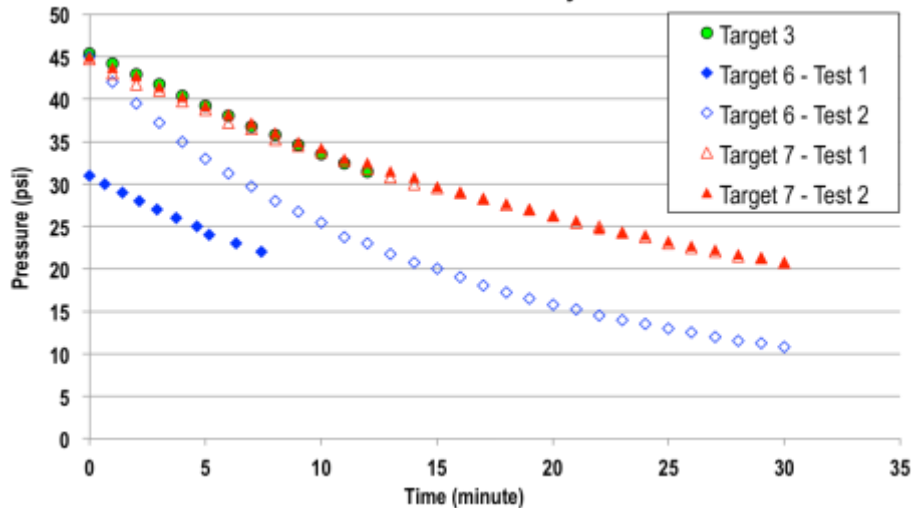
Interstitial Pressure-decay Tests

Leaks from the target vessel were confirmed for Targets 6 and 7 by leak-down testing

- Leaks were confirmed in Targets 6 and 7 using pressure decay testing
- Debris from cavitation erosion and spallation products are *somewhere* in the mercury loop
- It was initially thought a partial blockage of mercury window flow may have occurred
- The window flow supply passage was inspected using an articulating videoprobe

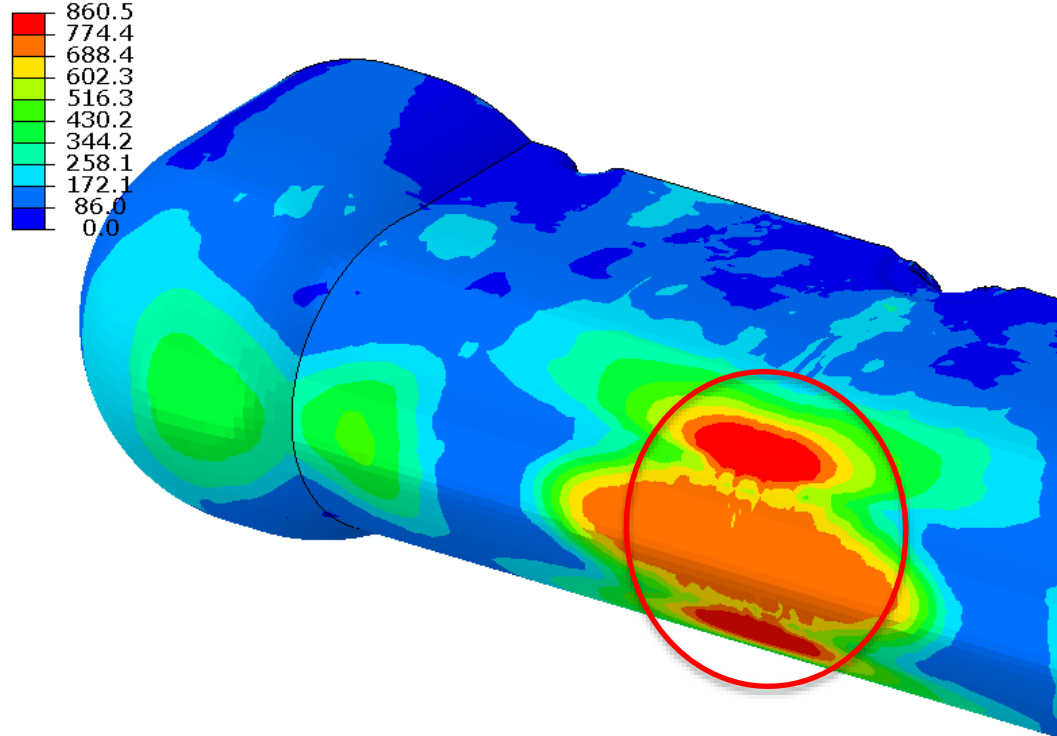
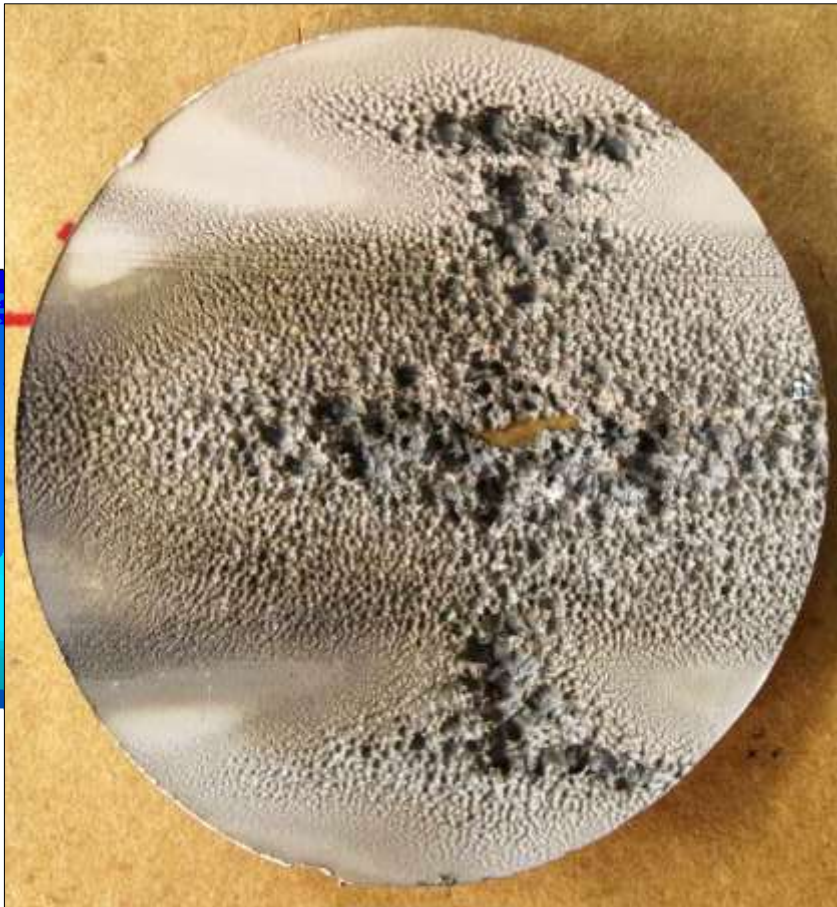
SDV_SATTIME
(Avg: 75%)

Saturation Time maps correlate with erosion patterns observed on bulk flow-facing surface of Target 1

Top and bottom of "I" clearly illustrated in saturation time map of bulk flow facing surface

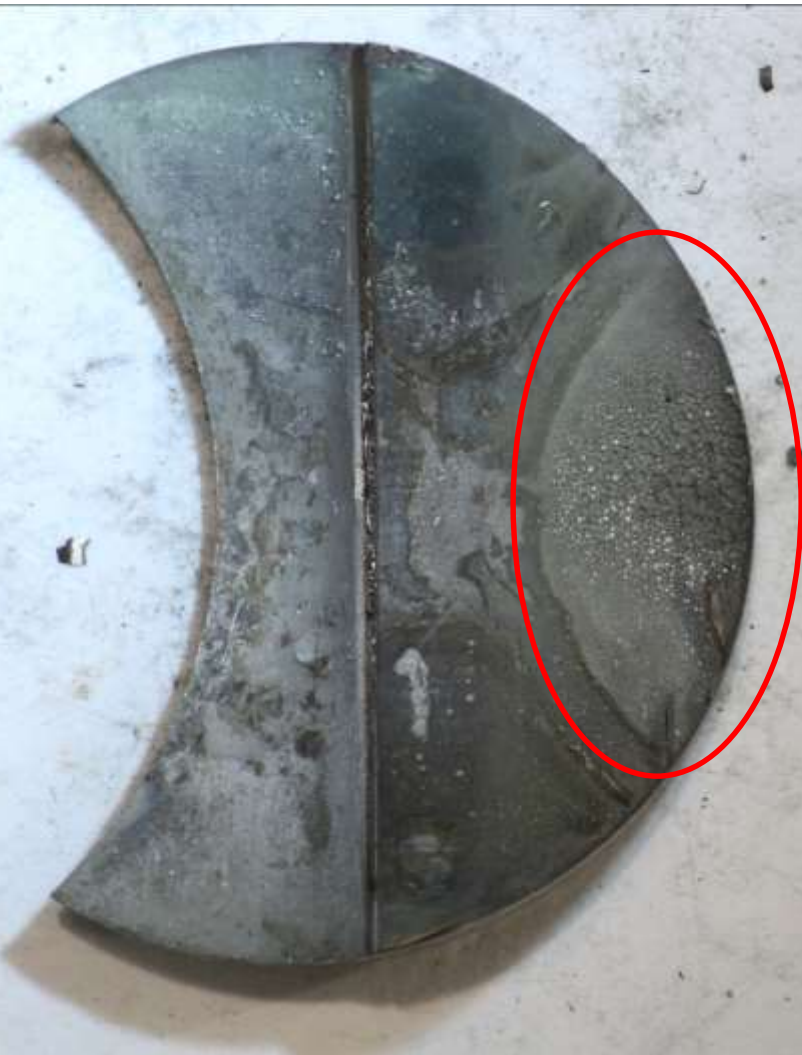
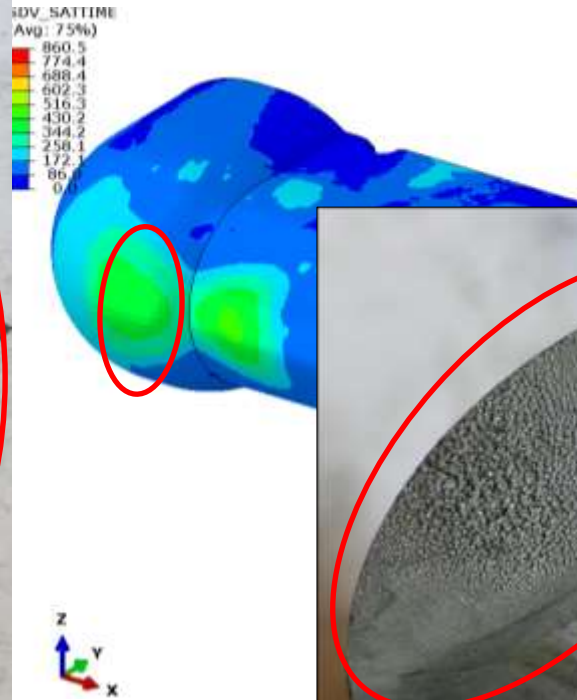
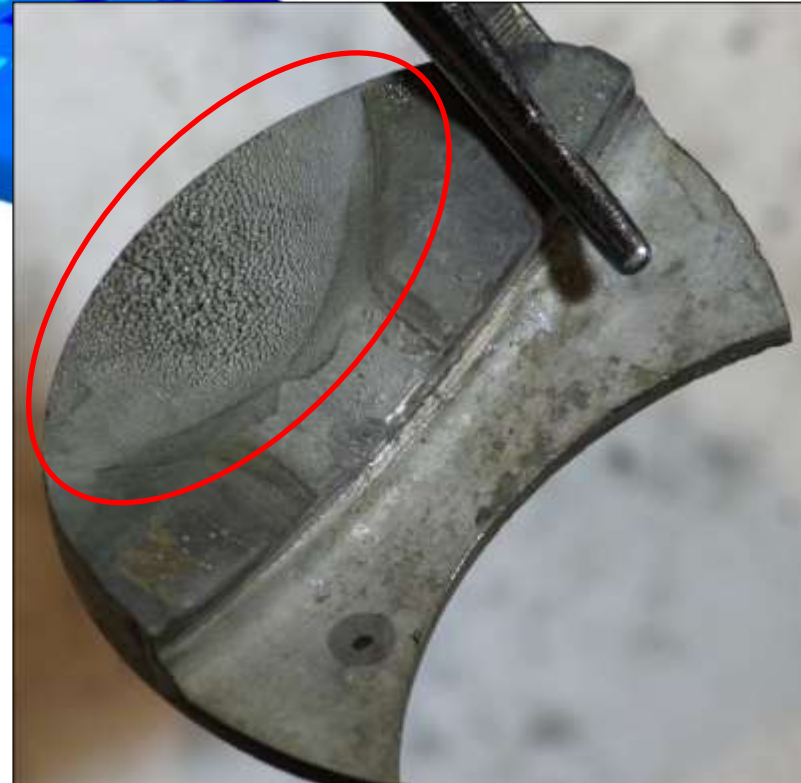
T3 Outer Wall – Ends of Bulk Supply Lines

Damage outside of beam path is indicated by saturation time

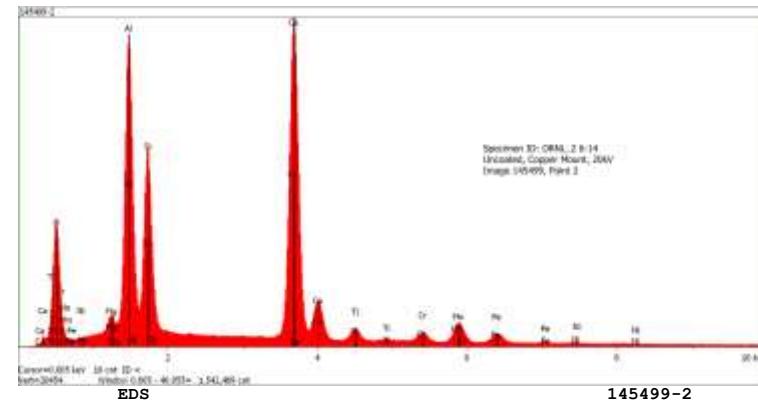
Figure 8.18: Disk 6, Section 6-16. Convex side.

Presence of nonmetallic inclusions prompted purchase of “clean-grade” ESR processed 316L

- Nonmetallic inclusions were observed in material of the Targets 1 and 2 beam-entrance region, or “windows”
- Inclusions were characterized for Target 2 material according to ASTM E45
- After consultation with steel manufacturers a “clean grade” plate of electro slag remelt (ESR) processed 316L was purchased
- The ESR processed 316L plate will be used to fabricate future target beam entrance windows

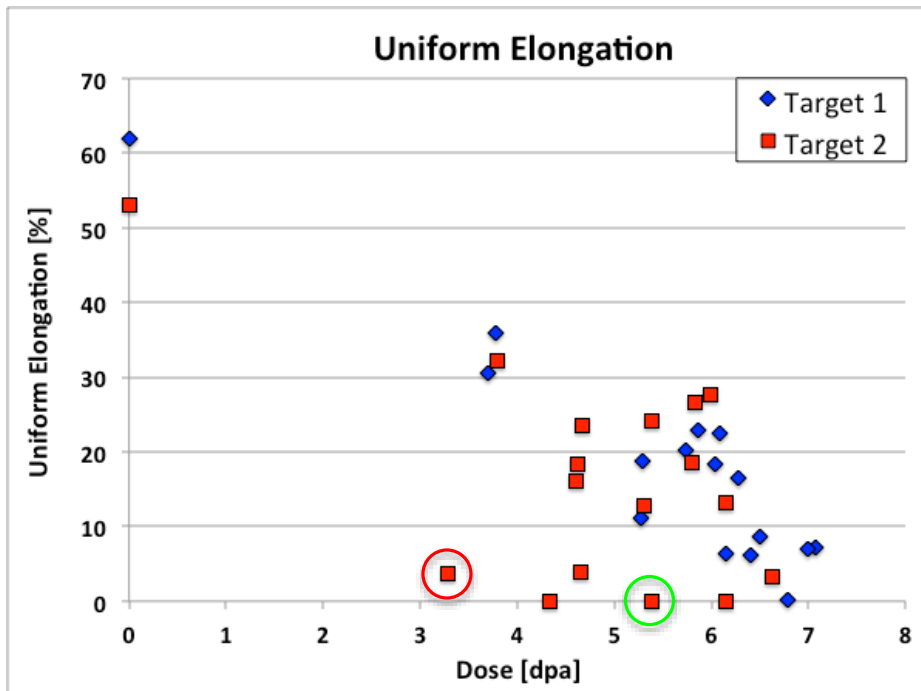
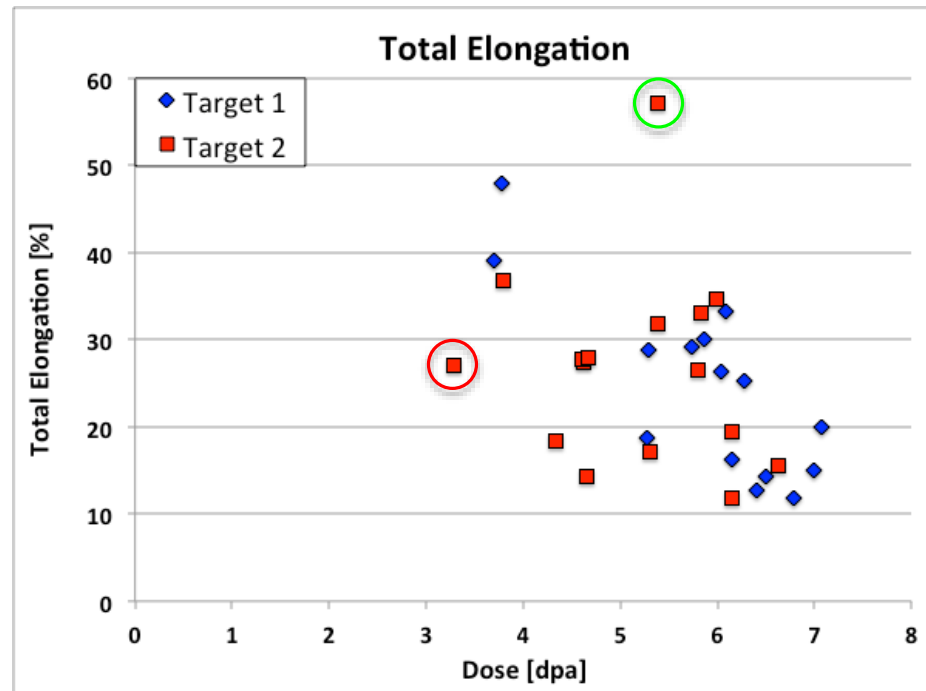
Tensile Data – Targets 1 and 2

- Steady decrease in uniform and total elongation with dose
- Scatter is attributed to the de-cohesion of nonmetallic inclusions and small specimen size effect (roughness)

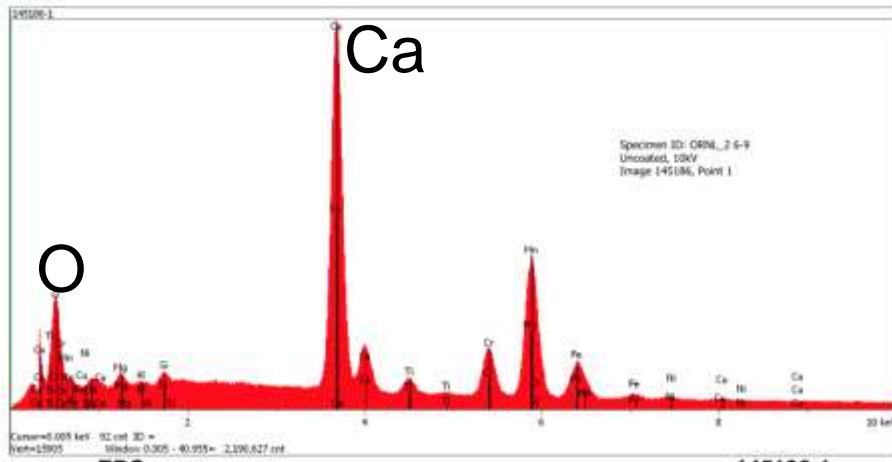
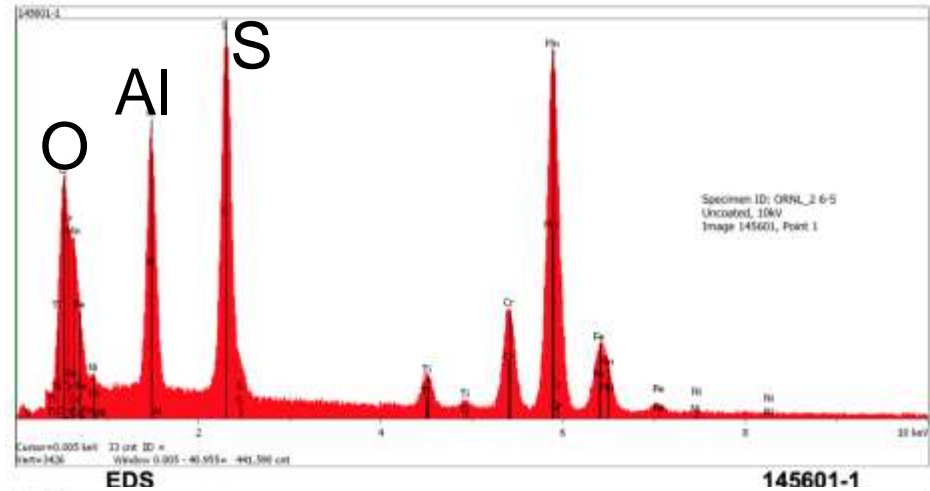
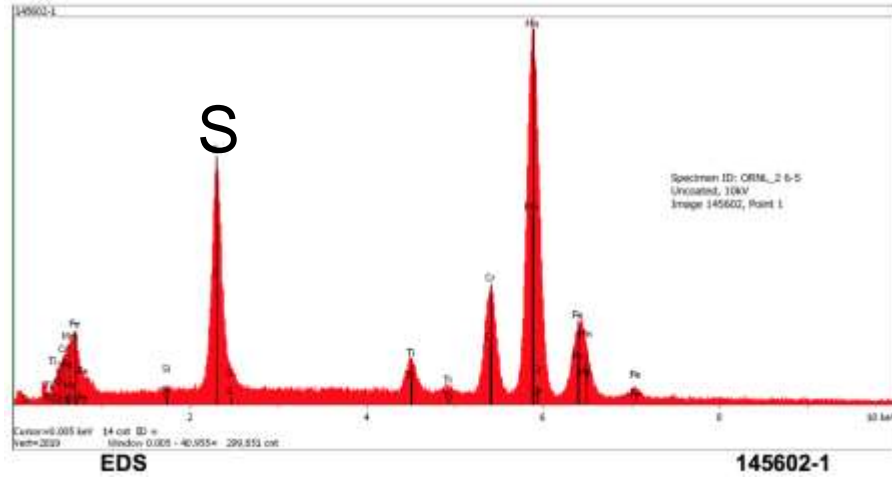
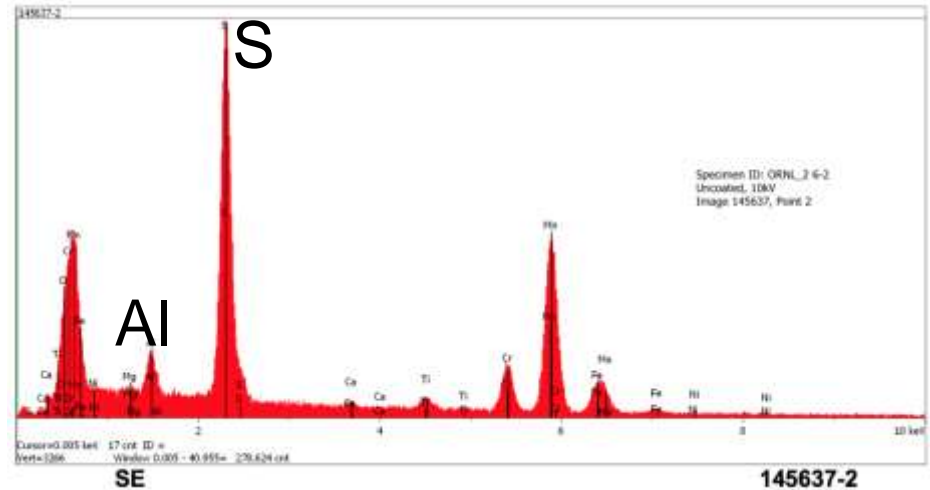
EDS Spectrums of Non-metallic

- Several different inclusion compositions were observed
 - Ca-rich
 - Al-rich
 - S-rich

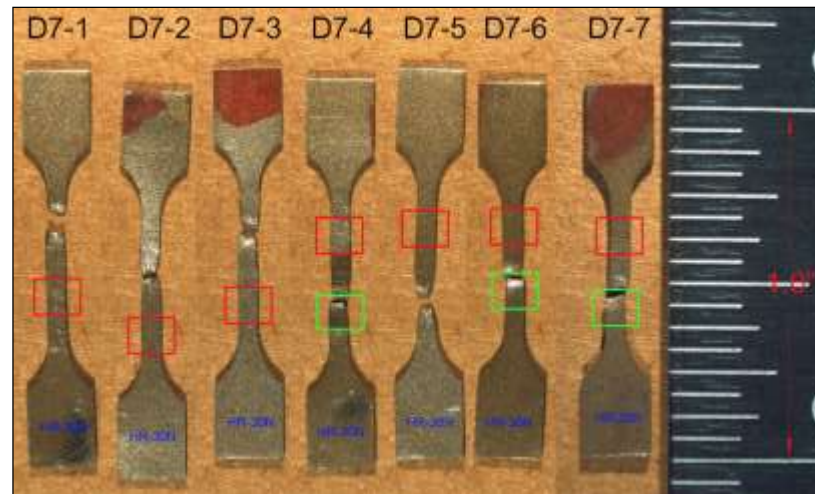
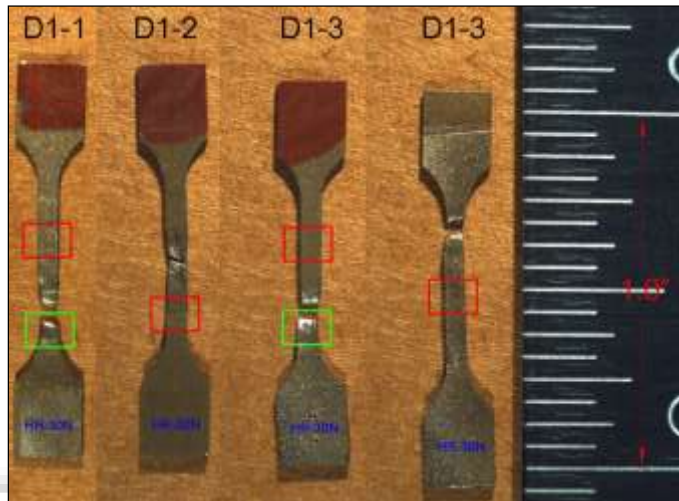
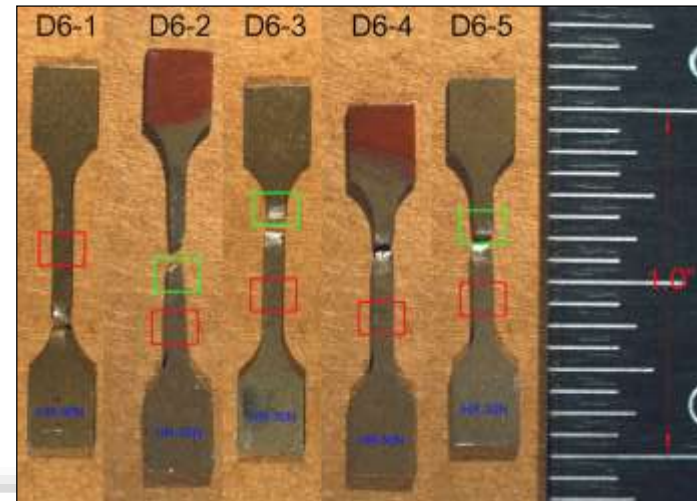
Tensile Testing Results

- Most specimens fractured in center of gauge section
 - Target 2 Tensile Specimens:

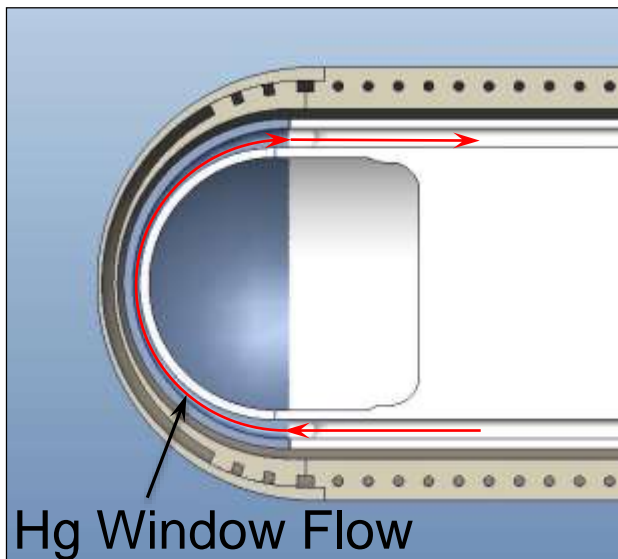
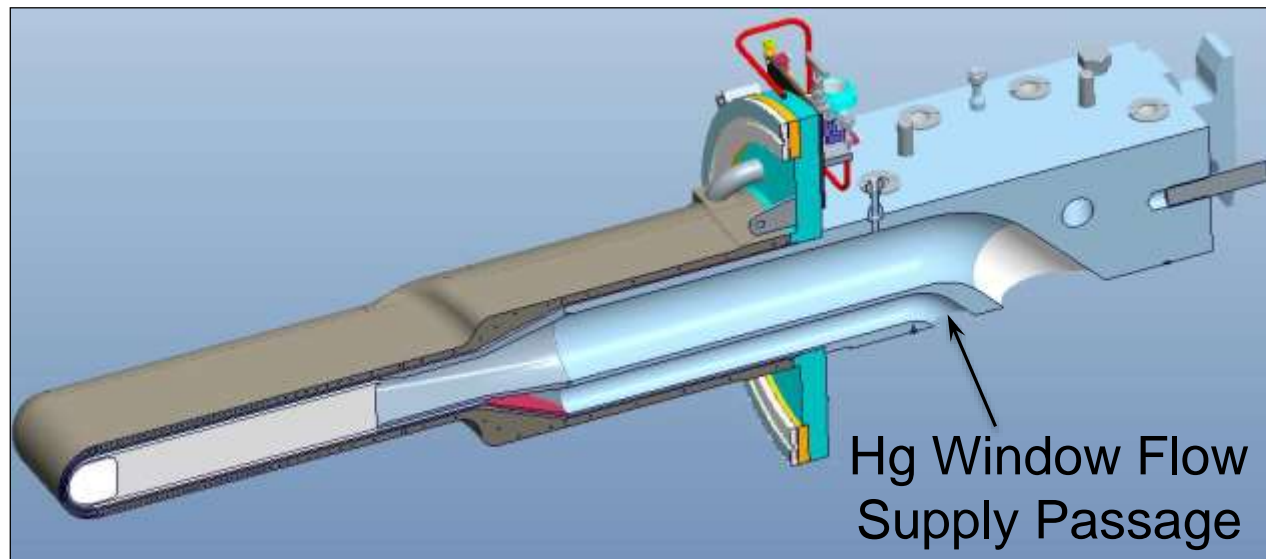
Target 6 – Mercury Window Flow

- Beam entrance region of the mercury target vessel is cooled by a uniform high-velocity (2.5 – 3.0 m/s) “window-flow” of mercury
- The high velocity mercury and narrow channel appear to mitigate cavitation-induced erosion
