# Linac Modulator Performance and Upgrades

**David E. Anderson, presenter**

# High Voltage Converter Modulator (HVCM) Talk Overview

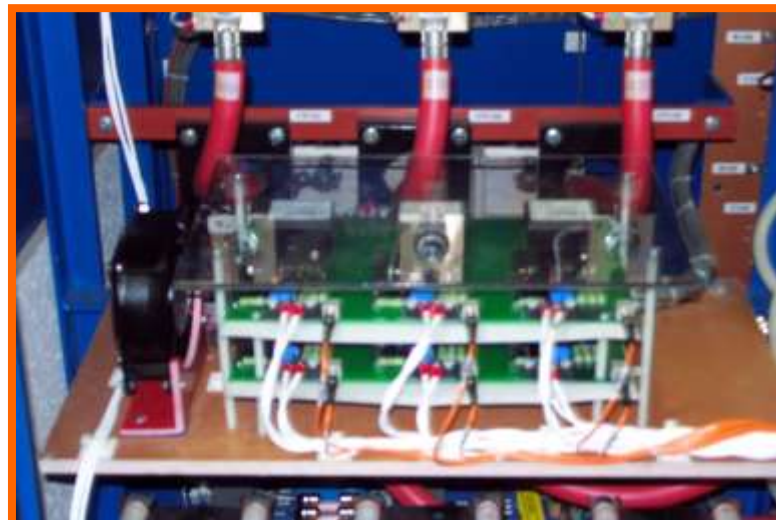
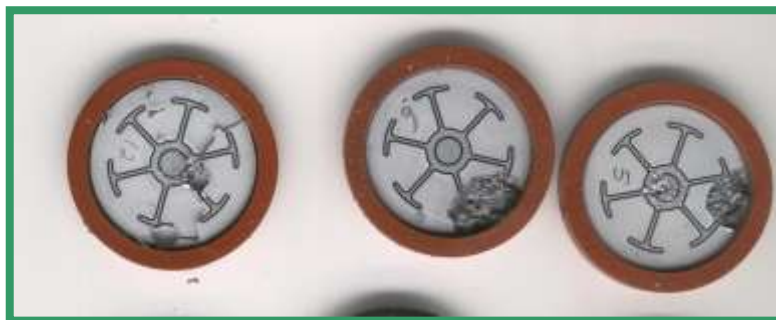
# HVCM History – SCR Issues

- **Early Operations revealed SCR reliability problems**
  - Replaced hard-fire cards to provide more robust gate signal
  - Replaced snubbers w/ non-inductive resistors
  - Installed fast overcurrent protection
  - Insulated gate leads (corona-induced failures)
  - Installed SOLA line conditioners
  - Other misc. upgrades
- **Completed FY05**
- **Significant MTBF increase (order of magnitude) since upgrades**

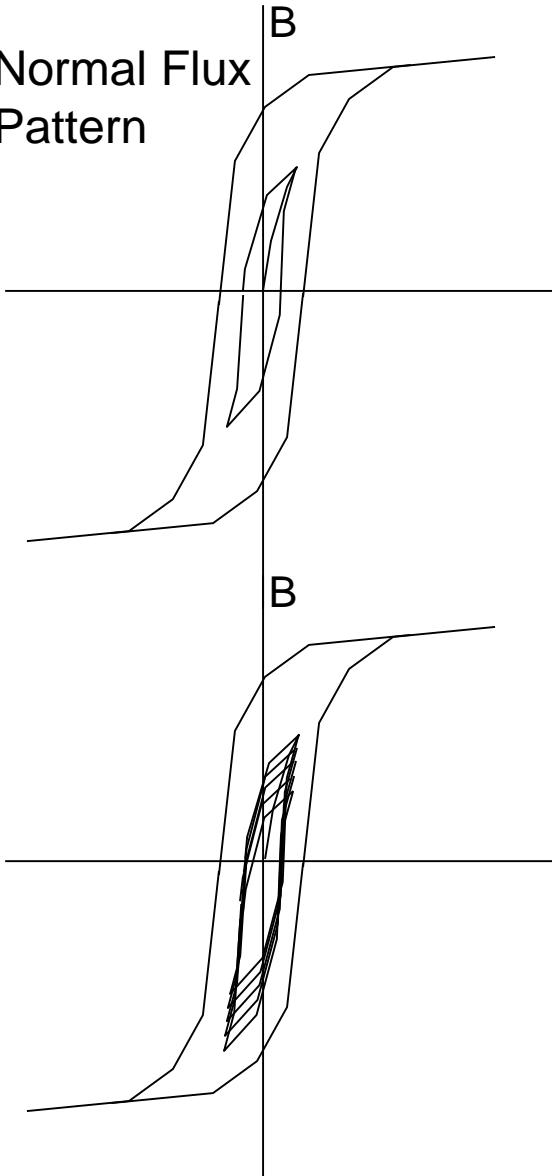
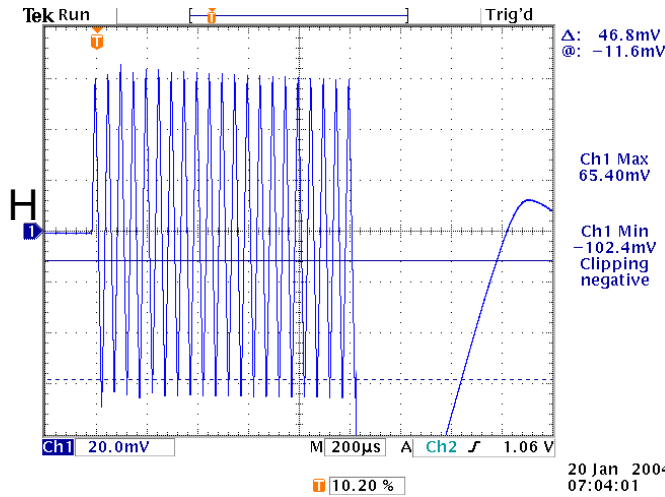
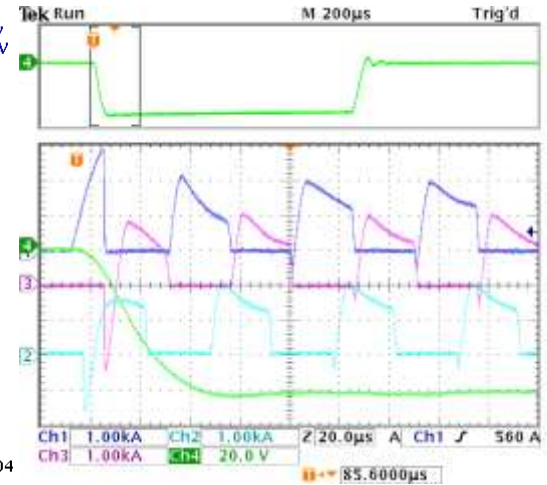
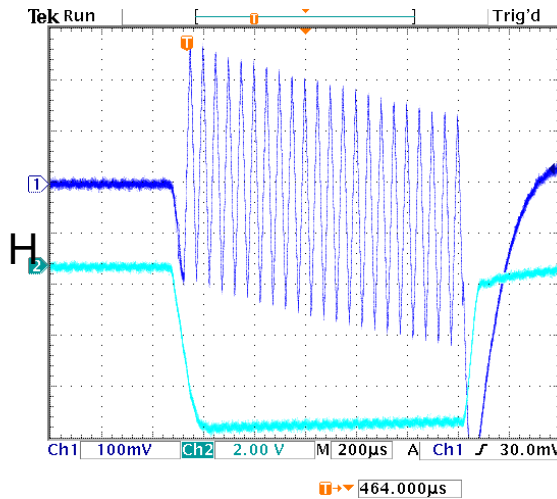
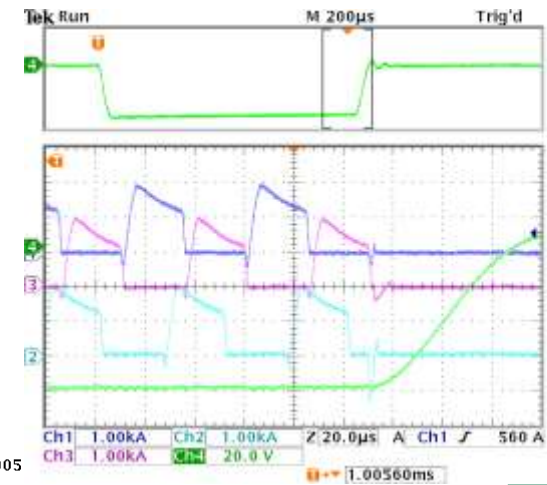
# IGBT Flux Saturation

Normal Flux Pattern

20 Jan 2004  
07:04:01

20 Jan 2004  
10:57:32

28 Jul 2005  
16:19:02

20 Jan 2004  
10:56:48

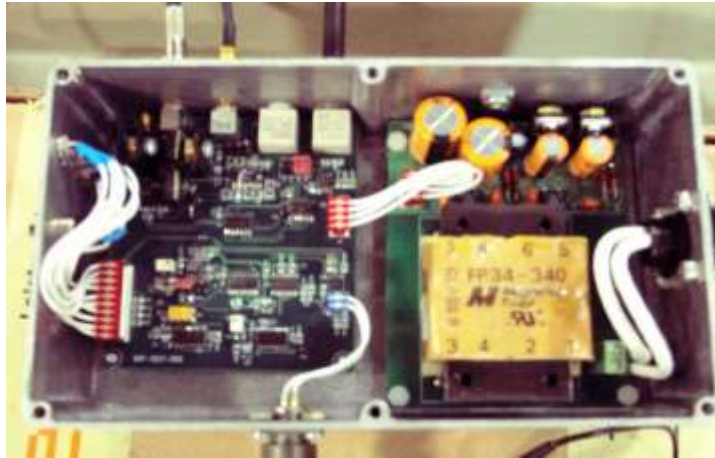
# IGBT Gate Drive Proto 1 Progress

- Typical fault current cleared
- Circuit response time  $1 \mu\text{s}$ , dominated by IGBT delays
- Slow  $V_C$  falltime due to device doping
