SNS target challenges and progress

Presentation to
**SNS Accelerator Advisory
Committee**

Phil Ferguson
SNS Source Development Group Leader

Oak Ridge, Tennessee
May 7, 2013

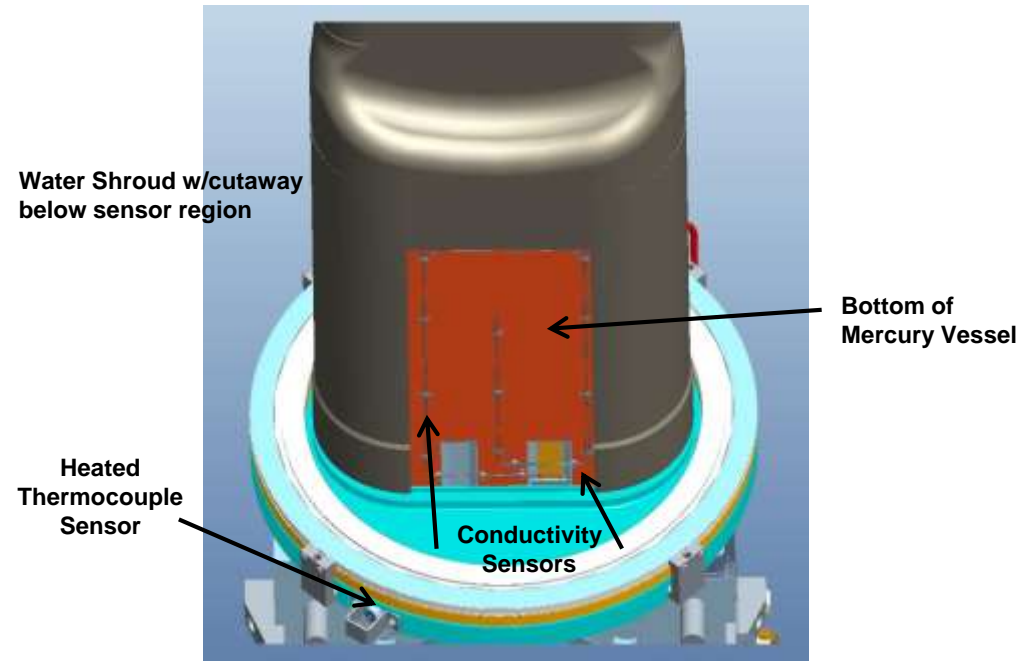
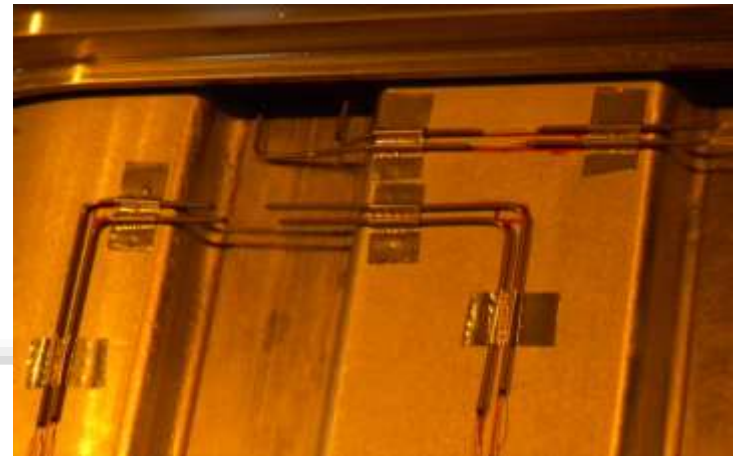
Sensors indicated mercury in the interstitial space of T6 on September 22, 2012 (~690 MW-hours of operation)

- Many questions, but still have 3 targets
- Return to operations and perform a detailed evaluation of the issue
 - Sensor issue, cavitation issue, etc.
- Exceptional effort to return to operations in record time

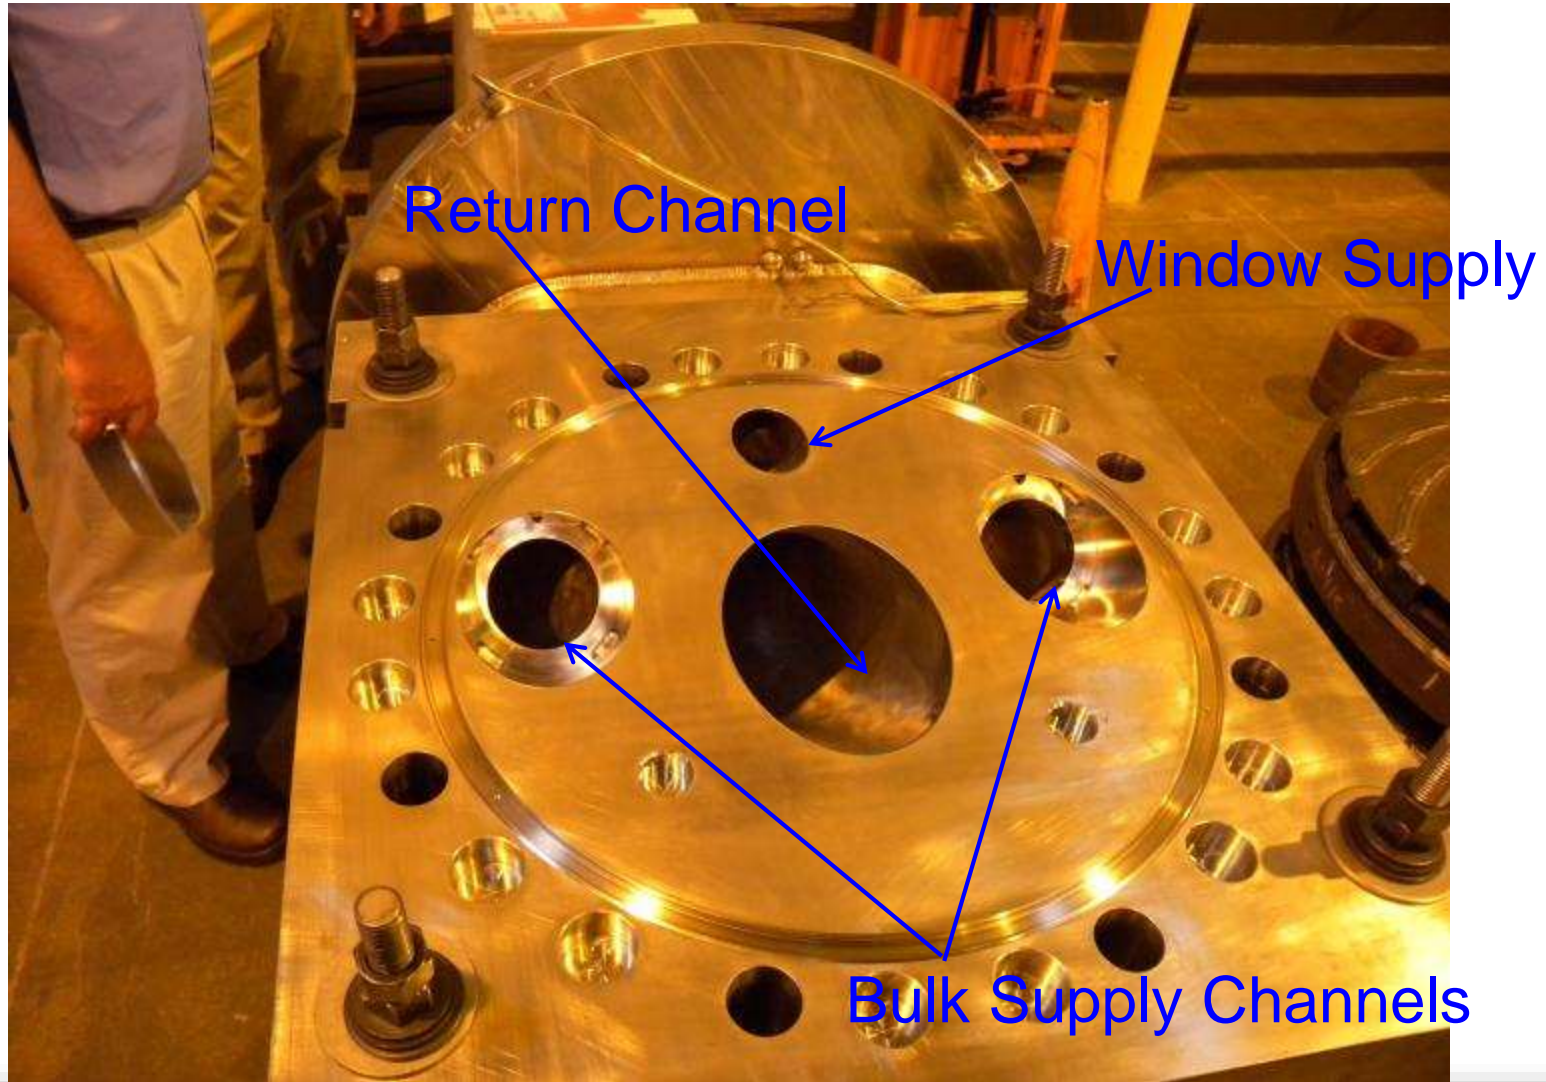
The manifold block provides access for limited internal video examination - probe lifetime is limited by radiation dose rates

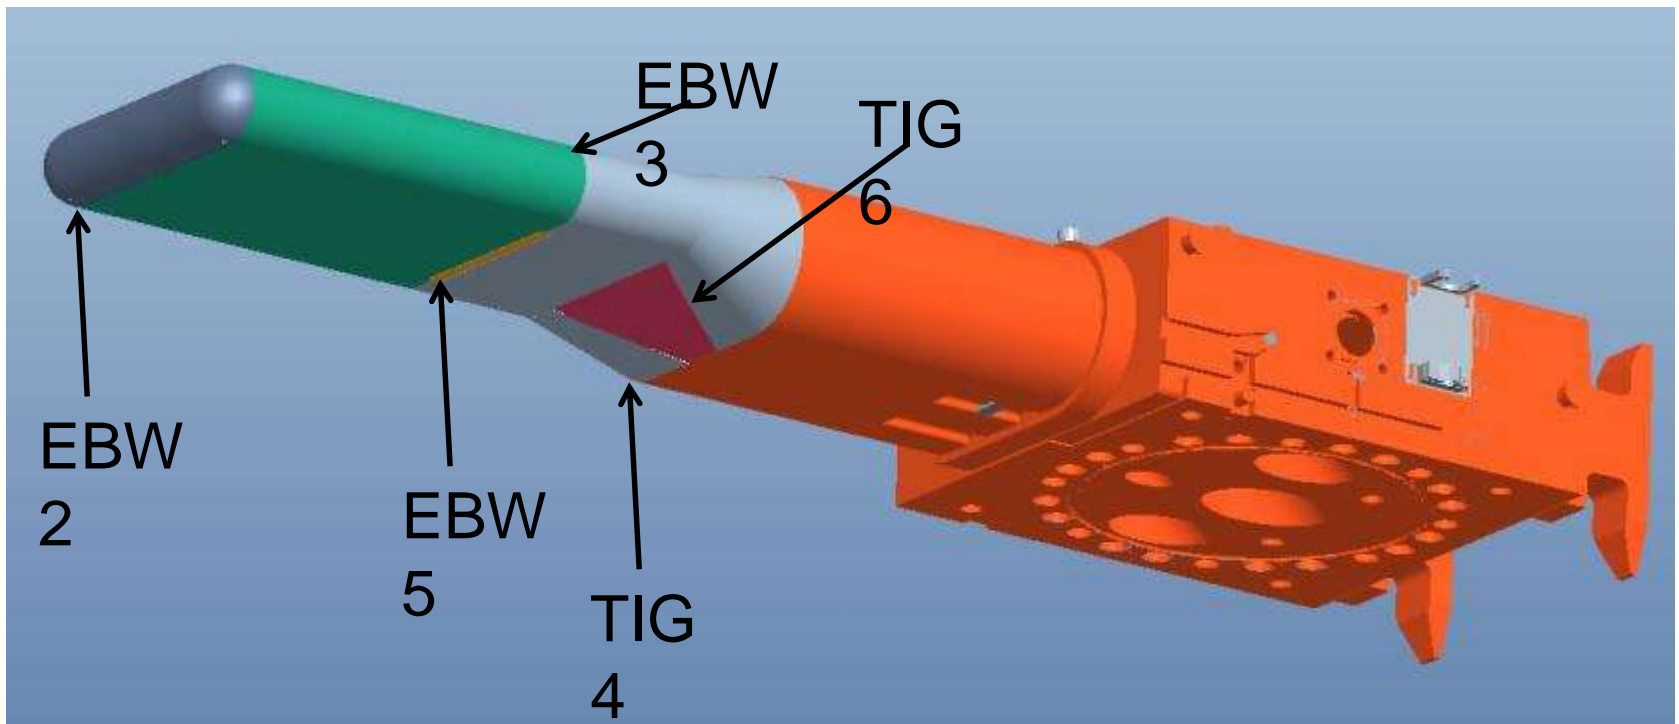
The mercury vessel pressure boundary requires 5 welds for integrity

- Flange (not shown) is not part of mercury boundary
- Weld 1 (EB) is internal and attaches the bulk flow front window
- 5 mercury pressure boundary welds (3 EBW, 2 TIG)

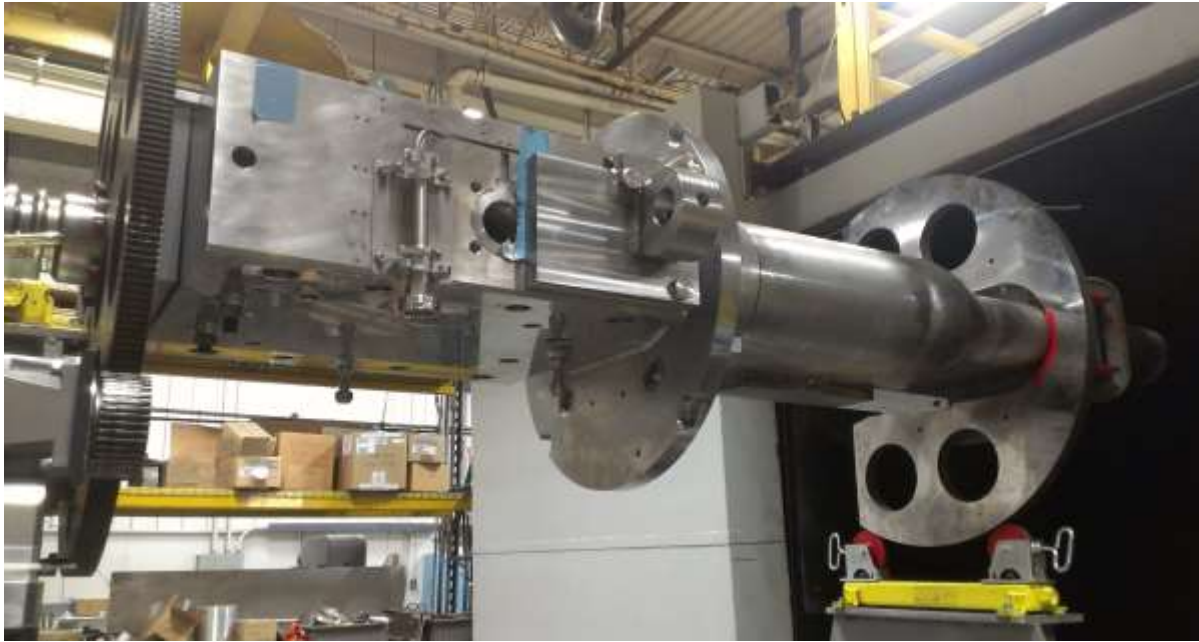
First target from Oak Ridge Tool delivered and on site with increased QA emphasis

ORTE-001 Target Module mounted on e-beam weld tooling just prior to final weld pass

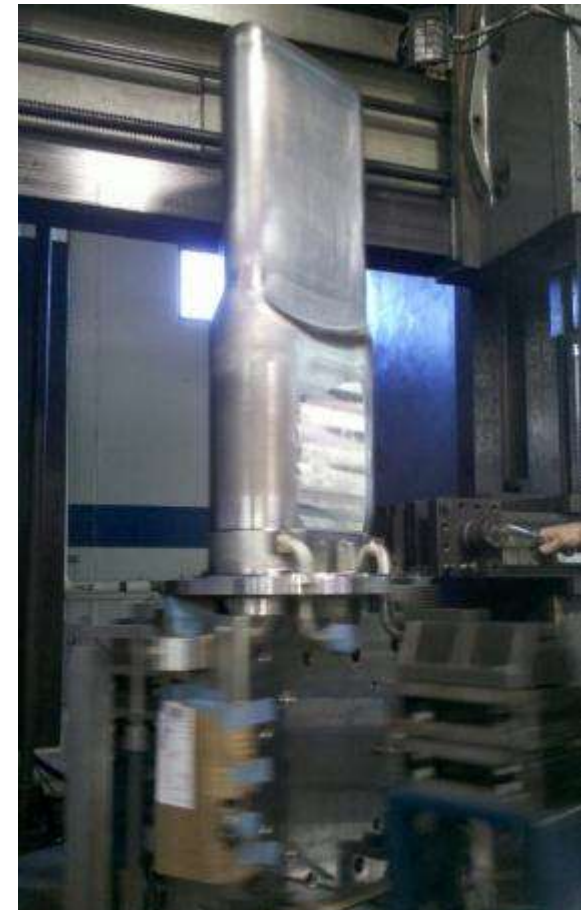
Final machining of ORTE-001 for mounting the inflatable seal

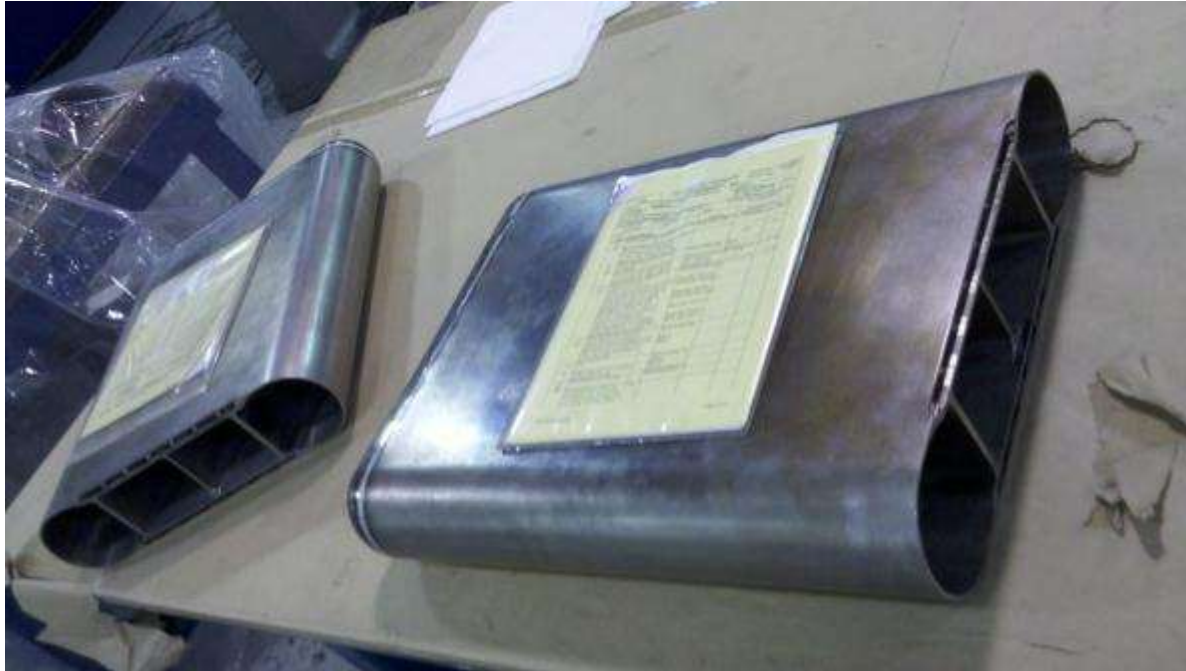
Mercury vessel front bodies, 002 and 003, with windows welded in place; ready for Kolsterizing

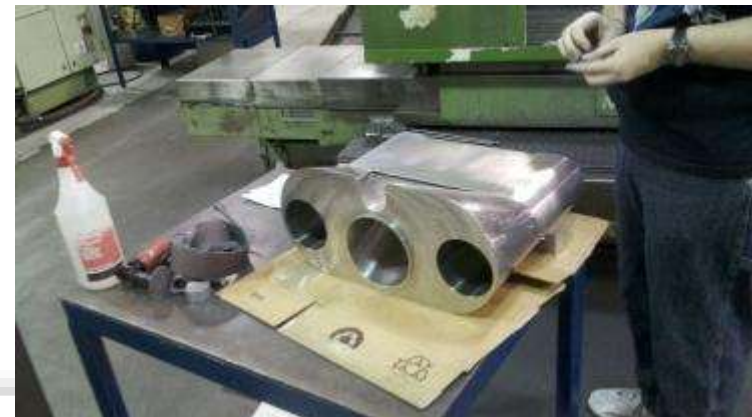
Mercury vessel transitions in final phases of clean-up

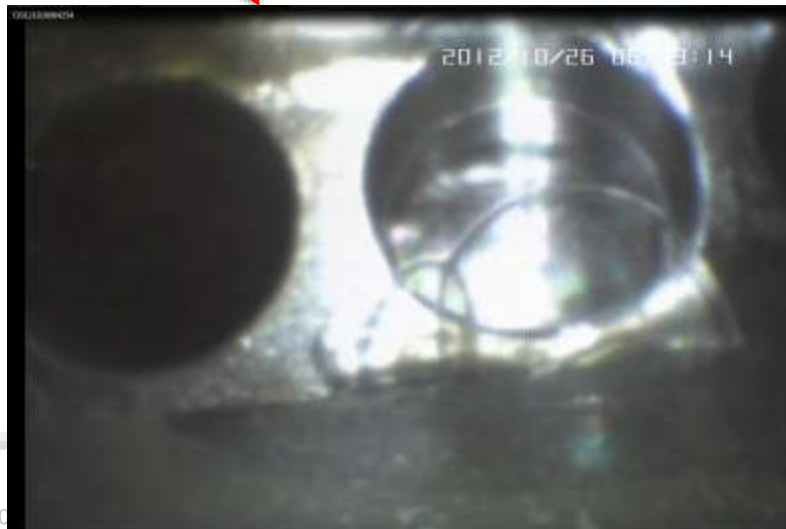
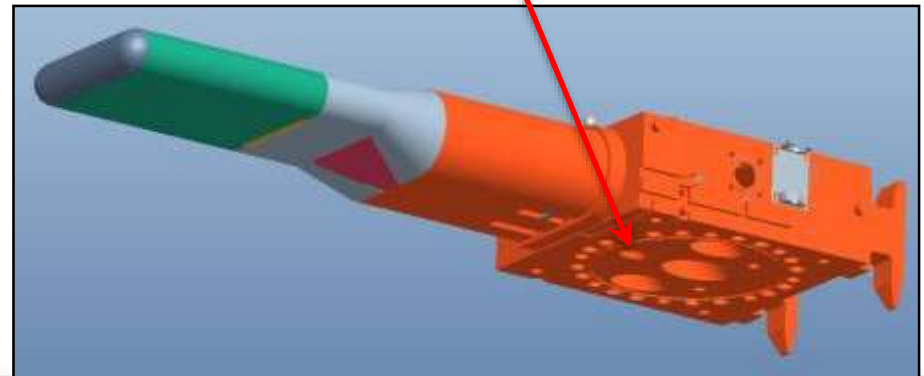
Mercury Window Flow Supply Passage

Location of Leaks in Targets 6 & 7 Were Located Using an Articulating Videoprobe

- An articulating videoprobe was inserted into the window-flow supply passage of Targets 6 & 7 and the leaks in were discovered using “Snoop” leak indicator
