Normal Conducting Linac RF Performance & Challenges

Accelerator Advisory Committee

March 24-26, 2015

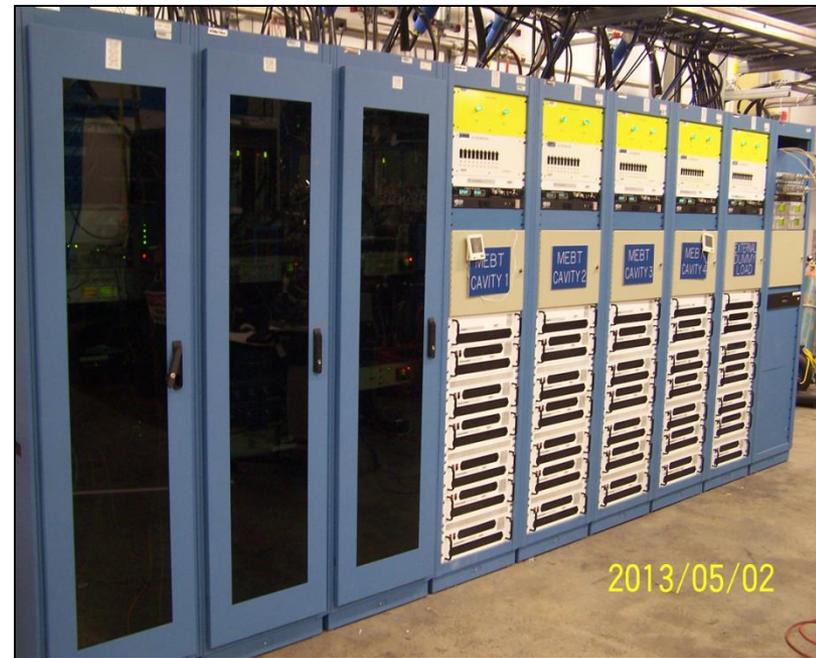
MEBT Rebuncher System

- MEBT Rebuncher RF amplifiers were upgraded in September 2010 to solid-state devices
- The amplifiers have performed well and cause minimal downtime
 - We have recently experienced two 4.2 kW amplifier module failures
 - One power supply has failed
 - One intermittent cable connection

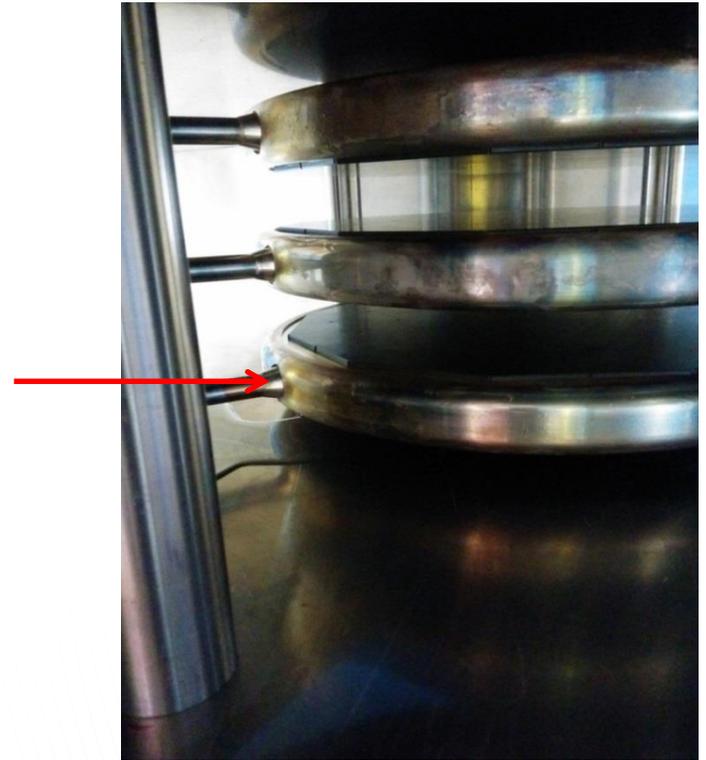
DTL Circulator Issues

- Arcing was detected in the DTL-6 circulator on June 16th, 2014
- A leak was detected on the bottom pancake of the circulator assembly
- A spare circulator was removed from the RFTF test stand and installed to allow for continued operations
 - No unused spares were available
- Inspections of the remaining 6 circulators revealed similar issues with all installed devices
 - Some show significant corrosion

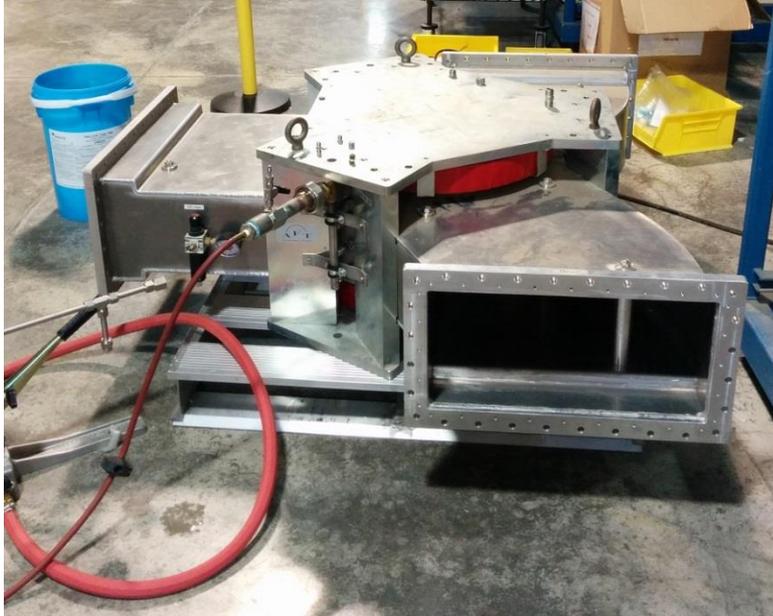
DTL Circulator Issues (cont.)

- Issue was isolated to the O-ring seals between the water inlet & outlet connections on the pancakes
- AFT was consulted and performed an on-site repair of the failed circulator and provided training on the repair techniques
- Three spare 402.5 MHz circulators are on order

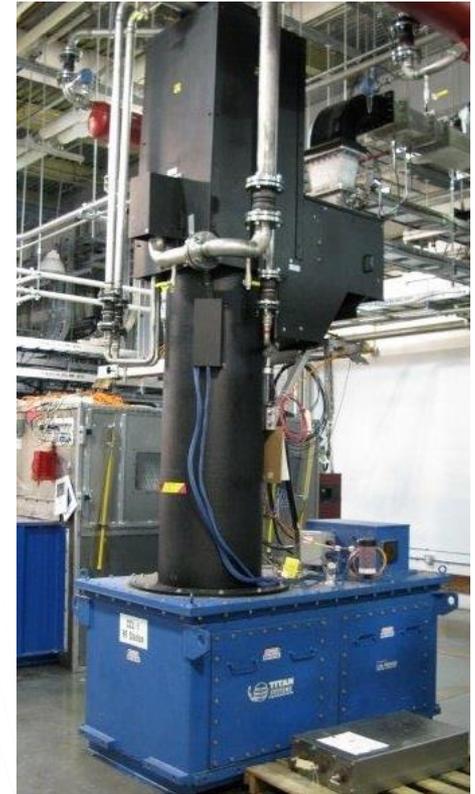
CCL Klystron Failures

- Three of the four original Thales 5 MW klystrons have failed within 1 year
 - Two klystrons failed on filament open failures (CCL 2&3)
 - One klystron is unable to generate RF power above 3.5 MW (CCL4)
 - Operating hours for the failed klystrons range from 51000 – 57000 hours
 - The remaining original klystron is still in service and the emission curve has not shown degradation
 - The average time to replace a CCL klystron is 14 hours
 - A Thales 5 MW klystron is staged in the klystron gallery ready for installation

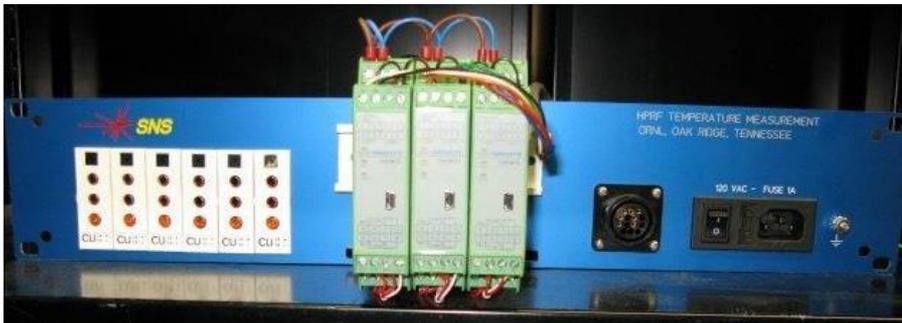
Transmitter Temperature Measurement System

- Installed temperature measurement system to monitor critical chassis temperatures
- Currently installed in Warm Linac & four SCL racks
 - Rack temperatures were unavailable
 - Supports troubleshooting

RF Range, DTL_HPRF 4			402.5 MHz
	Present	High Limit	Status
SSA Input FWD	-2.48 dBm		
SSA Output FWD	43.81 W	170.00 W	Ok
SSA Output REFL	2.11 W	17.00 W	Ok
SSA Gain	48.90 dB		
SSA Temperature			Ok
Rack Ambient Temp.	90.8 F		
Filament PS Temp.	89.2 F		
Mag PS 1 Temp.	101.4 F		
Mag PS 2 Temp.	91.8 F		
Window A Temp.	Not Used	CCL Only	
Window B Temp.	Not Used		
Klystron Input FWD	36.48 W		
Klystron Input REFL	0.26 W		
Klystron Output FWD	2310.29 kW	2700.00 kW	Ok
Klystron Output REFL	18.82 kW	50.00 kW	Ok
Klystron Gain	48.02 dB		
Status		Main Breaker	Closed
Timing Pulse	Enabled	RF Switch	To SSA
Delay	0.53 ms	Faults	No Faults
RF Data Com		Mode	Rad. For HV
SSA Gate	Ok		
	Ok
